Industry Alert

Risks associated with trunnion pin type suspension systems

This industry alert provides information about the risks associated with repair or refurbishment of trunnion pin type rear suspension systems common to many heavy vehicles.

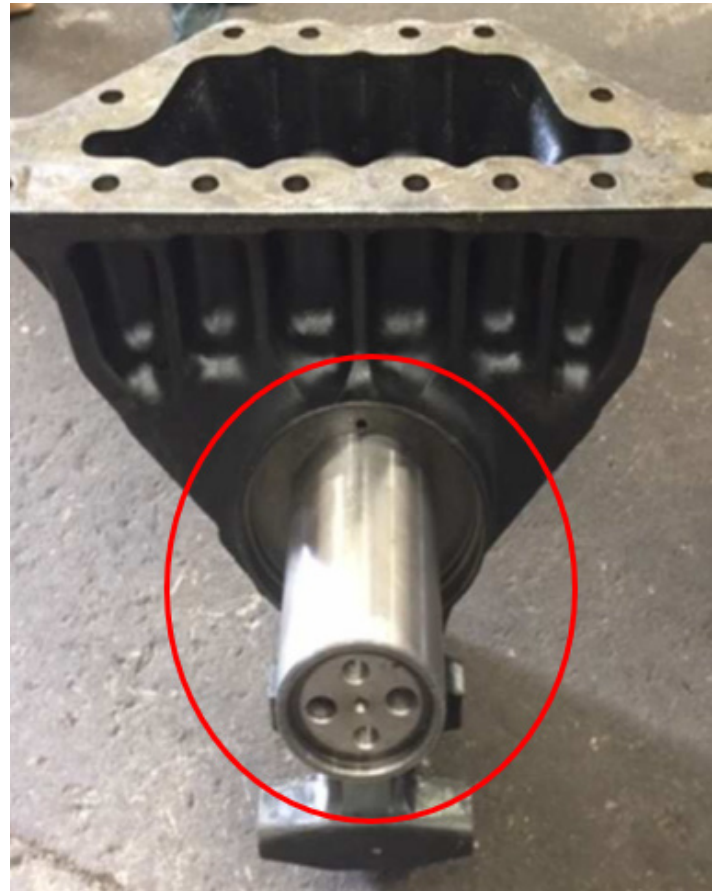
Figure 1: Trunnion housing and pin assembly (source NZ Police)

This industry alert is aimed at heavy vehicle service providers and heavy vehicle operators to ensure all repairers of heavy vehicles are aware of this issue. It addresses the trunnion pin type suspension where the pins and housings are separate from the cross shaft (figures 1 and 2).

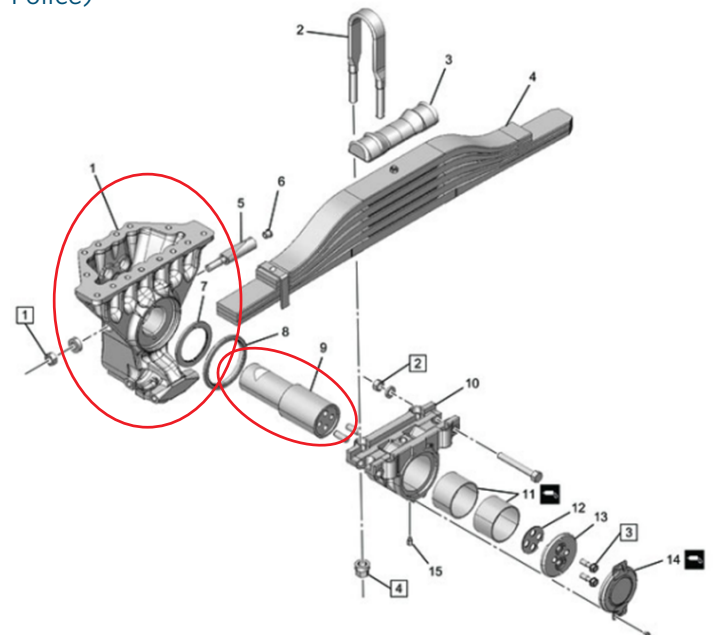
Figure 2: Exploded view of trunnion pin type suspension (source Isuzu NZ)

Vehicle manufacturers using this type of suspension DO NOT support any repair, machining or refurbishment of the trunnion pin or the trunnion housing (indicated in figure 2).

OE service parts purchased from a reputable supplier are recommended for both the pin and the housing assembly as these manufacturers don't carry rebuilt or reconditioned items and have no repair method for them.

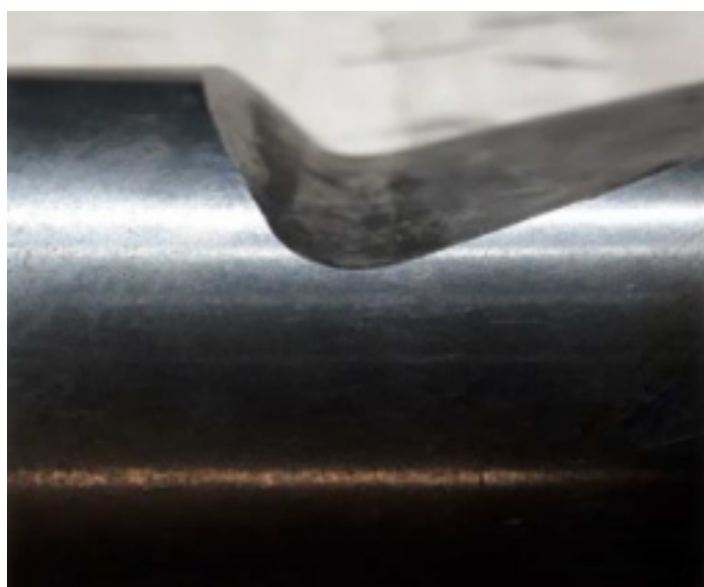
Figure 5: Genuine pin (source NZ Police)

Aftermarket trunnion pins are available but metallurgic analysis of some of them found inherent flaws in both the steel strength and subsequent machining. One difference observed between an OE pin and a sub-standard aftermarket pin can be seen in figure 5. The shape of the notch has a profound effect on the load path transferred through the pin to the trunnion housing.

The OE pin (figure 5) is designed to have a tolerance fit in the housing. The steel grade and notch can sustain large lateral load transfer that would provide a long service life.

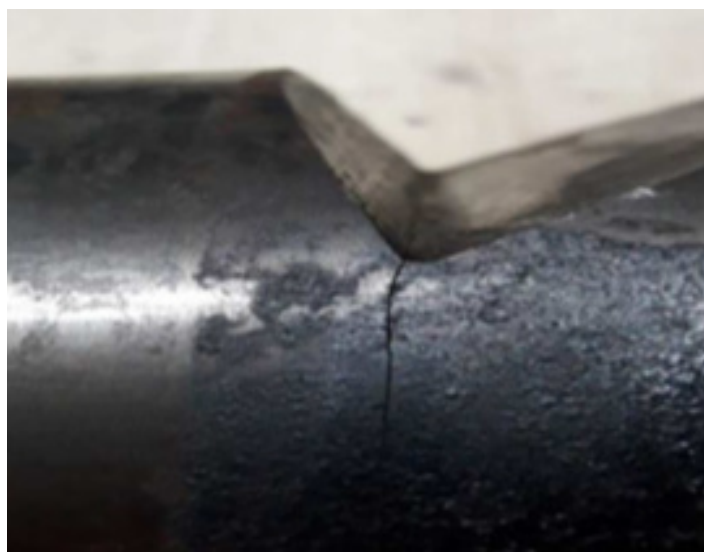
Figure 6: Substandard pin (source NZ Police)

Sub-standard aftermarket pins (figure 6) were found to have a lower steel grade and a notch design that promotes cracking at its base. The resulting fatigue and stress would lessen the expected service life, leading to premature failure. The use of these pins must be avoided.
