Industry Alert

Risk of cracks in perforated chassis rails

Waka Kotahi NZ Transport Agency are issuing this industry alert to warn heavy vehicle specialist certifiers and heavy vehicle service providers about the risk of cracks forming in perforated chassis rails.

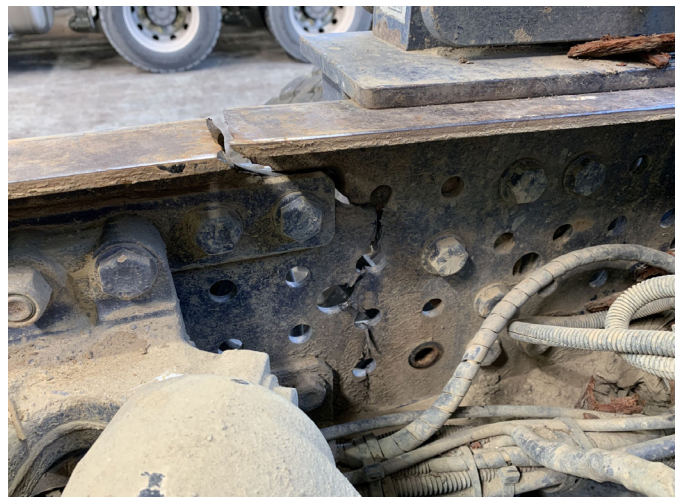
Two instances of cracked chassis rails in logging trucks have been reported to Waka Kotahi. In both cases, a crack developed between the rear suspension hanger and the log bolster attachment (Figure 1).

Figure 1: Cracked chassis rail

Waka Kotahi and a heavy vehicle specialist certifier investigated and found the crack started in a large perforation in the central chassis rail web, where changes in geometry and stiffness produced an 'alleyway of flexibility'. The crack then extended to the top and bottom flanges, causing the rail to fail.

The high bending stress combined with the chassis flexing through the 'alleyway of flexibility' has started the cracks, and ultimately led to the chassis failing.

We're not currently providing detailed repair instructions or drawings with this alert. Any repairs must be carried out according to instructions from the vehicle manufacturer and/or a heavy vehicle specialist certifier.

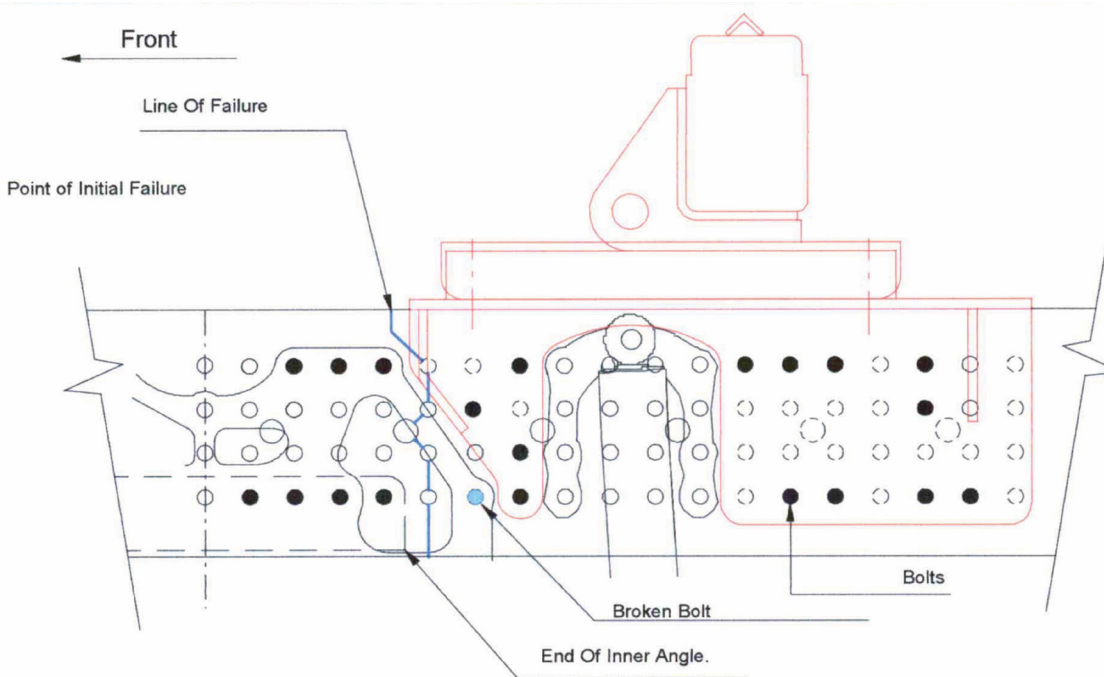
The cracks began in a large central hole. Due to tension when the trailer was loaded with logs, the crack travelled downwards through the perforations and into the bottom flange. This is shown by the *Line of failure* in Figure 2.

The crack weakened the chassis considerably so when a trailer was carried, the top of the chassis was loaded in tension. Then the crack extended rapidly upwards until it broke across the top flange. This bent the chassis down until the rear of the truck was dragging along the road.

Figure 2: Schematic of crack location

It's important to note that lateral reinforcement must be provided in these designs.
