Ilam Road, University Crossings – Post Construction Stage Road Safety Audit

Prepared for Christchurch City Council (Client)

By Beca Ltd (Beca)

23 August 2013

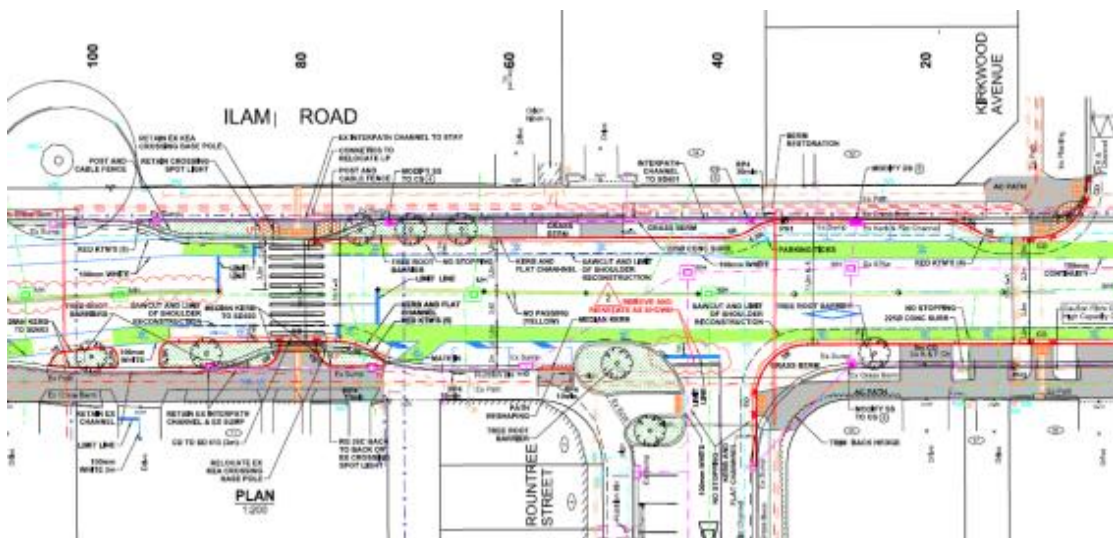
2.1.1 Tactile Paving in Vicinity of Rountree Street

Moderate

The tactile paving to the zebra crossing and crossing point adjacent to Kirkwood Avenue are inconsistent. There is no kerbside tactile paving on the eastern side of the zebra crossing and there is no directional paving to the eastern side of the informal crossing point adjacent to Kirkwood Avenue. This may make it more difficult for partially sighted users to determine the location of crossing points which could potentially result in conflict.

Figure 2-1 Note inconsistent tactile paving

Consistently apply tactile paving.

Report Ref.	Rank.	Recommendation:	Designers Comments	Auditors Comments	Exception Reporting
2.1.1	Moderate	Tactile Paving in Vicinity of Rountree Street Consistently apply tactile paving.	Fig 2.3 Disagree. The layout of the tactile paving conforms to the philosophy of RTS14. Fig 2.2 Agree The missing warning tactile markers will be installed as identified in the issued Defects List	Accept conforms to RTS14. But ideally should be consistent with other crossings in the vicinity. Accept

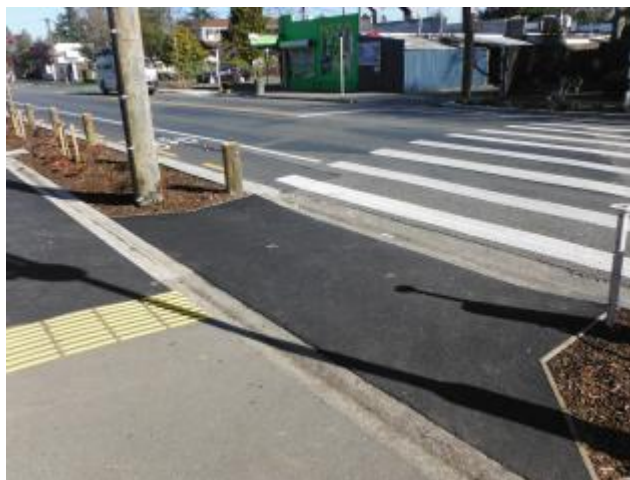
Figure 2-2 Zebra Crossing north of Rountree St. Note missing tactile paving

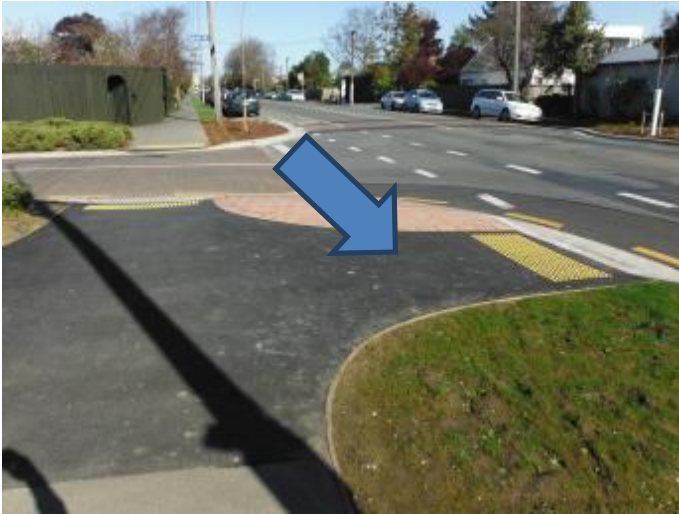
Figure 2-3 Crossing point adjacent to Kirkwood Avenue. Note no directional paving to crossing point

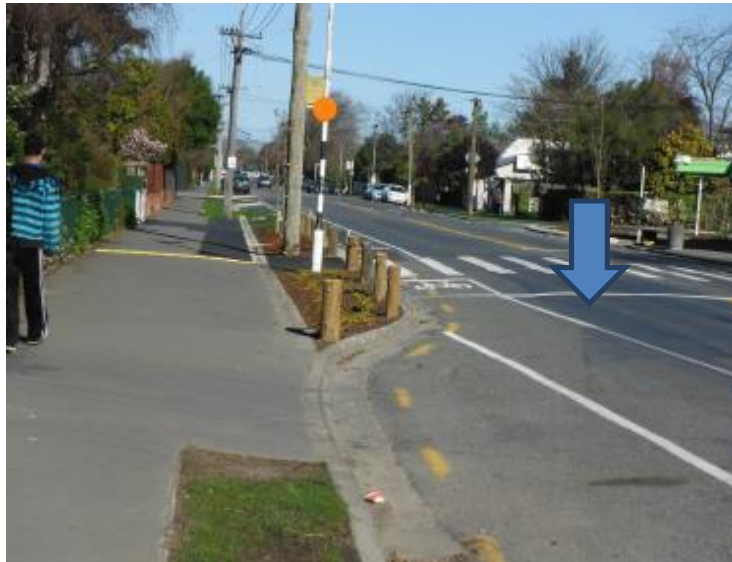
2.1.2 Surfacing on approach to zebra crossing, north of Rountree St

Moderate

It is noted that the road surface is binder rich on the approaches to the zebra crossing. This could result in less than desirable skidding resistance which could have considerable impact on a vehicles ability to stop, particularly in wet conditions. The result may be an increased risk of pedestrians being struck on the crossing.

Figure 2-4: Note binder rich surface on approach to the crossing.

Carry out testing to determine the skidding resistance of the surface and rectify if necessary.

2.1.2	Moderate	Surfacing on approach to zebra crossing, north of Rountree St Carry out testing to determine the skidding resistance of the surface and rectify if necessary.	Agree. This work is beyond the scope of this project and will be referred to the Maintenance Team to address as part of its routine maintenance works.	Accept

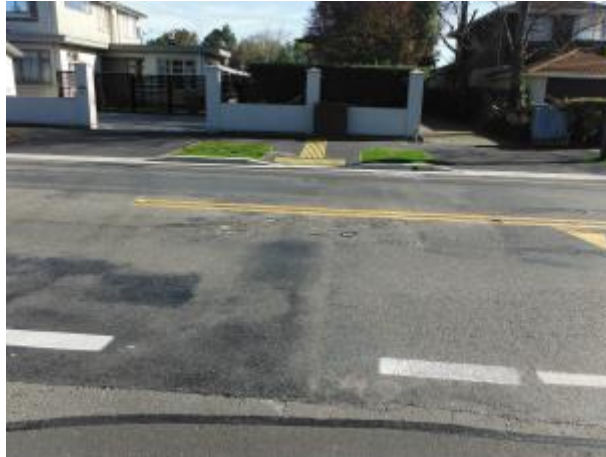
2.1.3 Crossing point adjacent to Kirkwood Avenue

Moderate

The surface condition of the road at the crossing point has deteriorated resulting in an uneven surface. This could present a tripping hazard for crossing pedestrians which could in turn increase the risk of conflict with vehicles.

Figure 2-5: Example of Bitumen Flushing

Repair road to provide a smooth level surface.

2.1.3	Moderate	Crossing point adjacent to Kirkwood Avenue Repair road to provide a smooth level surface.	Agree. This work is beyond the scope of this project and will be referred to the Maintenance Team to address as part	Accept

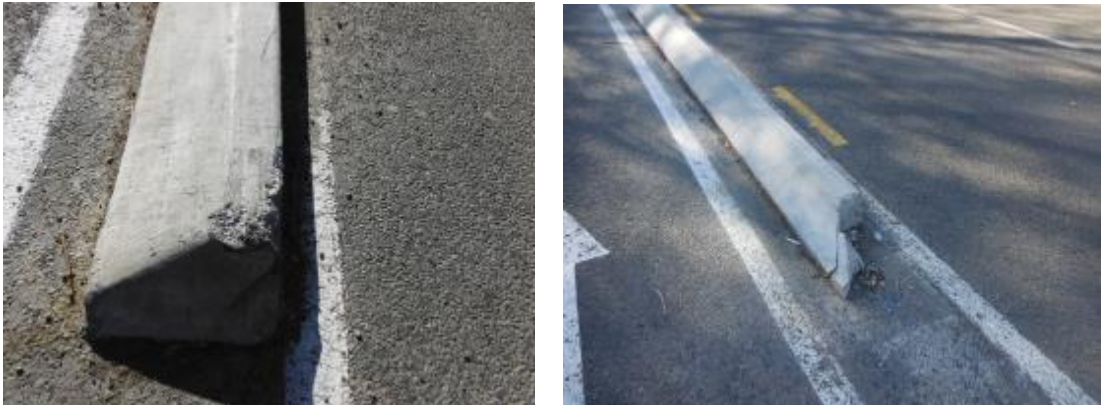
2.1.4 Concrete separator kerbs to on-road cycle lane - General

Significant

- The kerbs have sustained damage including missing reflective road studs and marker posts. This is indicative that the kerbs are not as visible as they could be and the reflectors are not robust enough.
- Night time visibility of the kerbs was good where the reflective roads studs remain. However, sections without these and in particular the kerb ends were less visible.
- The cycle lane is not wide enough for cyclists to overtake slower moving cyclists within the lane, The frequency of gaps and position of the kerbs may result in an exaggerated overtaking manoeuvre out into the traffic lane. This may be unexpected by drivers and could potentially result in conflict between cyclists and vehicles.

Figure 2-6 Note damaged kerbs and missing reflective studs

Re-attached the reflective road studs where missing and apply additional studs on the lead end of each run of kerbs in addition to a marker post. Consider applying reflective paint to kerbs, this will increase awareness and maintain visibility where reflective studs and posts become damaged. Should these continue to be struck, then it would be worth considering a mountable option. Note example in Figure 2-8 from Sydney, which has wider segregation kerb, surrounded by a white road marking and green surface in cycleway which improves visibility of facility.

Report Ref.	Rank.	Recommendation:	Designers Comments	Auditors Comments	Exception Reporting
			of its routine maintenance works.		
2.1.4	Significant	<p>Concrete separator kerbs to on-road cycle lane - General</p> <p>Re-attached the reflective road studs where missing and apply additional studs on the lead end of each run of kerbs in addition to a marker post. Consider applying reflective paint to kerbs, this will increase awareness and maintain visibility where reflective studs and posts become damaged. Should these continue to be struck, then it would be worth considering a mountable option. It is recommended that the potential issue with overtaking cyclists is monitored and addressed if necessary.</p>	<p>Agree that delineation of separator kerbs should be improved.</p> <ul style="list-style-type: none"> KTMs will be maintained as designed as an interim safety measure. Additional KTMs /reflective paint will not be applied as alternative delineation measures are currently being investigated for implementation The issue of cyclists behaviour will be monitored but deviant behaviour cannot be addressed as part of this project. 	<p>Accept</p> <p>Accept but it is recommended that changes are subject of a safety review.</p> <p>Accept</p>

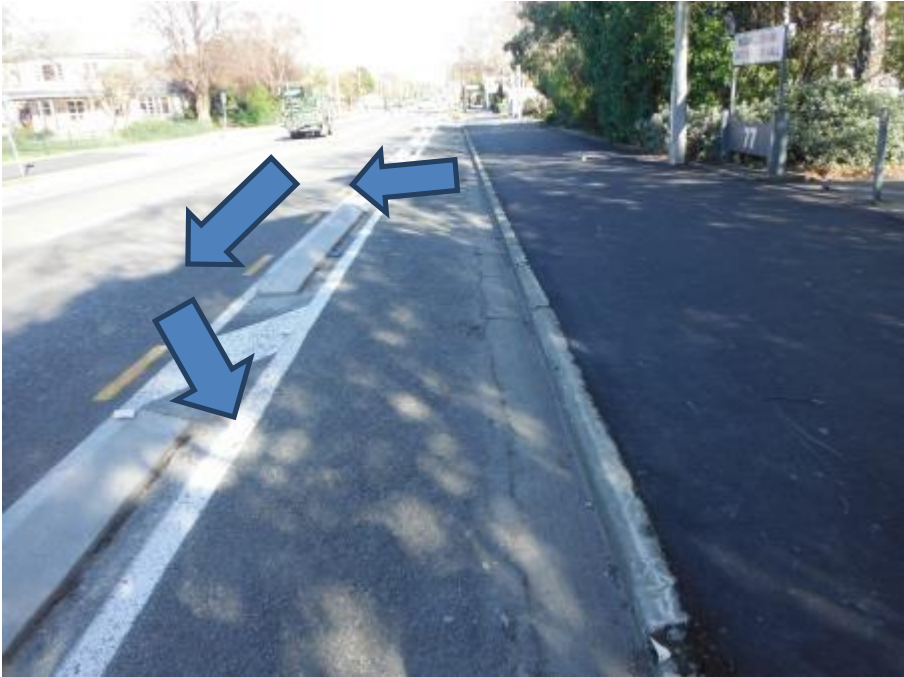
Figure 2-7 Note width of the cycle lane and the kerb restriction may make it difficult for cyclists to overtake

It is recommended that the potential issue with overtaking cyclists is monitored and addressed if necessary.

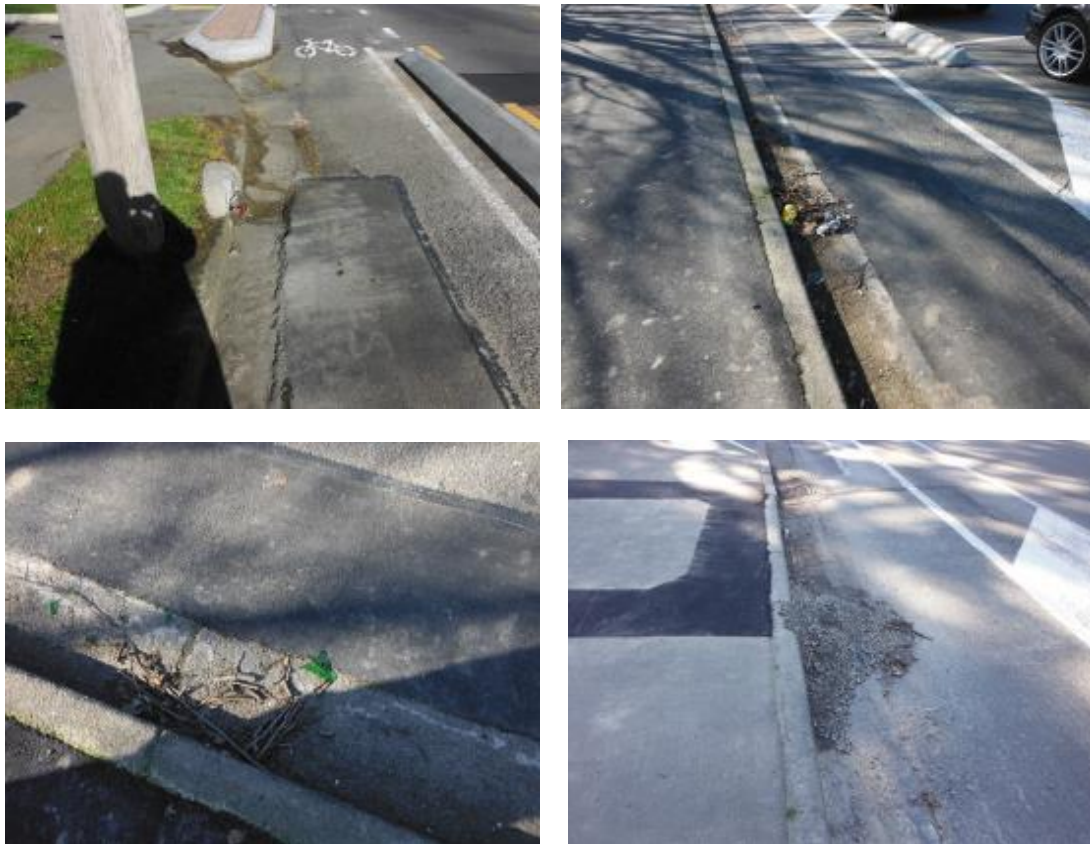
2.1.5 Surface Condition – on road segregated cycle lane

Significant

The surface condition is uneven in places. It has vertical faces down from the surface to the channel, trench reinstatements and drain covers which can make it uncomfortable for cyclists and reduce the effective width of the facility. This issue is exacerbated by the presence of debris in the cycle lane which includes glass, litter and loose material. The safety concerns with this are two-fold; these issues may increase the risk of a cyclist losing control and; potentially cyclists will use the traffic lane to avoid these issues, which may be unexpected by drivers and increase the risk of collision. Some cyclists were observed to be using the traffic lane.

Figure 2-9: Note uneven surface and debris in cycle lane

Ideally provide a smooth and level surface throughout the cycle lanes. As a minimum ensure that the facility has regular cleaning to minimise debris.

2.1.5	Significant	<p>Surface Condition – on road segregated cycle lane</p> <p>Ideally provide a smooth and level surface throughout the cycle lanes. As a minimum ensure that the facility has regular cleaning to minimise debris.</p>	<p>Disagree. The edge of seal edge break and level differential have been rectified (500 lineal meters of mill and fill) and is now trafficable by cyclists.</p> <p>Agree. Periodic cleaning of channels is undertaken (recently done and the issues identified have been resolved)</p>	<p>Accept</p> <p>Accept</p>

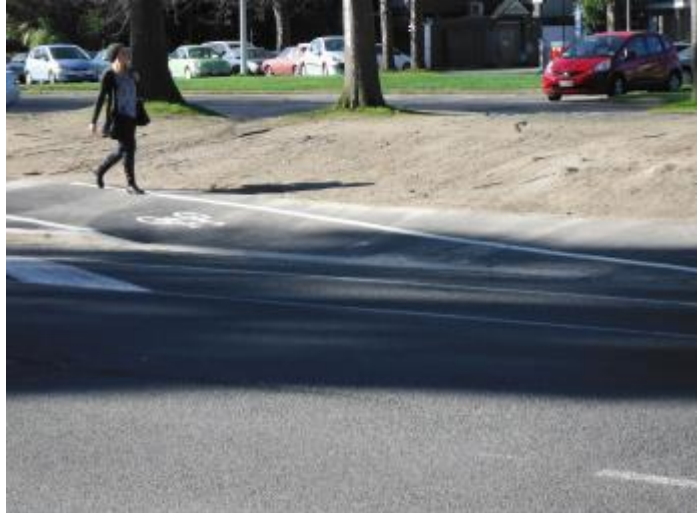
2.1.6 South bound bus stop cycle bypass lane - Ramp

Minor

Opposite Homestead Lane there is southbound cycle lane which bypasses the bus stops. The ramp onto the road appears steep and has a small kerb upstand before meeting the camber which rises to the crown of the road. While this facility is continuous, the transition from off-road to on-road is not as smooth as may be expected. This may increase the risk of a cyclist losing control.

Figure 2-10: Note steep ramp on the transition to the on-road cycle lane

Consider providing a smoother and less steep transition in future maintenance works.

2.1.6	Minor	<p>South bound bus stop cycle bypass lane - Ramp</p> <p>Consider providing a smoother and less steep transition in future maintenance works.</p>	<p>Agree that a minor risk exists. We are not aware of any difficulties existing and will monitor the ramp performance and undertake remedial action if necessary.</p>	<p>Accept 20/1/14.</p>

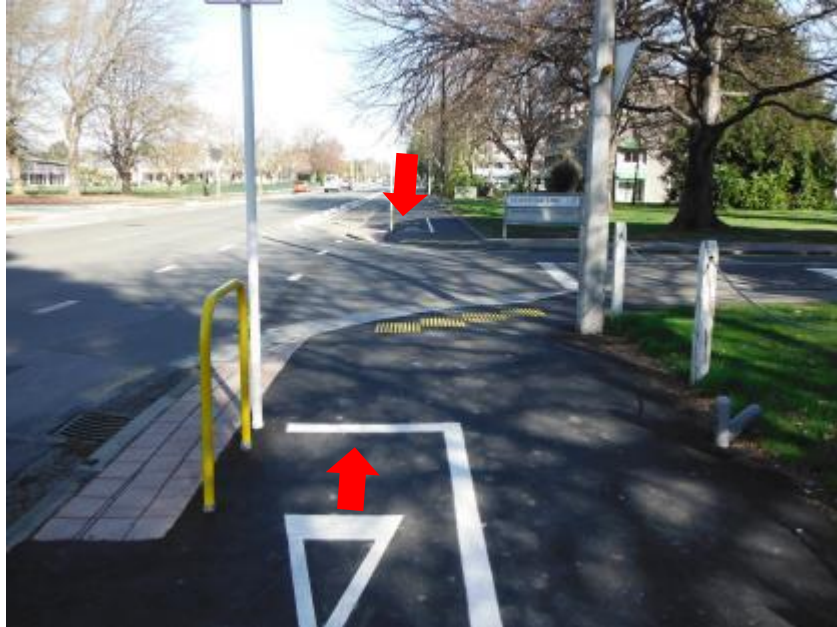
2.1.7 Give Way markings on cycle lane adjacent to Homestead Lane

The give way markings for cyclists are both located on the kerb side of the facility. The width allocated for cyclists at this point is not sufficient for cyclists to pass. This effectively guides cyclists head on with each other. While it is considered unlikely to present a significant safety hazard, should there be pedestrians in the vicinity as well it may make it more difficult to negotiate and/or create confusion.

Figure 2-11: Clarity Required for Shared use Path

Consider setting back street furniture to allow more width for opposing cyclists to pass or switching the give way lines on the southern approach to the left.

2.1.7	Comment	<p>Give Way markings on cycle lane adjacent to Homestead Lane</p>	<p>Disagree. The layout is specifically designed to prevent cycle/pedestrian</p>	<p>Accept</p>

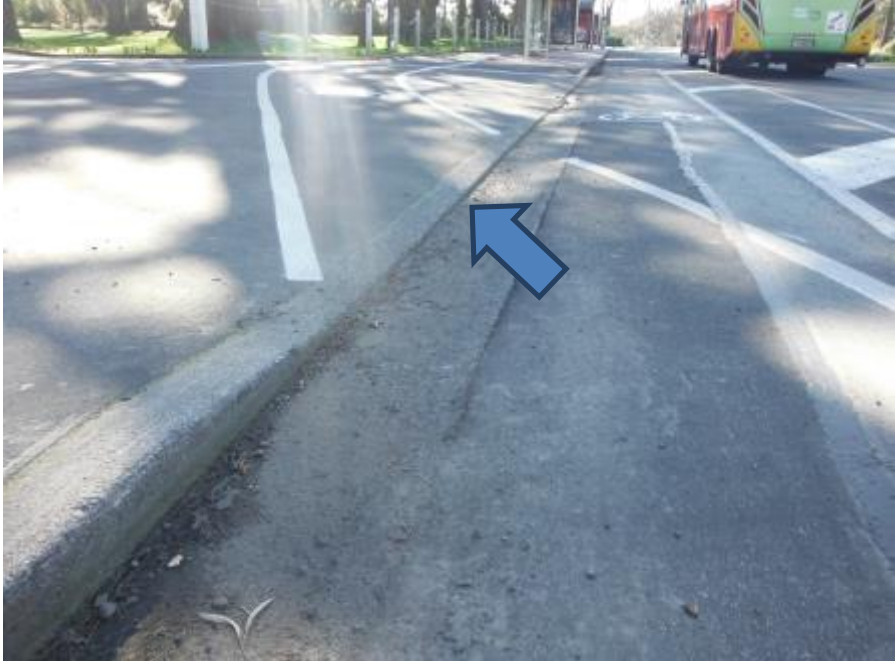
Figure 2-12: Note

The transition from the on-road cycle lane to the off road bypass lane is at an acute angle which when combined with the kerb upstand could result in a cycle wheel catching and the cyclist losing control. This issue may be exacerbated in wet weather conditions.

Provide flush kerb between on and off road facility.

2.1.8	Moderate	Northbound cycle bypass – transition from on to off road Provide flush kerb between on and off road facility.	Agree. The cut down lip shall be ground down to channel level.	Accept

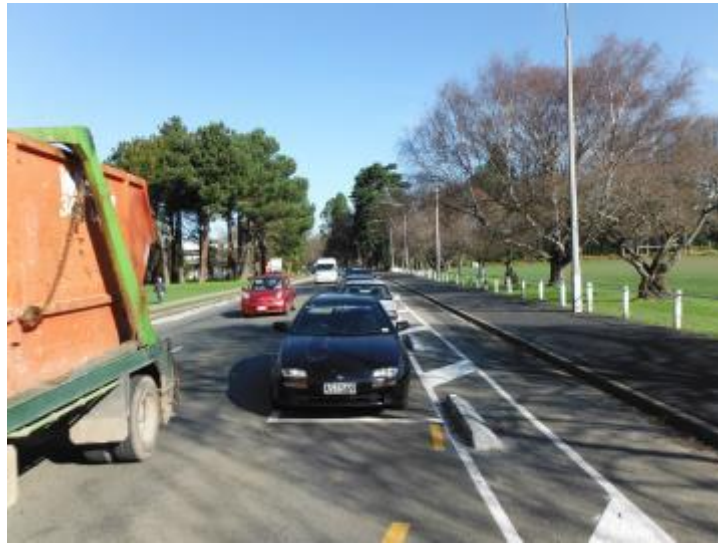
There is parking provided on-road on the western side of Ilam Road north of University Drive. Although there are parking bays between the traffic lane and the on-road cycle facility, which effectively segregates the two, kerbed separators have been provided. Parked cars were observed to be located outside of the parking bays in the traffic lane, which has a knock on effect on the position of through traffic. Regular occurrence of larger vehicles was also observed, particularly buses, which tended to track closer to or over the centreline. There are tyre marks on the opposite segregation kerbs which suggests that this is resulting in a pinch point. The intermittent nature of the kerbs adjacent to the parking bays could make it more difficult for drivers to judge their position whilst parking and their ability to avoid striking the kerbs. This may be causing poor positioning of parked cars. The safety concern is that opposing through traffic could be involved in collision.

Figure 2-13: Note parking is influencing position of traffic

Consider removal of separation kerbs or provide regular reflector posts on the kerb so that drivers can more accurately judge the distance to the kerb.

2.1.9	Significant	On-road parking north of University Drive Consider removal of separation kerbs or provide regular reflector posts on the kerb so that drivers can more accurately judge the distance to the kerb.	Disagree. Poor parking practice will occur as is common throughout the city. We acknowledge the consequences of poor parking and will refer it to/recommend that the enforcement team undertake an educational approach to this.	Agree with the education and enforcement approach. Will be worth monitoring this to see if any improvements are seen. Thereafter design and layout should be refined if appropriate. Provision of a mountable kerb which is less forgiving to manoeuvring traffic may improve parking.

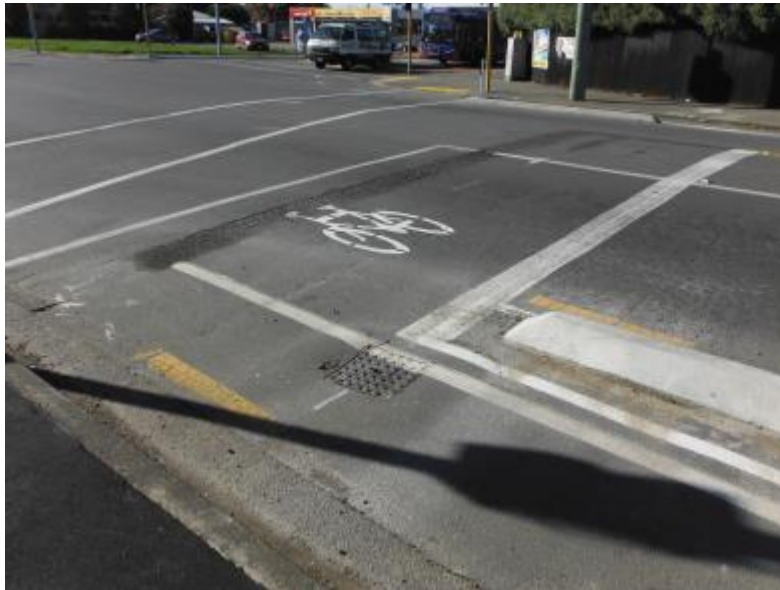
There are a number of road markings and surface changes within the vicinity of the cycle stop box area. These result in a confusing layout and make it difficult to determine the box.

Figure 2-14: Current Visibility of Carrs Road Crossing

Provide green coloured surfacing to the cycle stop box and the lead-in approach to highlight the intended use.

2.1.10	Minor	Advance cycle stop box Ilam Rd/Creyke Road Provide green coloured surfacing to the cycle stop box and the lead-in approach to highlight the intended use.	Agree. The stop box markings will be corrected in conjunction with the green surfacing work still to be done.	Accept

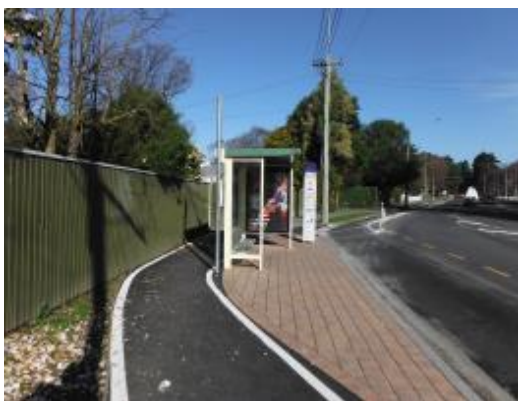
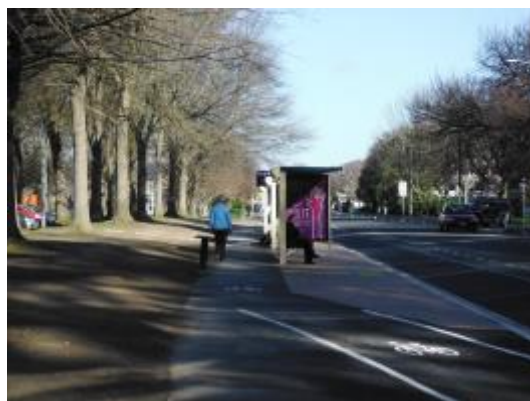
2.1.11 Cycle lane bypasses at Bus Stops - general

Minor

The shared use cycle lane/footpath behind the bus stops is relatively narrow. In addition, the advertising on the bus shelters restricts visibility of pedestrians that may be emerging from buses.

Figure 2-15: Note narrow shared use facility and restricted visibility through bus shelters

Monitor for any issues and if necessary consider removing bus shelter advertising to improve sightlines.

2.1.11	Minor	Cycle lane bypasses at Bus Stops - general Monitor for any issues and if necessary consider removing bus shelter advertising to improve sightlines.	Agree. This situation will be monitored. Relocation of advertising panels to the back wall of the shelters will be investigated.	Accept
