rail safety update

Special edition October 2013

Special edition: Dry pipe failures – steam locomotives

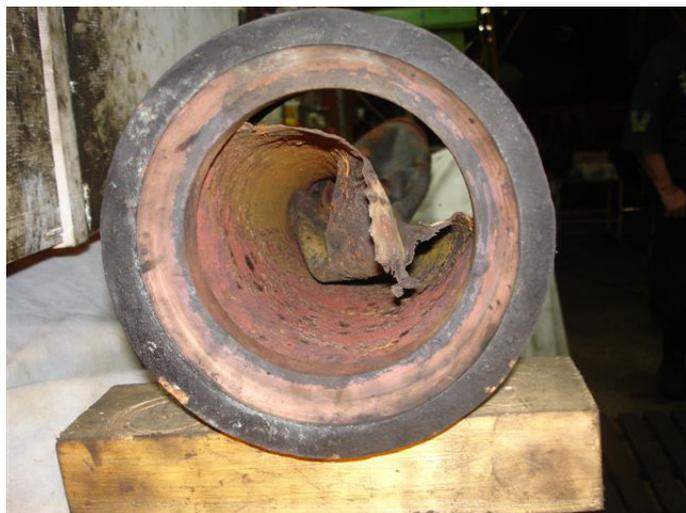
As the pictures show, the dry, or main, internal steam pipe of WW480 collapsed because it had been thinned by corrosion. This pipe carries steam from the regulator in the boiler dome to the cylinders via the super-heater. Because the pipe runs through the boiler, with the regulator shut, the pressure is external to the pipe and internal pressure would be zero. However, although called the "dry pipe", it is wet inside and out, whereas the tubes and flues are wet on the outer surface only, which may account for a higher rate of corrosion. When the pipe collapsed, steam bypassed the regulator valve and was able to pass directly, uncontrolled, to the cylinders, regardless of the setting of the regulator.

As the pictures show, the top of the pipe collapsed just behind the front tube plate (where leaking problems usually occur), causing the end of the pipe to peel away from the end casting into which the tube is brazed. The brazed joint was not particularly sound, and the heat of the brazing process may have weakened the tube locally. The collapsed pipe was sawn into sections and it can be seen that the thickness (ie corrosion) is by no means uniform, being thickest at the regulator end thinnest about 400mm from the outlet end. Whether the corrosion was from the outside in or vice versa is hard to say.

Collapsed dry pipe - end view

The basic problem was that the dry pipe had been in the boiler too long, in this case over 20 years. These pipes are virtually inaccessible unless all the boiler tubes including super-heater flues are withdrawn, and the super-heater header is removed - a major job. Therefore the usual annual visual boiler inspection did not pick the problem, nor was there any prior indication by means of leaks, water running from cylinder cocks, etc. More common problems are leaking tubes, which can easily be noted by examining the tube plates. It was quite bad timing when the incident occurred as the locomotive WW480 was coming up for its 10 year survey and Glenbrook Vintage Railway (GVR) planned to replace the various tubes and dry pipe anyway.

GVR records don't show the specification of the tube used when the dry pipe was last replaced, but it may well have been to NZR Spec which called for (from memory) 1/4" wall thickness. This imperial size pipe is no longer readily available, but a fairly close metric equivalent in seamless line pipe is available, and we propose to do what Steam Incorporated and Weka Pass have done, and use Schedule 80 line pipe, which has a wall thickness of 9.25 mm, which being thicker should give a longer life than tube to NZR spec.

GVR are now proceeding with a complete re-tube of the boiler, and have found several tubes that would have soon developed pin holes anyway, so the re-tubing exercise is timely. Similar situations can occur if water is carried over through the regulator, known as "hydraulic" and with the regulator closed the locomotive will keep steaming ahead powered by steam generated from water in the super-heater elements. The important thing is that drivers know what to do in such circumstances.

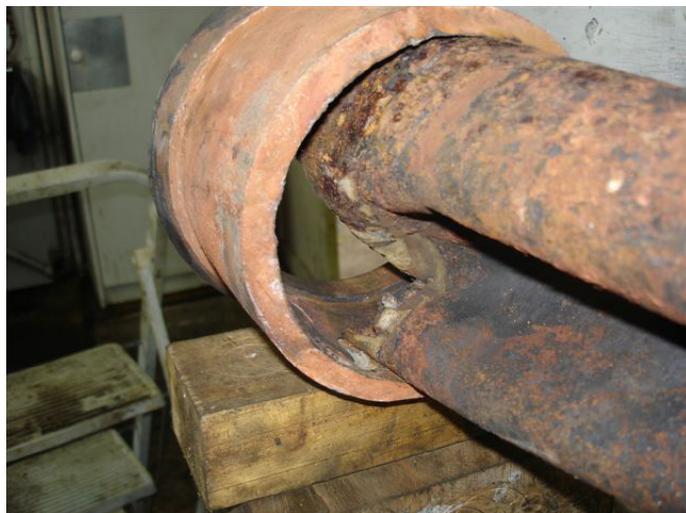
Dry pipe - joint view

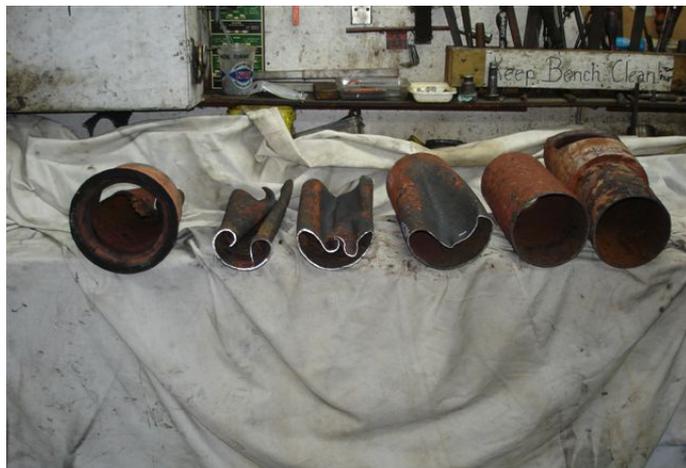
Dry pipe pieces

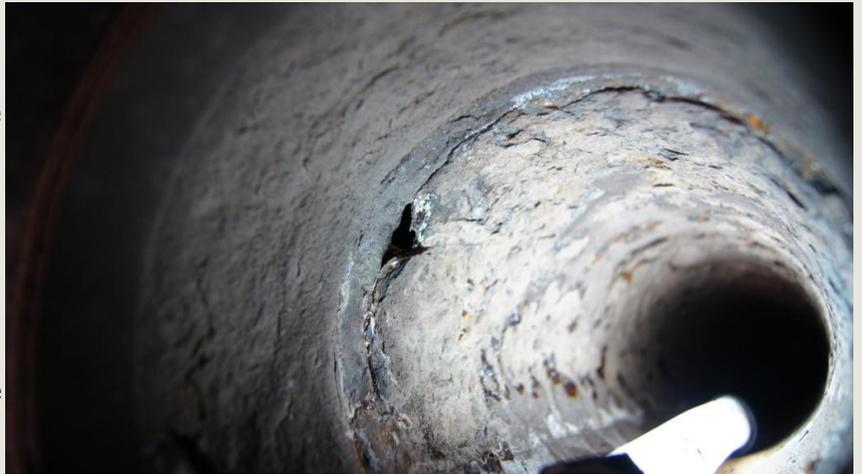
A different type of dry pipe failure occurred at Weka Pass Railway on A428 in October 2012. A small hole developed in the dry pipe which made the locomotive more difficult to control and this was reported by the locomotive crew.

The locomotive was withdrawn from service and a picture of the corrosion damage is attached. It should be noted that the hole as pictured is slightly bigger as it had been poked and prodded as part of the incident investigation. Virtually all of the rest of the pipe in this case was found to be at, or close to, the original thickness.

A428 dry pipe - interior view

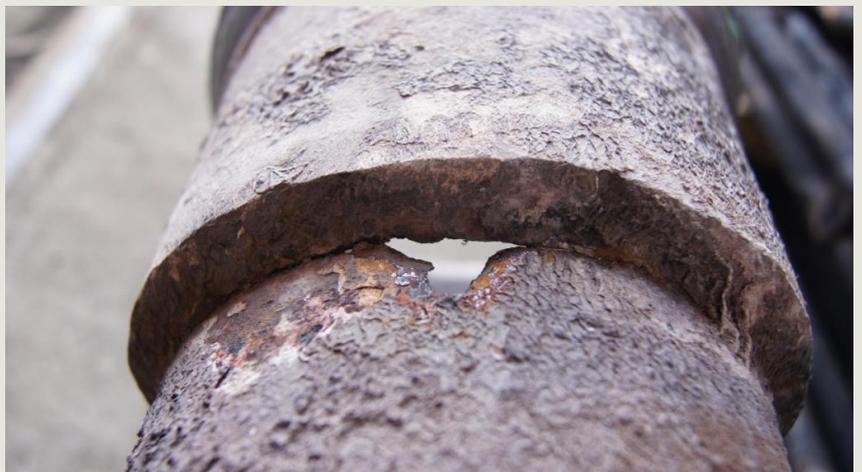
A428 dry pipe - exterior view

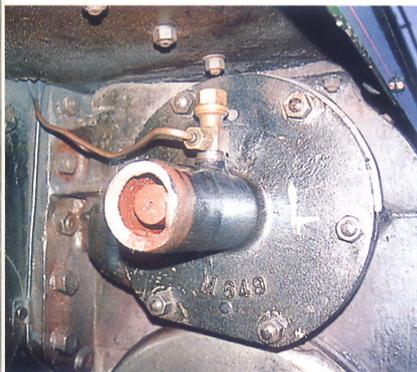
The damage to *Blue Peter* saw much of the motion and valve gear wrecked. In addition to bent rods were many other damaged components. The piston valve tailrod over-travelled and punched a hole in the piston-valve cover. MAURICE BURNS.

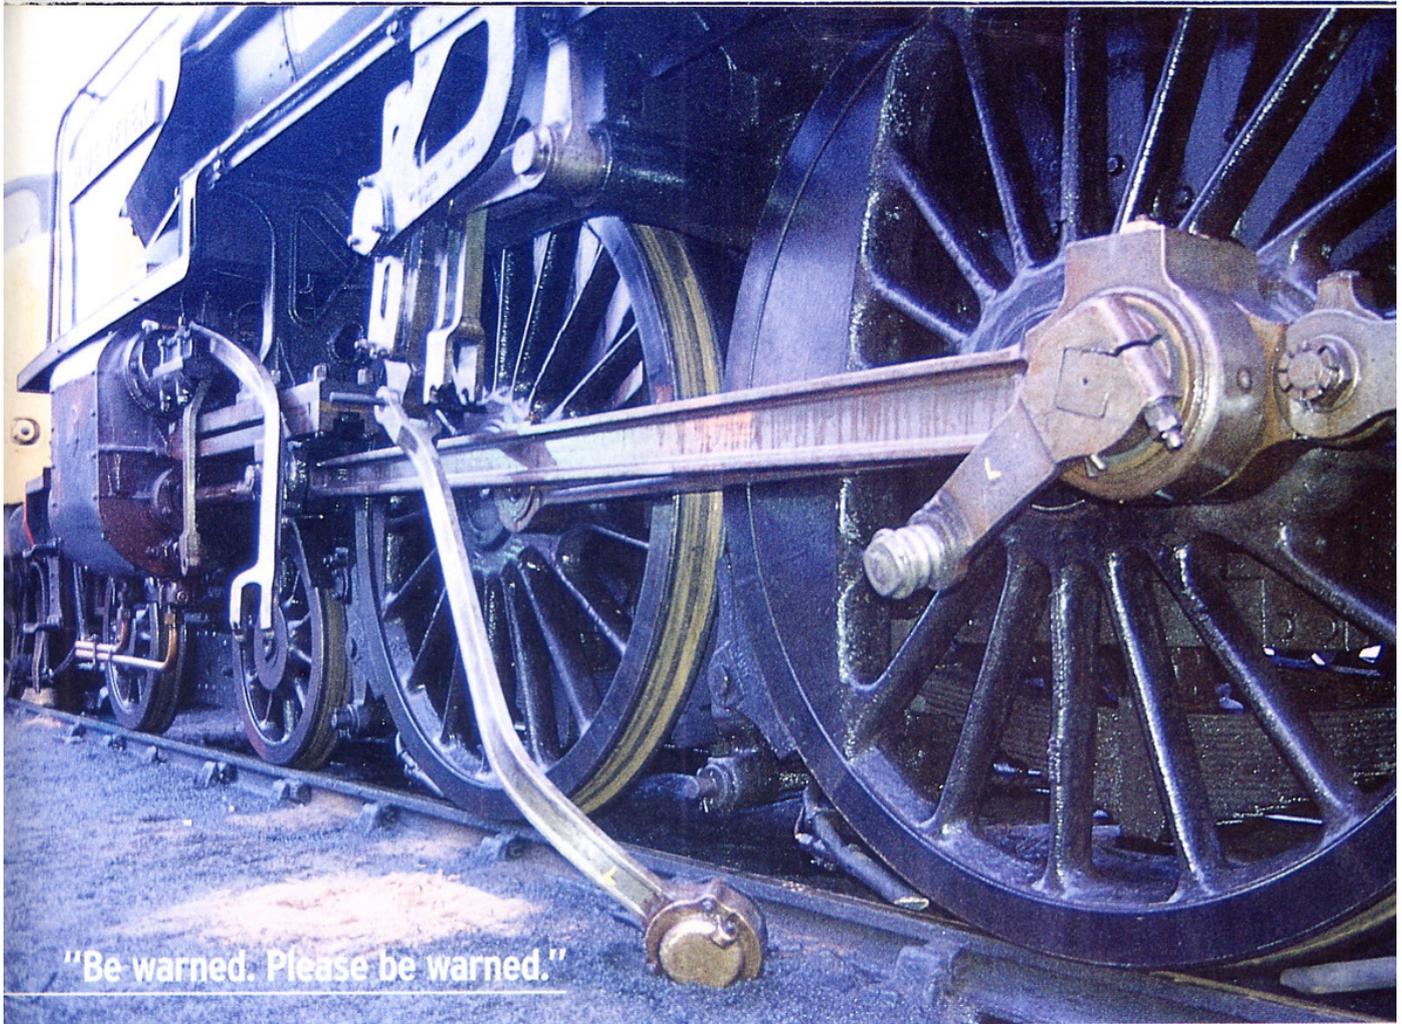
Whilst there have been a number of incidents over the years, none was as calamitous as that involving LNER 'Pacific' No. 60532 *Blue Peter* at Durham on October 1 1994. In a massive 36-second wheelslip, when *Blue Peter* would have reached 140mph if it had been moving, the locomotive literally thrashed itself to bits. The repair, which included extensive replacement of motion and valves, plus pioneering work to press a driving wheel onto the crank axle, cost £65,000. It also saw the engine lose nearly two years of its boiler ticket - it didn't steam again until April 28 1996. This view shows the broken radius rod and eccentric rod. MAURICE BURNS.

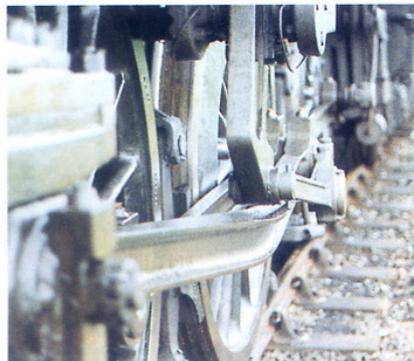
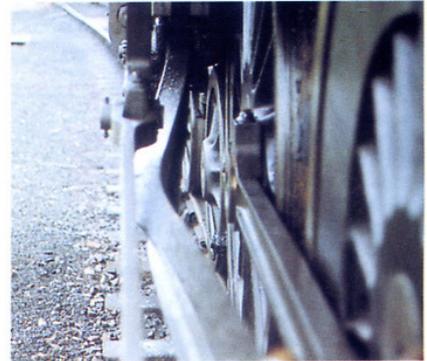
One of the latest incidents, at Fort William on July 13, left BR 'Standard 4' No. 75014 with a badly bent connecting rod and damage estimated to cost £15,000 to repair. This is a classic illustration of the damage that priming can cause.

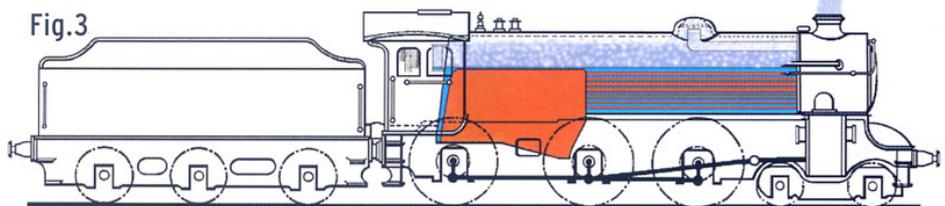
Fig.3

■ **Cause 2** Dirty boiler water or unsuitable water supply. This is a difficult situation to cope with but fortunately not a common problem with the carefully maintained star performers of today. It happens if the boiler water is over-full of salts and other solids left behind as the pure water is boiled off over a period of days. The steam raised within the body of water now finds it difficult to get through to the surface. We can get an idea of what takes place by considering a saucepan of soup or porridge which, all the while we stir it, boils happily. But if we neglect to stir it for a moment, it boils over and messes up the stove!

Dirty boiler water causes foaming and priming.

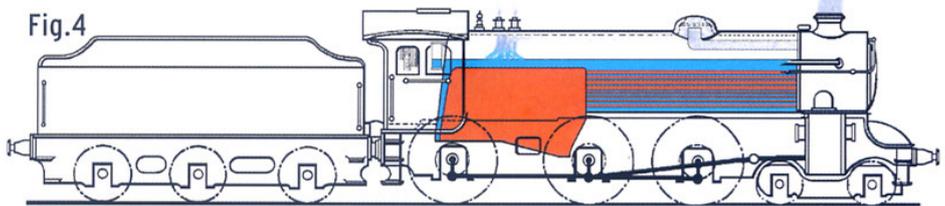
Fig.4

■ **Cause 3** Within the boiler we'll notice the area of boiler water immediately beneath the roaring safety valves is behaving differently. Volumes of water will rise in a spout towards the valves, as the steam coming with difficulty out of the overall surface area (because of the pressure above it) now discovers an easier path. The release of steam - both valves, or three or four (depending on the locomotive in question) are releasing pressure in a very localised area. A lot of the steam that is pent-up within the body of water will now come out in one place and the water is carried up with it as a water spout. Some of it will hammer the fine edges of the safety valves and spoil them, the rest will follow the path of the steam flow into the regulator valve. Water-laden steam cools down the superheat, entering and leaving the cylinders in a fine spray of condensing steam that increases the blast on the fire as it goes out of the chimney with an increasingly muffled roar. The fire is drawn to fiercer heat and small

Safety valves discharging violently initiates priming.

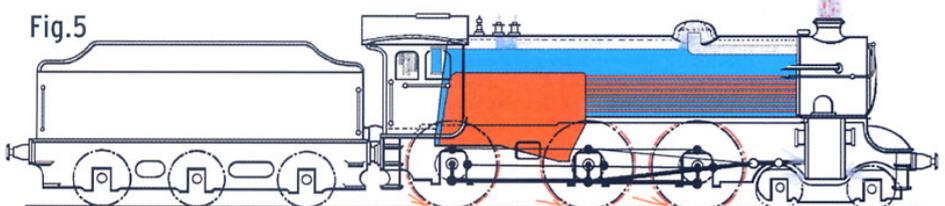
Fig.5

▶ valve initiates a localised low-pressure area into which most of the available steam within the water will flow, carrying a water spout with it. Now our unobservant driver is in trouble: his engine is revving up on the spot with the pistons and valves hammering out the incompressible water. He flies to the regulator and cannot close it! Water pressure has locked the sliding plates solid. He is used to the feel of steam pressure against the valve, but this is a new feeling. The regulator handle is solid and immovable despite the efforts of both men (Fig. 5).

Regulator locked open by heavy priming.

The locomotive is totally out of control and can only be brought to heel by first applying the engine's brakes fully, then opening the cylinder drain cocks and attempting to put the reverser in mid-gear. Once the wheels are no longer able to turn, or the reverser is in mid-gear, the regulator will be docile again as the hydraulic pressure that locked it builds up on the superheat side of the valve and equalises with conditions on the waterside. But in the meantime, as we have seen all too often of late, the locomotive will have suffered a great deal of damage (see pictures).
