Transport noise Visual integration

NOISE BARRIER CASE STUDY 7

Maoro Street Interchange

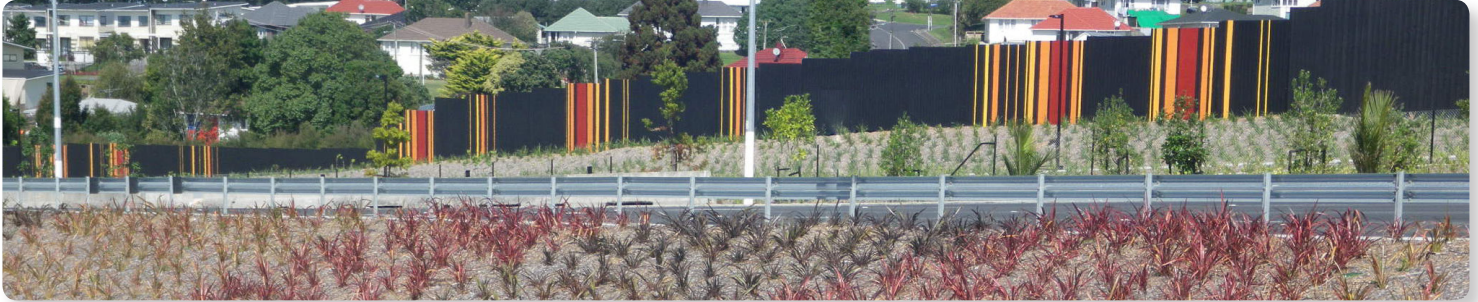
Noise barriers adjacent to the new Maoro Street Interchange.

An earlier stage of the Western Ring Route (WRR) in Auckland was the SH20 Mount Roskill Extension (2005–2009), which created a temporary termination of SH20 at the local road Maoro Street. Noise barriers were installed around the temporary junction as part of that project. The adjoining Waterview Connection project (2012–2017) will extend SH20 further to the north of Maoro Street to complete the WRR. In preparation for the Waterview Connection, the Maoro Street Interchange project (2010–2011) constructed a new half-diamond interchange between SH20 and Maoro Street. Additional and retrofitted noise barriers were installed as part of the project.

A requirement of the project was to use where possible the existing barriers in order to keep costs down and to replace and build new barriers where the realignment of the road required it. The project also gave the NZTA an opportunity to retrofit what were recognised as visually substandard barriers to achieve a better visual outcome for the local community and road users. The design concept was developed as part of the Urban and Landscape Design Framework (ULDF) for the Waterview Connection project and was based on a 'volcanic highway' theme of overlapping and contrasting materials and textures, with red, orange and gold colours on a black background.

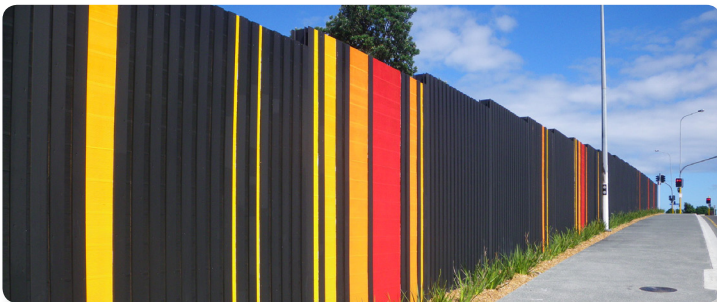
Barrier colours following the Waterview Connection ULDF.

While all barriers have been installed by the NZTA, some are located on NZTA land but others are on Auckland Council land. Responsibility for maintenance rests with the land owners. Initially, the council preferred single-colour barriers to minimise maintenance costs, although experience has shown that non-uniform colours deter graffiti. However, in order to provide continuity in the barrier appearance, agreement was reached between the NZTA and the council to retain the ULDF colour scheme with red, orange and yellow stripes on a black background throughout.

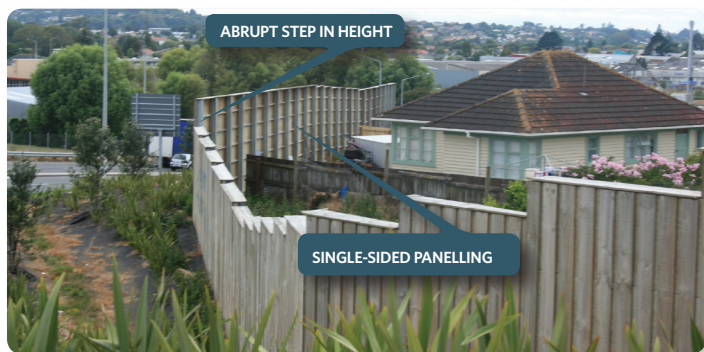
Original barriers on Maioro Street with a poorly designed height step and single-sided panelling.

The opportunity was taken to improve the visual treatment of the existing barriers. Prior to the construction of the new interchange, the existing barriers comprised unpainted sheet plywood panels just on the road side of timber framing fixed between steel posts. The road side of the panels also had vertical wooden strips applied. Over time as these barriers had been tagged, maintenance teams had painted out the graffiti. Where these barriers have remained, they have been integrated with the new barriers by painting on the road side with the black, red, orange and gold colour scheme of the ULDF. As shown in the photographs below, work was also undertaken to remove the large visually jarring steps from the top of the noise wall to provide more regular and smaller changes in height.

- Single-sided barriers should be avoided.

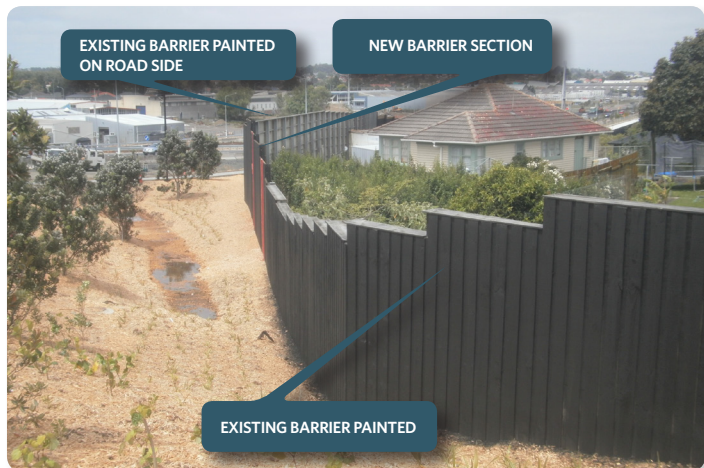
Integrated barriers on Maioro Street.

The Ezyshield system used for the new barriers has horizontal grooves and panels. To match the appearance of the original panels, additional vertical wooden strips were applied, as shown in the adjacent photograph. Likewise, vertical features mimicking the strips were cast into the panels of the concrete barrier.

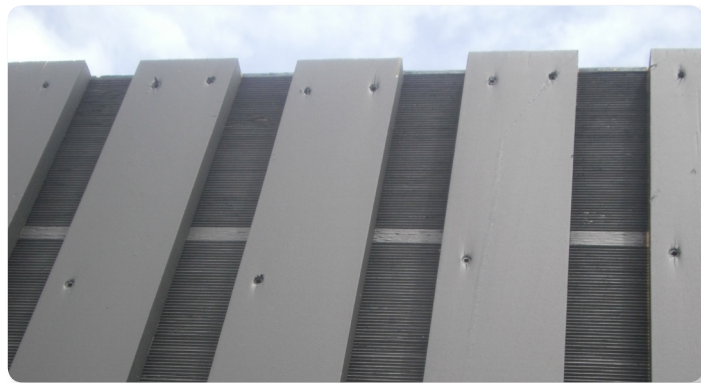
Ezyshield plywood panel with additional vertical strips.

A specific product was named ('Ezyshield' from Boral) for the plywood panels, although an equivalent product would have been allowed. Ezyshield has been discontinued by Boral but an identical product named 'Nuibarrier' is sold in New Zealand by Gunnersen.
