KAIKOURA EARTHQUAKE UPDATE - no. 22

23 June 2017

## FIVE OF THE LARGEST LANDSLIDES HAVE BEEN CLEARED

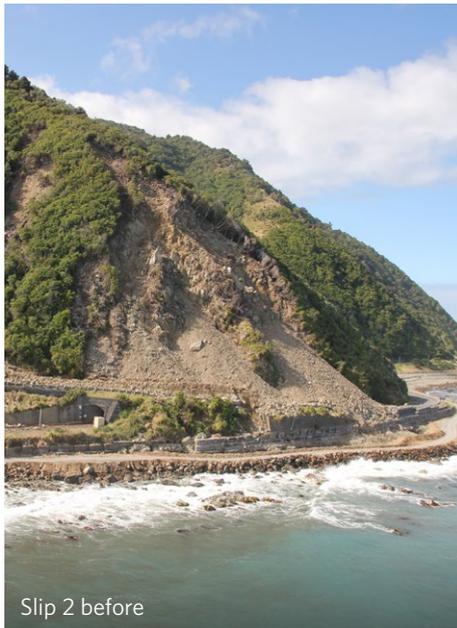
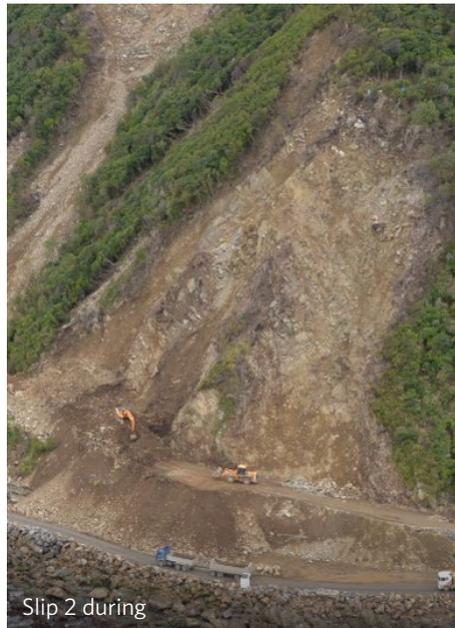
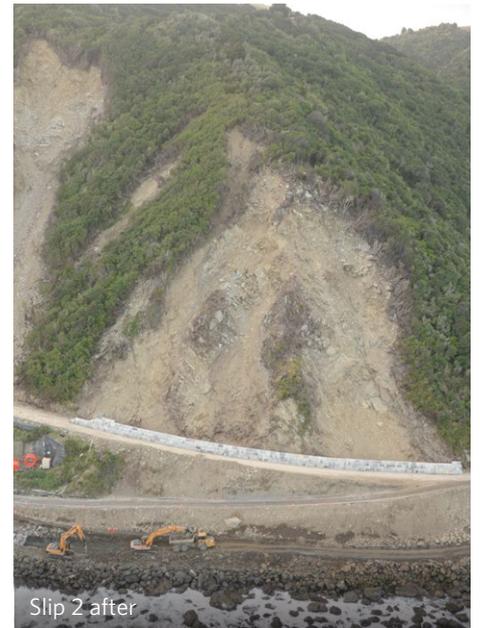
The photos above show the 'before, during and after' stages of clearing the landslide at Site 2 near Irongate.

NCTIR's earthworks teams and trucks have been working around the clock to get that job done, completely removing giant slips that fell near Mangamaunu, Irongate Stream and Half Moon Bay during November's quake (sites 1 to 4).

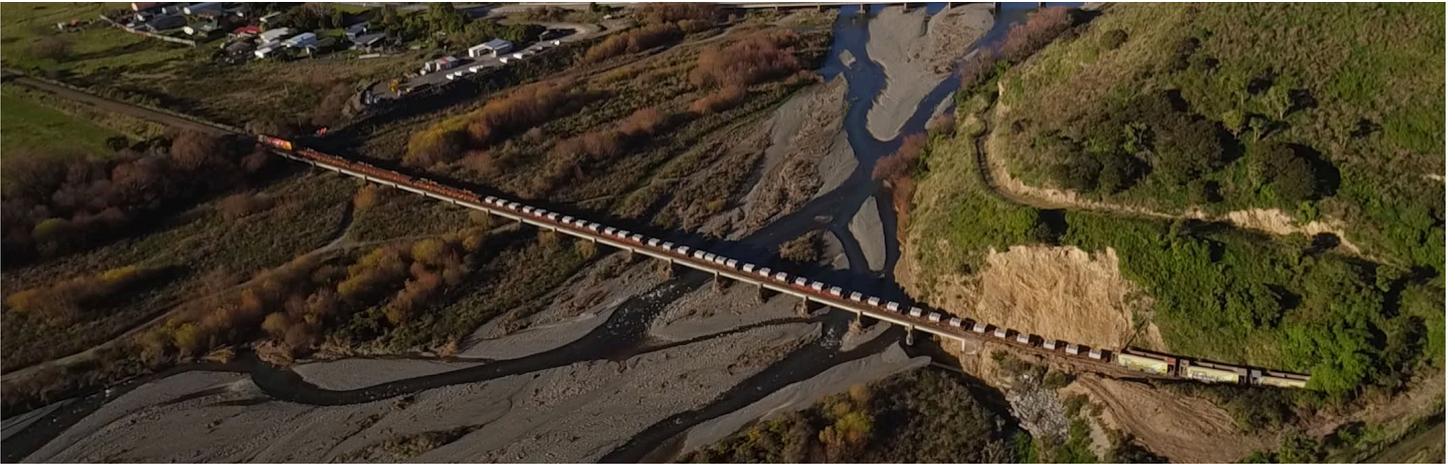
Work Train 70 (pictured) consisted of:

- A front locomotive
- Six wagons carrying long lengths of rail track
- Each of those wagons also had a crane on board for lifting the rail track
- 12 wagons carrying new concrete sleepers to replace damaged or buried ones
- 12 ballast wagons (carrying the stone ballast which forms the bed of a railroad track)
- 1 plough van for spreading the ballast on the track
- 500m empty flat-decks
- A tamper - this is the regulator machine that clears ballast off the sleeper tops and more accurately places it. The tamper then lifts the sleepers and packs ballast around them
- A back locomotive

Why two locomotives, and why so long? The 'locos' at each end of the train were used to push and then pull the train through the badly-damaged Tunnel 13, which is still under repair. This was done to remove any risk to the train drivers. The empty flat-decks were needed to make the train long enough to stick out of the ends Tunnel 13 and the adjacent Tunnel 12, so the drivers could transfer from the front to the rear of the train before pushing the train through the damaged tunnel.

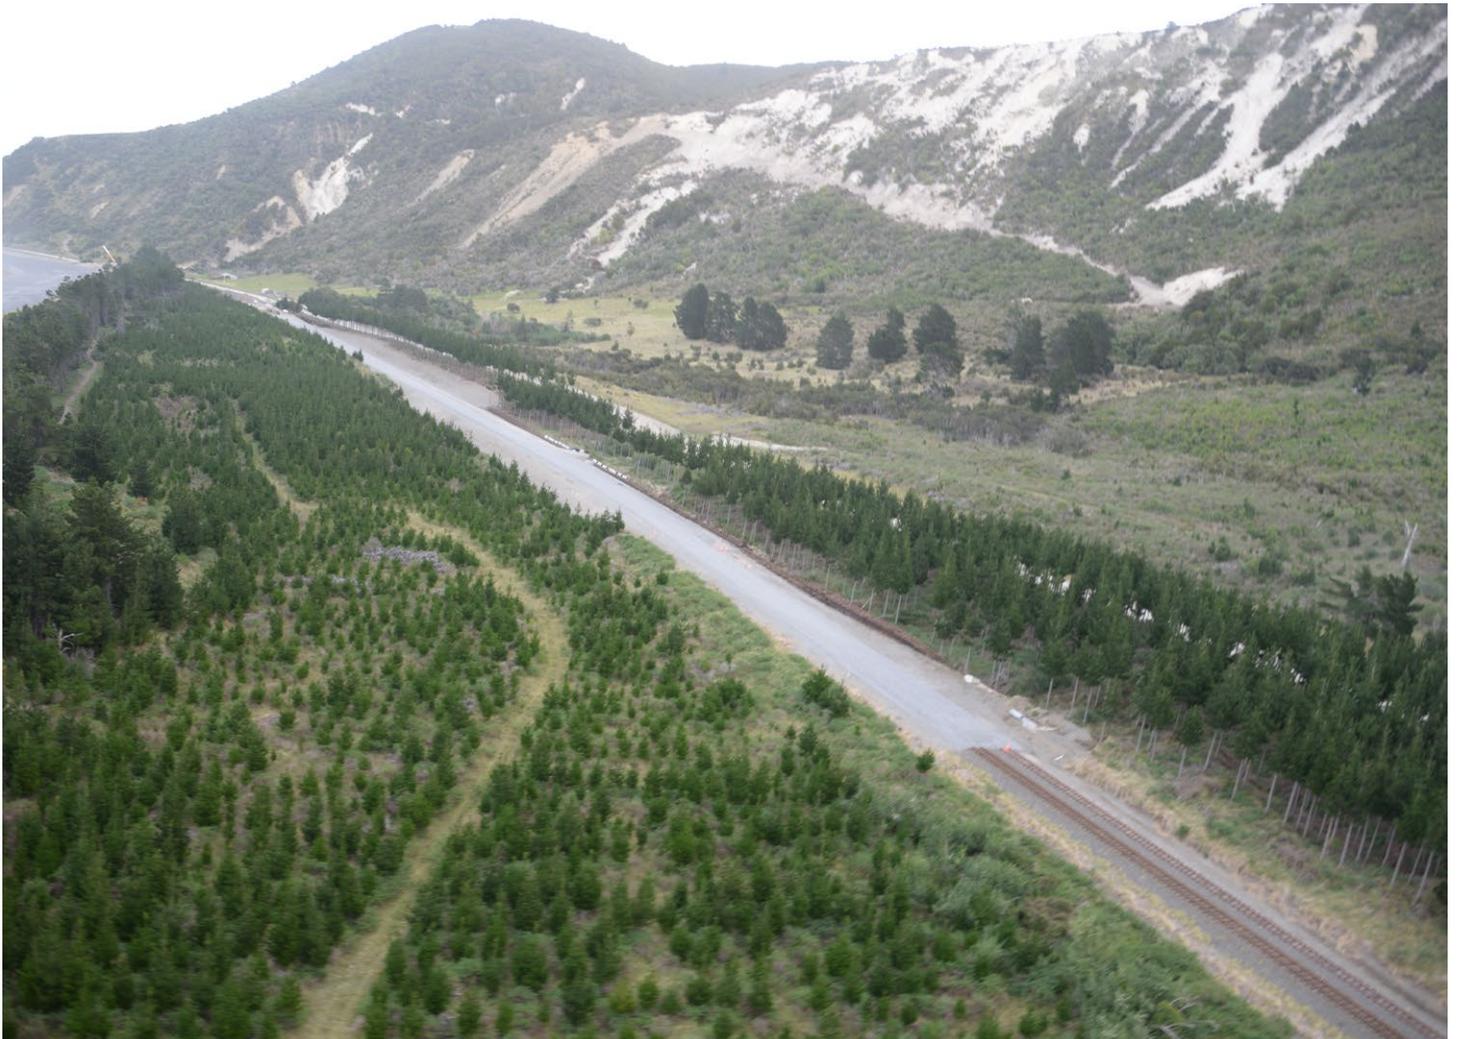
Finally, a major earthworks operation at The Pines is drawing to a close. The picture below show the transformation of the site as new ballast and track is laid so the work trains can continue south.

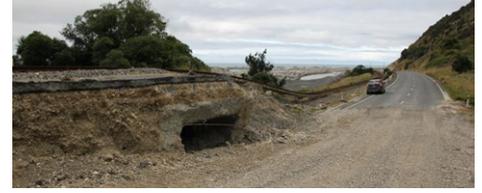
November's earthquake caused massive damage at Mounseys Creek at The Pines (see picture to the right). To make sure this creek is now able to flow into the ocean a new culvert was installed last weekend. This is a huge step forward in progress to open the Main North Line.

The first large box culvert units delivered to The Pines site, just north of Waipapa Bay.

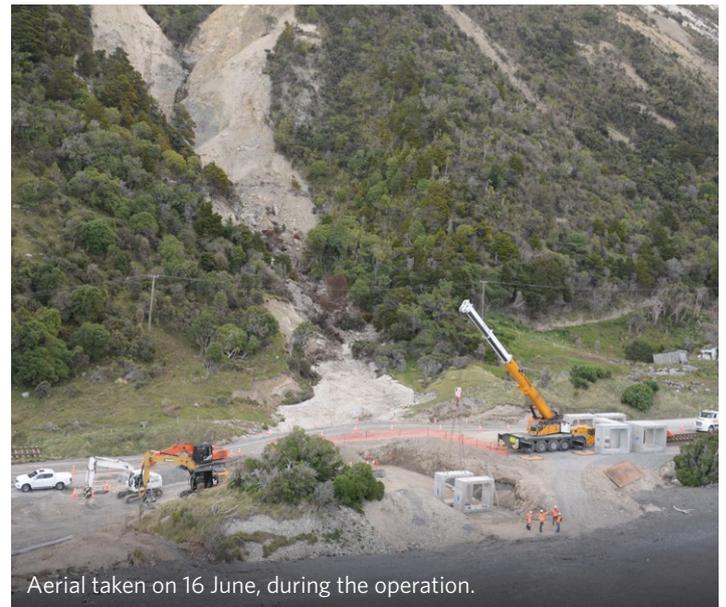
Aerial taken on 16 June, during the operation.

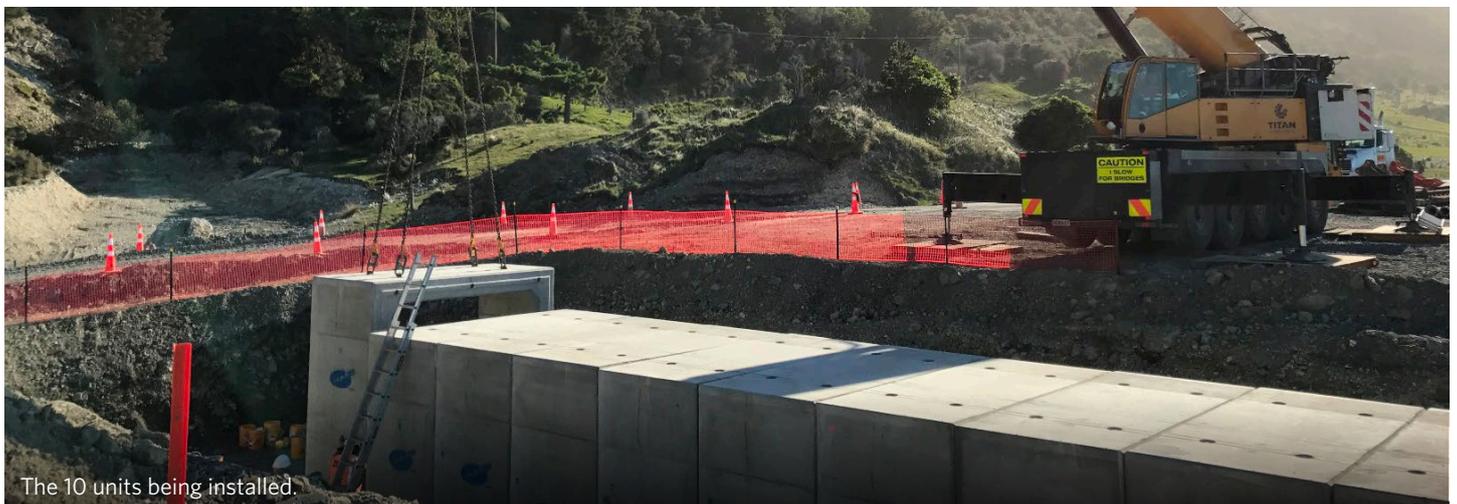
The 10 units being installed.

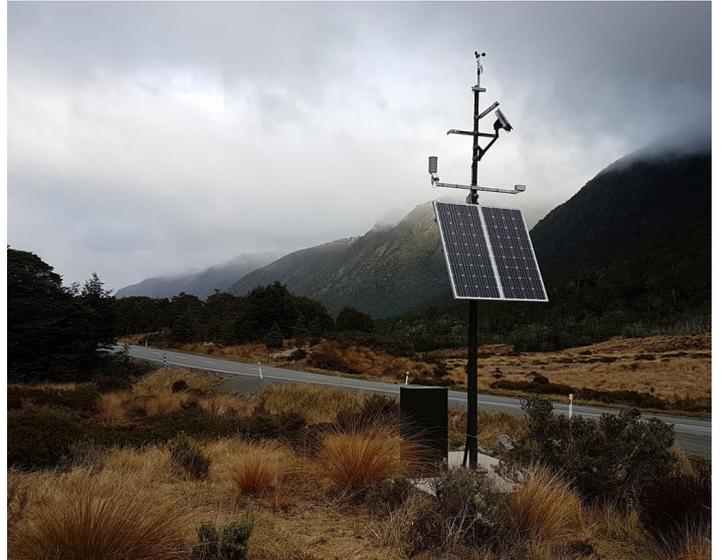
Newly-installed weather stations, like the one shown here through Lewis Pass, are providing valuable information for the 24/7 road crew that is working hard to keep the alternate Christchurch to Picton route open.

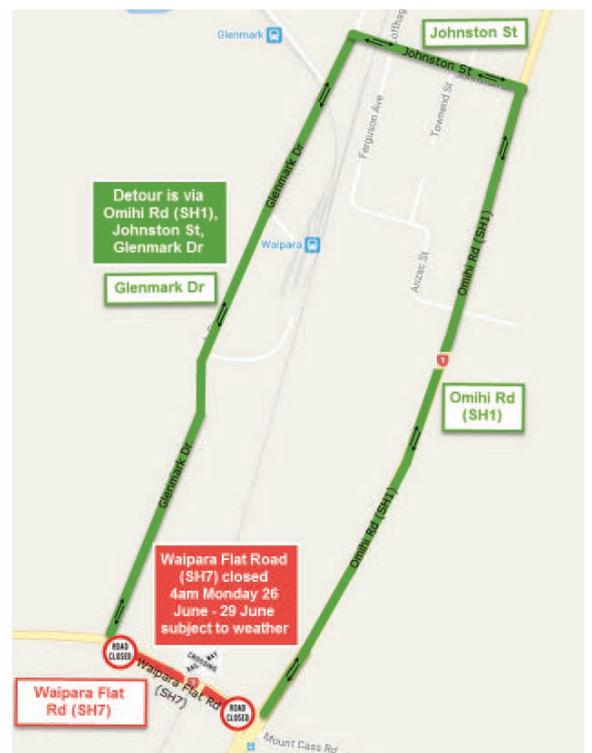
Driving south - If you are driving along SH7 towards the SH1 turnoff, you'll be detoured through Waipara just before the railway crossing, and then via Johnston St on to SH1.

All drivers are asked to follow the signs, drive to the conditions and take care along the detour. (See map).

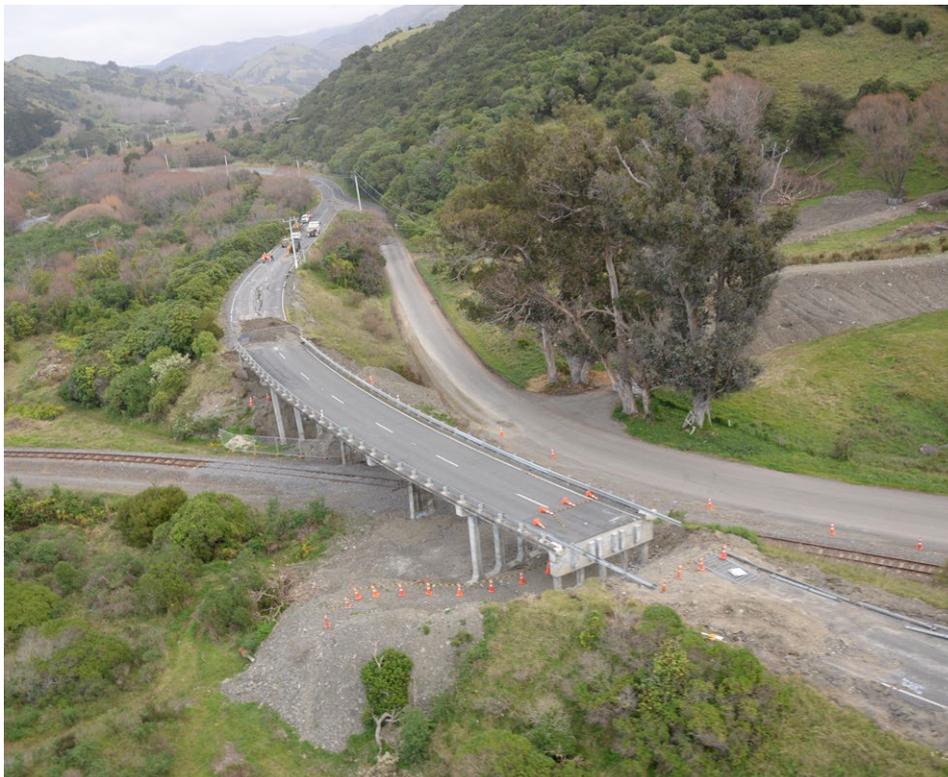
One of the most extreme examples of earthquake damage to SH1 is what happened to the Oaro road and rail bridge.

The restoration process will involve removing existing guard rails, clearing out the damaged sections of retaining walls and forming a suitable base to construct new retaining structures. This is a tricky, labour-intensive job that will include repairing and replacing wire baskets and excavating the road out approximately 2m behind the wall to place flexible reinforcing so the wall can be tied into the pavement. In short, it is not an easy fix.
