KAIKOURA EARTHQUAKE UPDATE - no. 28

4 August 2017

MILESTONE: RAIL LINE COULD OPEN WITHIN THE MONTH

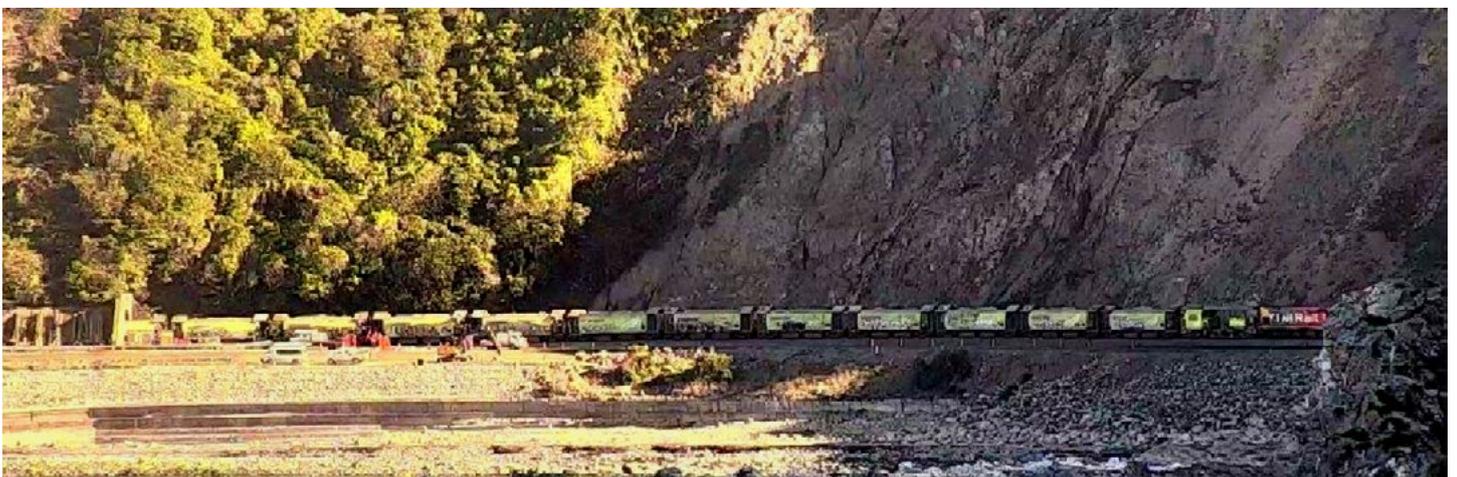
However, work on critical projects has already progressed to a point where work trains are able to move between sites carrying rail and ballast. Pictured below is a work train coming through Half Moon Bay north of Kaikoura.

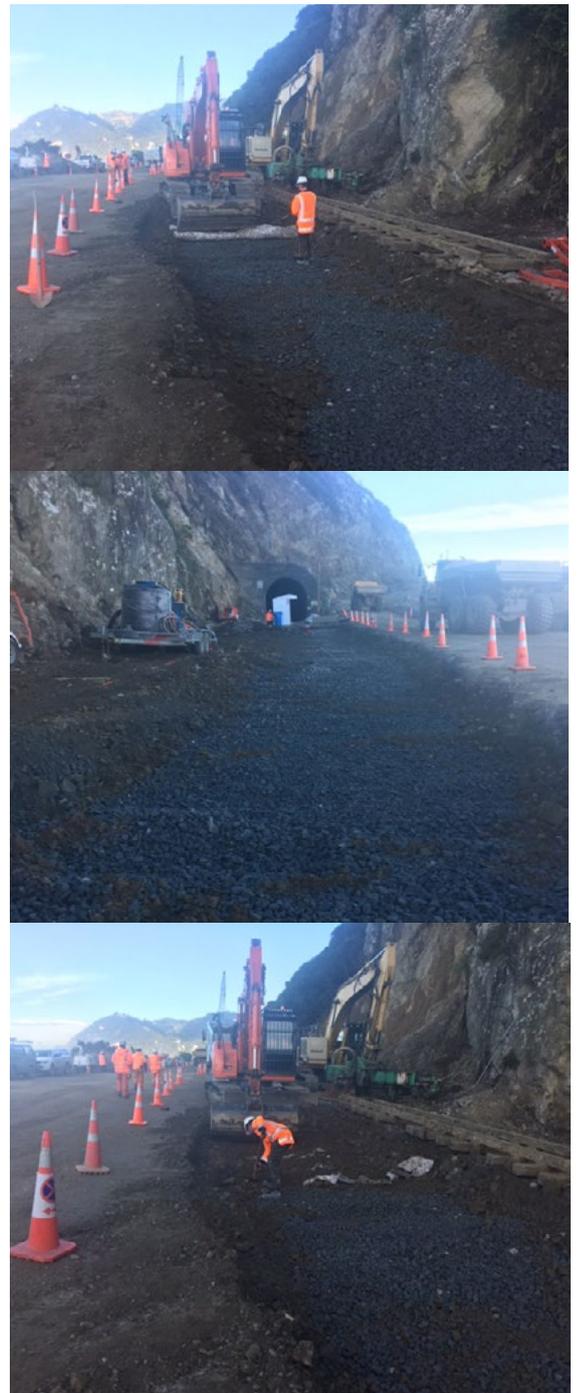
A LARGE SECTION OF RAIL TRACK HAS BEEN UNCOVERED SOUTH OF OHAU POINT.

Because of the risk of more material falling, the rail tracks needed to be shifted out four metres to a safer location before trains could run again. There was, however, a problem. The new location of the tracks would be directly in the way of hundreds of trucks moving tonnes of material from Ohau Point during July.

To deal with that situation, a 20 person team from KiwiRail worked overnight to excavate a new formation trench, 150m long, one metre deep and five metres wide. Structural fill was laid and railway ballast placed on top before being protected with a layer of geofabric cloth and covered in a thick layer of dirt.

A row of shipping containers has also been placed on top of the old section of rail. This will act as a temporary rock fall protection measure until permanent works are completed.

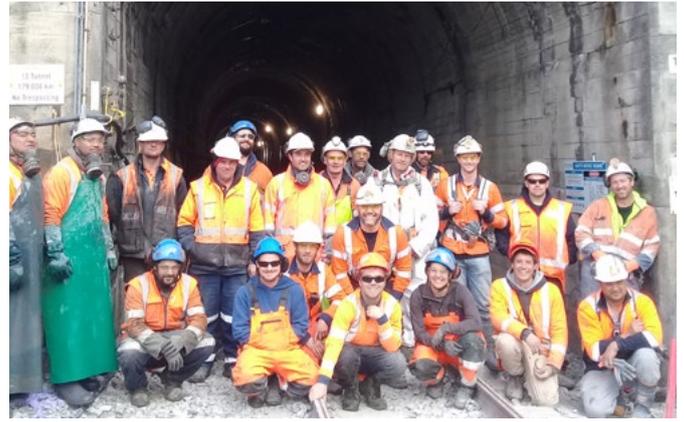
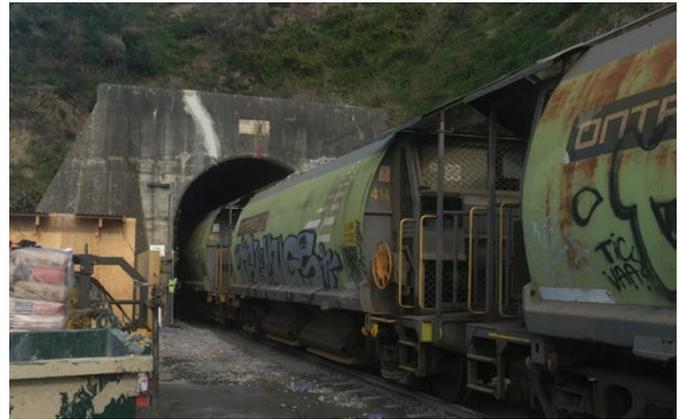
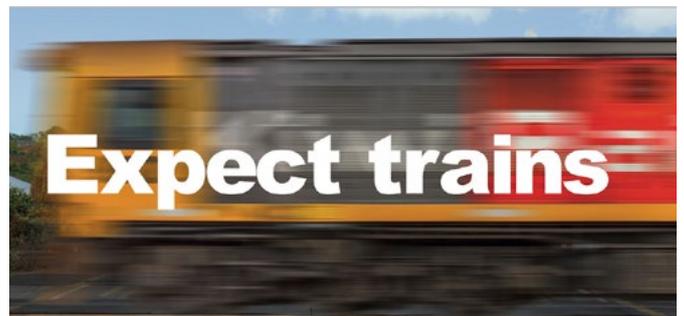
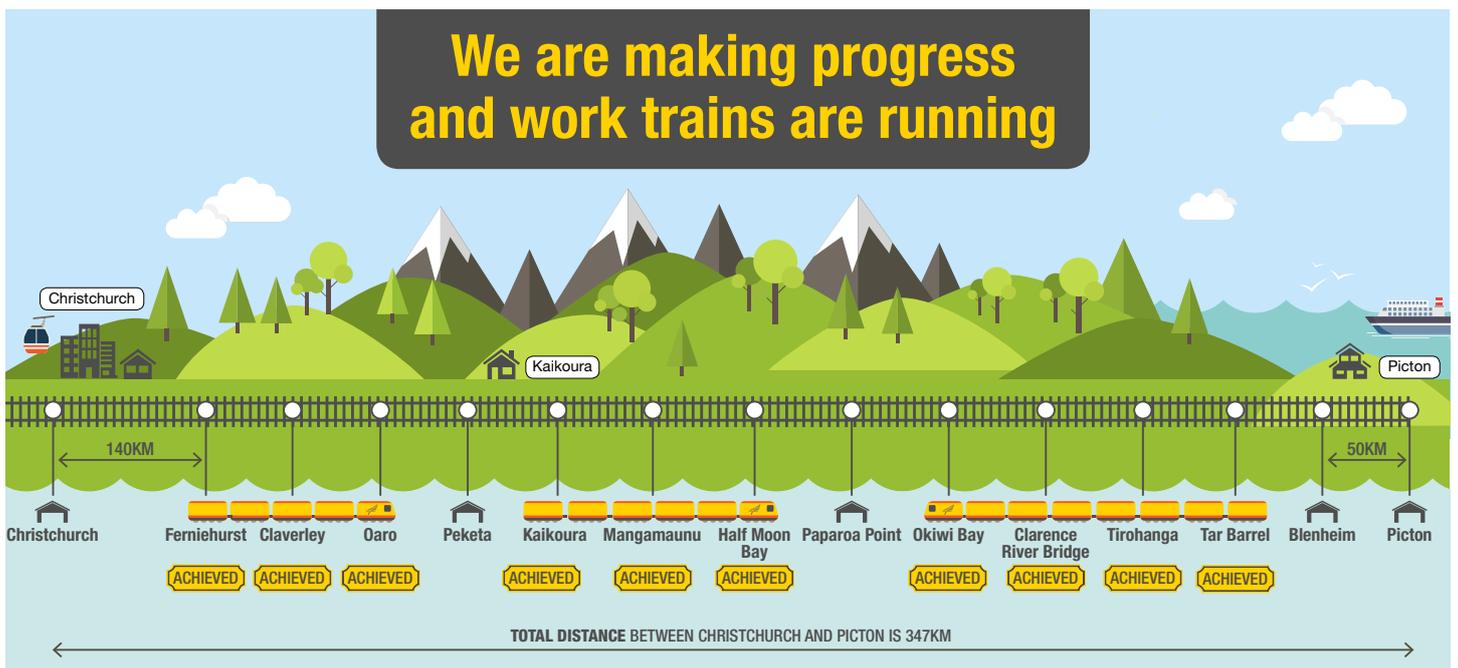
For nearly three months a team of about 20 people (pictured) have been working day and night to fix Tunnel 13 just south of Kaikoura beyond the Kahutara River Bridge.

"The biggest challenge for this project has been ground conditions," says site engineer Innes Duncan.

"Highly fractured rock is not good for tunneling as it makes it difficult to drill through and install anchors," Innes says.

The team met the challenge head on with innovation; a propping system was put in place to keep the fragile tunnel from collapsing.

The propping system has since been removed after 800 tonnes of grout was injected via tubes through the tunnel walls into the adjacent hillside to improve the rock mass surrounding the tunnel. These improvements to stabilise the tunnel has allowed 150 rock anchors to be installed with more to be installed in the coming weeks.

The best proof of progress for this tunnel was, however, was seen when a work train drove through it earlier this week (pictured right).

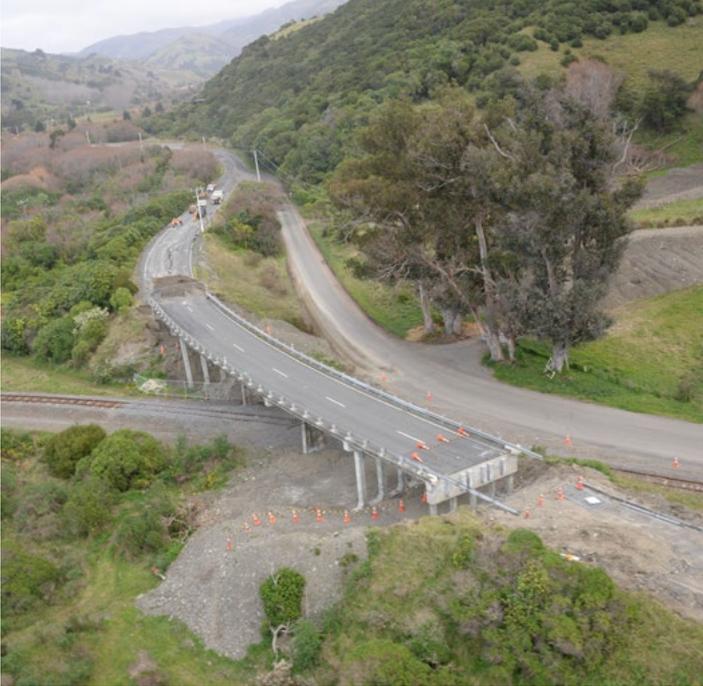
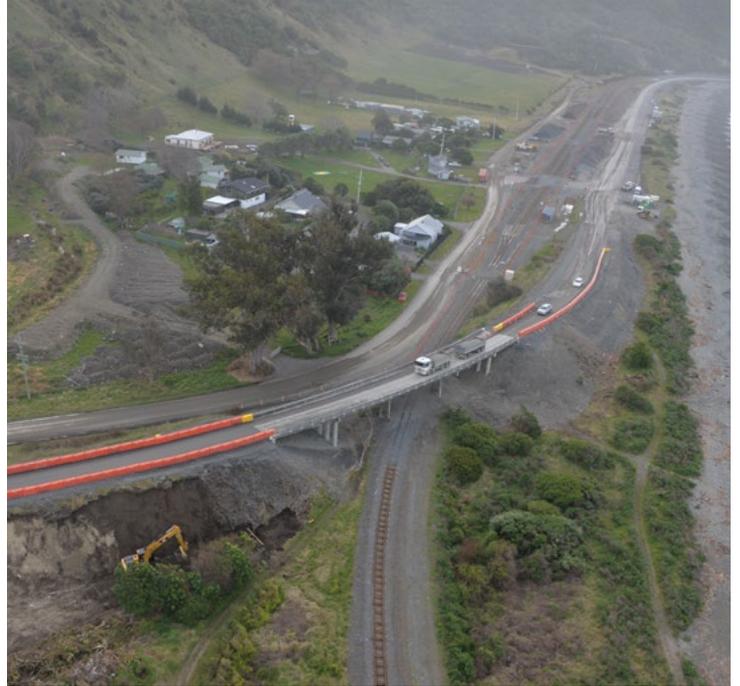
The first vehicles travelled over the Oaro Bridge last week following months of work to restore this critical piece of infrastructure on State Highway 1 south of Kaikoura (see before and after photos below).

This challenging project has involved the reinstatement of gabion basket retaining walls, reinforcement of retaining structures and laying down of new road. The last stage of this project will be installing guard rails in late September.

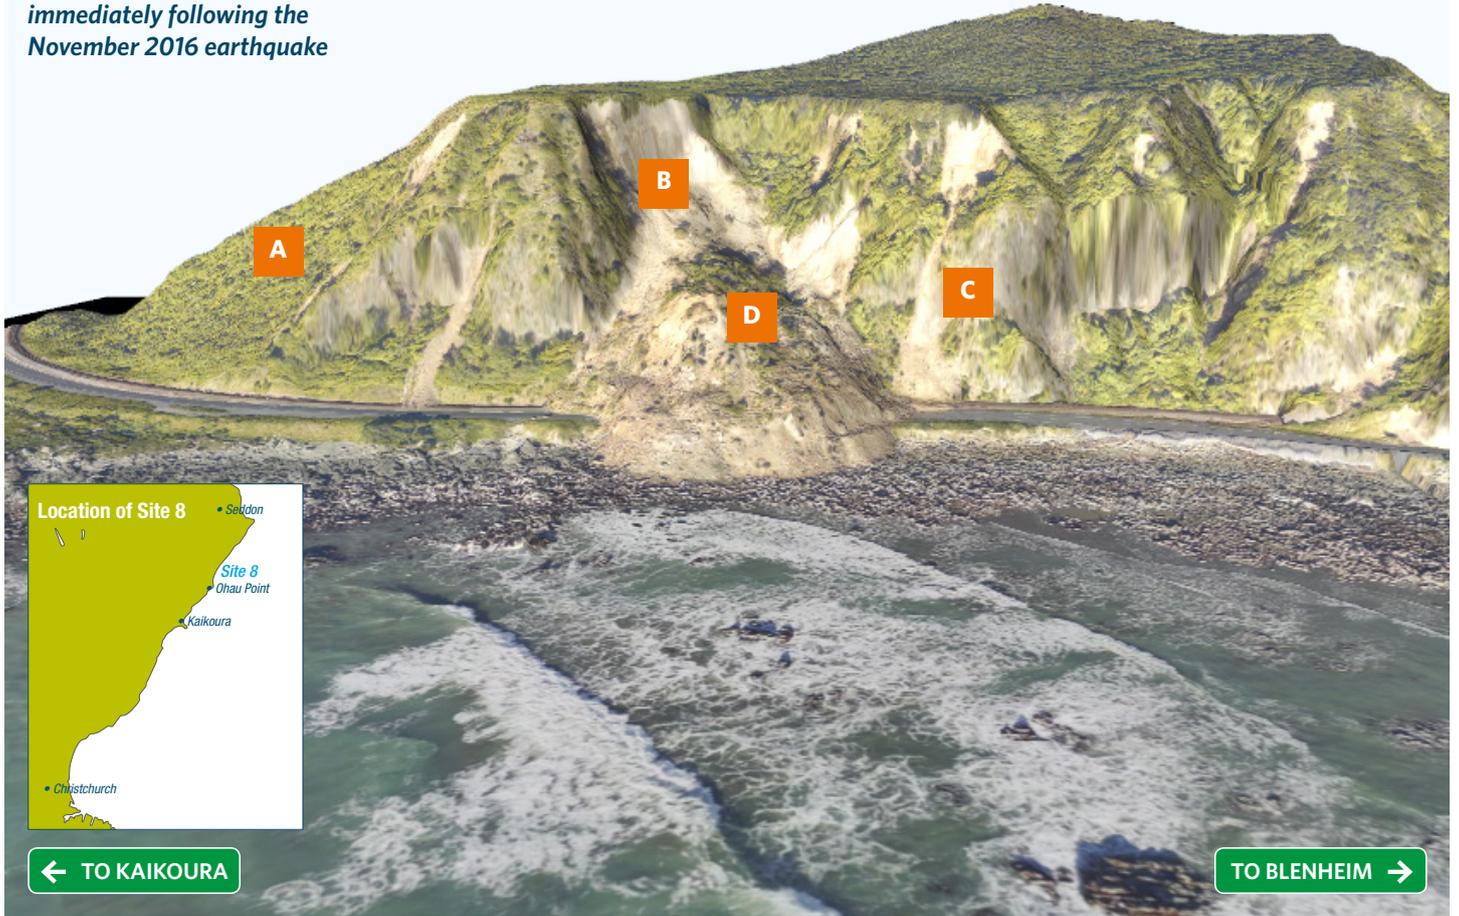
3D image of Site 8 immediately following the November 2016 earthquake

Site 8 north of Ohau Point is swarming with machinery, biting chunks out of the monster landslide that towers above the excavators (see photos next page).

An old overgrown farm track leading to the top of the landslide was used so an excavator and bulldozer could begin to cut a deep bench into the centre of the site in a horse shoe shape.

A container wall has been installed around the northern section of the bottom of the landslide until the full bench is cut in at the top. This will protect the construction access track around the base of the slip which is being widened to two lanes to remove the risk of a bottle-neck forming.

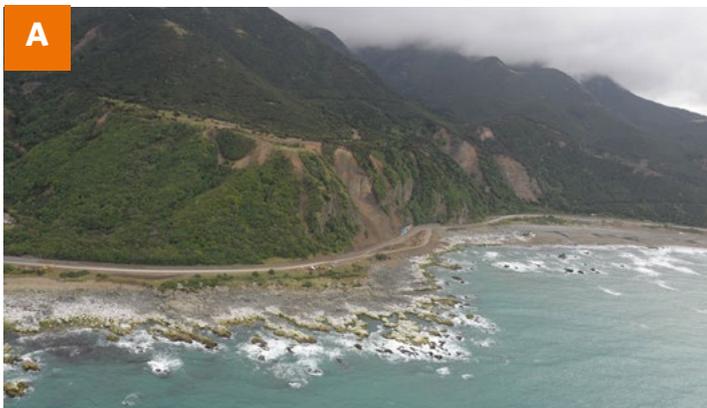
Looking north towards Site 8 you can see that much of the material has been cleared.

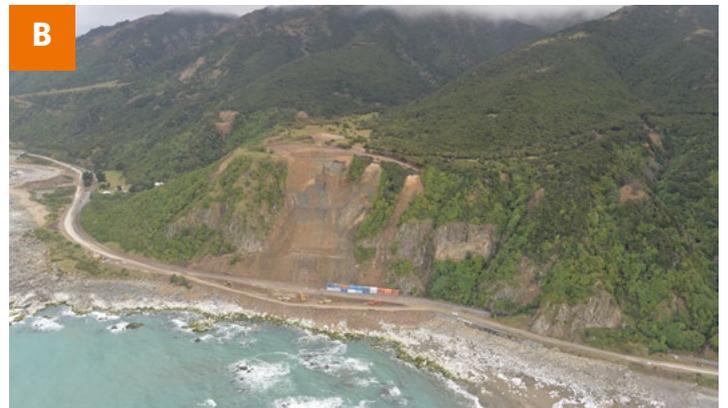
Looking face on to the slip face the bench and the container wall can be clearly seen.

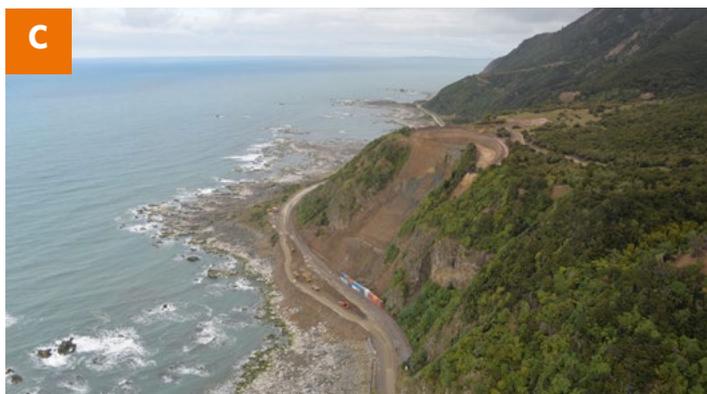
The flat work site at the top of the slip is clearly visible from this angle.

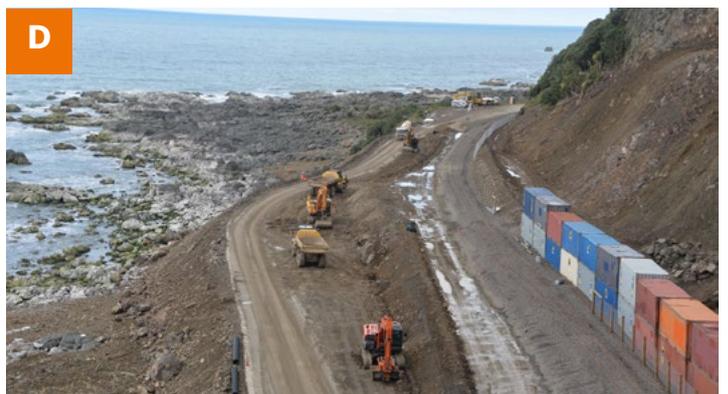
Work is well underway on the road realignment around the toe of the slip. The construction access track is also being widened to two lanes.

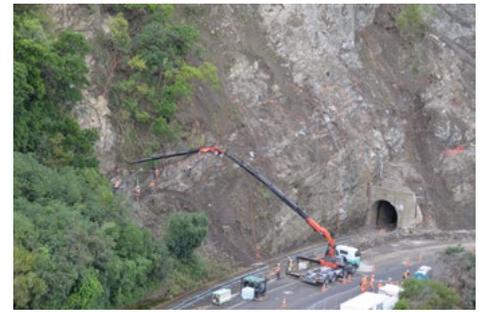
Shallow landslide barriers are being used as part of a road and rail reinstatement project (pictured right).

So what exactly is a shallow landslide barrier? To put it simply, a shallow landslide barrier is made up of steel posts, covered with mesh, and anchored into the hillside; it is a sort of big strong fence meant to withstand high impact and velocity and keep rock and debris from falling onto the road or rails.

When material hits the barriers it absorbs the shock because it has some degree of expansion, not unlike a spider's web. The barriers have to be put together piece by piece on site, and access determines the length of time it takes to put it up.

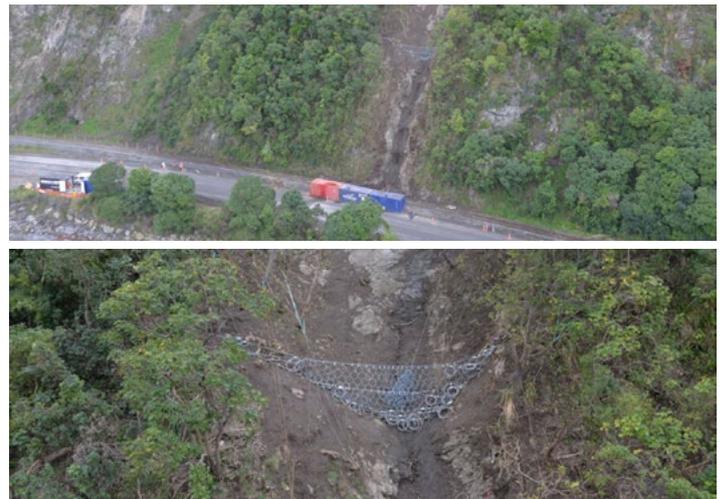
Work on slip material barriers near site 27 on State Highway 1 south of Kaikoura is nearly complete.

This particular form of protection is specifically designed for narrow gullies that run down the side of a cliff face and operate like a giant, hyper-strong, mesh bag.

The steel cable mesh is secured with rock anchors suspended flat across a gully. In this compressed form it is ready to catch any material moving down the channel, expanding and containing the landslide with its own momentum.

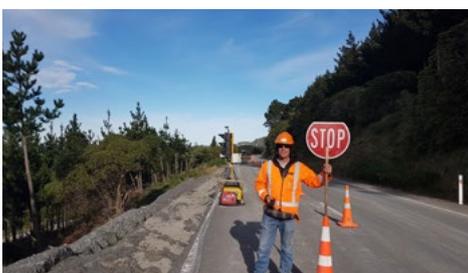
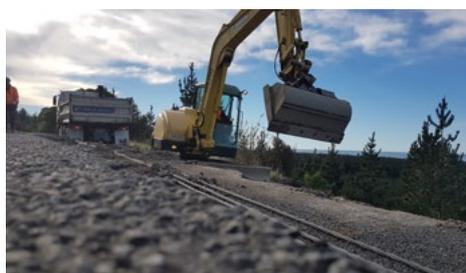
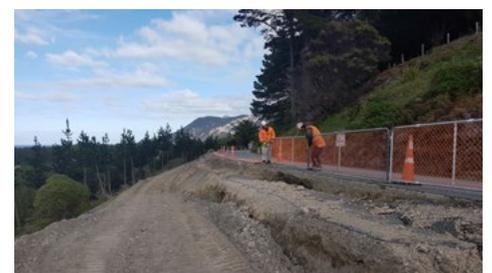
Work to repair the road and reconstruct the five gabion retaining wall structures at the Sand Pit, just south of the Clarence River, started late last week (see photos).

The Sand Pit is a section of the State Highway 1 that was substantially damaged in the earthquake at which time the southbound lane and shoulder as well as the retaining walls failed because of the sandy nature of the surrounding area.

Work is currently underway to remove the guardrail barriers and the damaged gabion baskets.

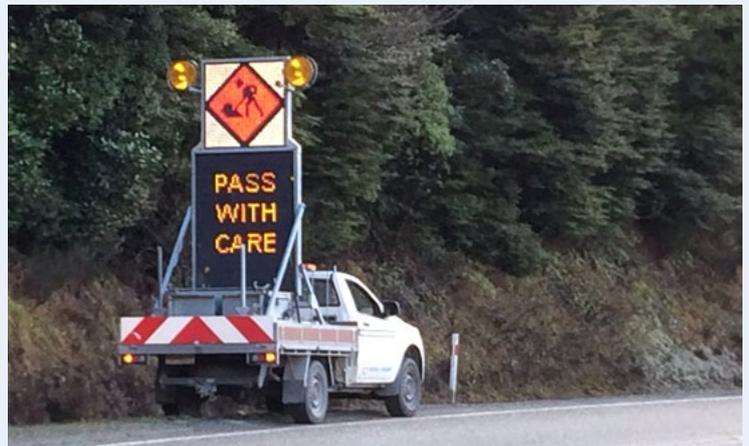
To help everyone - traffic and road crew - stay safe while also alerting road users to a hazard ahead, a new VMS (Variable Message Sign) ute has been making its appearance along the alternate Picton to Christchurch route. This extra safety tool can be quickly deployed where and when it is needed and may become a more regular feature of your drive.
