The Bulletin Kaikoura earthquake update

This weekly bulletin provides the latest information about the rebuild of road and rail networks damaged by the Kaikoura earthquake in November 2016. The bulletin is produced by the North Canterbury Transport Infrastructure Recovery (NCTIR) - an alliance representing the NZ Transport Agency and KiwiRail, on behalf of Government.

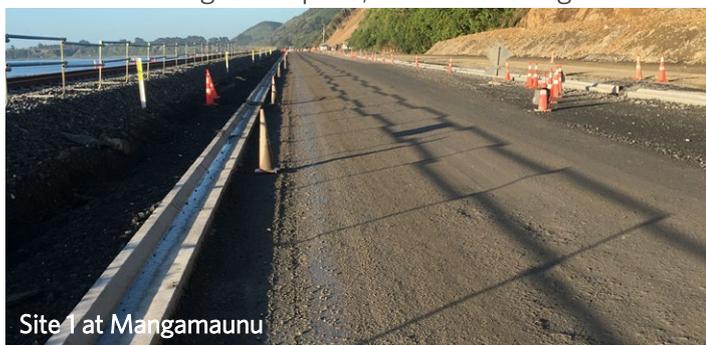
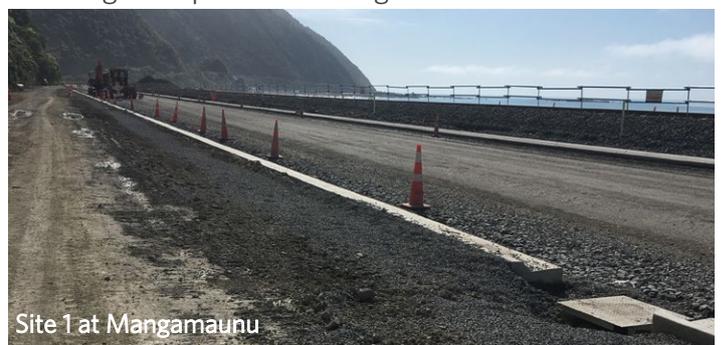
Site 1 at Mangamaunu is bustling with activity as the work to rebuild State Highway 1, north of Kaikoura, ramps up.

The two major slips at this site has meant the new road alignment stretches more than 1km, the highway having to be shifted seawards to create space for rockfall protection and a new rail alignment.

The coastal realignment team, of about 30 people, has been working hard since April to get this section completed. Underneath the road, seven new drainage culverts were installed to take water that comes off the mountains and divert it from the road.

Kerbing has been completed and next week work begins installing the guardrails at the site. The kerb had to be completed before placement of AP40 (which is a 40mm maximum size aggregate, a loosely compacted mix of sand, gravel, and stones) could begin. 'Now the team is working to place AP40 over the entire 15,000 square metre area, and that should be completed by the middle of next week. Following placement, we will cement stabilise it.' Cement stabilisation involves a large hoe coming in and milling the AP40 and adding cement to the aggregate which strengthens the material.

'The road is really taking shape and once it is stabilised, we can give it a final compaction using various construction rollers. After this we can start laying the chip seal,' says David. 'There is a lot of pavement work and sealing to complete, and our team is working around the clock to accomplish our goals,' says Delivery Manager Cherie Leckner.

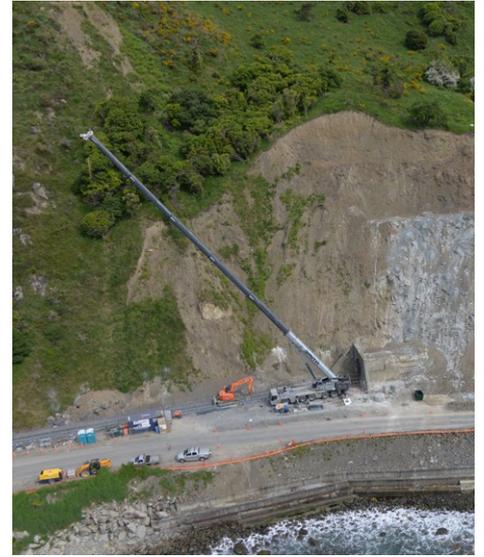
A team of 24 people worked around the clock for more than four months at the badly damaged Tunnel 13, just south of Kaikoura, beyond the Kahutara River Bridge. Now the tunnel team's hard work is paying off. At this stage, the slope above the tunnel has been fully unloaded, mesh has been applied on the face of the slope, and slope stabilisation is 100% complete. All 116 anchors have been installed and grouted with 1750 tonnes of cement outside of the tunnel. Using an innovative propping system that was the first of its kind in New Zealand, all 346 anchors have been installed and grouted with 1689 tonnes of cement from inside the tunnel. At a site that was once considered an exclusion zone, it is no small feat that work trains are passing safely through Tunnel 13 on schedule.

With the priority of stabilizing the tunnel in order to ensure work and freight trains can pass safely through now completed, Tunnels Manager Rafael S Ballen says they can look ahead to the next goal; constructing a 65 metre extension at the southern portal of the tunnel.

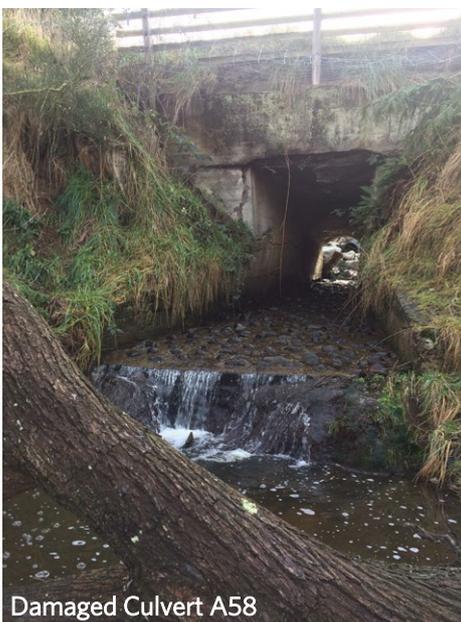
More than 750 fish have been re-released into Lane Stream on the Inland Road (Route 70) following the repair of Culvert A58. The culvert, over a tributary of the Conway River, was badly damaged in the earthquake. The stream flows through Culvert A58 on the Inland Road (Route 70), just over 30km from the Kaikoura township.

An environmental survey earlier in the year suggested fish were having trouble navigating through the broken pipe - many migratory and non-migratory fish were present downstream, but only a few upstream. 'Even though the pool was only about 2m x 3m and by 1m deep, we captured more than 750 fish.'

Damaged Culvert A58

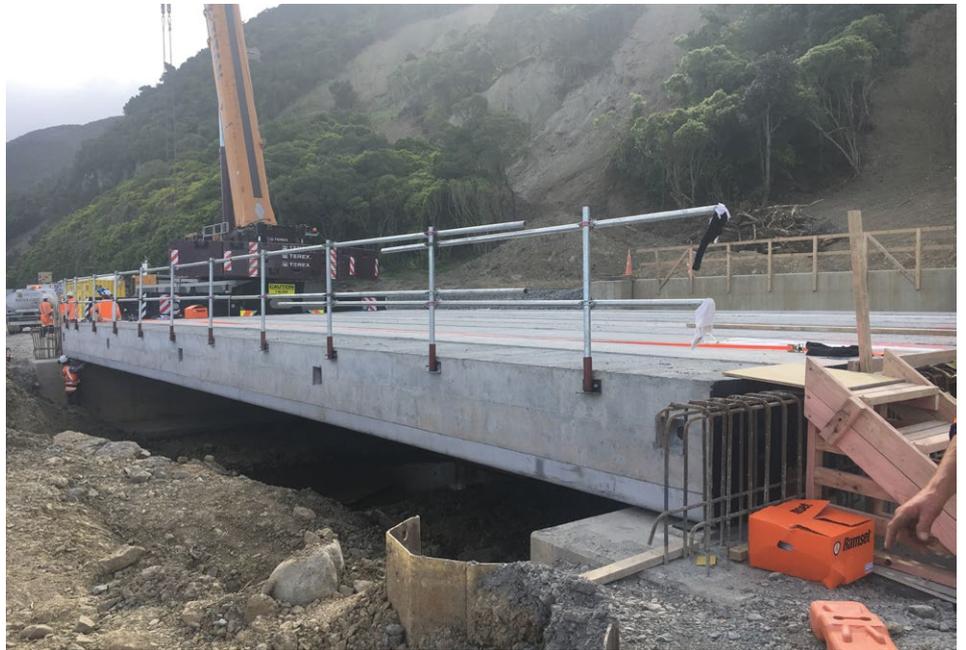
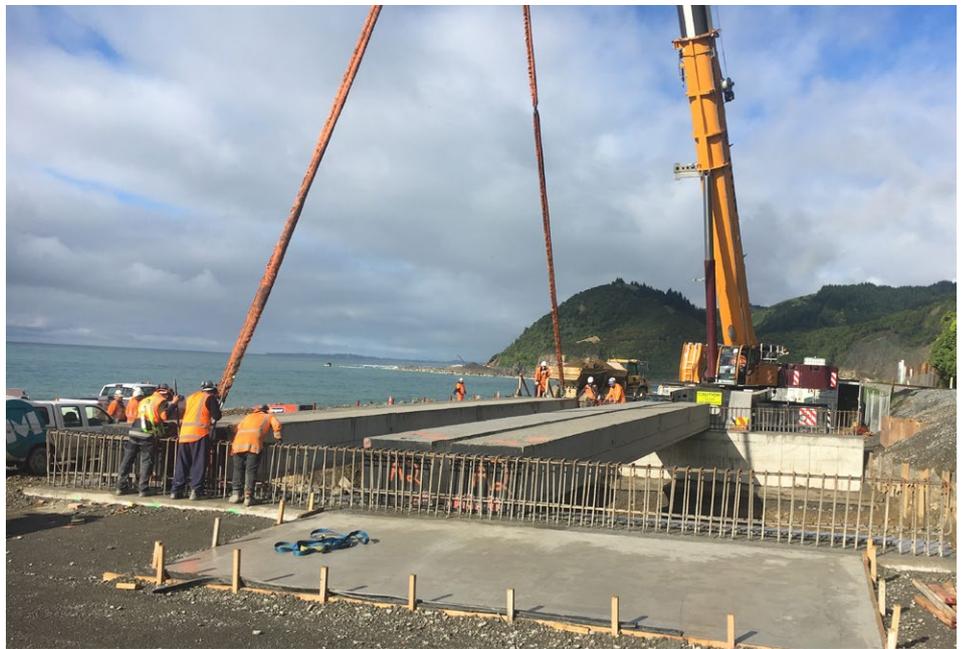
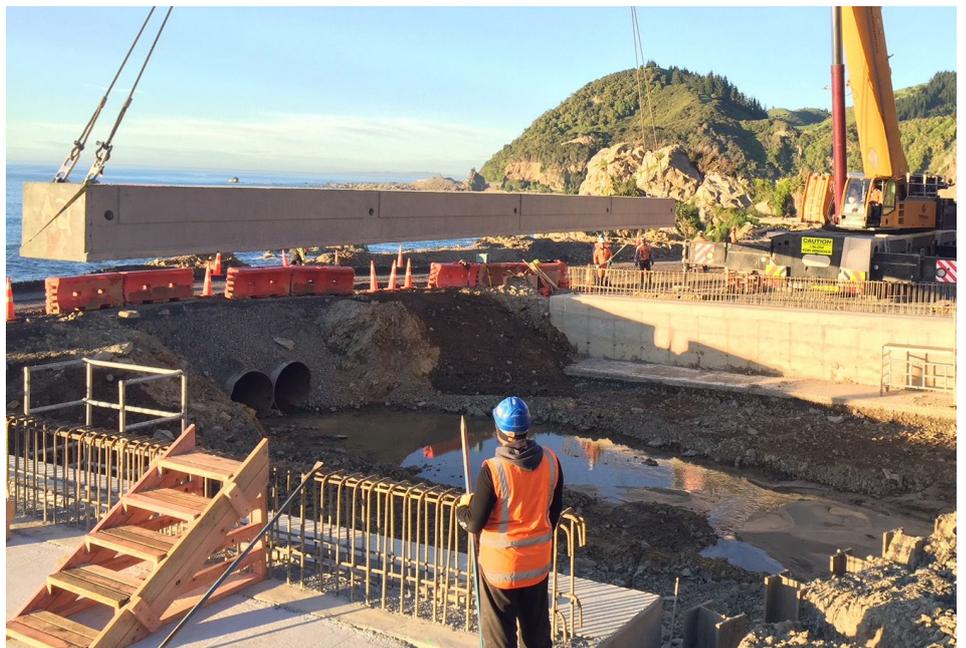
After just two weeks of work, what was recently a worksite buried in slip debris after heavy rain, is now a nearly complete debris channel bridge north of Half Moon Bay. Crews have cleaned up the worksite and are now ahead of schedule after a weekend of heavy rain turned the site into a swamp.

Pictures of the mud-soaked bridge made national headlines earlier this month, however last week a series of major milestones were reached when the cleaned-up site had ten 21m long bridge beams installed last week (see **last week's Bulletin** to find out more).

'The debris bridge wasn't complete when the rain sent the muck rushing down. Instead of being a covered channel for material to flow through, the unfinished and open construction site filled up with mud like a pool.

Faced with a muddy worksite, the earthworks team joined forces with the structures team and carried out the clean-up in just five hours.

To help clear material from the top of the slip, a section of rail line was cut out so machinery could move the mud. Four excavators, bulldozers and huge dump trucks worked to clear the mess, and it wasn't long before the site was back to normal.
