The Bulletin Kaikōura earthquake update

This bulletin provides the latest information about the rebuild of road and rail networks damaged by the Kaikōura earthquake in November 2016. The bulletin is produced by the North Canterbury Transport Infrastructure Recovery (NCTIR) - an alliance representing the NZ Transport Agency and KiwiRail, on behalf of Government.

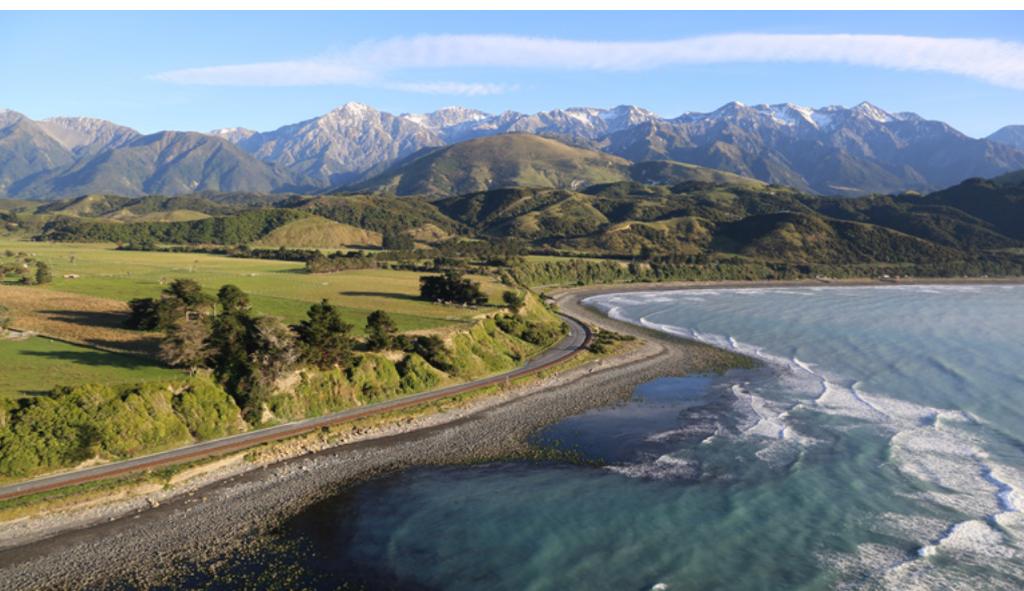
The design is still a work in progress. The broad footprint was consented by Kaikōura District Council and Environment Canterbury Regional Council in July 2017. An amendment in March 2018, was a result of design refinement of possible works and included the provision of coastal protection (ie sea defences) adjacent to the proposed shared path.

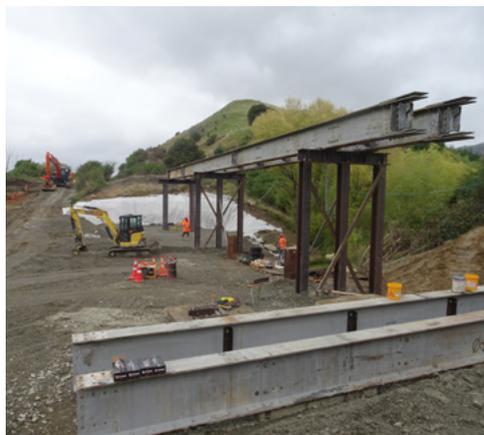
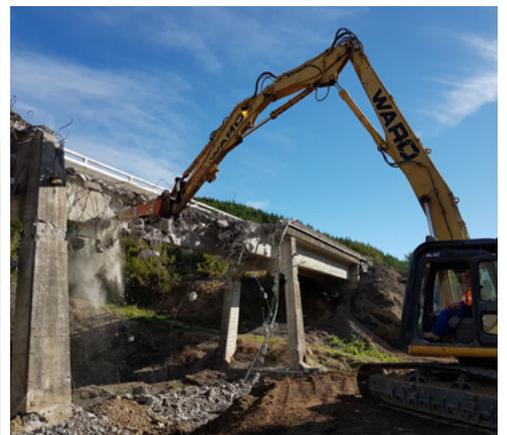
The new build will include constructing embankments, putting in piles, installing abutments to hold the bridge at each end, and fitting four 30m-long beams across the bridge.

'It's a pretty standard rail bridge' says project engineer James Kelly. 'Our biggest challenge will be getting the materials to site as it is quite remote. The 50 tonne beams in particular will require a high level of planning

The earthquake-damaged bridge at this site was demolished in March 2017 with a temporary bridge installed using KiwiRail emergency bridge spans so the MNL could start running again.

The rail line will be moved onto the new bridge before the temporary bridge is deconstructed.

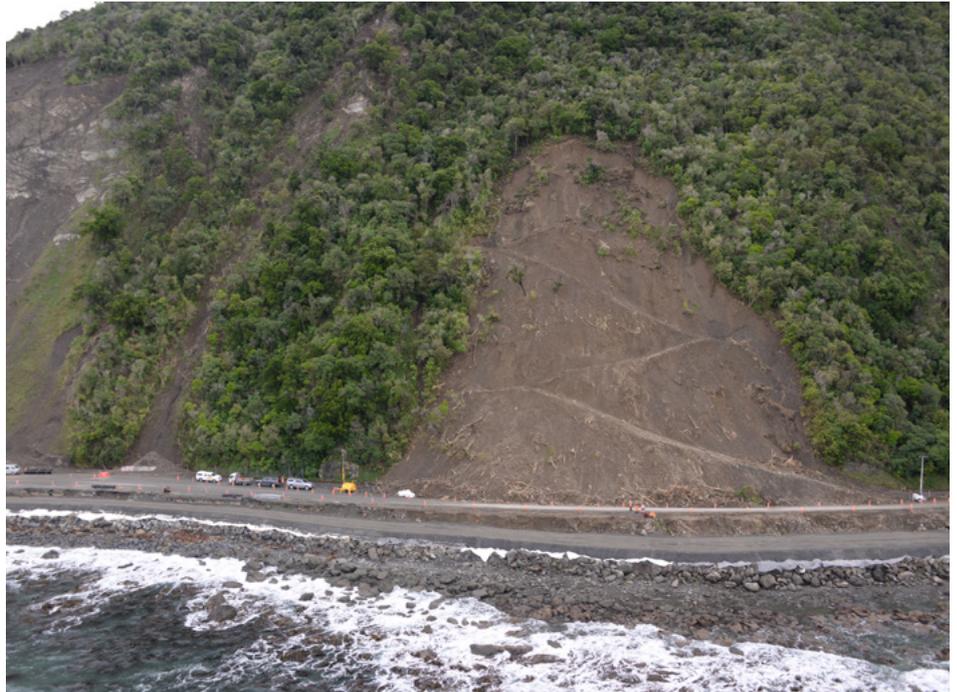
Slip 29A not long after ex-cyclones Debbie and Cook in 2017

Site 29A didn't fail in the original Kaikōura Earthquake, however ex-cyclones Debbie and Cook brought down 232 mm of rain on top of the slope over 10 days in 2017, causing it to slump 12 metres into the transport corridor.

The road was blocked for more than a week while crews attempted to stabilise the 90-metre-long slip. Fifteen thousand cubic metres of material were removed in the process.

To avoid removing the toe of the slump and risk de-stabilising the slope further, the rail and road were rebuilt further out towards the foreshore, curving around the toe of the slip.

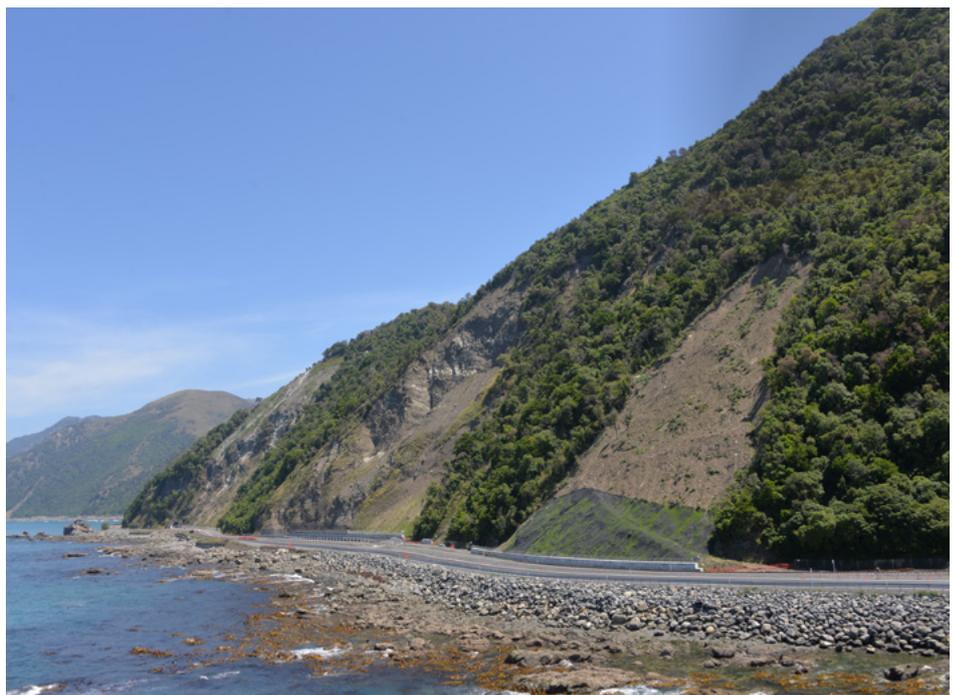
Site 29A with the road realigned

When this year's ex-cyclone Gita hit in February, 300 mm of rain fell at this site in just one day. This saturated and reactivated the remaining slump material causing a 30,000 cubic metre landslide to bury the rail line and State Highway 1.

The failure exposed the rockface behind the material which meant it was considered safe to remove the remainder of the original slump material.

Geotechnical engineer William Marshall says right now both the rail and road are protected from any further loose material.

'Without vegetation cover there is a risk of rock fall and minor debris avalanches from the exposed slope, so we have constructed a 4m-high bund at the base of the slope to protect the road and rail,' explains William.

Ex-cyclone Gita had the same effect on the site as a large scale sluicing operation. Now the displaced material has been removed, the design team can consider improvements to the transport corridor alignment as part of the permanent design.

'In an ideal world we would like road and rail to be as straight as possible, but to achieve this we need to shift the transport corridor closer to the slope.

We need to build a rock fall protection barrier for this to happen and the design for this has just begun,' explains William.

While the design of the alignment and slope protection will be finalised over the next few months, the barrier is likely to resemble the structure at the base neighbouring Rosy Morn slip. At 29A, a 5.5m-high barrier is being built which includes a 3.5-metre-high gabion wall with a 2m-high debris fence on top.

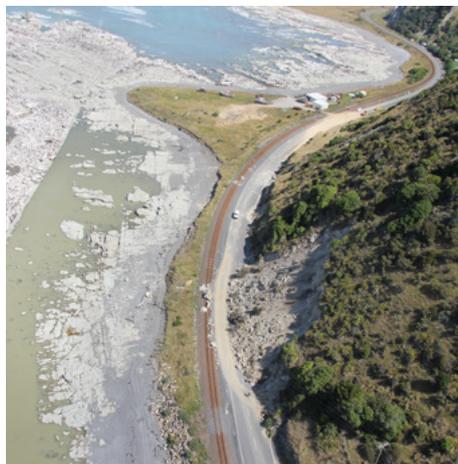
Site 9 then

Check out Waipapa Bay at this time last year and how it looks today. The crew at Site 9 are well underway completing the road and rail realignment.

Eighty thousand cubic metres of recycled slip material has been laid to build up the base of the new site. Right now crews are building up the rail embankment. In just over a week, rail crews will begin laying new track here. Once the rail is complete, the crew will begin building a Terramesh rock fall protection wall and the new road.

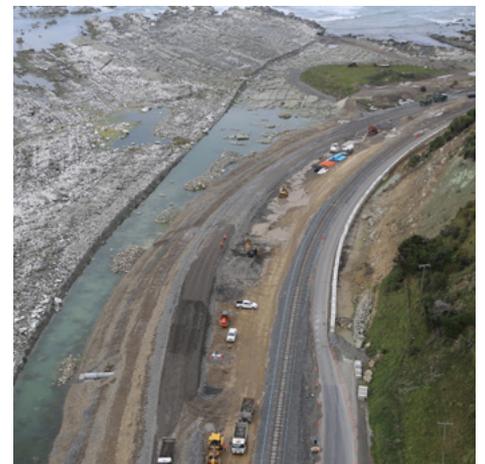
Site 9 now

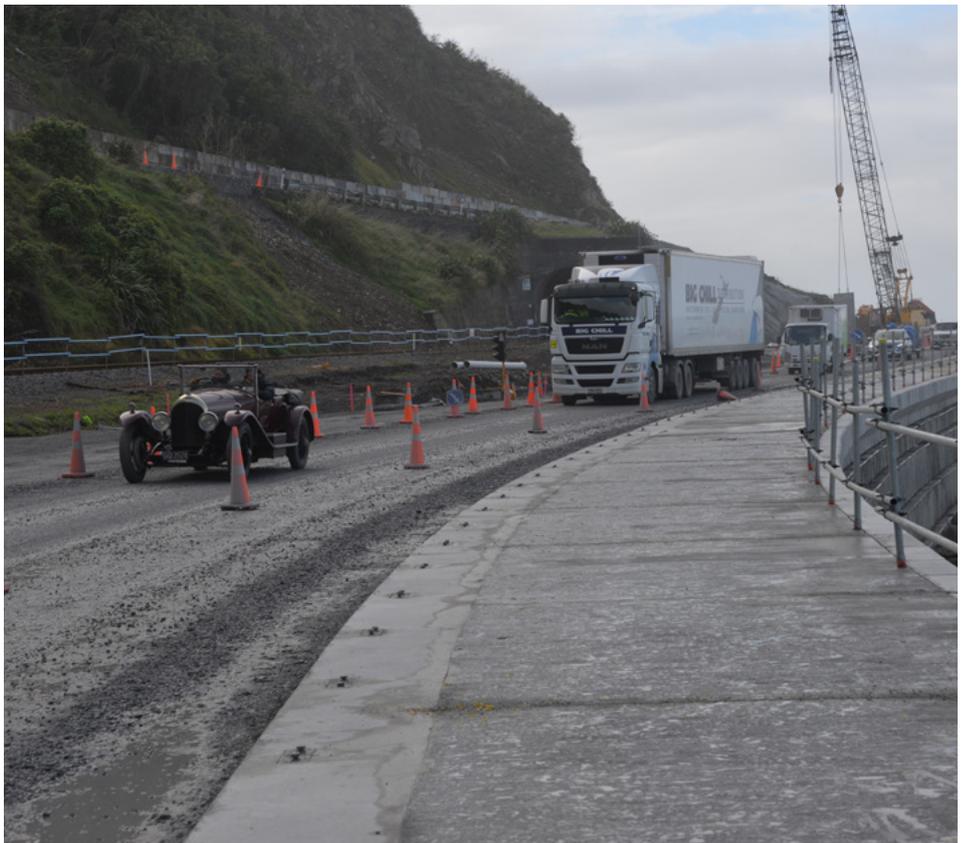
One of NCTIR's hard working teams chalked up a milestone last week - they finished laying the first 560m section of the shared walk and cycle path at Irongate Stream north of Kaikōura.

This part of the shared path is being constructed as part of the seawall structure built to realign SH1 seaward and away from the landslide. Once handrails are added, this section of the path will be one small part of the rebuild job that's finished, offering a glimpse of what SH1 will look like in the future.

The concrete is 50mPa, a super strong structural concrete, and has a micra silica additive to prevent the steel reinforcement from corroding in the marine environment. This makes it a challenging product to work with as it sets very fast.
