# **Impact on Driver Behaviour of Overtaking Lane Design for New Zealand Roads**

**Transfund New Zealand Research Report No. 255**

Rebecca E. Luther, Brett D. Alley, Samuel G. Charlton,  
Brenda J. Wigmore, Peter H. Baas  
TERNZ Ltd, Auckland

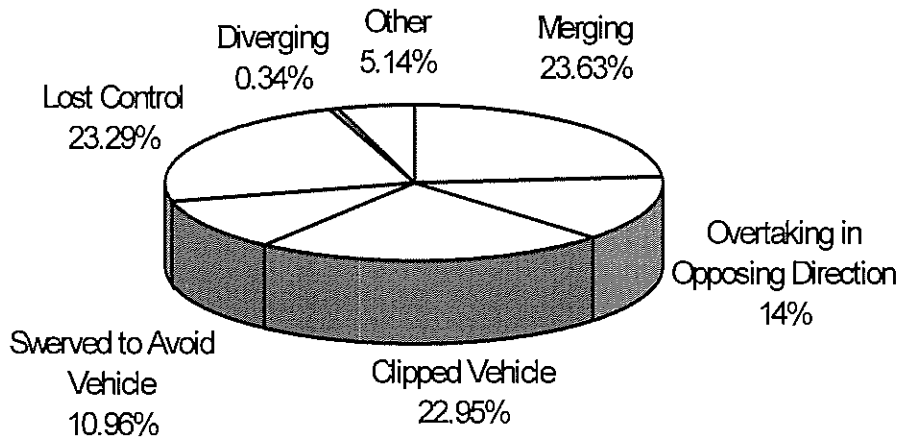
Figure 2.1 Causes of crashes in passing lanes for the period 1996-2001.

The causes of the crashes identified in this analysis were determined from the crash reports recorded in the CAS system. As Figure 2.1 shows, several prominent factors contributed to the passing lane crashes. The leading factors were: one car clipping another when changing lanes (23%), failing to merge correctly (24%), losing control within passing lane (23%), and overtaking using a passing lane for the opposing direction (14%).

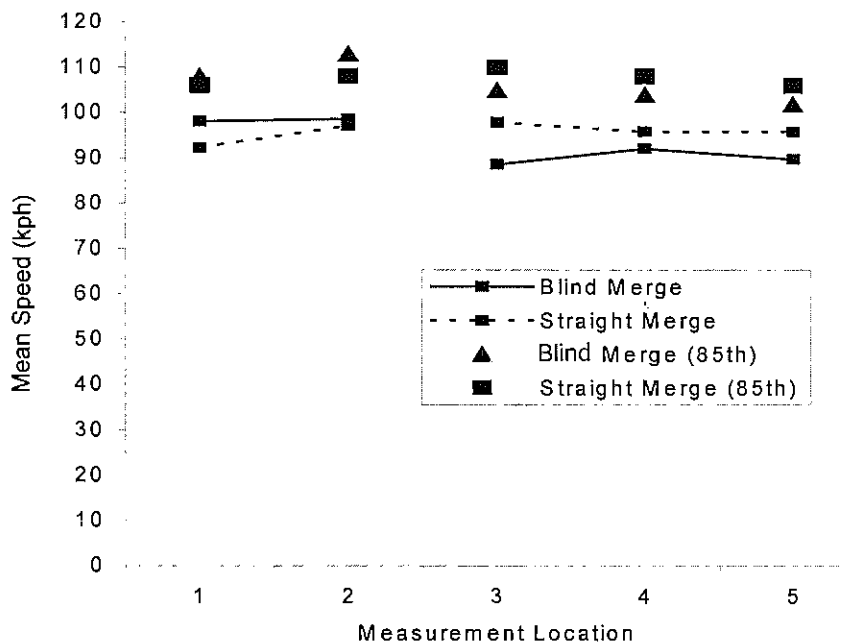
Figure 3.2 Vehicle speeds for the two on-road sites<sup>2</sup> at the diverge (on left) and merge (right) sections.

As Figure 3.2 shows, traffic in the blind diverge (locations 1 and 2) exhibited very consistent mean speeds (98.0 kph and 98.6 kph respectively) across the two locations. By comparison, a distinct increase in mean speeds for traffic occurred in the straight diverge for locations 1 and 2 (92.2 kph, 97.1 kph respectively).

Mean speeds at the merge area differed notably between passing lanes. Recorded speeds were noticeably slower for vehicles at the blind merge site (ranging from 88.6 kph to 92.11 kph). By comparison, vehicles at the straight merge site showed higher speeds (ranging from 97.9 kph to 95.8 kph). Much of this difference may be attributed to the geometry of the sites in which the two merges occurred. At the blind merge site, drivers were cresting a rise as they approached the merge area, after an extended climb. The speed profile for this merge shows drivers increasing their speeds slightly from locations 3 to 4, and then decelerating from locations 4 to 5. The

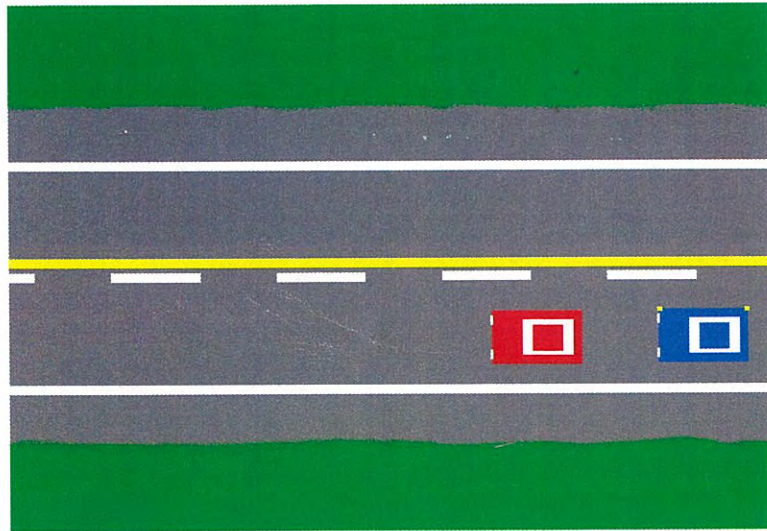
Figure 4.6 Two-lane road with solid yellow no-overtaking line on opposing lane only.

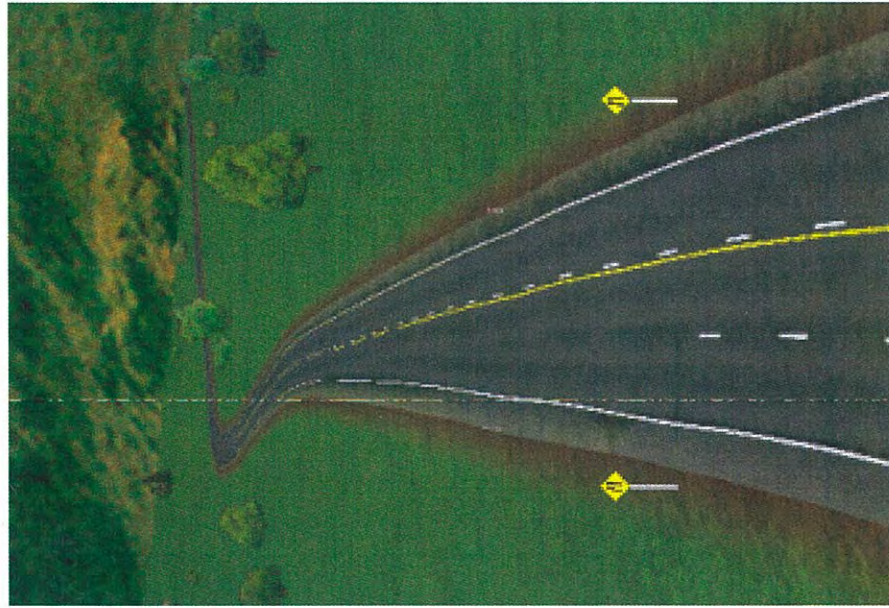
Figure 5.1 Oblique scan (left) and screen shot of the plan view (right) of the simulated control treatment.

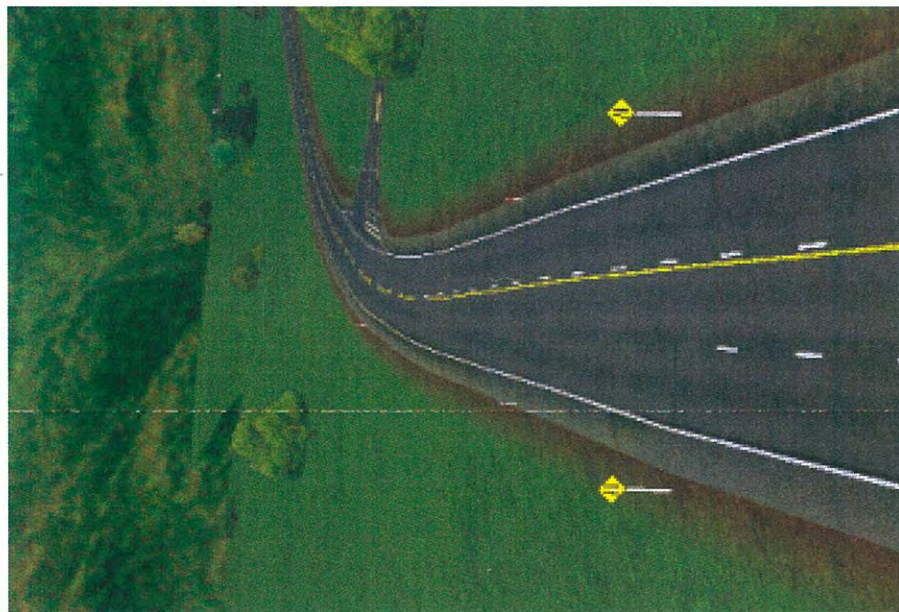
Figure 5.2 Oblique scan (left) and screen shot of the plan view (right) of the simulated validation treatment.

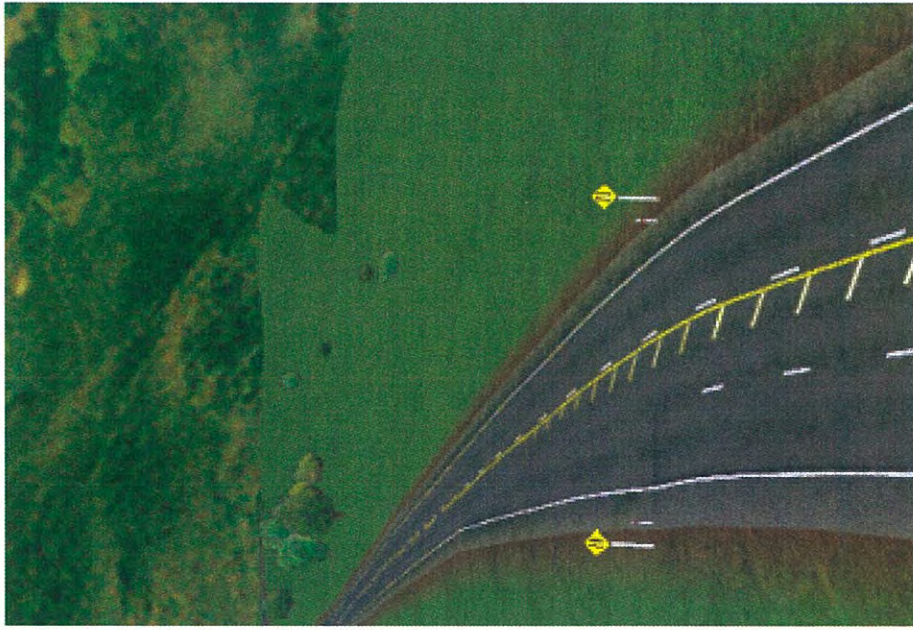
Figure 5.30 Oblique scan (left) and screen shot of plan view (right) of the simulated right herringbone with short taper merge design.

The last analysis carried out was of the right herringbone treatment<sup>10</sup> on short taper merges. Figures 5.27, 5.28 and 5.29 provide comparisons of average speed, lateral displacement, and headways. Figure 5.30 shows plan and oblique views of this treatment.

<sup>10</sup> A right herringbone is placed on the right side of the passing lane adjacent to the road centreline.

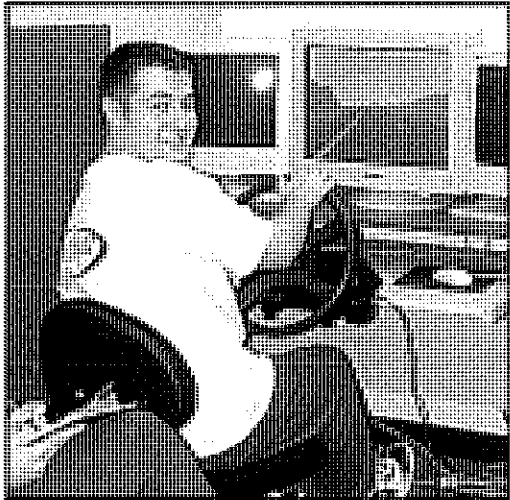
Figure 1 Driving simulator configuration.

On-line measures that are typically collected include lane positioning, braking, speed maintenance, headway distances, stopping times, and occurrence of collisions.

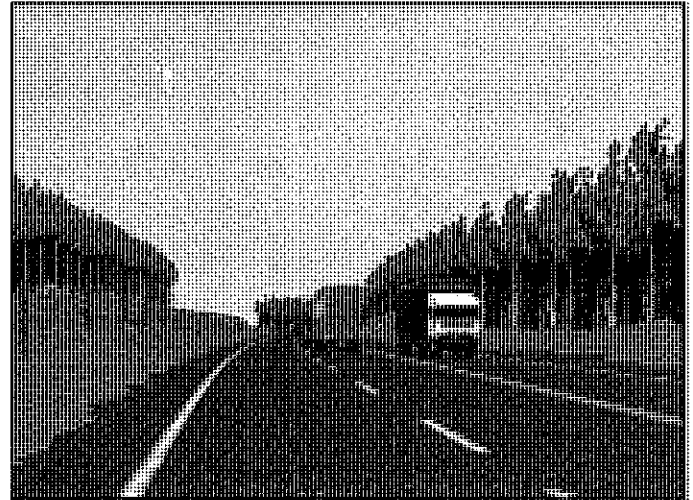
Figure 2 Typical simulated road scene.

The DS3 driving simulator is one in a line of successively refined driving simulators developed at the University of Waikato in conjunction with TERNZ for the specific purpose of traffic safety research. The DS3 is a medium-fidelity driving simulator comprising a 21-inch CRT displaying coloured road scenes and steering wheel and foot pedal controls (see Figure 1). A typical driving scene from the simulator is shown in Figure 2.
