Options Report

Northland One Lane Bridges Replacement

May 2015

Prepared By
Hawley
Andrew Tovey
Work Group Manager

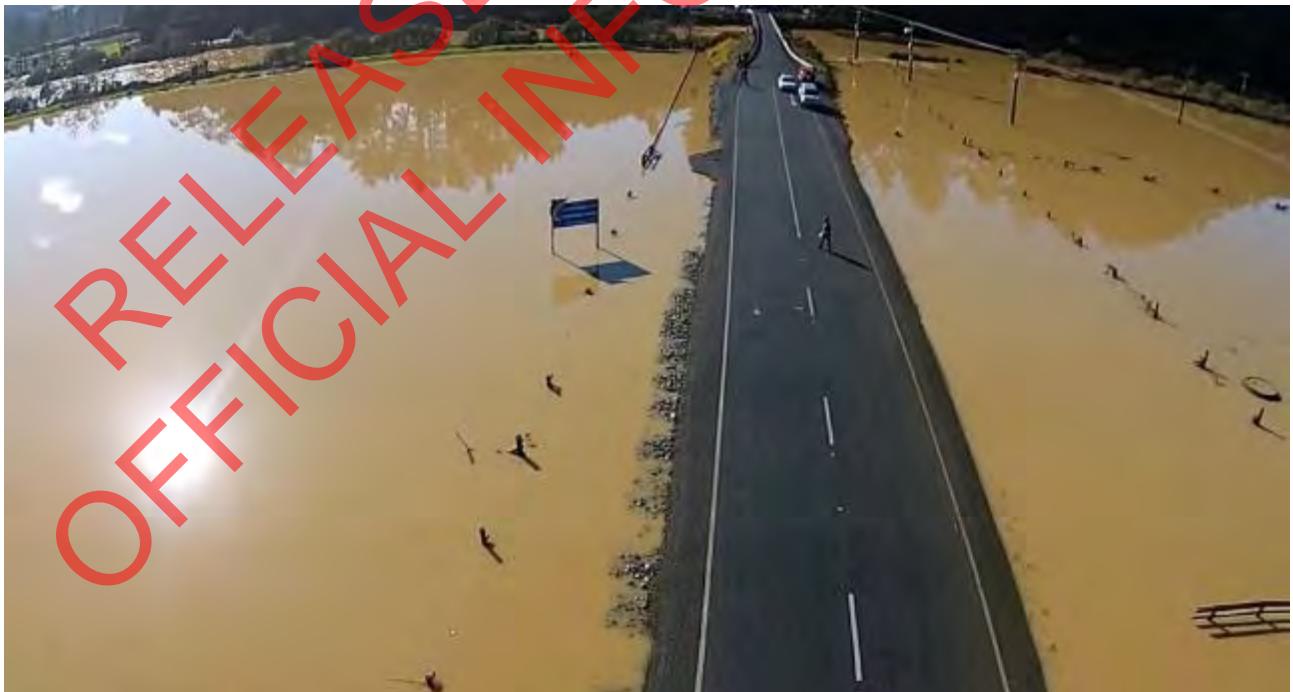
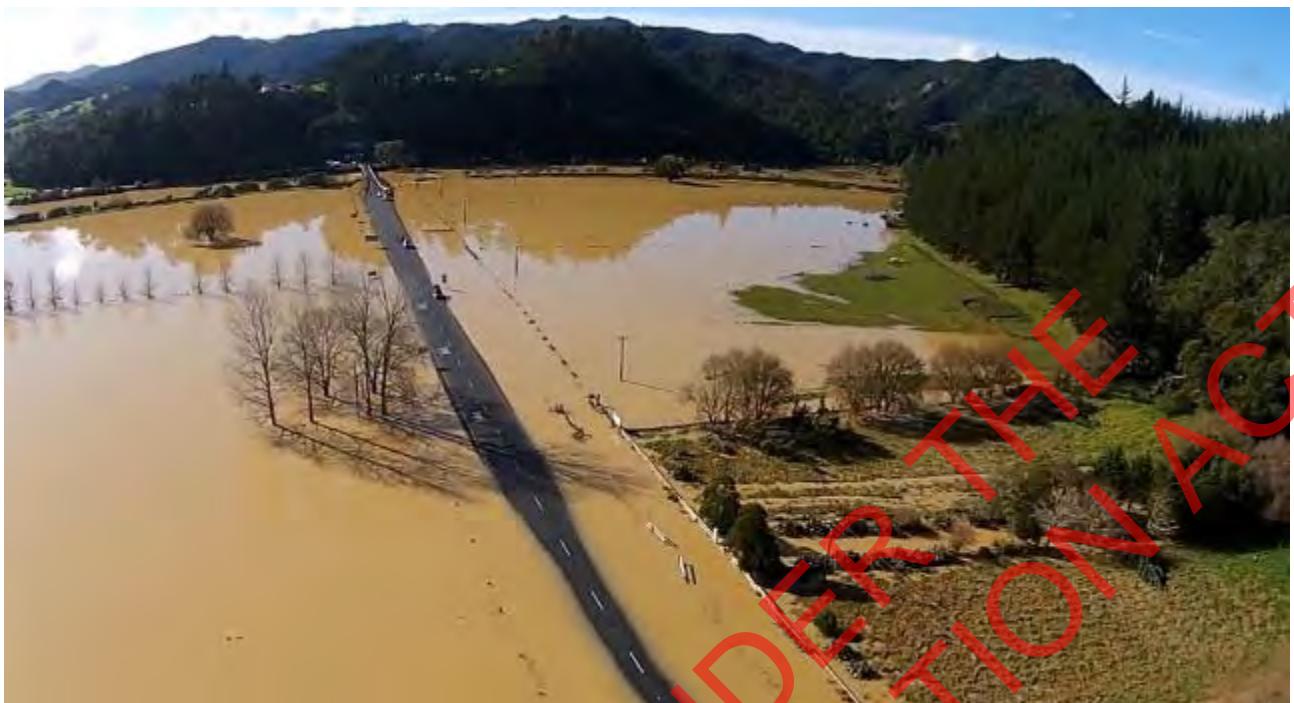
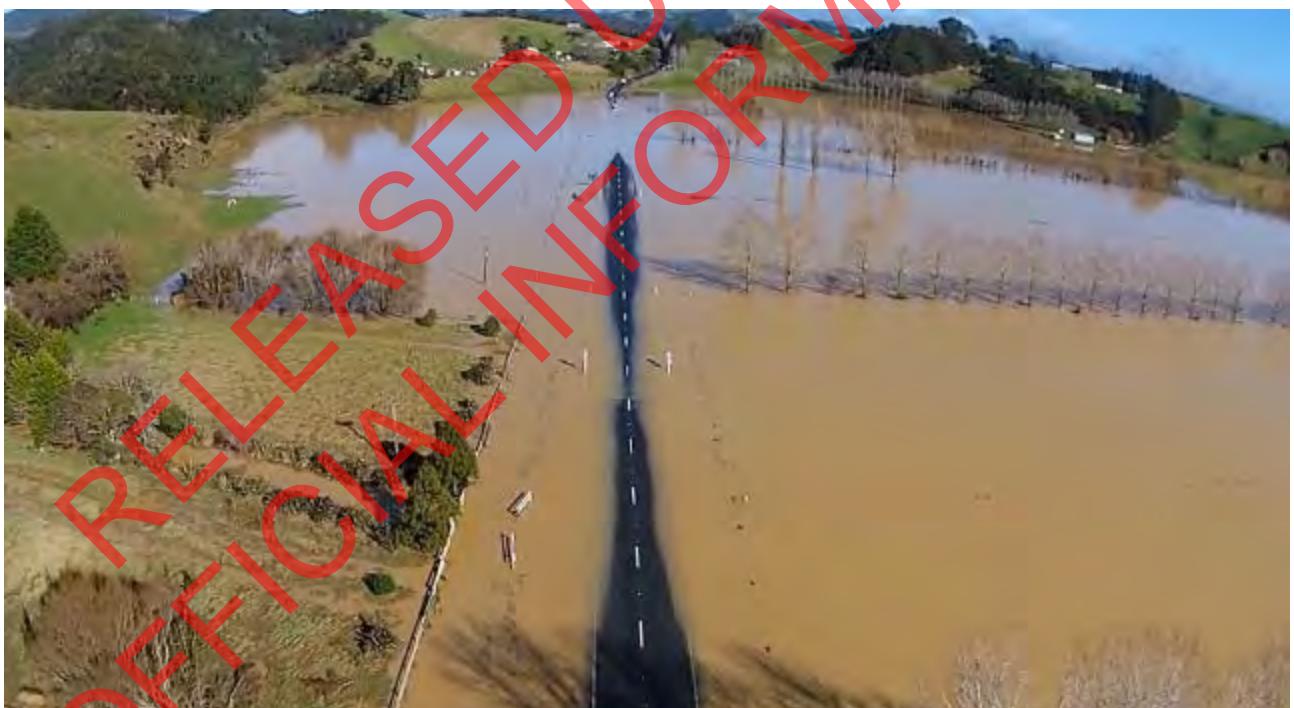
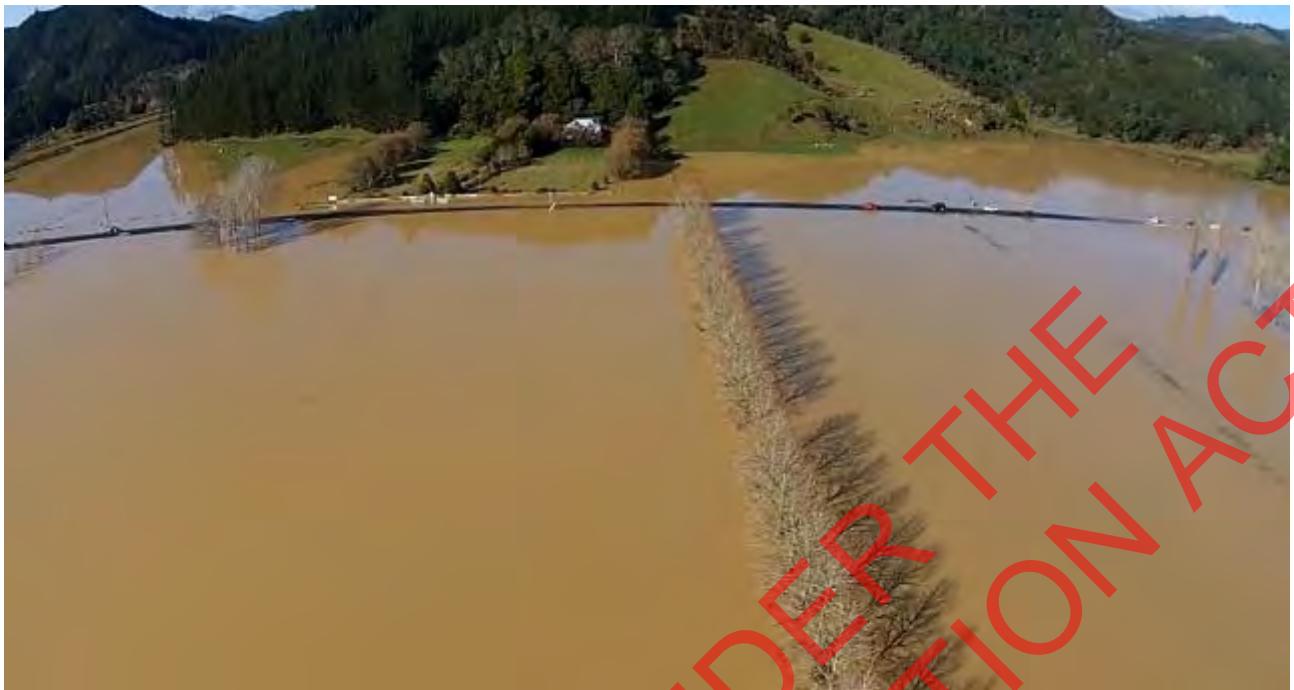
The photos below demonstrate the susceptibility of the road to flooding. These images were taken the day after the rain in July 2014. Water levels have receded in the photos. The level of flooding can be significantly affected by the state of the tide from the Whangaroa Harbour. Any upgrade of the bridge should be investigated in parallel with the raising of the road to add resilience to the network, whilst being mindful of the environmental impact.

Photograph looking east, toward the one lane bridge.

Photograph looking east toward the one lane bridge.

Photograph looking west, away from the one lane bridge

Photograph looking south, taking in SH10, the one lane bridge is to the left, just off the photo.

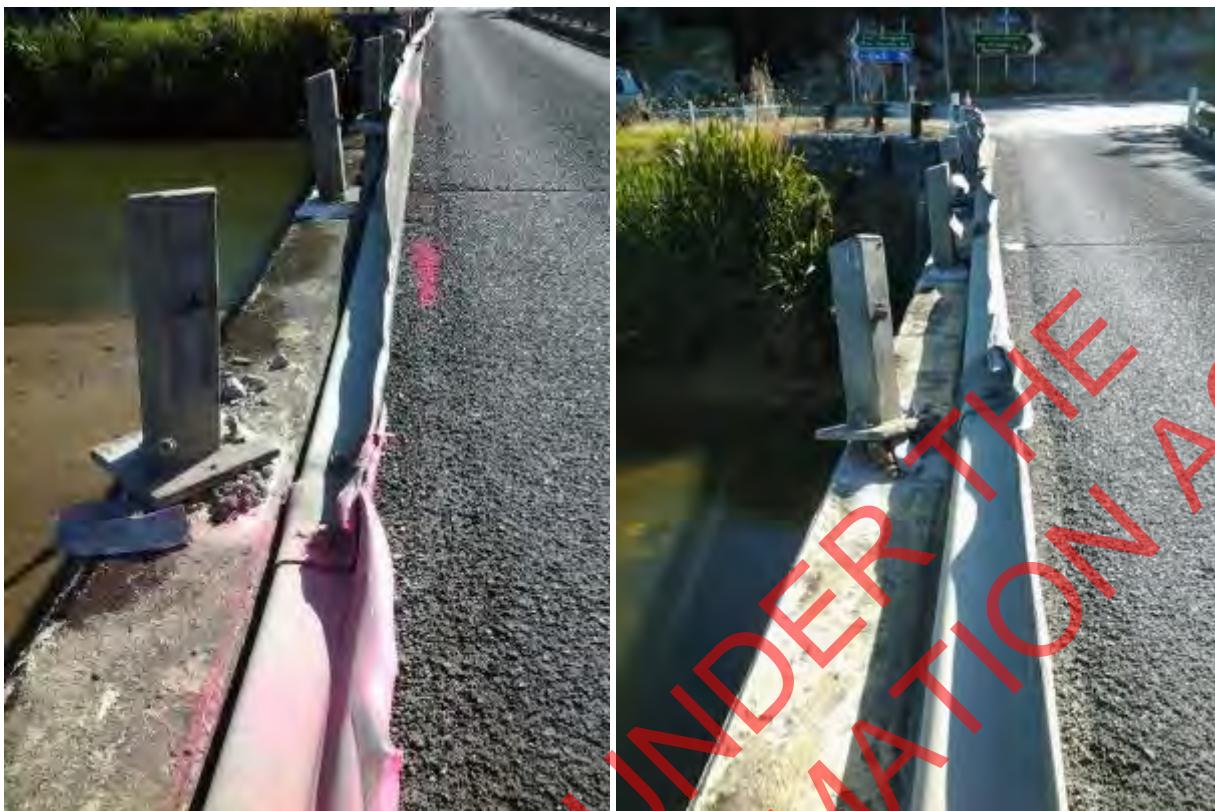
Furthermore, the reduced bridge width is problematic for oversized vehicles and recently \$66,000 worth of damage has occurred resulting in significant guardrail replacement. Typically, repairs are required to the guardrail 3 to 5 times a year. The photos overleaf show the significant damage that was sustained recently.

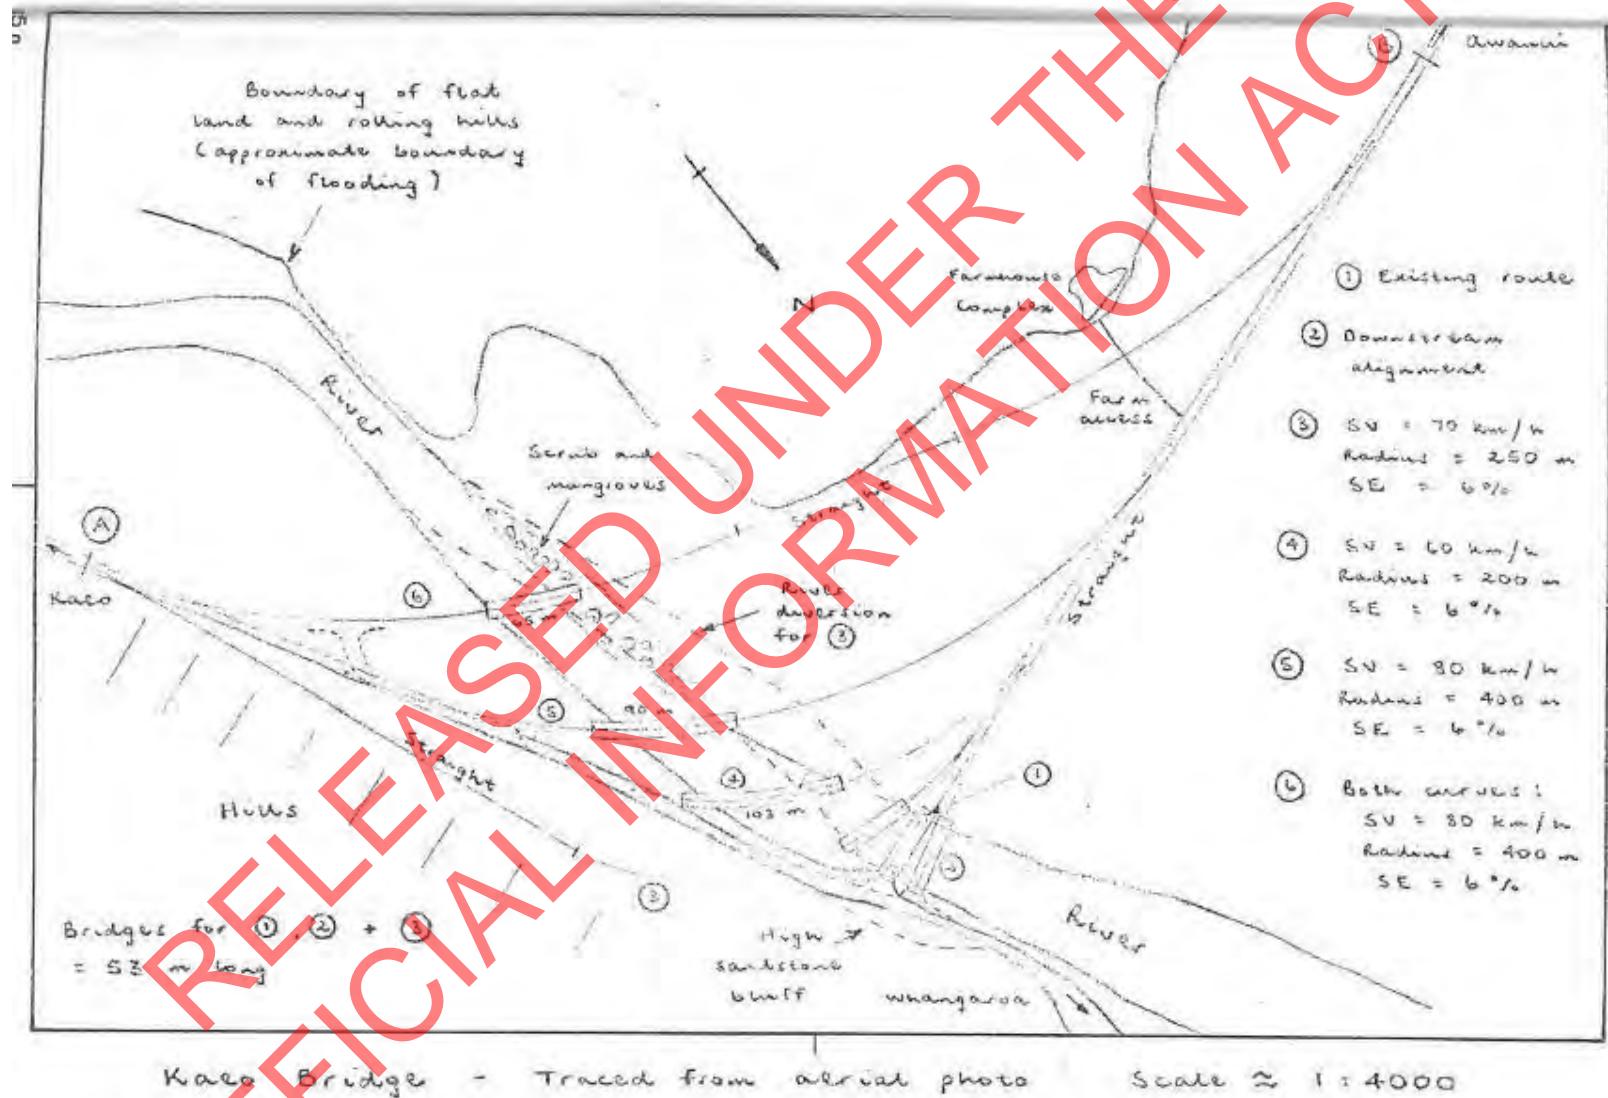
However, it is not practicable or desirable to replace the bridge on the existing alignment. Opus undertook a detailed option appraisal many years ago and the base plan for this is shown on the following page. The preferred option has a sweeping radius with a skew bridge over the river. This, combined with the cost of constructing a new section of road brings the estimate up to **\$11.5M**.

The 90m radius bridge option was used for estimating purposes.

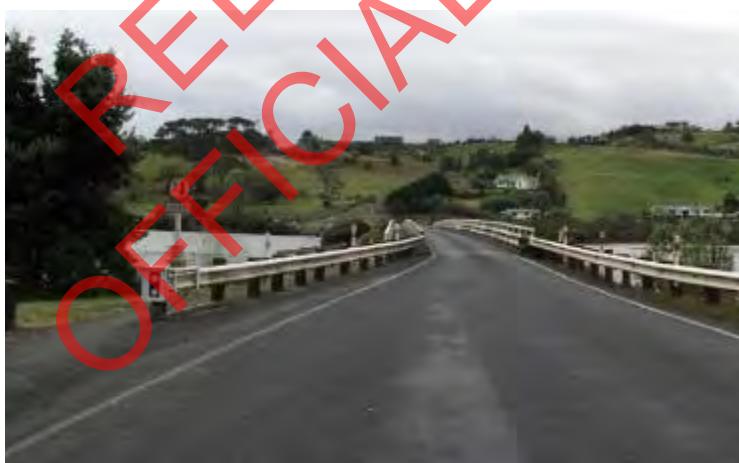
Travelling south, due to the alignment of the bridge both horizontally and vertically vehicles are unable to fully see the far end of the bridge, this does lead to conflicts in times of peak traffic.

As this is a popular holiday destination around Christmas it is common for queues to occur on this bridge. Currently these are controlled by the installation of temporary lights; this works fairly successfully.

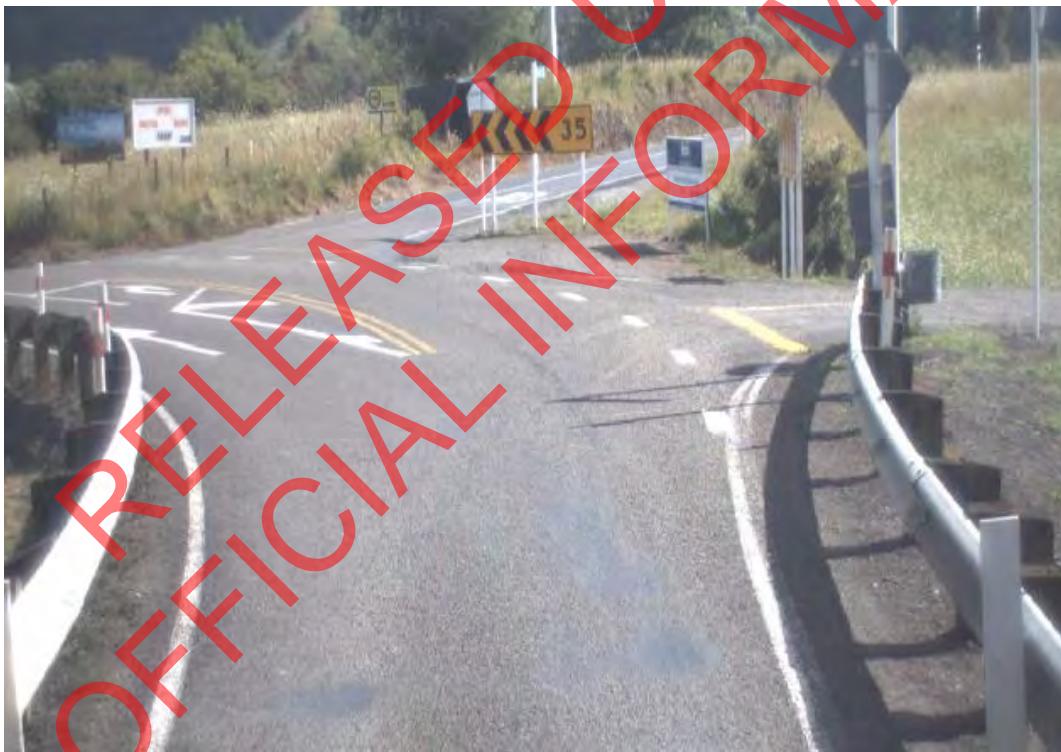
View travelling north to the Bay of Islands

Travelling north, there are two intersections with SH11. One of these is for a minor road. These are directly on the bridge approach resulting in very poor alignment and compromised visibility, as shown in the image below.

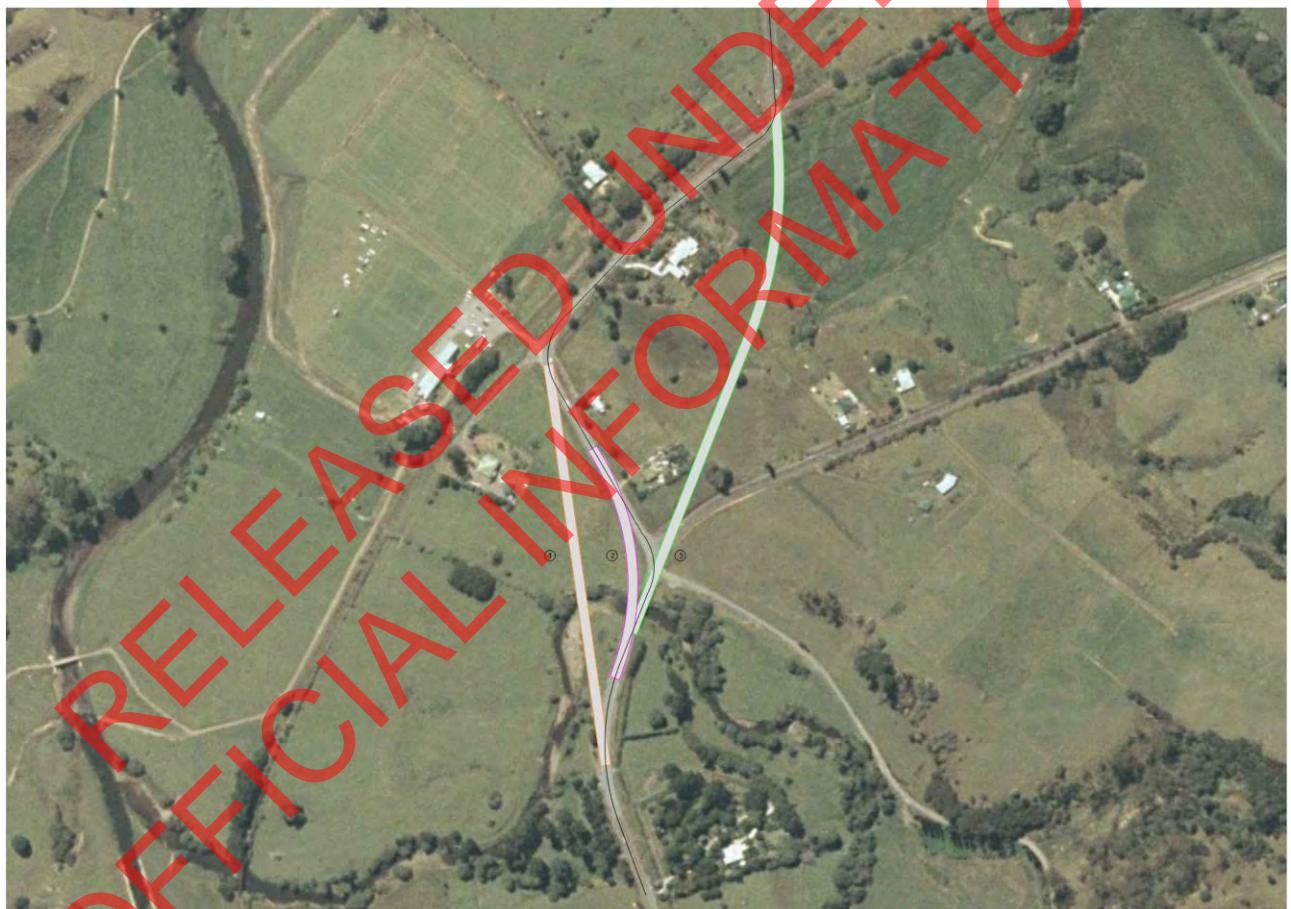
Ariel view showing alternate alignments

A full bridge replacement, off line to the west (Option 2 below) is feasible. This would improve the geometric layout of the approaches and address the substandard intersections with Waikare and Doel Road immediately north of the bridge. All the opportunities would be realised including crash reduction, pedestrian and cycle facilities, journey reliability etc.

A realignment even further west (Option 1 below) to improve the geometric layout again could be constructed but it is felt that this may not be cost effective due to the river alignment and topography of the land but should still be considered through the Indicative Business Case procedure.

There is the further option of a major realignment to the east (Option 3 below), effectively removing three bends and constructing 350m of new road together with upgrading the bridge. It is likely that this option would not be financially viable and that land acquisition would be problematic as there is a *historical* house adjacent but should still be considered through the Indicative Business Case procedure.

- ▶ Option 1: The estimated budget for the replacement of Tirohanga Stream Bridge on a new alignment to the west, eliminating two bends is **\$5.7M**
- ▶ Option 2: The estimated budget for the replacement of Tirohanga Stream Bridge on its current alignment, modified slightly west to tie in with the existing road network is **\$4.79M**
- ▶ Option 3: The estimated budget for the replacement of Tirohanga Stream Bridge on a new alignment to the east, eliminating three bends is **\$6.2M**

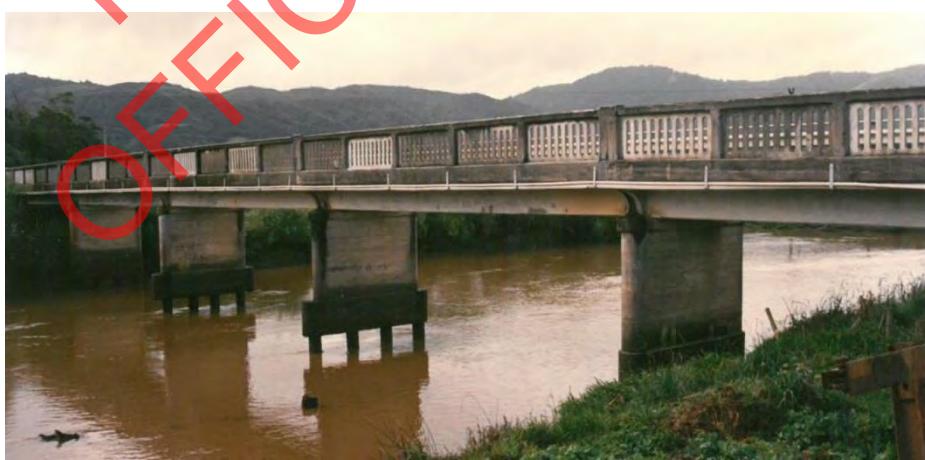
Side elevation of the Rangiahua Bridge on SH1

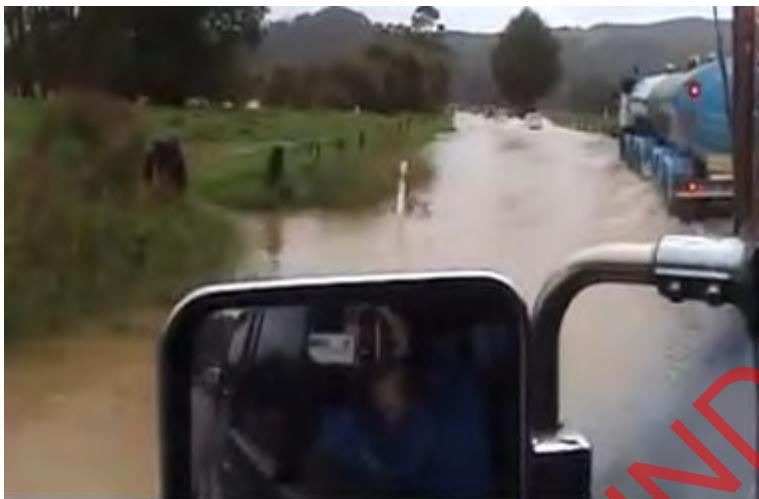
The photos below demonstrate the susceptibility of the road to flooding. These images were taken after the July 2014 event. Water levels would appear in places to be up to about 350mm deep.

The level of flooding can be significantly affected by the state of the tide from the Hokianga Harbour as the river is still tidal at this point. Any upgrade of the bridge should be investigated in parallel with the raising of the road to add resilience to the network.

- Flooding - resilience cannot be achieved without addressing the road flooding, see earlier photos
- Consultation and obtaining Resource Consents is likely to be publicly notified and time consuming, especially if raising of the road is included in the project
- Insufficient budget to meet both bridge replacement and network resilience requirements

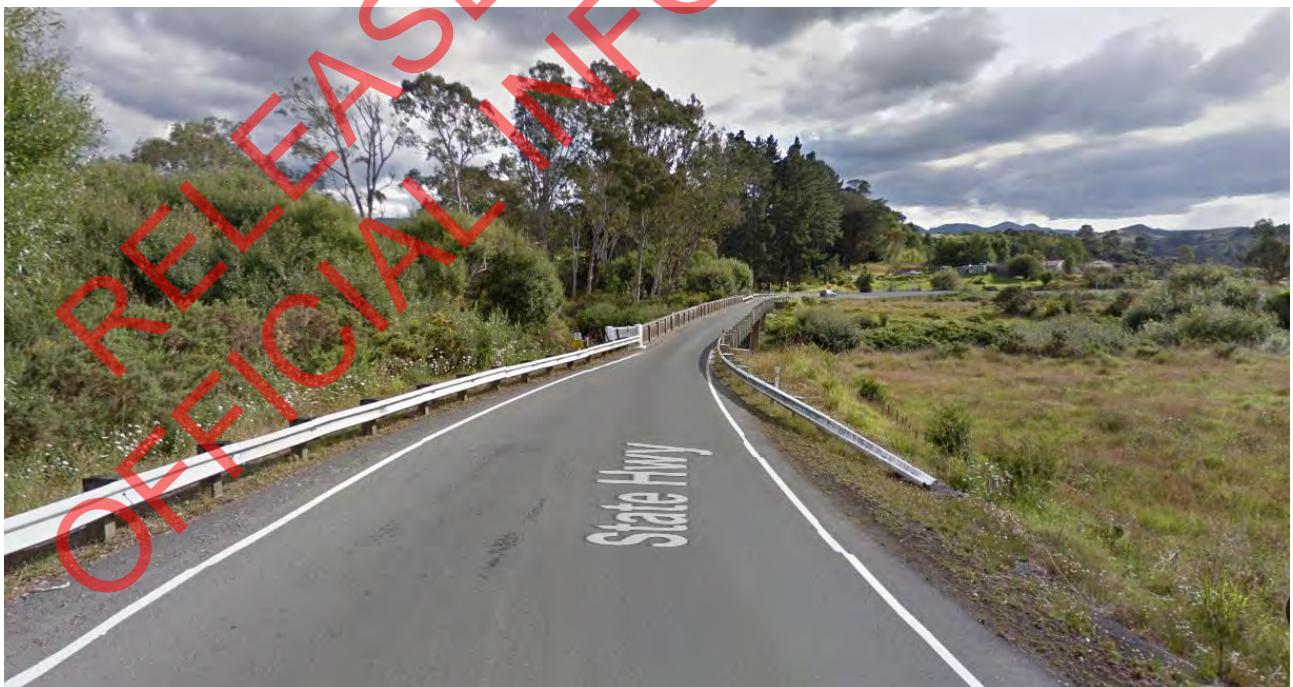
Due to the horizontal alignment there are recurring issues with vegetation growth obstructing sight lines. This requires regular pruning every few years and can been seen to the right of the above image. There are no route security issues at this location and no reported significant delays to road users at the bridge.

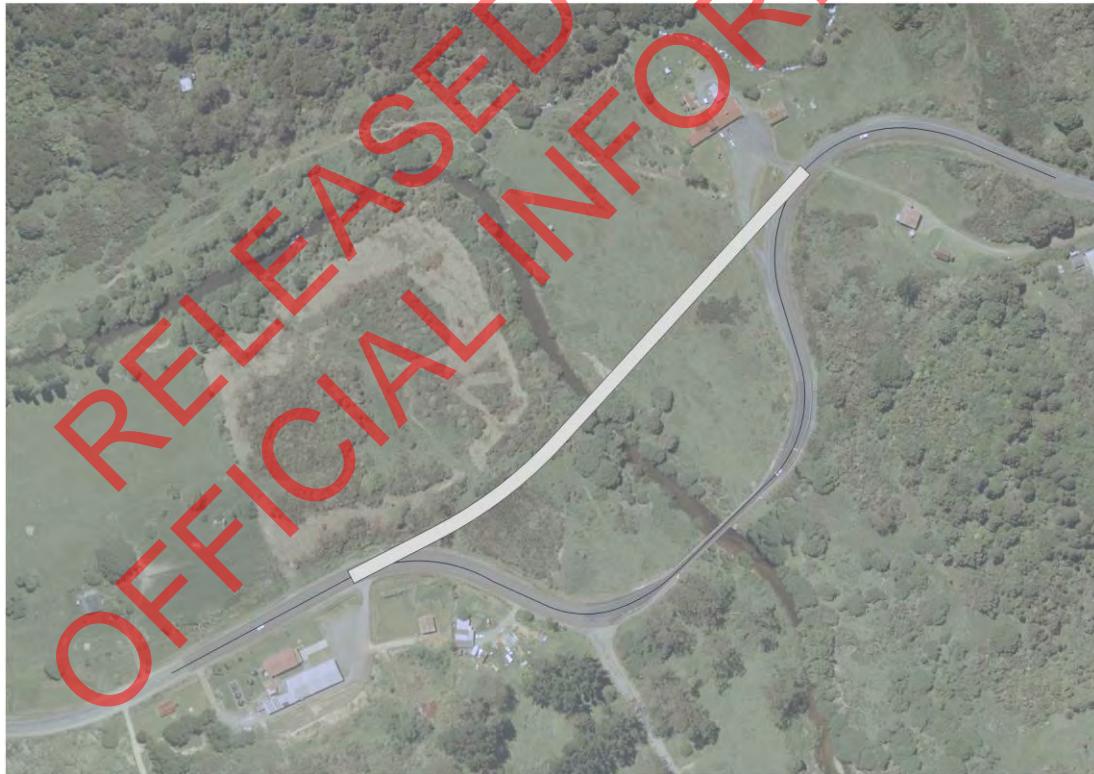
The construction of a two lane bridge immediately to the north west of the current bridge with realignment to the two approach curves.

Potential option of bridge and realignment to the northwest.

- ▶ The estimated budget for the replacement of Taheke Bridge on its current alignment is **\$8.0M**
- ▶ The estimated budget for the replacement of Taheke Bridge on an improved alignment eliminating the three bends is **\$9.5M**
