| Subject: | Nightshift Handover Report - Paving SH1 | ļ |

| | Nightly Update | |
|---|--|---|
| Location | SH1 NB Constellation to Greville – Southern Extent | |
| Activity | SH1 NB Southern Extent OGPA 1. Full mill @ 30mm South of Bridge 10. | ł |

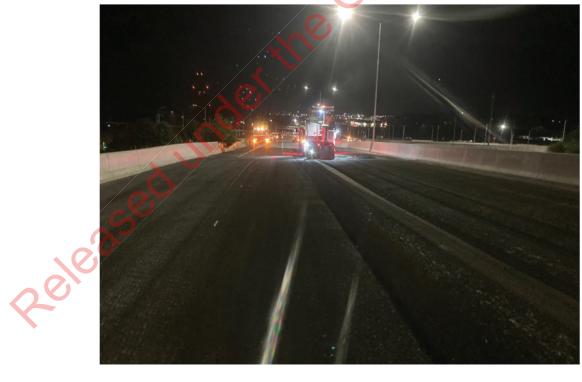
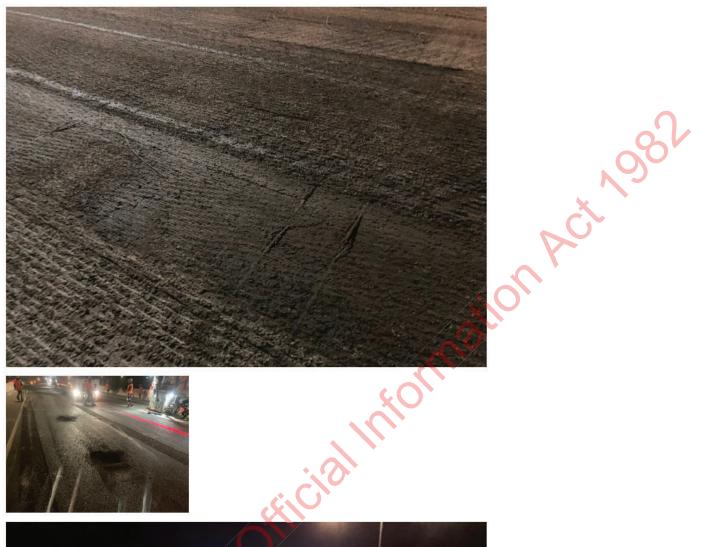
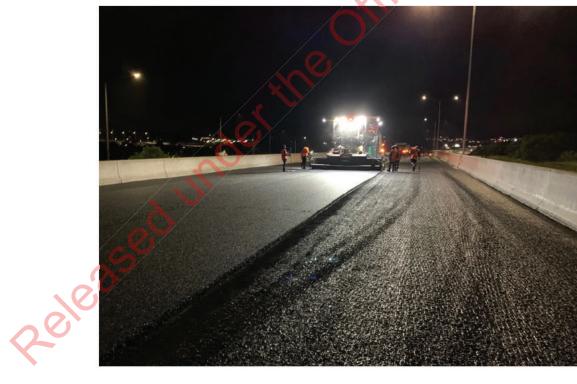
| | Nightly Update | |
|---|--|---|
| | Loops in existing OGPA cut with the miller and will need to be recut | |

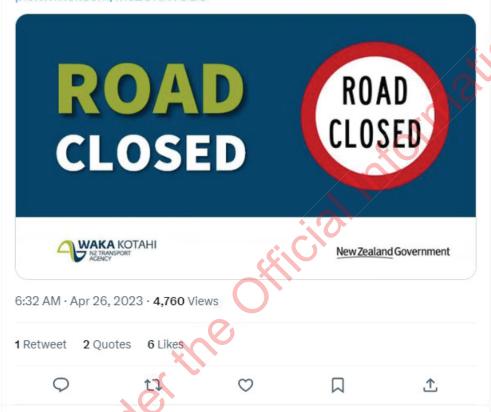
## SH1, ROAD CLOSED, 6:30AM

SH1 is closed to northbound traffic between Constellation Dr off-ramp and Constellation Dr on-ramp, due to a machinery fault when reopening after night works, southbound lanes are open as normal. ^MS pic.twitter.com/mcZURKY6GU

| | Nightly Update | |
|---|--|---|
| | 06 10 after discussions with ATOC on site it was determined that the best option was to leave roller on shoulder and close the slow lane in order to open the road | |
