Average speed camera information

Northland — Kaitaia-Awaroa Road, Kaitaia

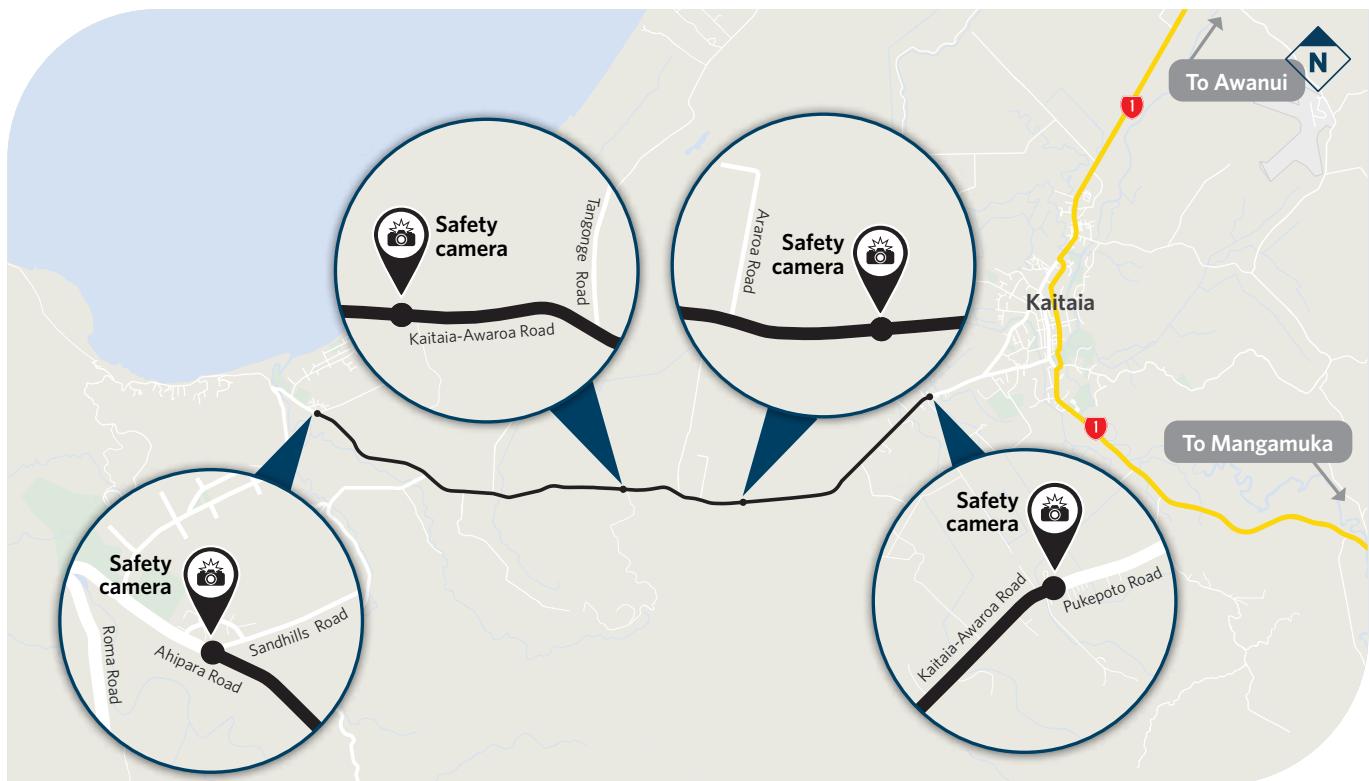
Safety camera type: Average speed – Redflex Halo 2 camera

Camera A	Camera B	Camera C	Camera D
Location	-35.129501, 173.250187	-35.154689, 173.230596	-35.160909, 173.211435	-35.17171 173.158983
Detection point	TBC	TBC	TBC	TBC
Distance between detection points	TBC	TBC	TBC	TBC

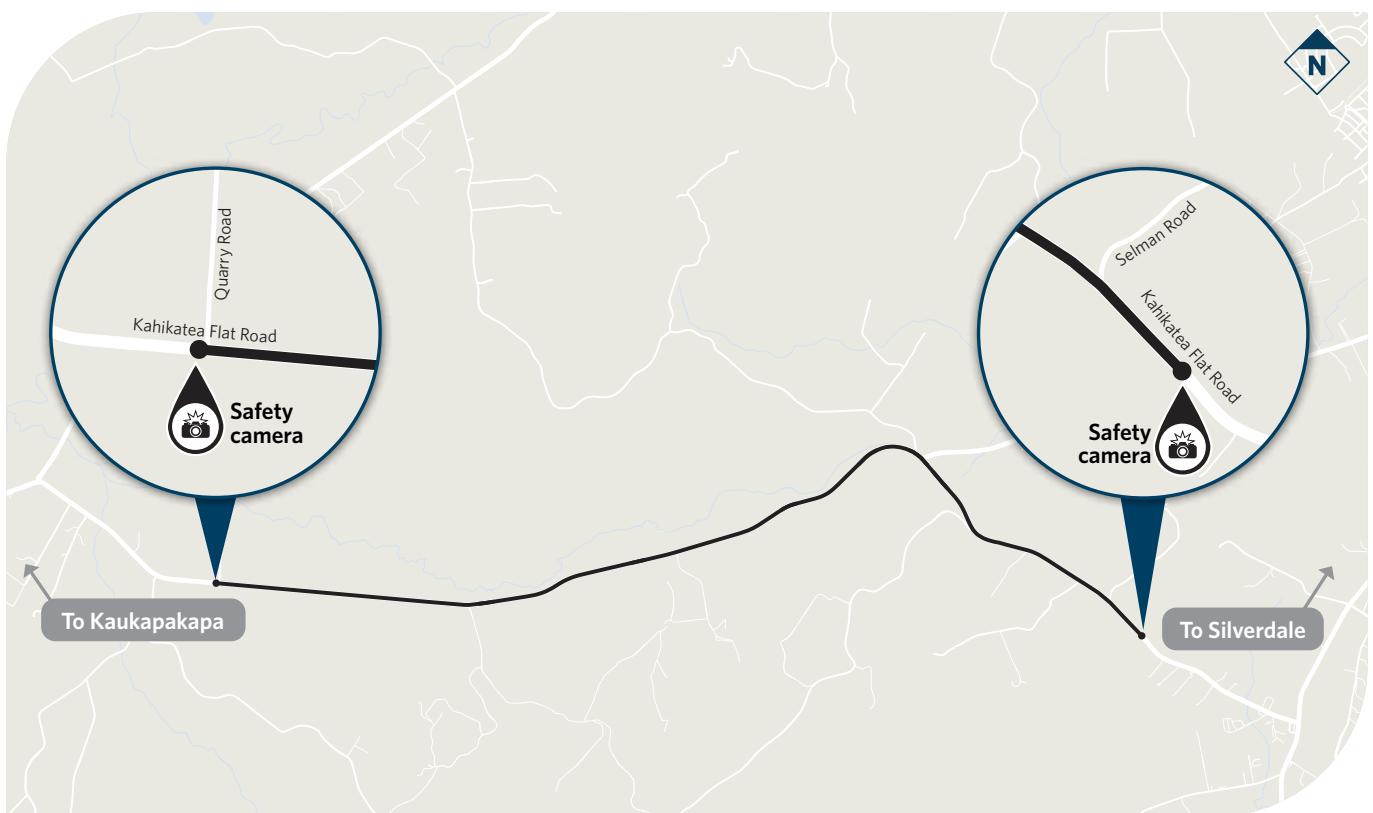
Auckland — Kahikatea Flat Road, Dairy Flat

Safety camera type: Average speed – Redflex Halo 2 camera

Camera A	Camera B
Location	-36.640388, 174.563899	-36.643479, 174.631107
Detection point	TBC	TBC
Distance between detection points		TBC

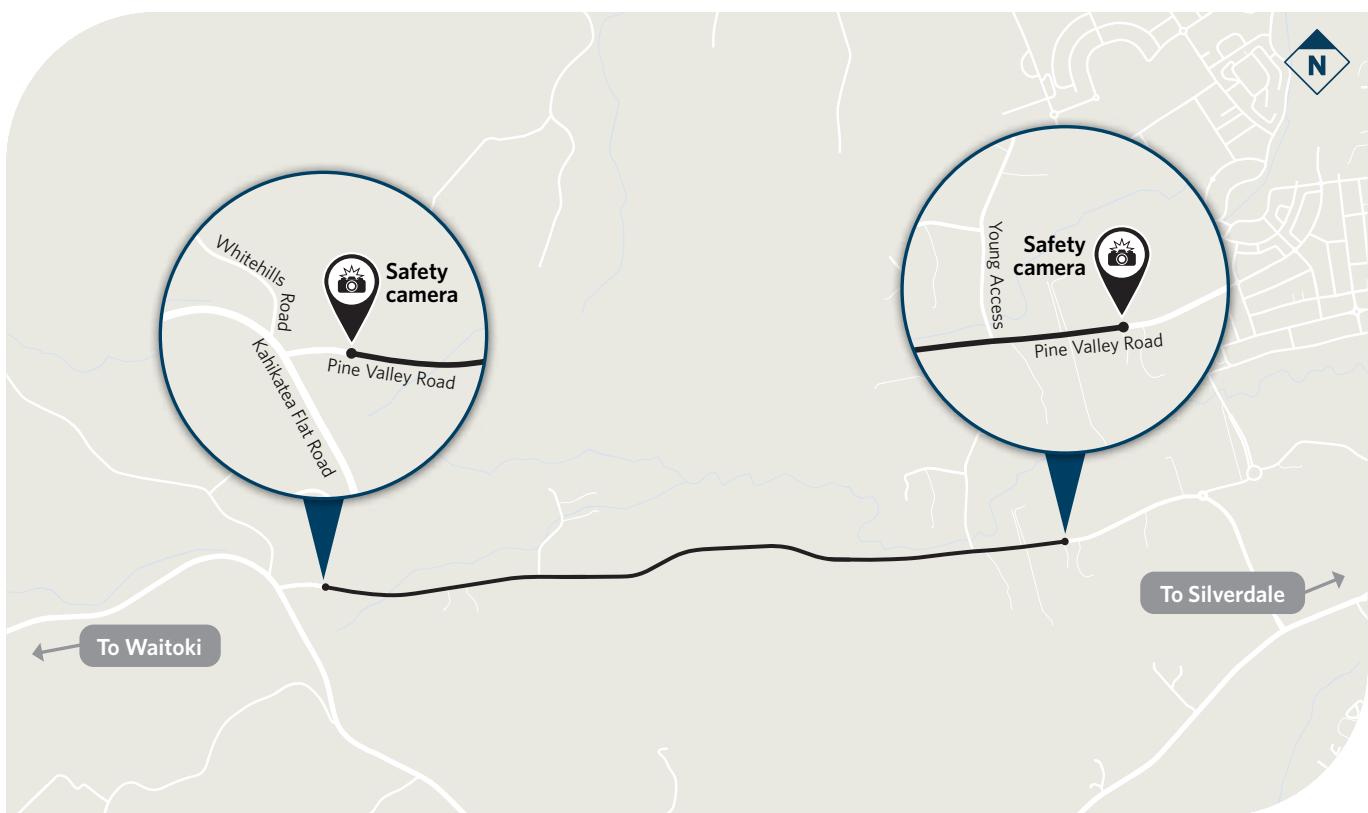
Auckland — Pine Valley Road, Dairy Flat

Safety camera type: Average speed – Redflex Halo 2 camera

Camera A	Camera B
Location	-36.632912, 174.617412	-36.625879, 174.648335
Detection point	TBC	TBC
Distance between detection points		TBC

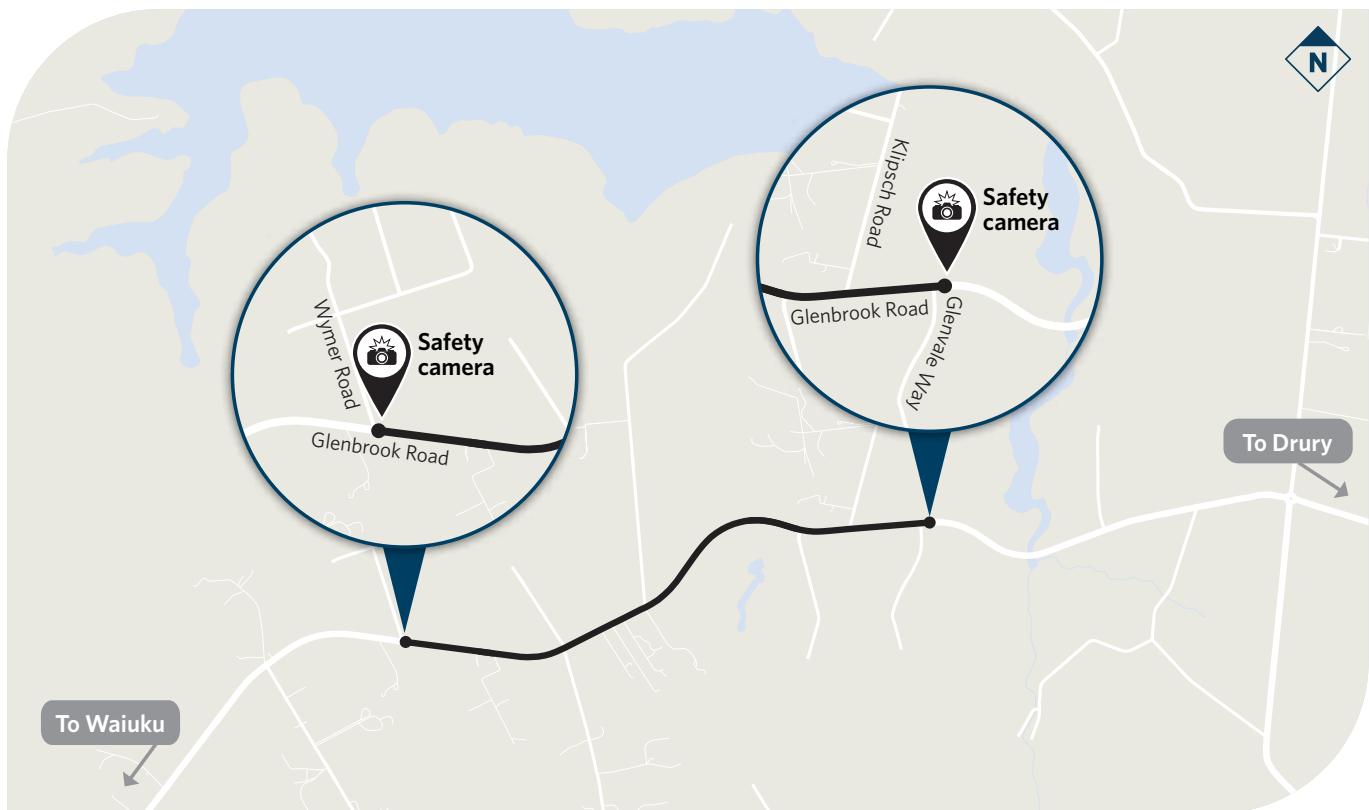
Auckland — Glenbrook Road (West), Glenbrook

Safety camera type: Average speed – Redflex Halo 2 camera

Camera A	Camera B
Location	-37.1748873, 174.7890976	-37.188864, 174.766417
Detection point	TBC	TBC
Distance between detection points		TBC

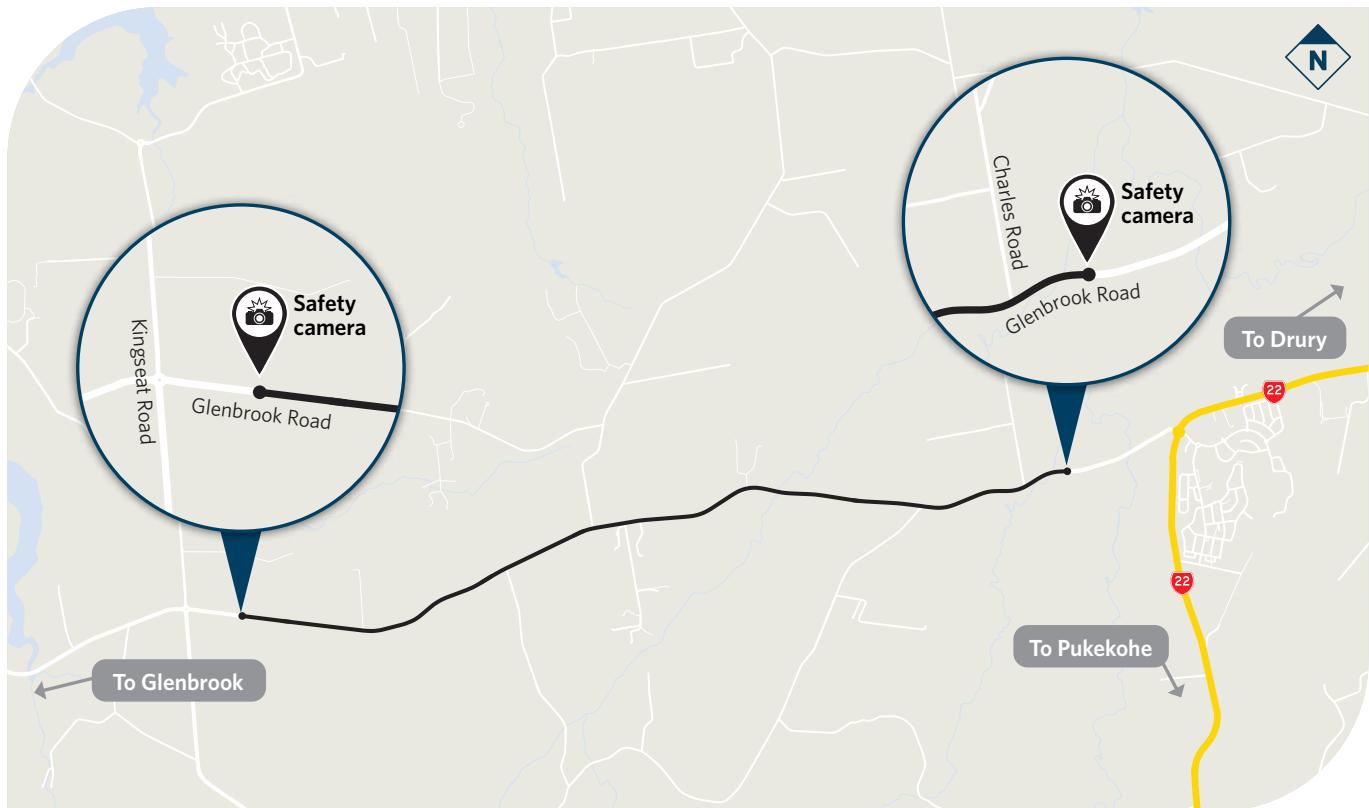
Auckland — Glenbrook Road (East), Karaka/Kingseat

Safety camera type: Average speed – Redflex Halo 2 camera

Camera A	Camera B
Location	-37.166933, 174.810206	-37.143163, 174.875309
Detection point	TBC	TBC
Distance between detection points		TBC

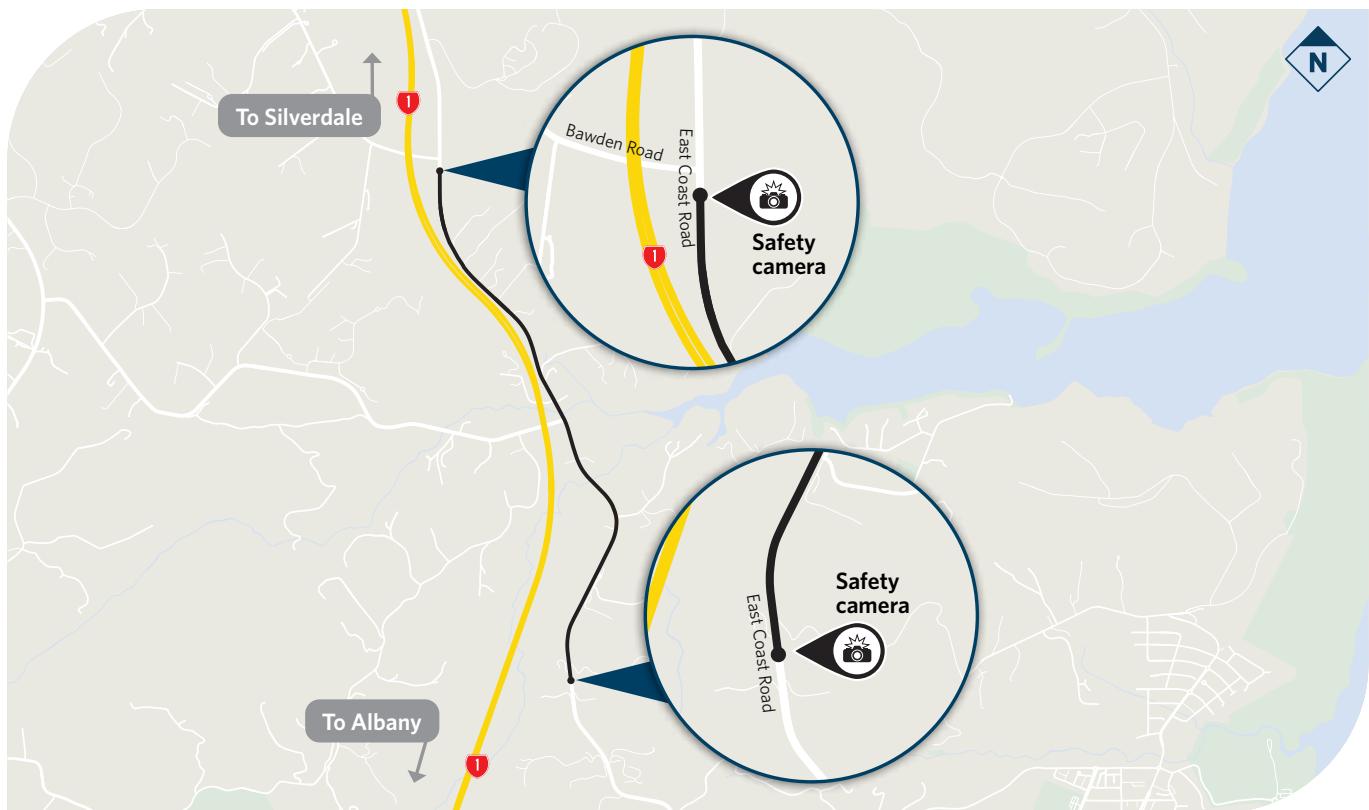
Auckland — East Coast Road, Redvale

Safety camera type: Average speed – Redflex Halo 2 camera

Camera A	Camera B
Location	-36.675162, 174.686483	-36.69386, 174.707431
Detection point	TBC	TBC
Distance between detection points		TBC

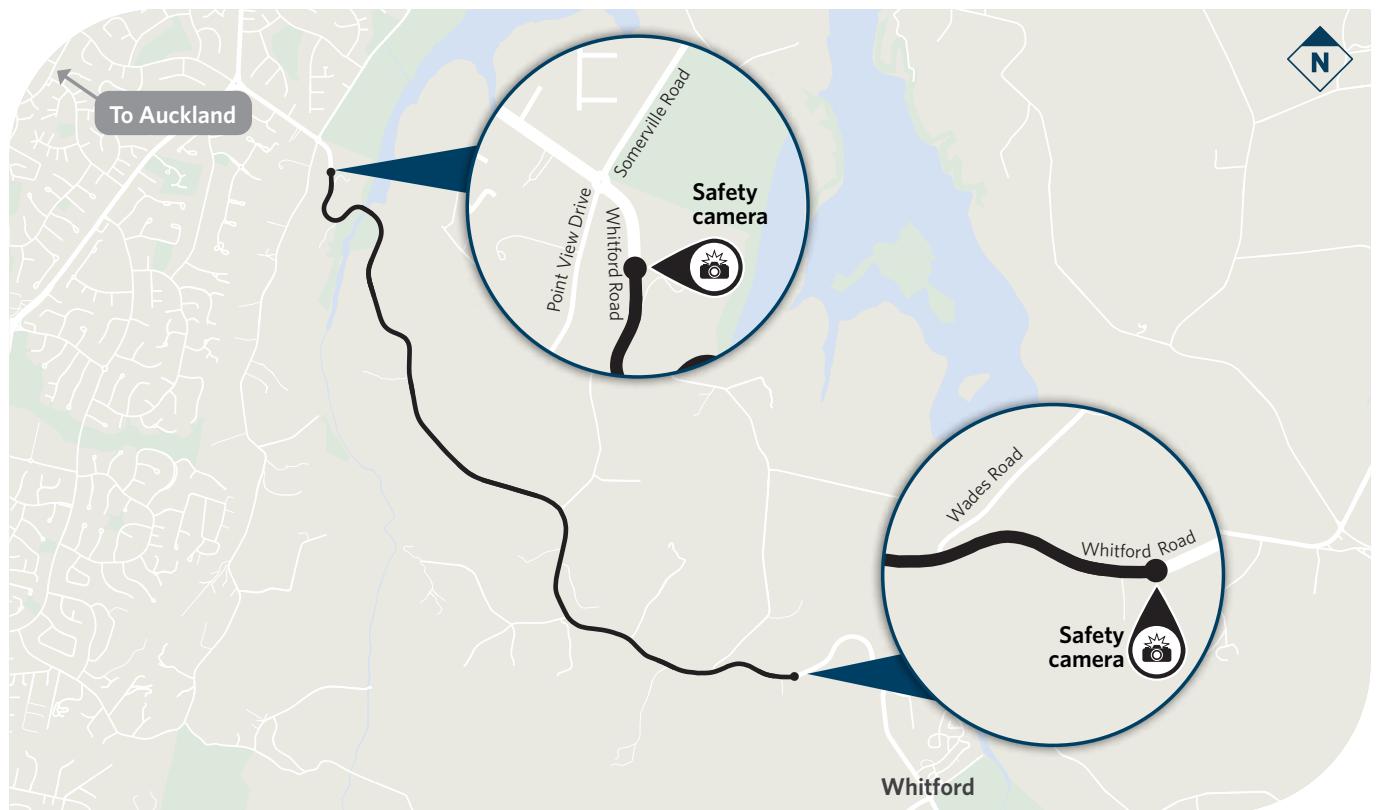
Auckland — Whitford Road, Shamrock Park/Whitford

Safety camera type: Average speed – Redflex Halo 2 camera

Camera A	Camera B
Location	-36.922501, 174.933412	-36.94507, 174.959009
Detection point	TBC	TBC
Distance between detection points		TBC

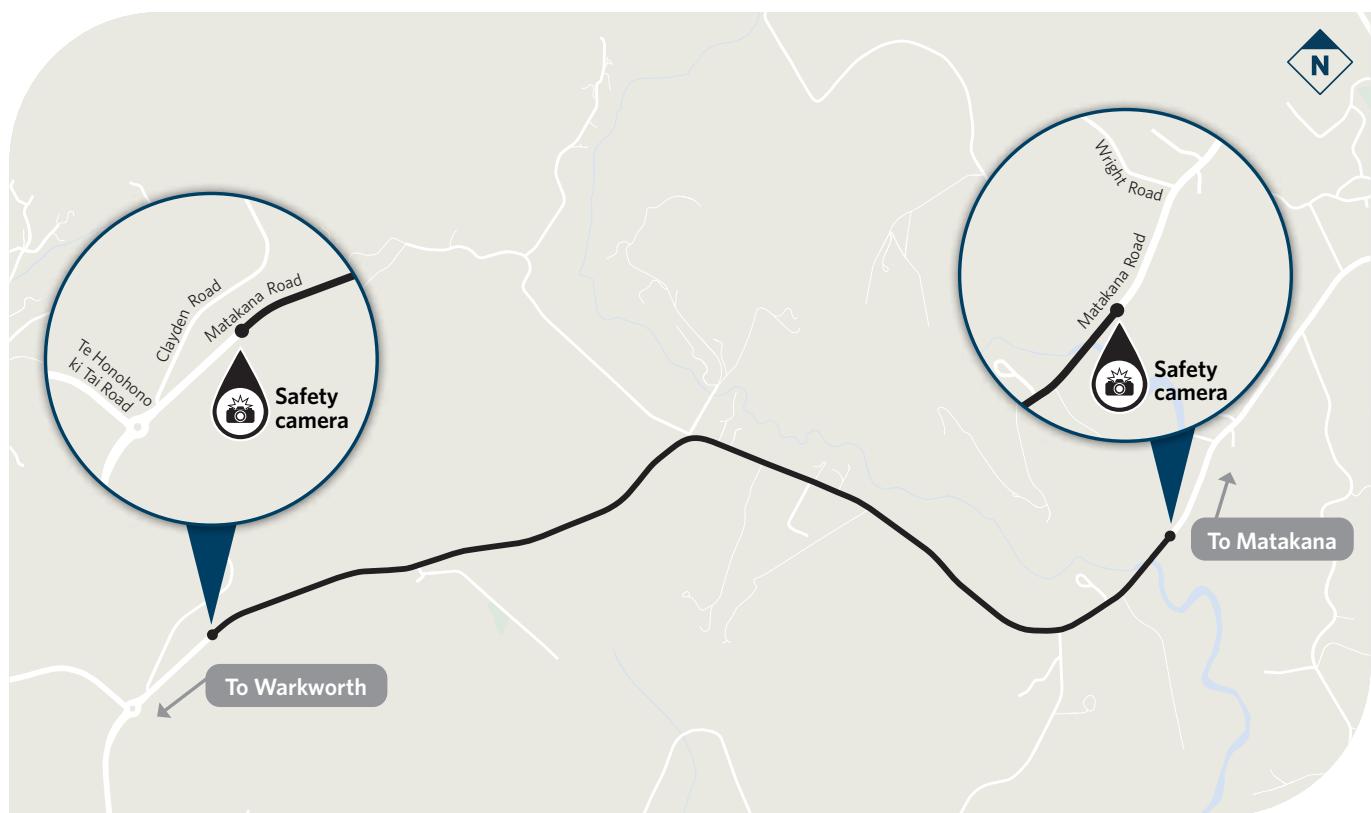
Auckland — Matakana Road, Warkworth

Safety camera type: Average speed – Redflex Halo 2 camera

Camera A	Camera B
Location	-36.381443, 174.662872	-36.367498, 174.707304
Detection point	-36.367671, 174.707154	-36.381615, 174.662691
Distance between detection points	4889 metres

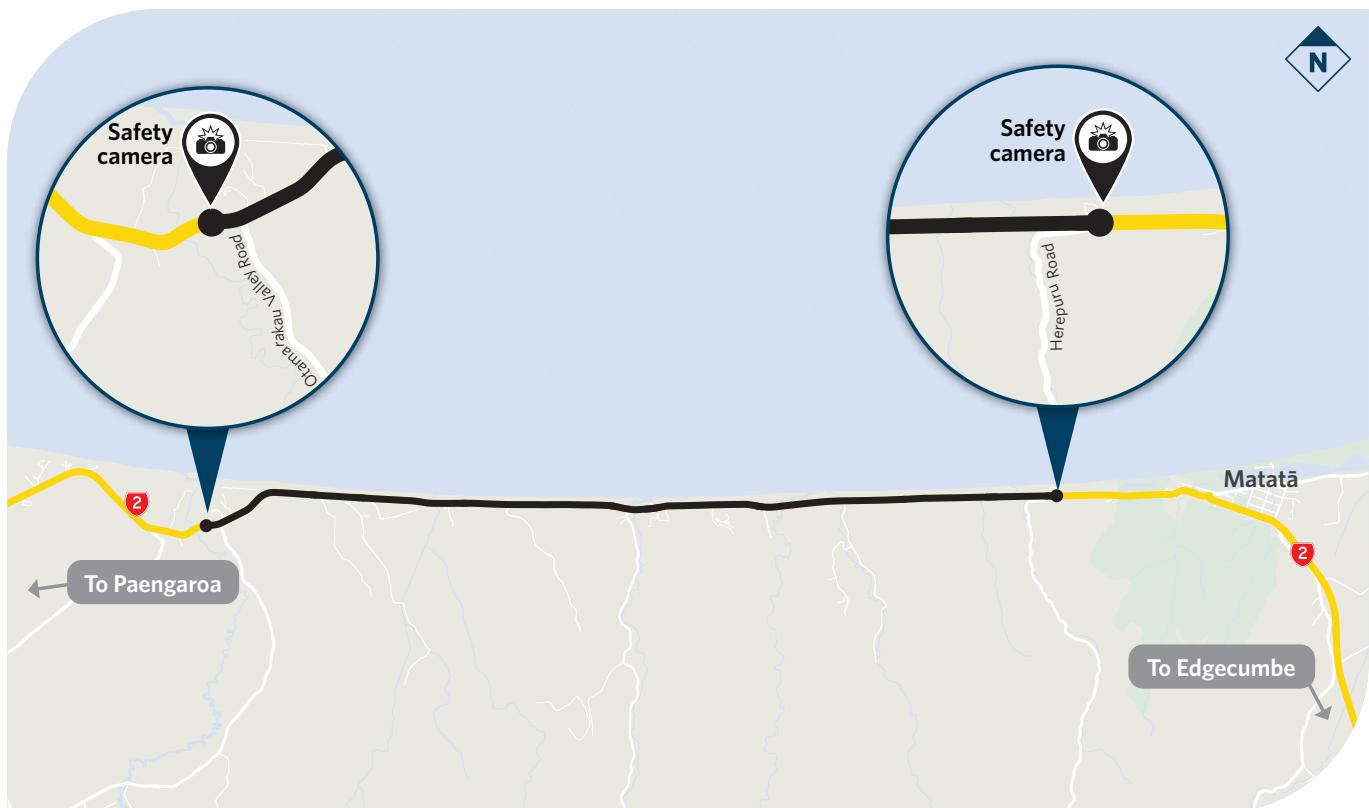
Bay of Plenty — State Highway 2, Matatā

Safety camera type: Average speed – Redflex Halo 2 camera

Camera A	Camera B
Location	-37.8349, 176.59801	-37.878729, 176.728236
Detection point	TBC	TBC
Distance between detection points	TBC

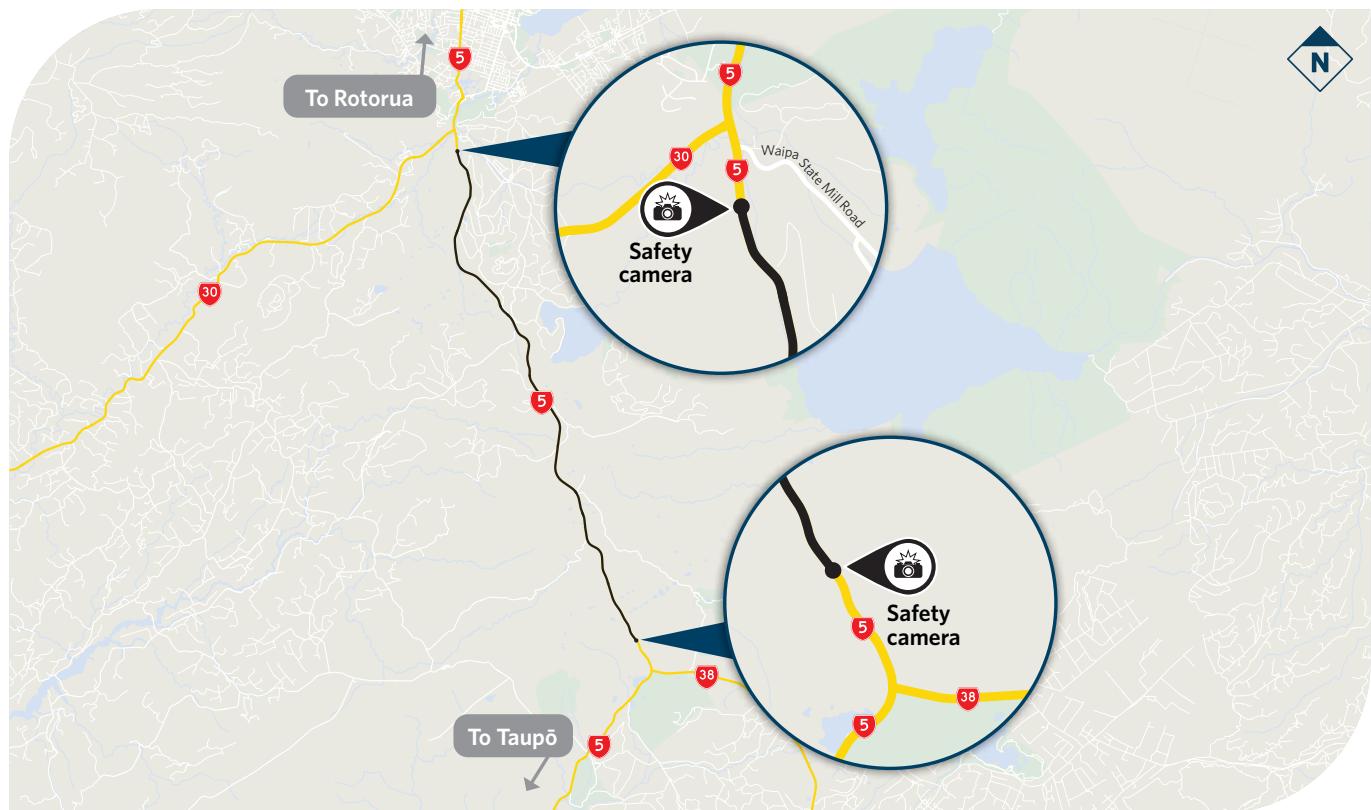
Bay of Plenty — State Highway 5, Tumunui

Safety camera type: Average speed – Redflex Halo 2 camera

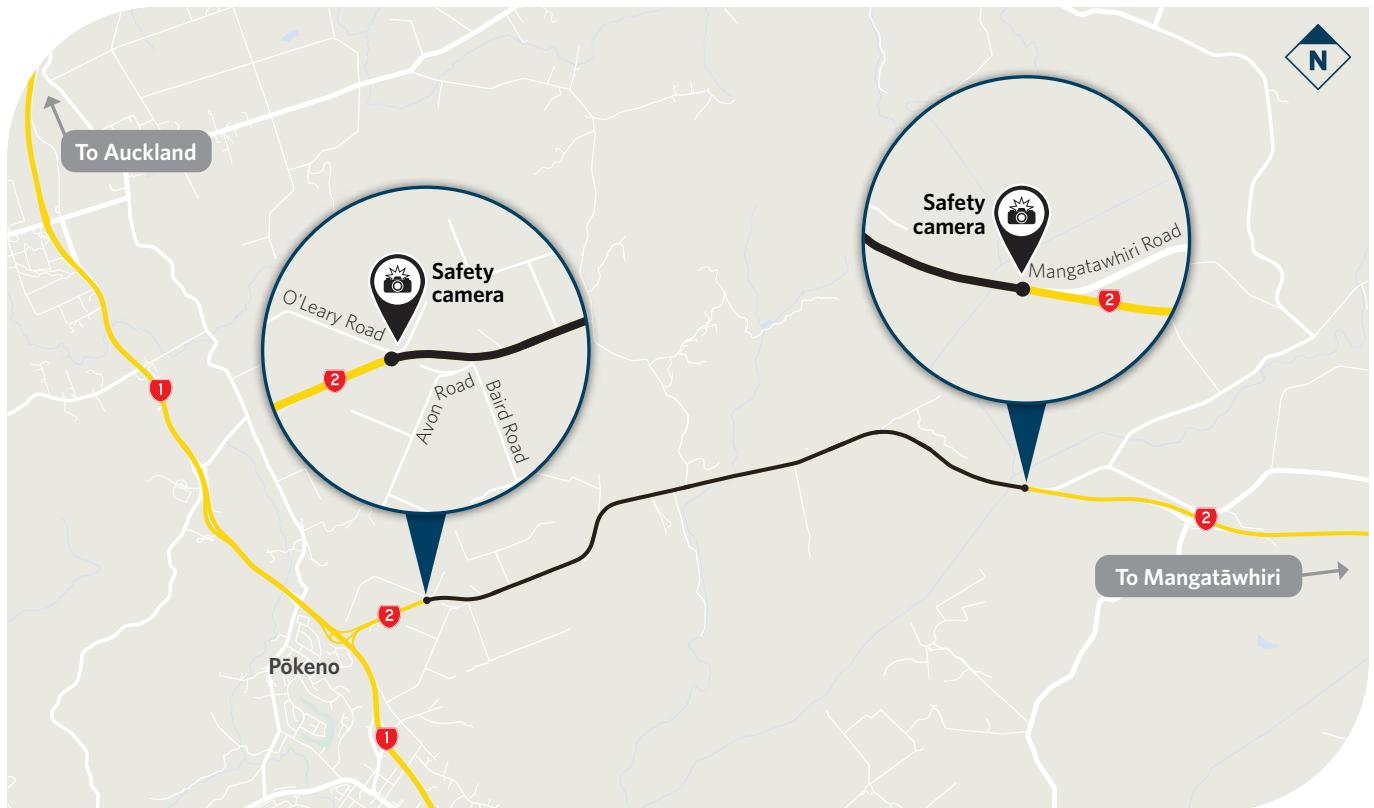
Waikato — State Highway 2, Pōkeno to Mangatāwhiri

Safety camera type: Average speed – Redflex Halo 2 camera

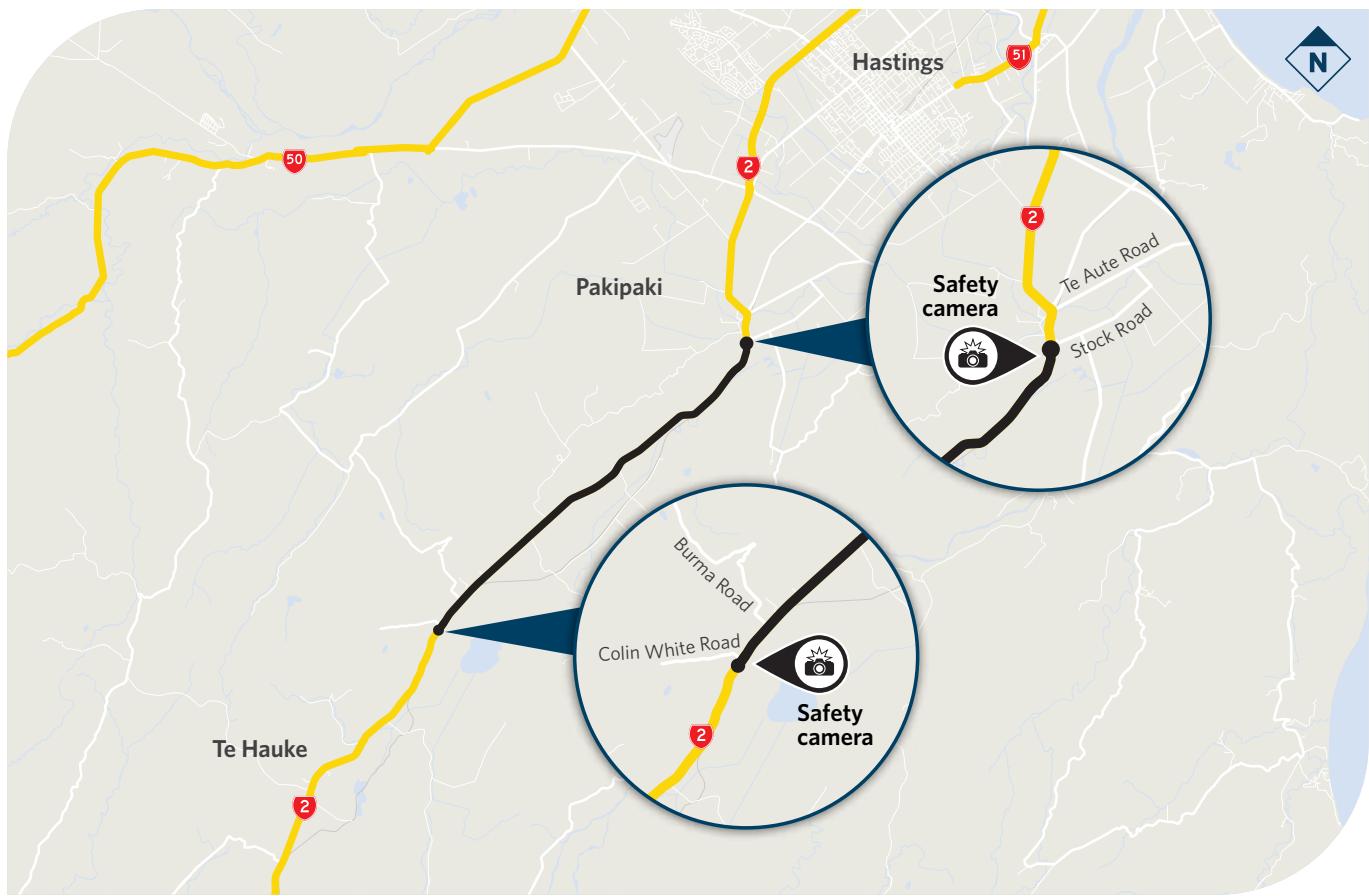
Hawke's Bay — State Highway 2, Te Hauke to Pakipaki

Safety camera type: Average speed – Redflex Halo 2 camera

Camera A	Camera B
Location	-39.6997634488164, 176.793375839221	-39.7759623036708, 176.686765170573
Detection point	TBC	TBC
Distance between detection points		TBC

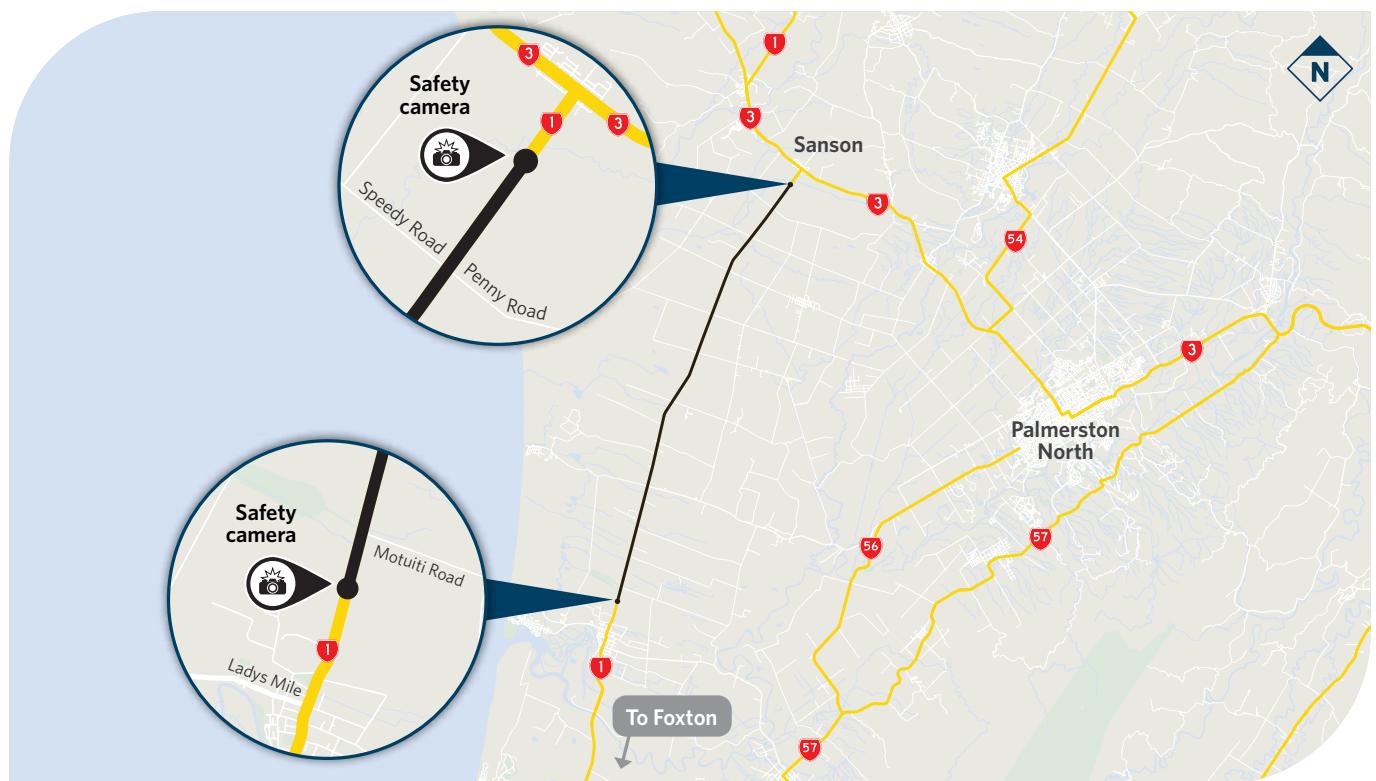
Manawatū-Whanganui — State Highway 1, Sanson to Foxton

Safety camera type: Average speed – Redflex Halo 2 camera

Camera A	Camera B
Location	-40.4511619223875, 175.294677082793	-40.2265142156218, 175.418087067976
Detection point	TBC	TBC
Distance between detection points		TBC

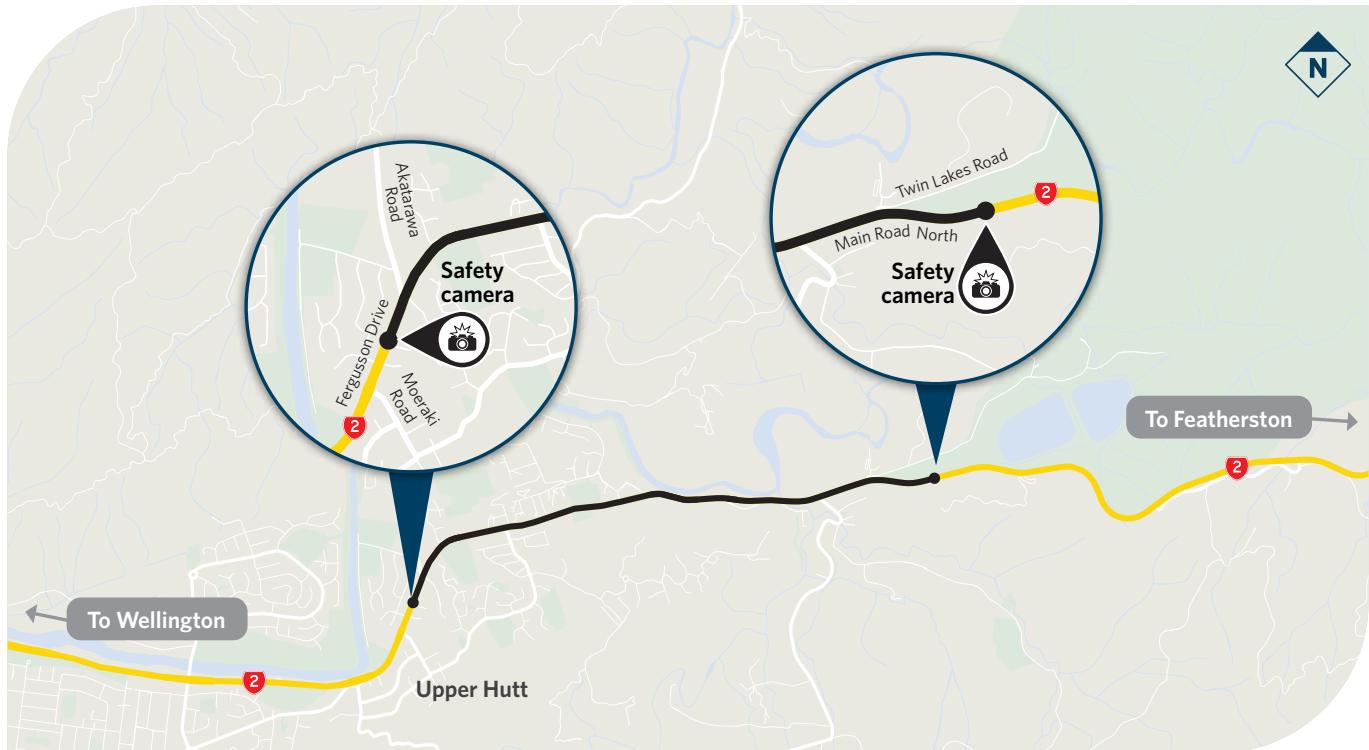
Wellington — State Highway 2, Te Mārua to Brown Owl, Upper Hutt

Safety camera type: Average speed – Redflex Halo 2 camera

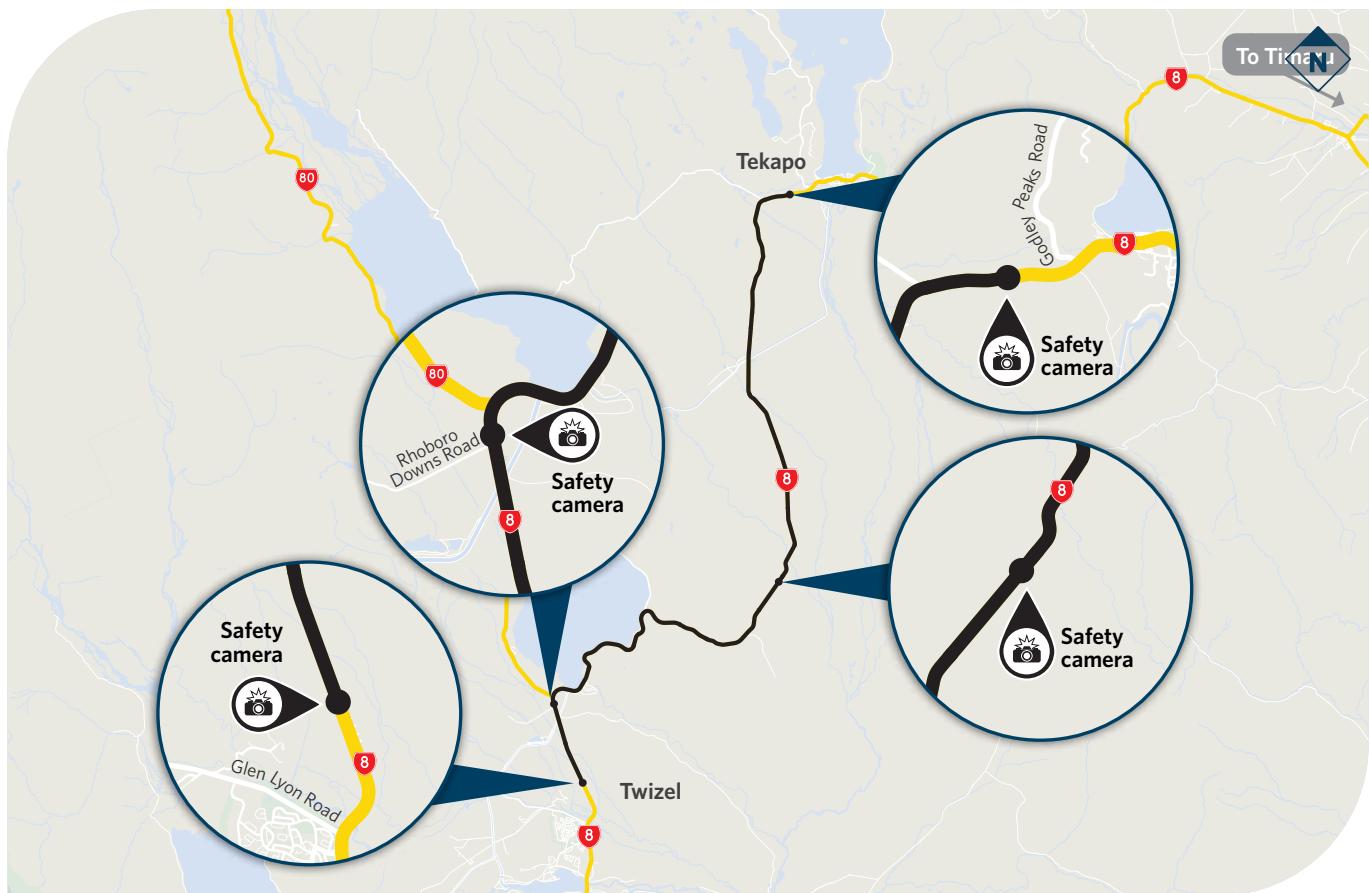
Canterbury — State Highway 8, Lake Tekapo to Twizel

Safety camera type: Average speed – Redflex Halo 2 camera

Camera A	Camera B	Camera C	Camera D
Location	-44.00090428, 170.4409152	-44.1838212, 170.3101349	-44.1932109, 170.1214449	-44.23803198538 170.116480150413
Detection point	TBC	TBC	TBC	TBC
Distance between detection points	TBC	TBC	TBC

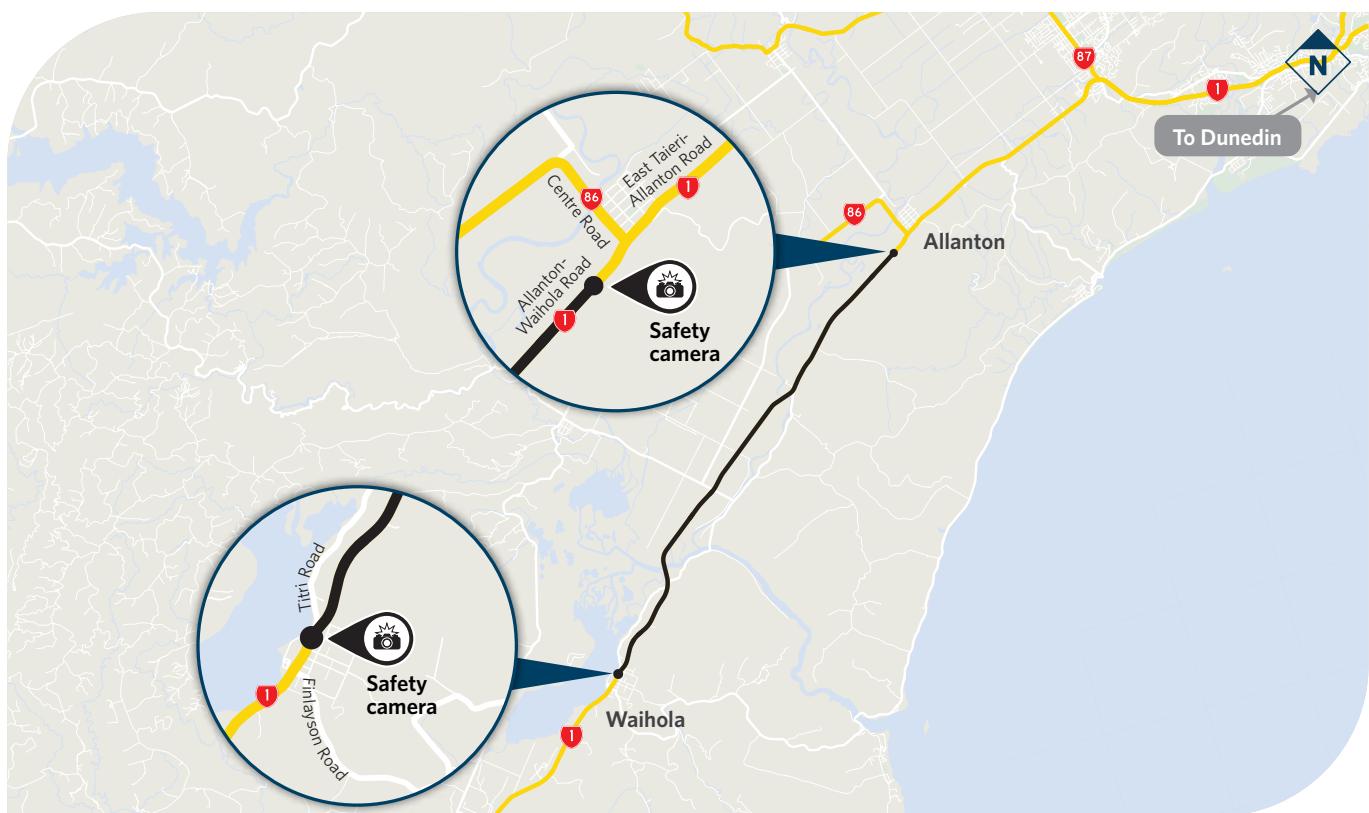
Otago — State Highway 1, Allanton to Waihola, Dunedin

Safety camera type: Average speed – Redflex Halo 2 camera

Camera A	Camera B
Location	-45.92331596, 170.2551553	-46.02070049, 170.0986848
Detection point	TBC	TBC
Distance between detection points		TBC

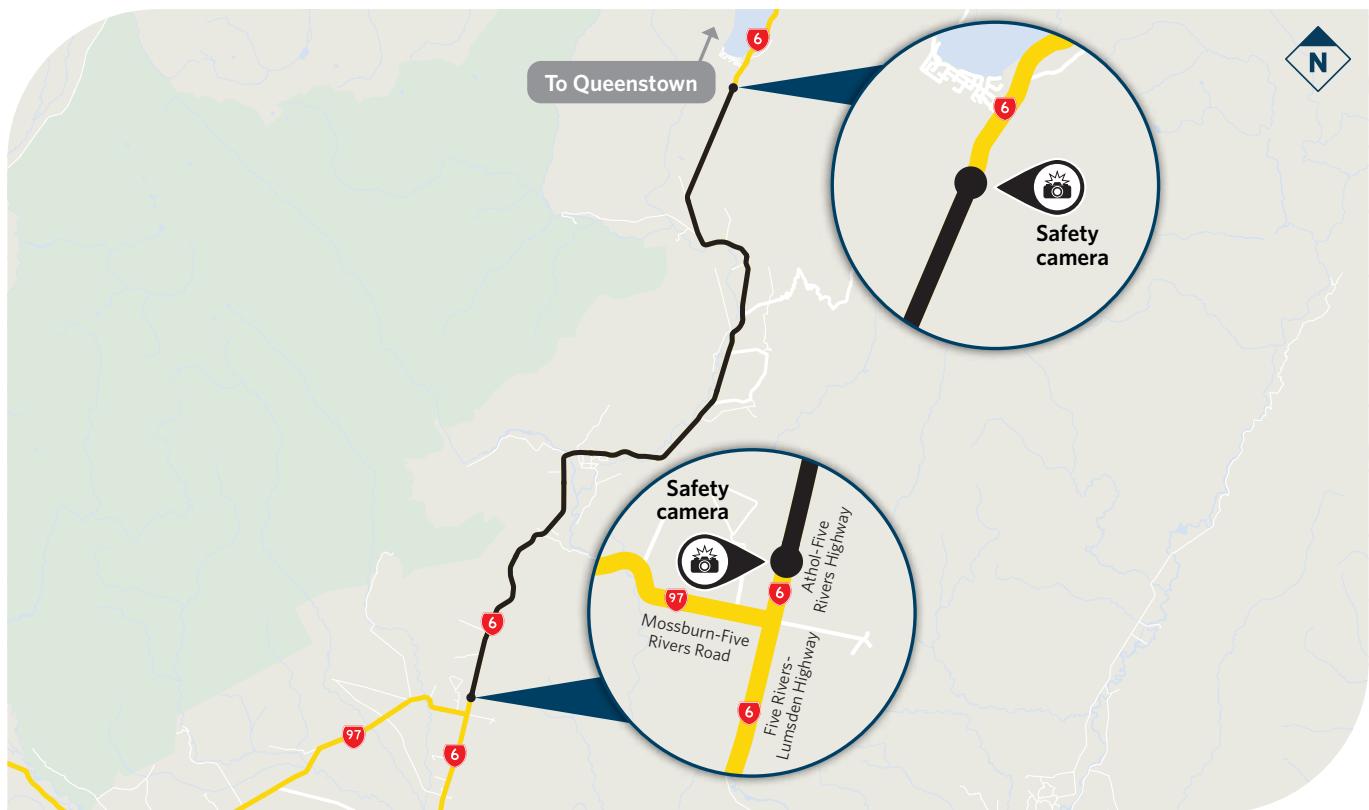
Otago — State Highway 6, Kingston to Five Rivers

Safety camera type: Average speed – Redflex Halo 2 camera
