The Bulletin Kaikoura earthquake update

This weekly bulletin provides the latest information about the rebuild of road and rail networks damaged by the Kaikoura earthquake in November 2016. The bulletin is produced by the North Canterbury Transport Infrastructure Recovery (NCTIR) - an alliance representing the NZ Transport Agency and KiwiRail, on behalf of Government.

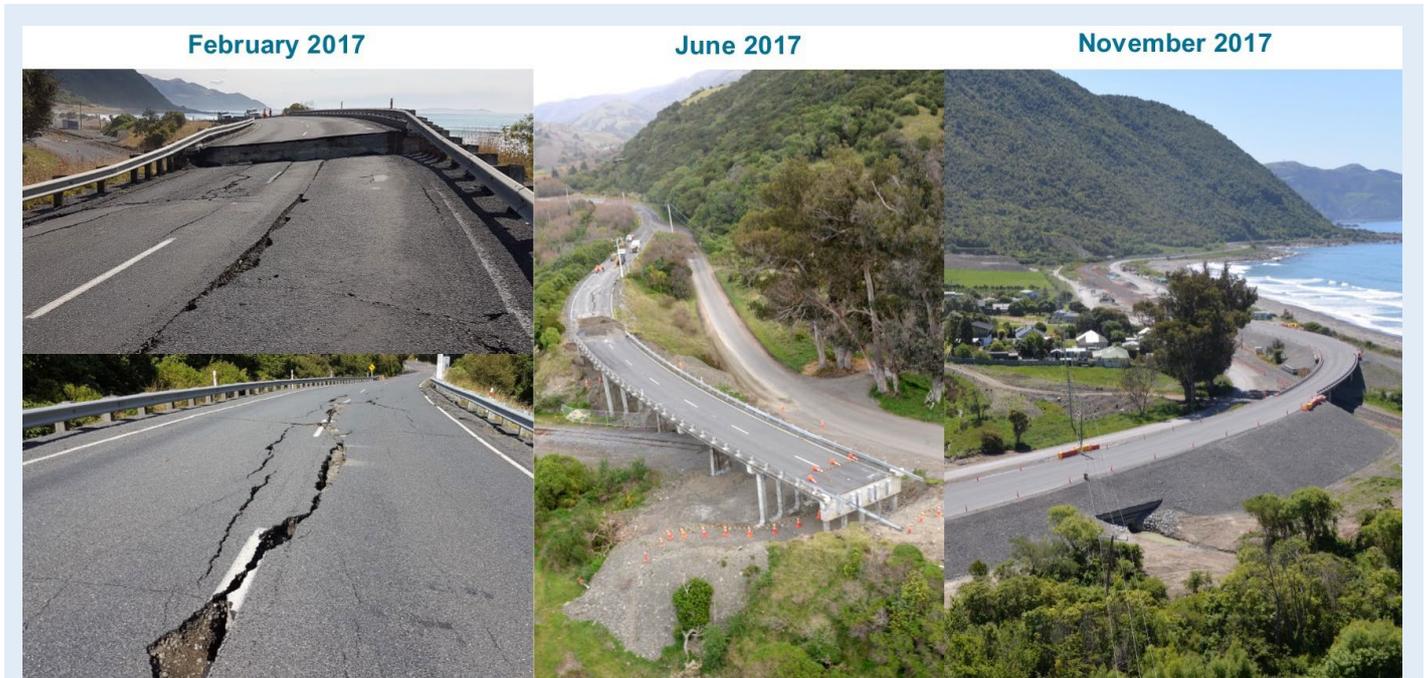
OARO BRIDGE NOW COMPLETE

One of the most extreme examples of earthquake damage to State Highway 1 (SH1) is what happened to the Oaro road over rail bridge.

The restoration process involved removing existing guard rails, clearing out the damaged sections of retaining walls and forming a suitable base on which to build new retaining structures. This was a tricky, labour-intensive job that included repairing and replacing wire baskets and excavating the road out about 2m behind the wall to put in flexible reinforcing to tie the wall into the pavement.

- Structural repairs carried out on the bridge from January to April.
- Road approaches began in June and were completed in October.
- The design included widening the approaches and improving the vertical approach to the bridge deck.
- A new steel post wall with timber infill was constructed to replace a damaged concrete crib wall near the railway line.
- The existing stream under the embankment was cleared of vegetation which enabled a channelled flow to carry storm water to the river.
- The old damaged safety guardrail has been renewed and extended to improve safety.
- Working near the rail track required close liaison with KiwiRail staff throughout the duration.

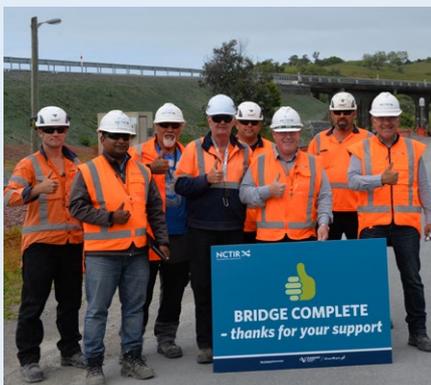
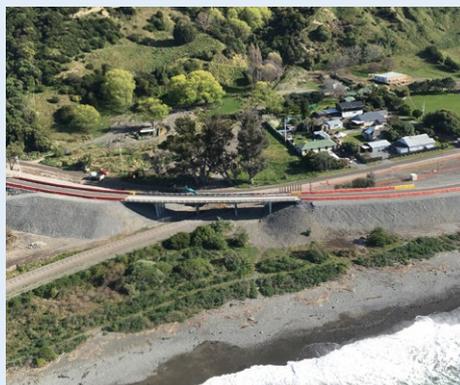
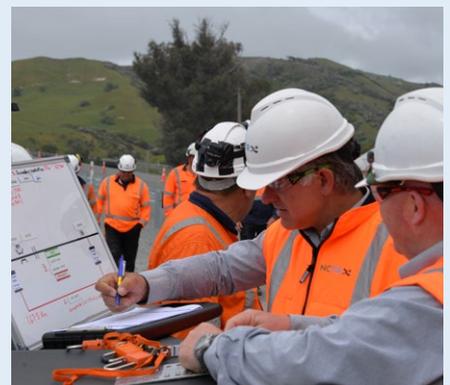
Work to repair and restore this vital piece of infrastructure has now been completed.

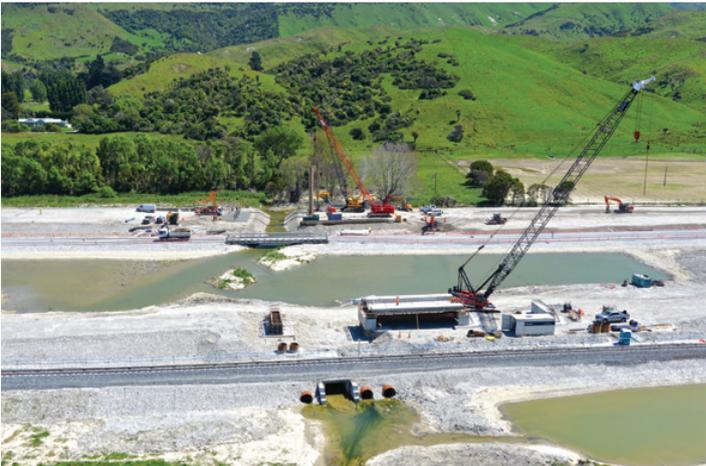
During the November earthquake the Kekerengu fault moved resulting in a new low lying area being formed on the north side of the faultline. The ground dropped by 2.2 metres north of the faultline and rose 0.3 metres south of the faultline. The net difference in level is 2.5 metres, which is expected to be prone to ponding. This movement also caused significant damage to the rail bridge in this area.

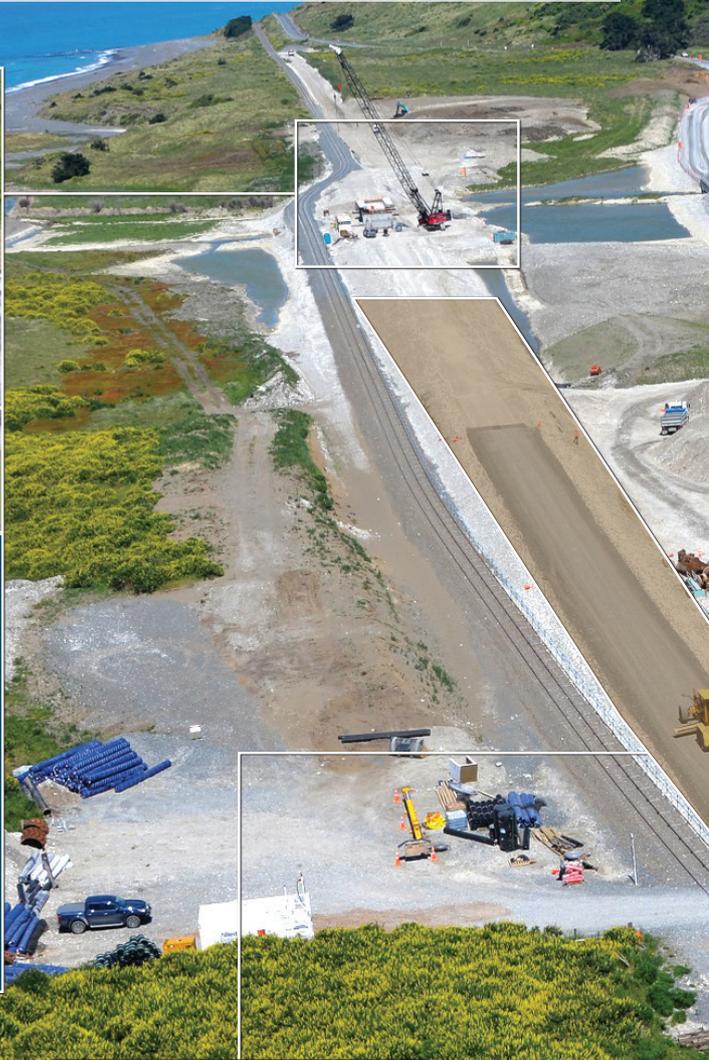
RAIL BRIDGE 129

The bridge known as Railway Bridge 129, located in Wharanui and crossing the Tirohanga Stream, includes three 14 metre spans. The original bridge, designed and constructed in 1948, sustained significant damage because of movement in the Kekerengu faultline, which dropped it 2.2 metres and moved it five metres laterally.

As a result the new bridge is being built about 65 metres north of the original bridge (which has been demolished) to relocate it away from the fault. The rail track has been temporarily realigned so trains can continue to run while the bridge is being built.

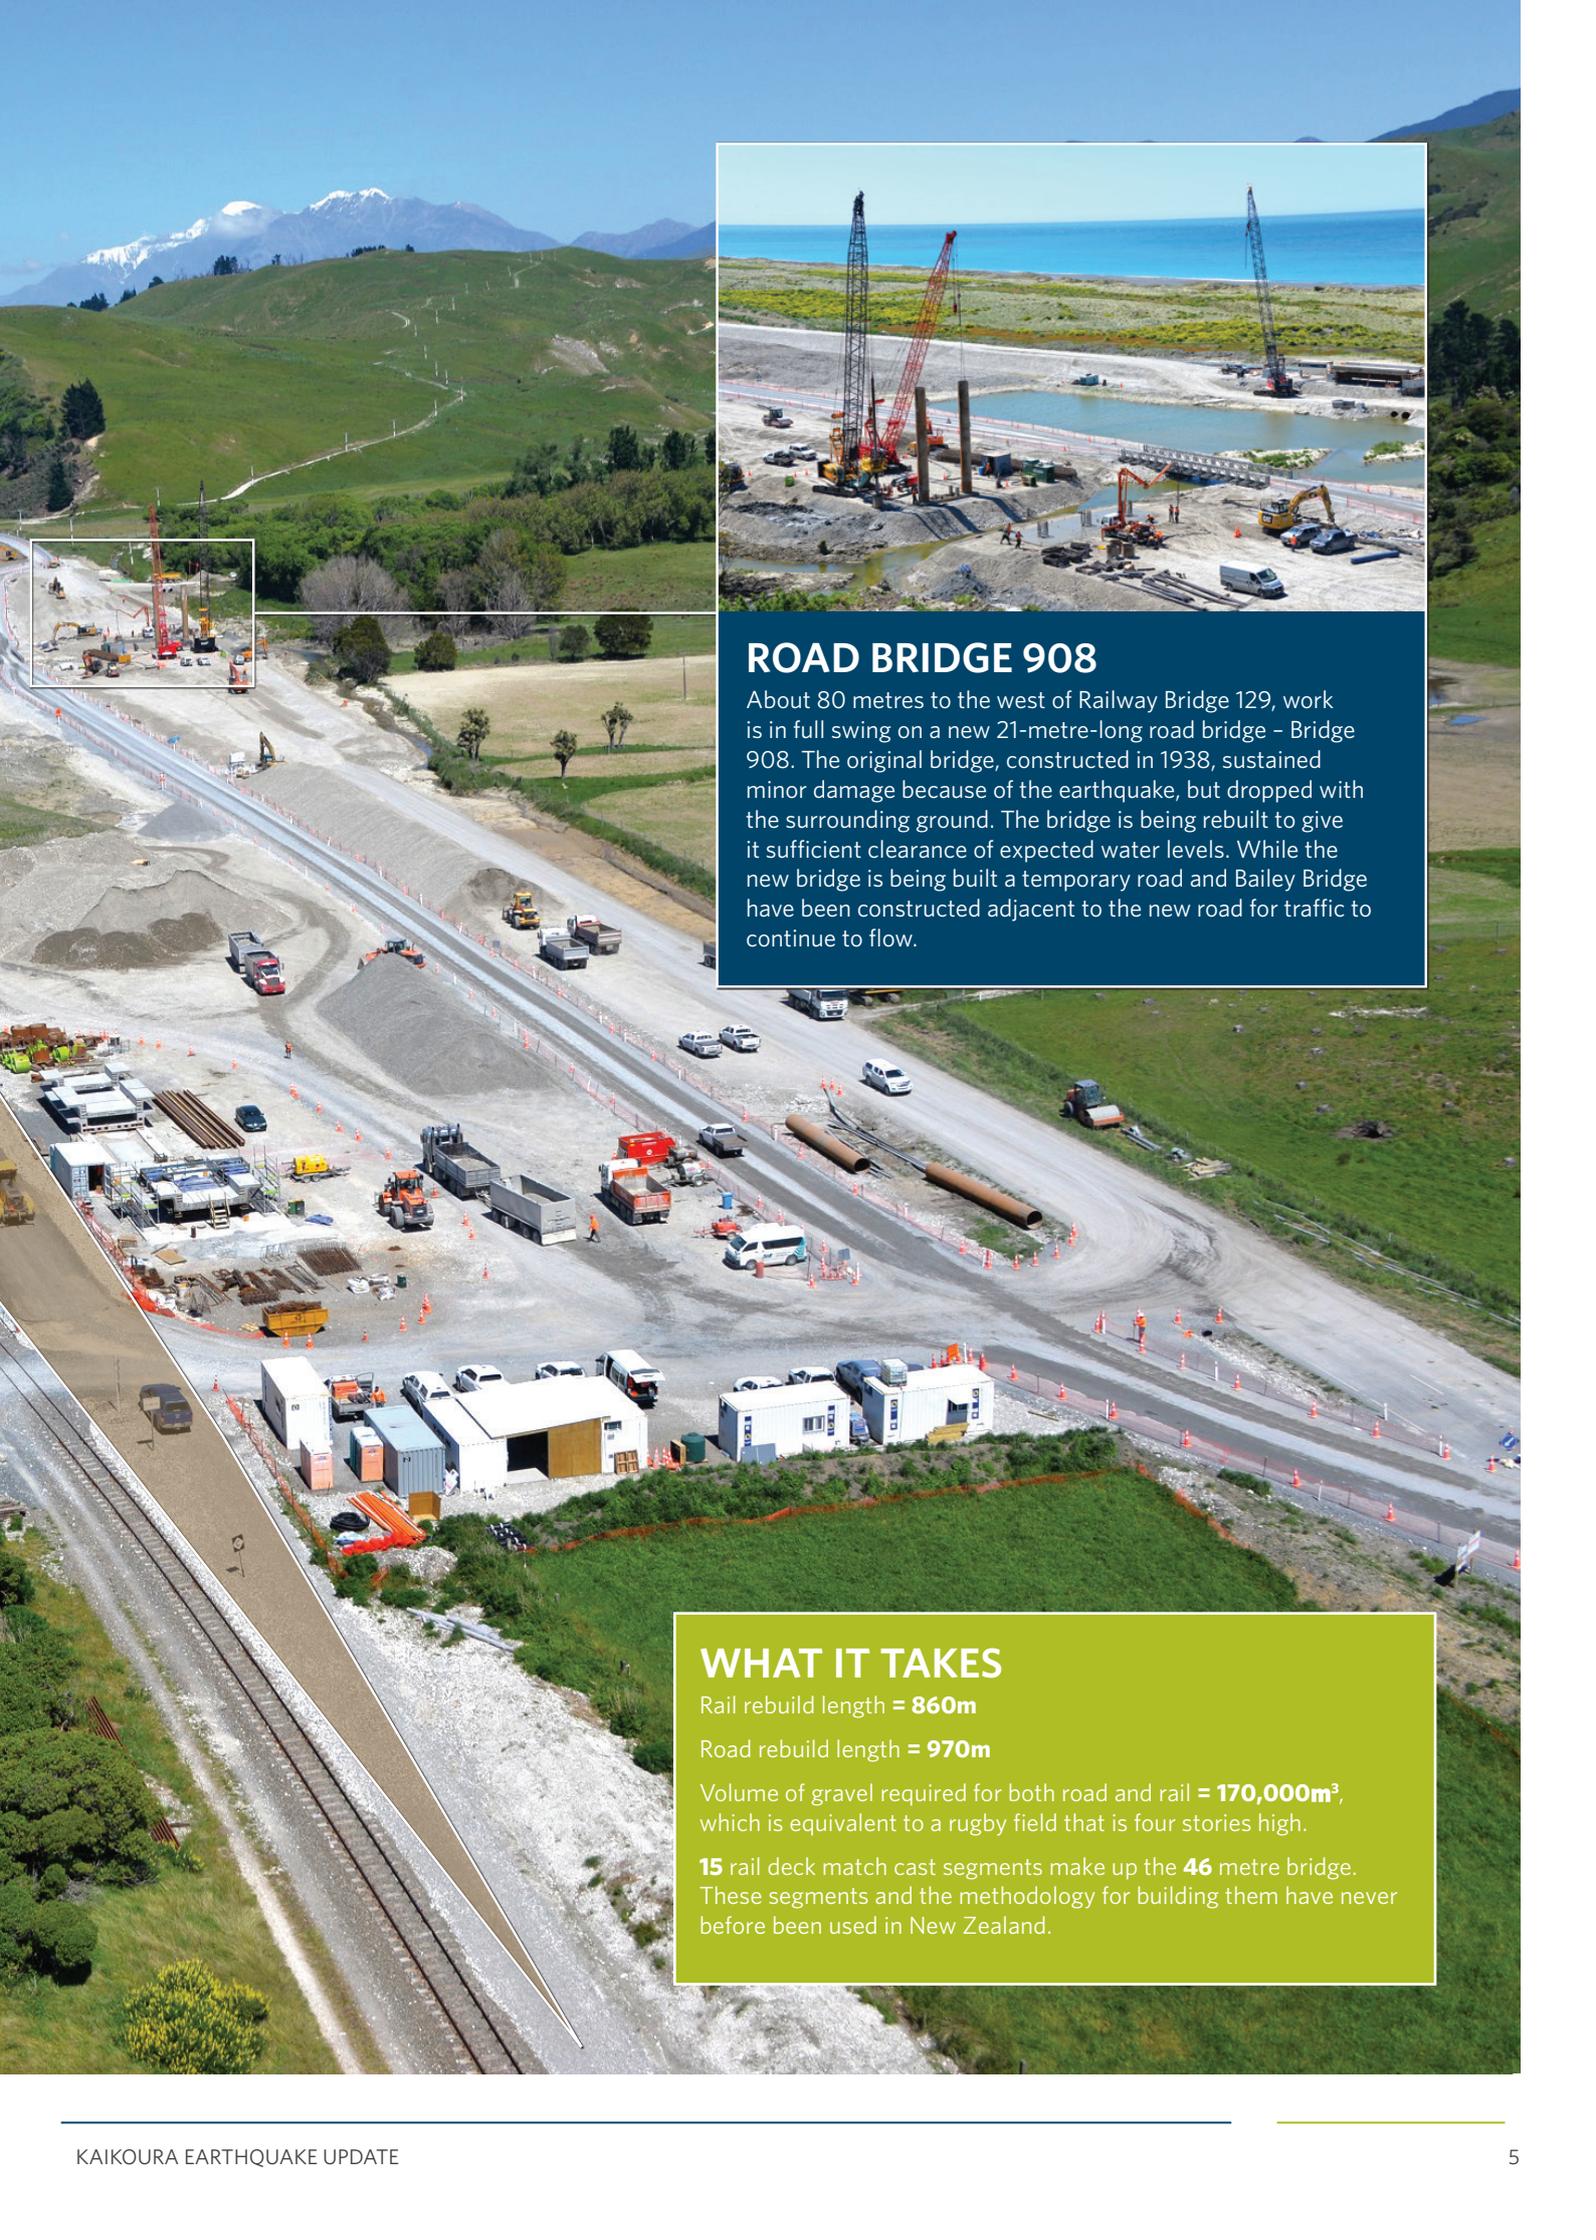
Due to the predicted ponding, new raised road and rail embankments are being built to a much higher level than the surrounding ground to protect them against flood risk.

About 80 metres to the west of Railway Bridge 129, work is in full swing on a new 21-metre-long road bridge – Bridge 908. The original bridge, constructed in 1938, sustained minor damage because of the earthquake, but dropped with the surrounding ground. The bridge is being rebuilt to give it sufficient clearance of expected water levels. While the new bridge is being built a temporary road and Bailey Bridge have been constructed adjacent to the new road for traffic to continue to flow.

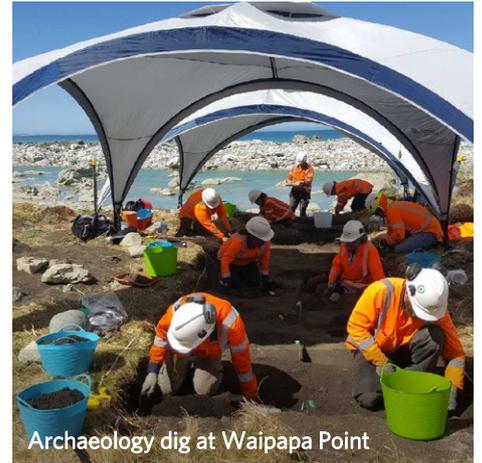
Archaeology dig at Waipapa Point

Being part of a construction outfit can be handy. The archaeology team uses a 'sieve station' made from scaffolding that can be moved from site to site.

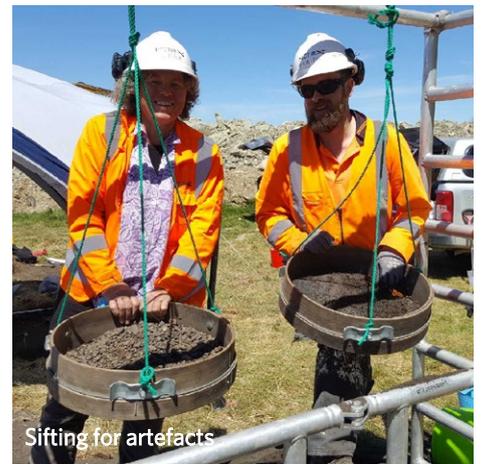
Sifting for artefacts

The sieves are used to check soil for artefacts and fragments of bone or stone that give clues to how people lived – things like fishing hooks can indicate what people ate and the ecology existed hundreds of years ago. 'It's a forensic examination of what's been left behind,' says NCTIR's lead archaeologist Nick Cable. 'We are sieving a set quantum of material using a standard mesh size in order to provide comparative data about the density of cultural material in this spot.'

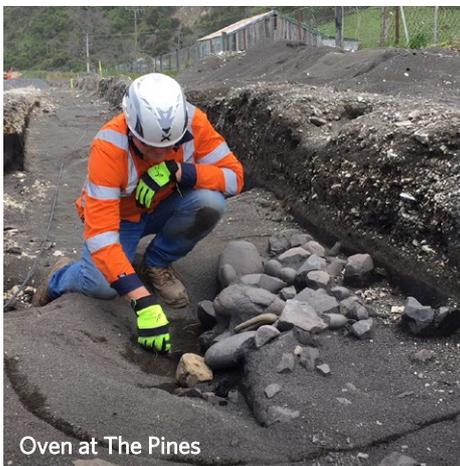
Oven at The Pines

One of NCTIR's field archaeologists, Dr Jeremy Habberfield-Short, examines a stone oven on the side of SH1 at The Pines. 'It's a rare find,' he says. 'The rocks are pretty much where they were placed and haven't been disturbed. In areas where people were settled for a period of time, we normally find that ovens have been raided of rocks to re-use in another oven close by. Over time you see an attrition in single use ovens.' Excavator operators are trained to call in archaeology support if they see a 'tell-tale layer' of dark, charcoal-rich soil, which can indicate a cooking site or midden (rubbish pile). Evidence of villages have been discovered at The Pines, Rakautara, Hapuku and Waipapa Point. 'We respond to call-outs throughout the NCTIR project and assess whether we need to investigate in more detail, and help form a strategy that will allow construction to go ahead with the least impact on heritage sites.'

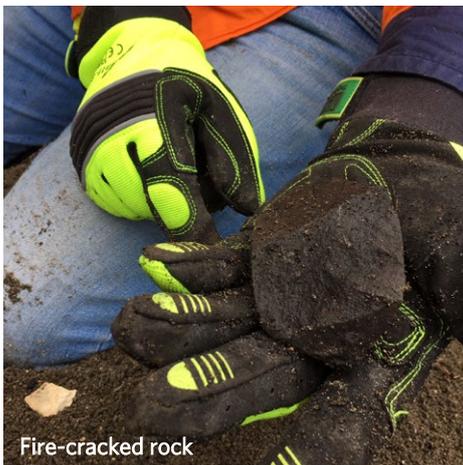
Fire-cracked rock

'One of the first things we do is look at a rock and ask whether it's been cracked manually, by machine or by heat, so that we can effectively distinguish between an archaeological or non-archaeological site. We can then carbon date materials from the site such as shellfish, bone and charcoal to find out when the area was inhabited,' Jeremy says.

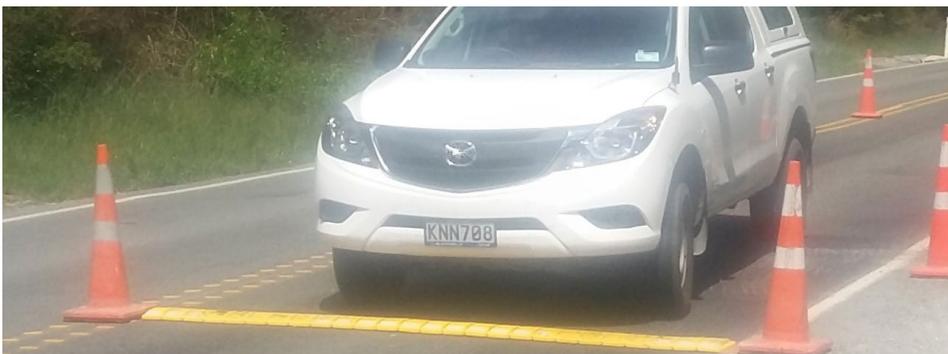
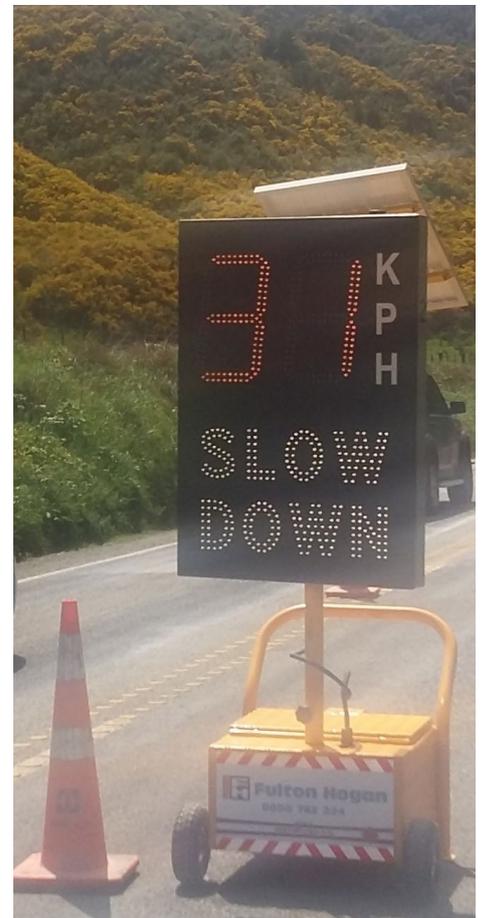
If you’re driving the busy alternate Picton the Christchurch route (via Lewis Pass), you’ll be passing through numerous sites, part of the \$60 million improvement programme of work being done by the end of this summer. You’ll also see many initiatives designed to keep everyone safe such as temporary ‘speed bumps’ and electronic road signs - both pictured.
