# The Bulletin Kaikōura earthquake update

## INNOVATING ON THE JOB

This weekly bulletin provides the latest information about the rebuild of road and rail networks damaged by the Kaikōura earthquake in November 2016. The bulletin is produced by the North Canterbury Transport Infrastructure Recovery (NCTIR) – an alliance representing the NZ Transport Agency and KiwiRail, on behalf of Government.

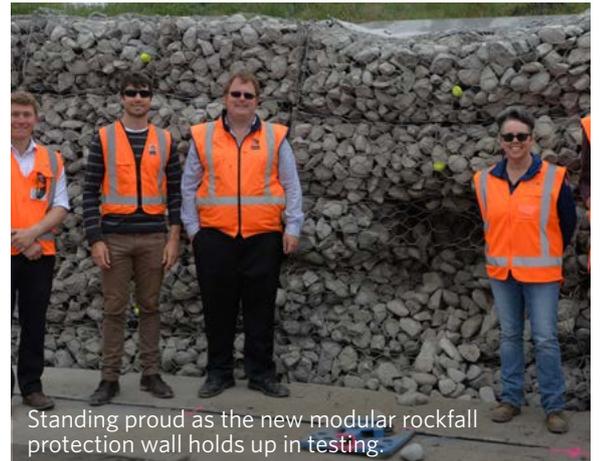
Standing proud as the new modular rockfall protection wall holds up in testing.

The newly designed modular wall has a narrower footprint than traditionally used reinforced soil walls, but can still withstand enough of an impact to protect infrastructure to required standards.

Large five-tonne blocks, which are being used to build seawalls on the coastal side of the corridor, have been repurposed and used for the modular wall. These are being reinforced by two closed metal cage baskets known as gabions. One of these baskets is filled with sand, and the other basket with rocks. The two gabions are attached to the front of the sea blocks and positioned towards the rock face lessening the force of falling rocks.

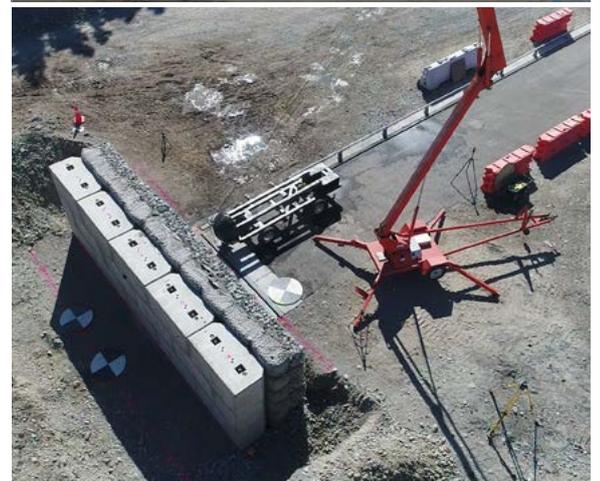
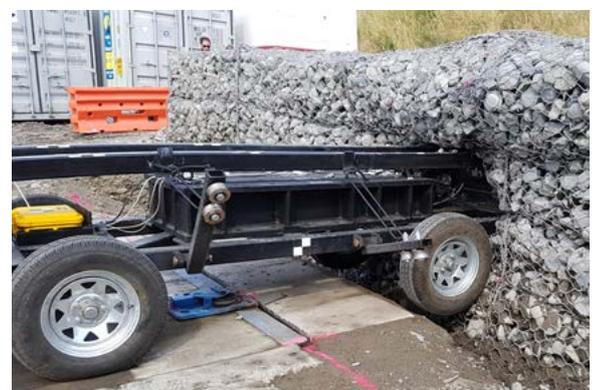
Full-scale physical testing was carried out in order to show the wall is up to the job. To do this, NCTIR joined forces with Stahlton NZ (which design the concrete blocks) and Holmes Solutions (which is renowned for its impact testing capabilities).

Together, they created a test 'bogie' to crash into the wall simulating a rock impact. The bogie hit the wall with energies up to 750 kJ, which is about 2.8 tonnes travelling at 90 km/h. The rockfall protection wall held up, proving it a viable option.

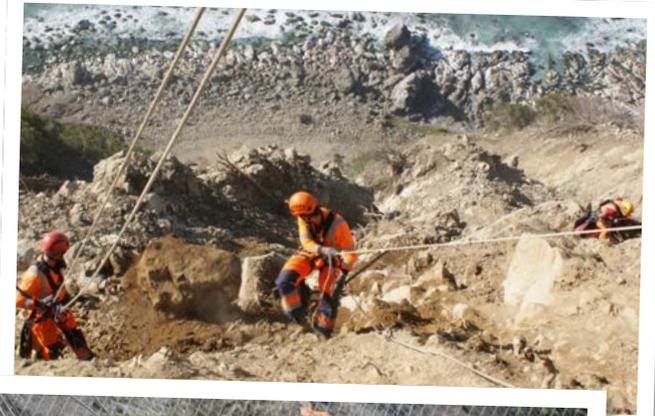
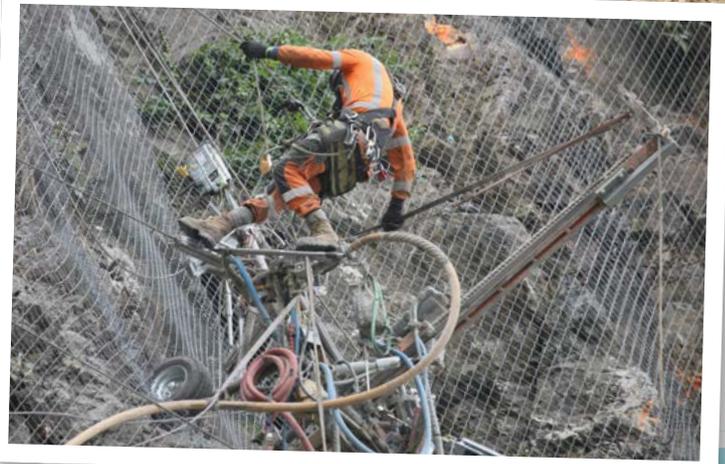
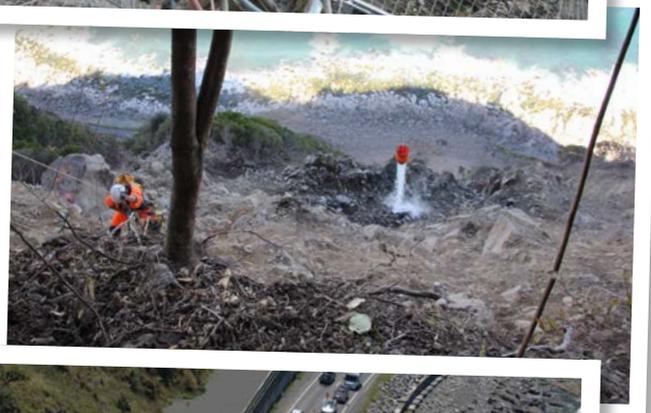
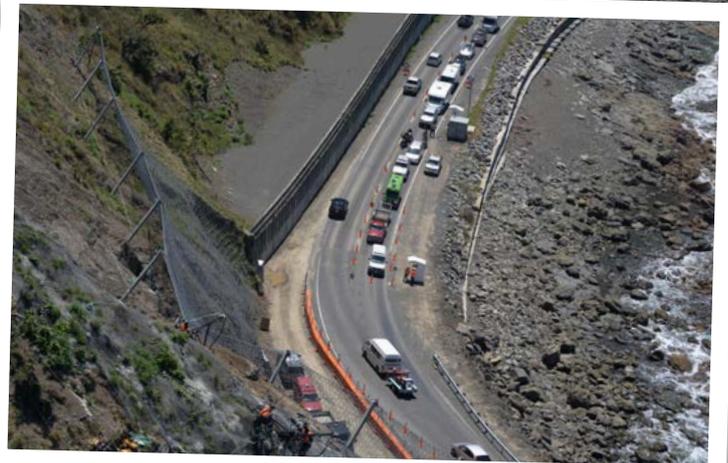
One of the main stabilisation techniques we have used to stop rocks from falling is simply to remove the loose ones from the slope. This has been done by sluicing (using helicopters to drop buckets of water on loose rock), using abseilers to push and blast rocks from the slope, and using excavators to carve out more stable slopes. Another method used is to hold damaged rock in place by using a combination of rock bolts and mesh.

On the protection side, the design team is using flexible attenuator fences installed on the slope faces to slow falling rocks and reduce them bouncing. Catch ditches, net fences and walls are also constructed at the bottom of slopes.

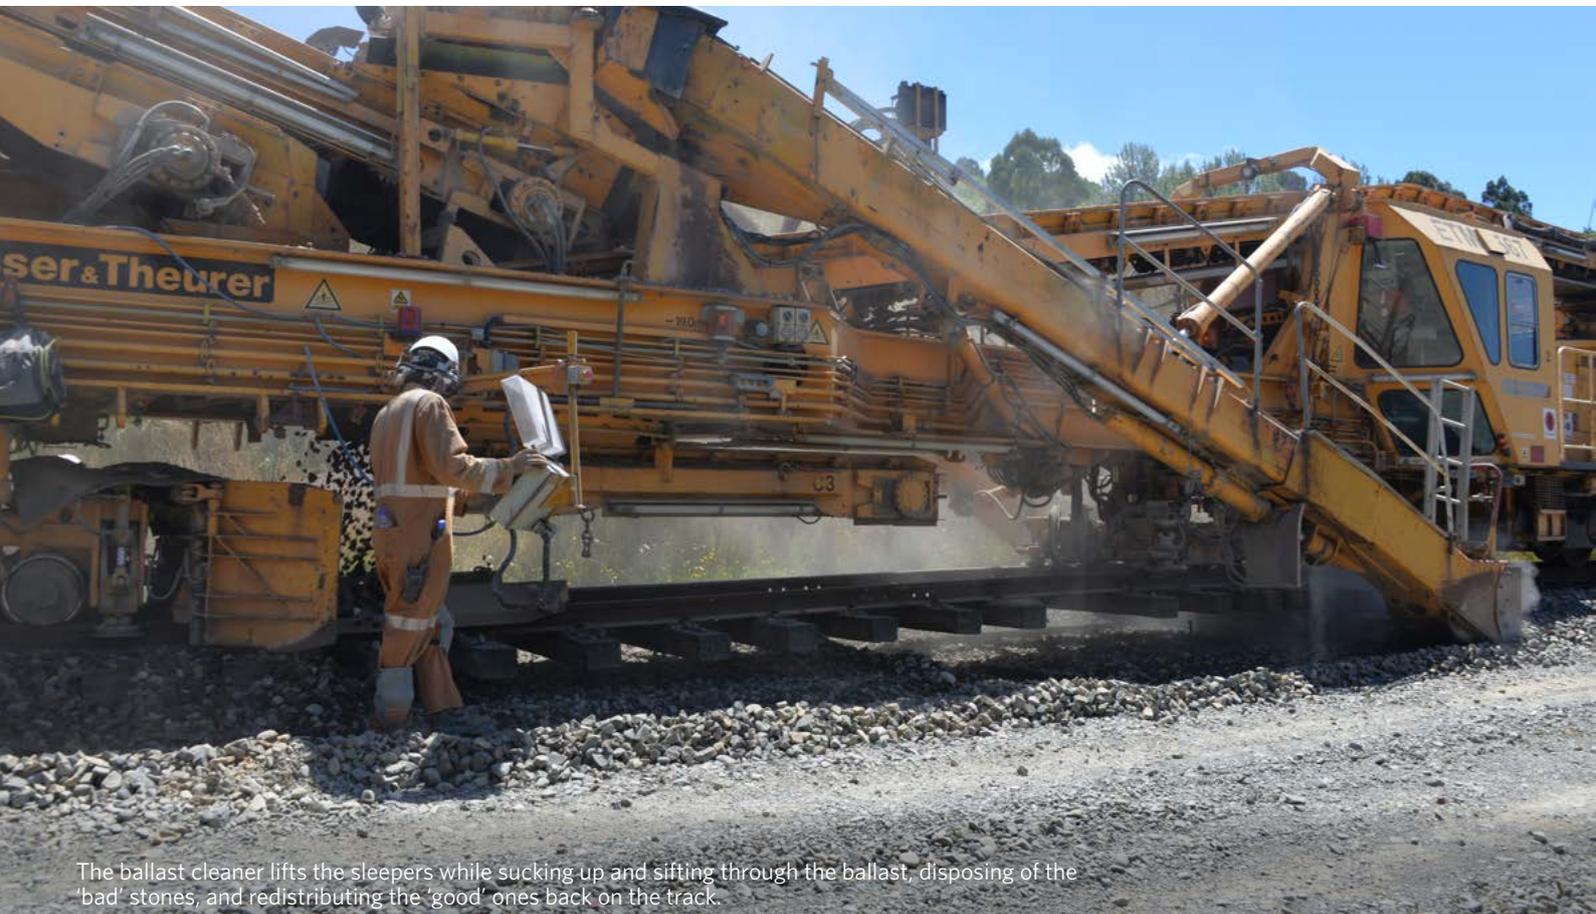
The ballast cleaner lifts the sleepers while sucking up and sifting through the ballast, disposing of the 'bad' stones, and redistributing the 'good' ones back on the track.

A special on-track 'ballast cleaner' machine was spotted on the Main North Line railway recently doing an important job of cleaning and screening the railway track ballast (stones). Ballast is the proper term used for the coarse stones, which form the bed of the rail tracks and support the track structure.

This ballast cleaner is an impressive machine - the specialist equipment is hooked together to create a train which is 230m long.

It works as a mobile screening plant and sieves out the 'good' stones from the 'bad' ones. It also removes any problematic vegetation, which can trap mud and dust and prevent the ballast from freely draining.

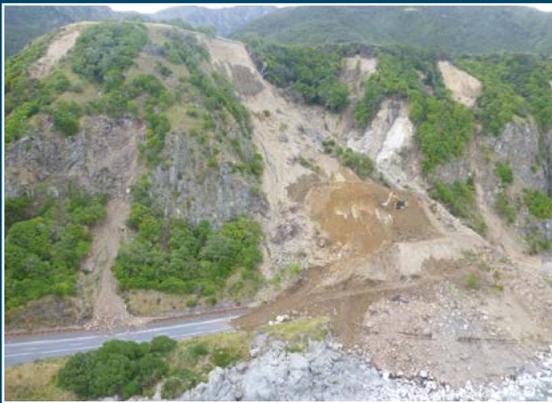
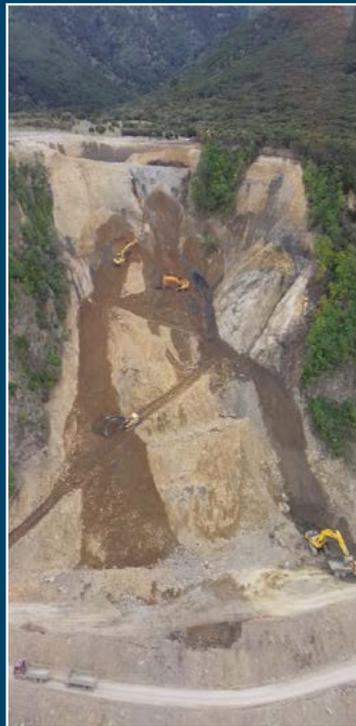
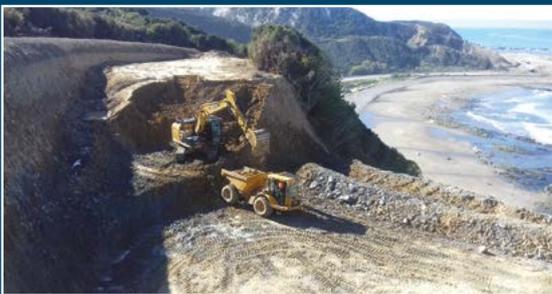
The earthquake triggered a landslide where weak rock collapsed along with the layers of loose gravel sitting above this rock. Our geotech and earthworks teams removed landslide material and reshaped the slip face to create flatter and more stable slopes giving it a carefully carved look. This new profile includes benches and catch ditches, and rockfall fencing will be put in to reduce the risk and impact of future rockfall.

To remove landslide material our earthworks crew created a route up the slip for diggers, which moved the slip material down to the base of the site. From the north side of Okiwi Bay a 3km access track was formed so machinery could get to the top of the hillside. From here, the earthworks team reshaped the loose gravel to reduce the upper slope height and to unload and improve the stability of the gravels.

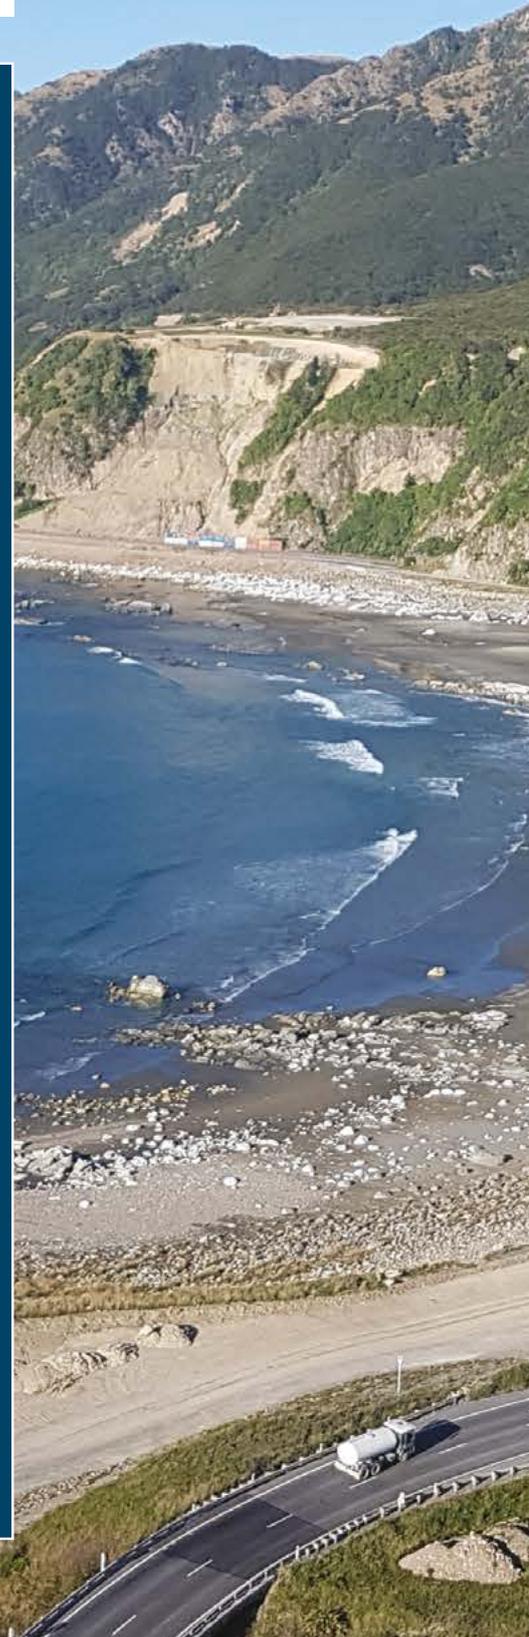
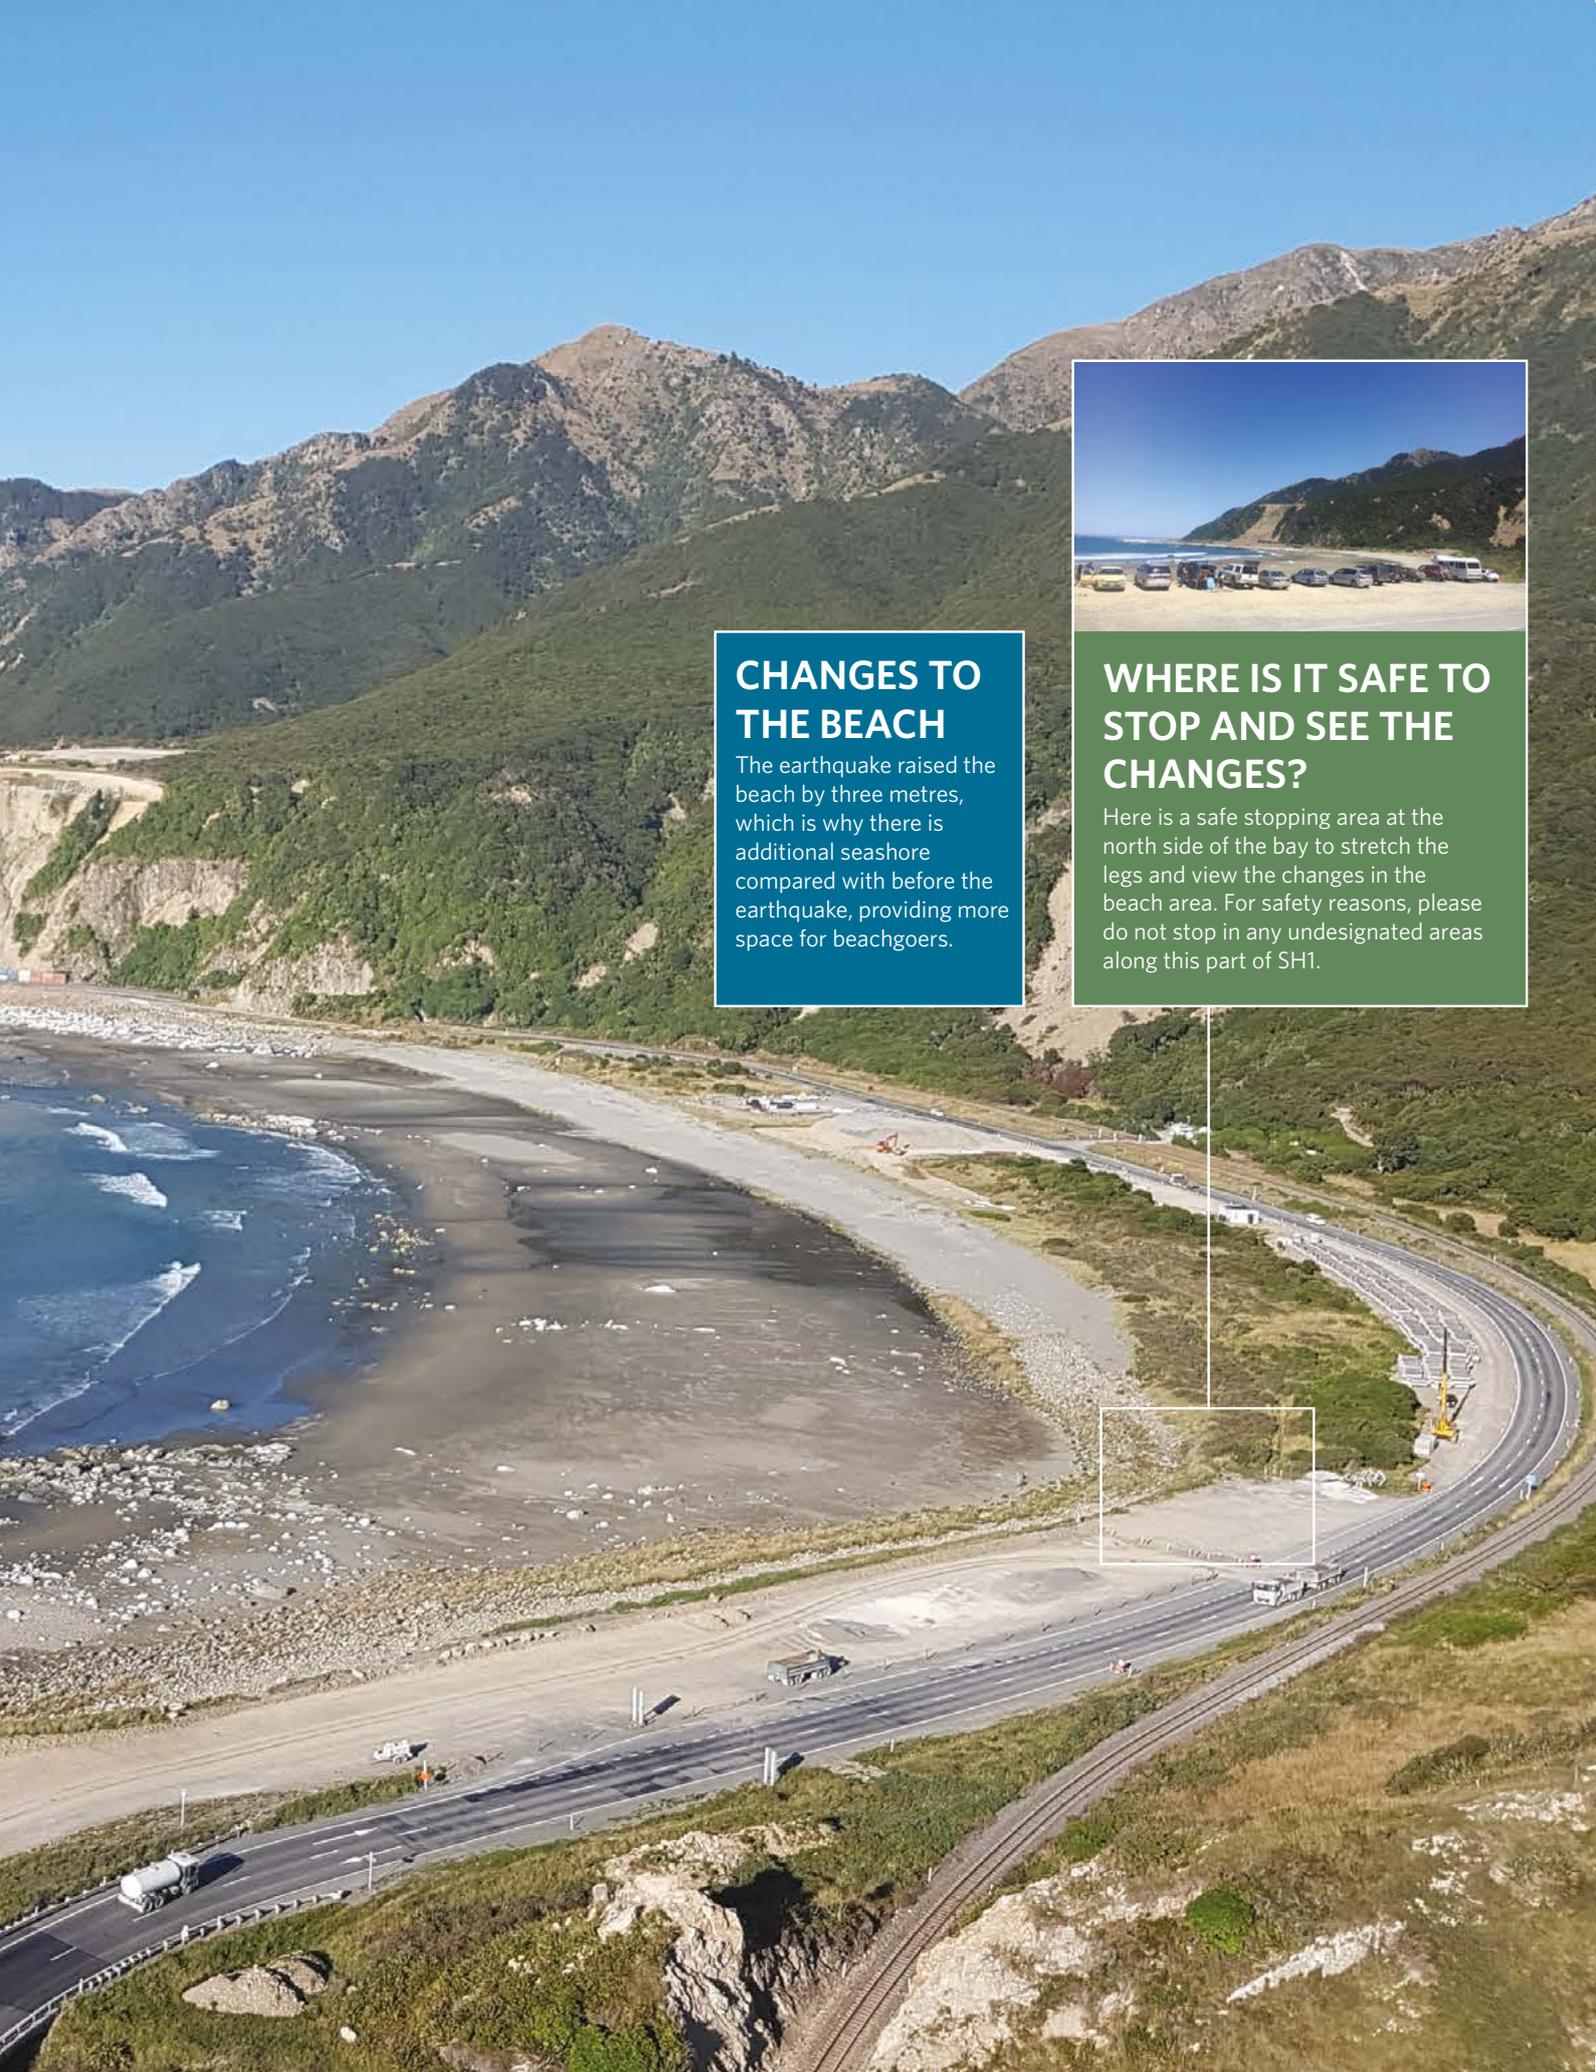
Because of the slip, we moved the railway 7m out from the hillside to protect it from further rockfall. This year our geotech team will be replacing the containers, which are providing temporary rockfall protection at the base of the hillside, with permanent protection in the form of bunds and fences.

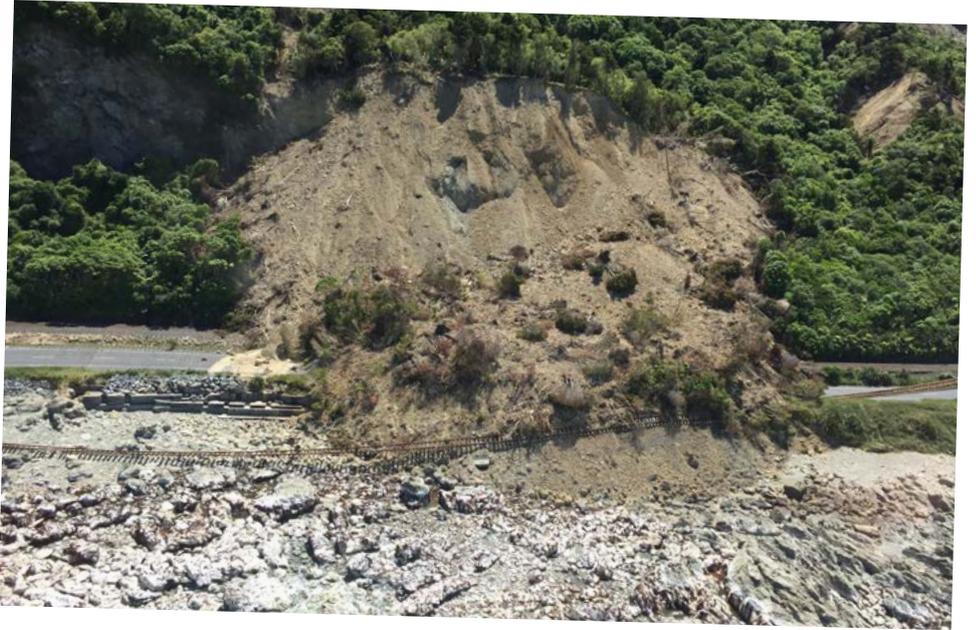
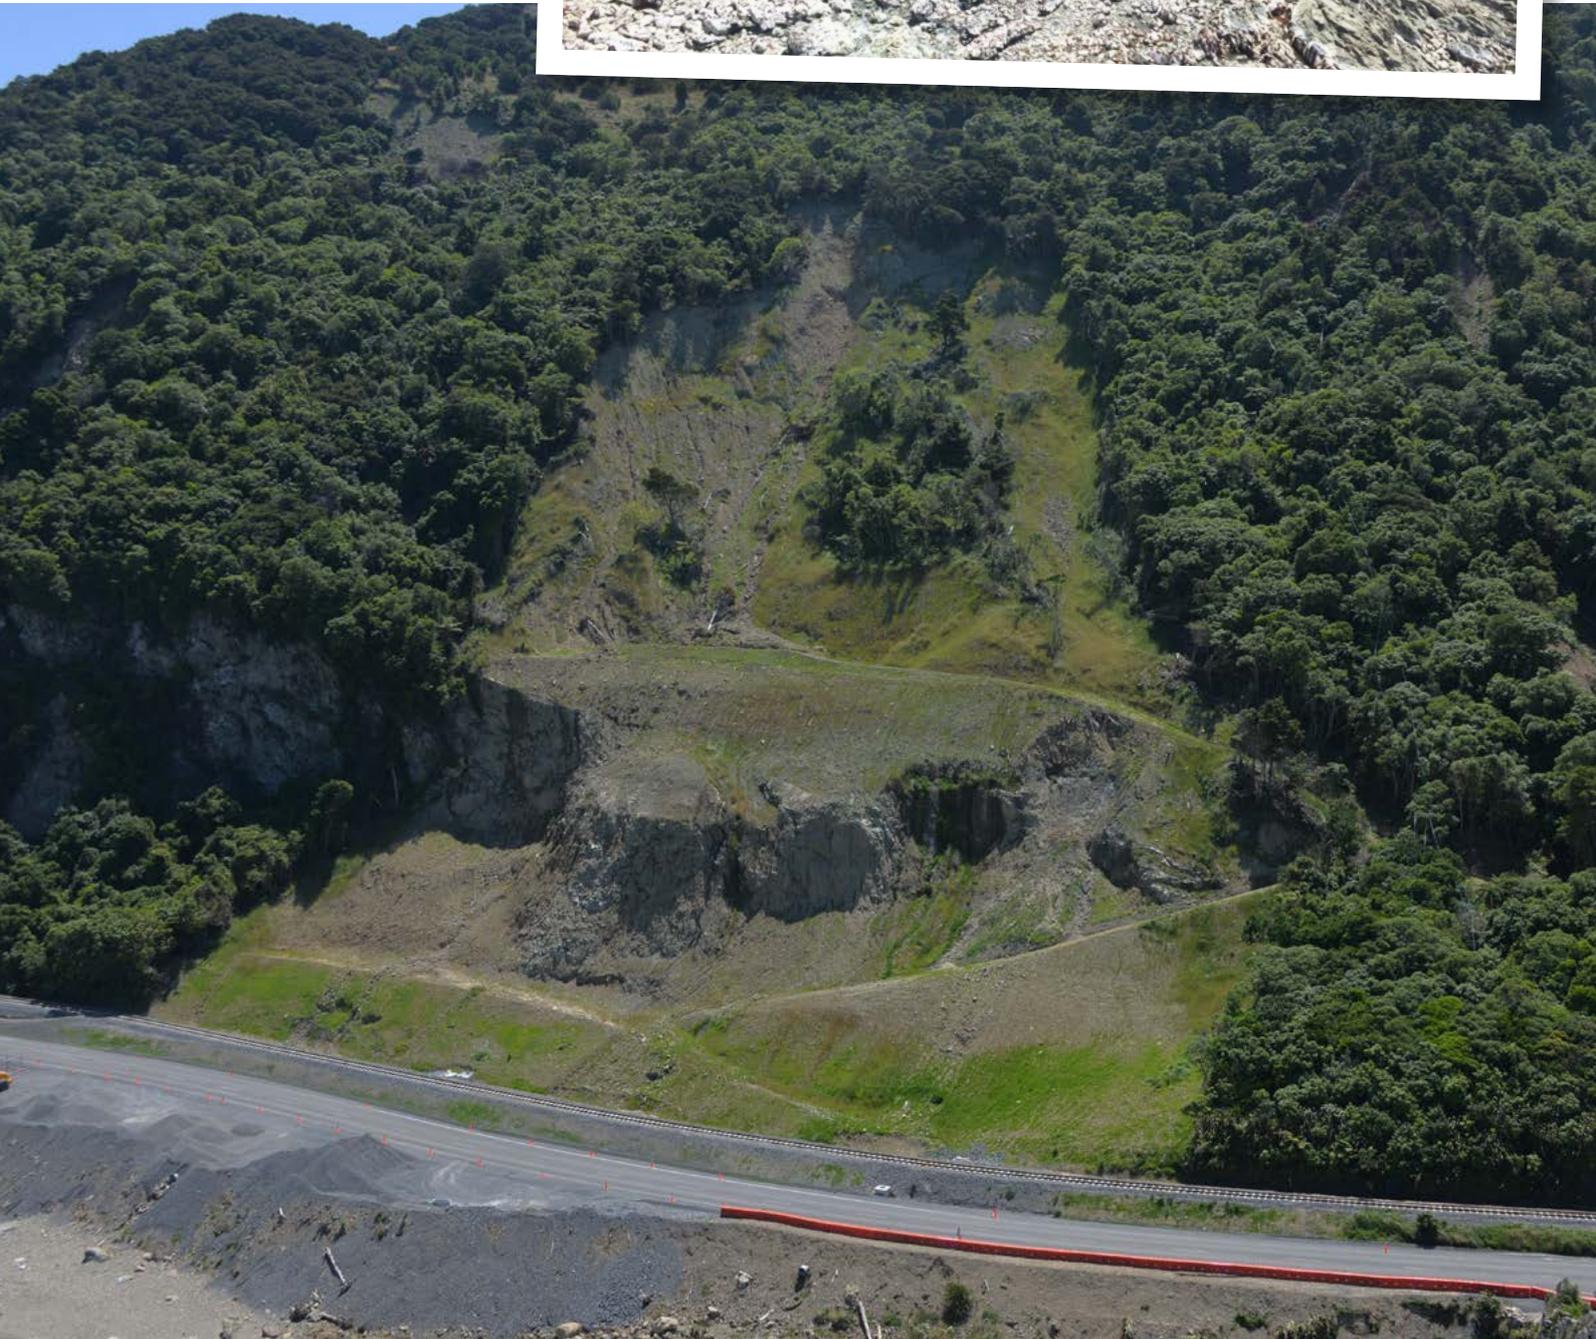
## THIS TIME LAST YEAR

North of Kaikōura, just past Halfmoon Bay, the 2016 earthquake triggered slip covered the road and pushed the rail line off its tracks into the sea. Since then, our crews have cleared 140,000m<sup>3</sup> of slip material from the road, rail and hillside, and restored the transport links at this location. Our earthworks and geotech teams created benches on the hillside to capture any landslide or rockfall. Hydro sprayed grass seed onto the hill has taken root and started to grow. This vegetation will help reduce erosion on this site.
