# The Bulletin Kaikōura earthquake update

This Bulletin provides the latest information about the rebuild of road and rail networks damaged by the Kaikōura earthquake in November 2016. The Bulletin is produced by the North Canterbury Transport Infrastructure Recovery (NCTIR) - an alliance representing the NZ Transport Agency and KiwiRail, on behalf of Government.

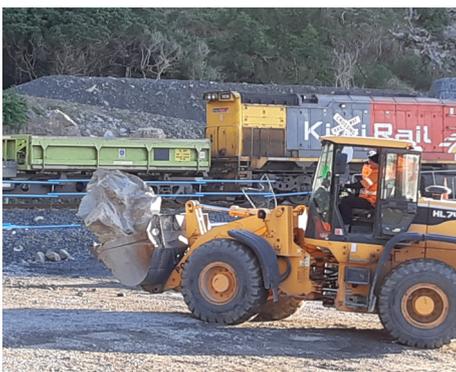
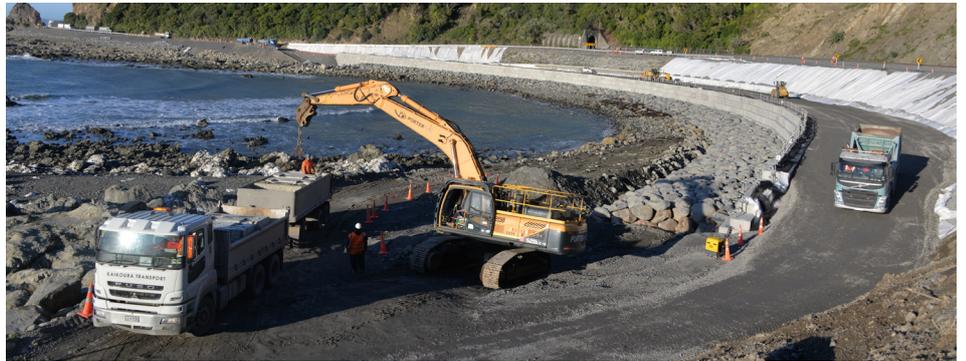
Over 1000 tonnes of slip rock cleared from behind NCTIR bunds has been transported by KiwiRail for repurposing on another of their projects south of Kaikōura. 'It's a win-win for everyone,' says NCTIR Foreman Butch McGinnis, who has been working alongside KiwiRail Civil Project Manager Nolan Chaston to load the rock onto rail wagons at Ōhau Point, where the material was sourced.

'We are currently using the slip rock to stabilise the access road and track formation embankment at Claverley,' explains Nolan. This project includes three rock revetment sections spanning just under 200m, and will require close to 7000 tonnes of rock to build. Nolan estimates that approximately 1500 tonnes of this rock will come from NCTIR sites, with three loads of rock taken so far, and two left to go. 'We are saving NCTIR from having to shift and dispose of the rock, and in turn we are receiving free material, and using one slip to stabilise another,' says Nolan. 'It's a win-win'.

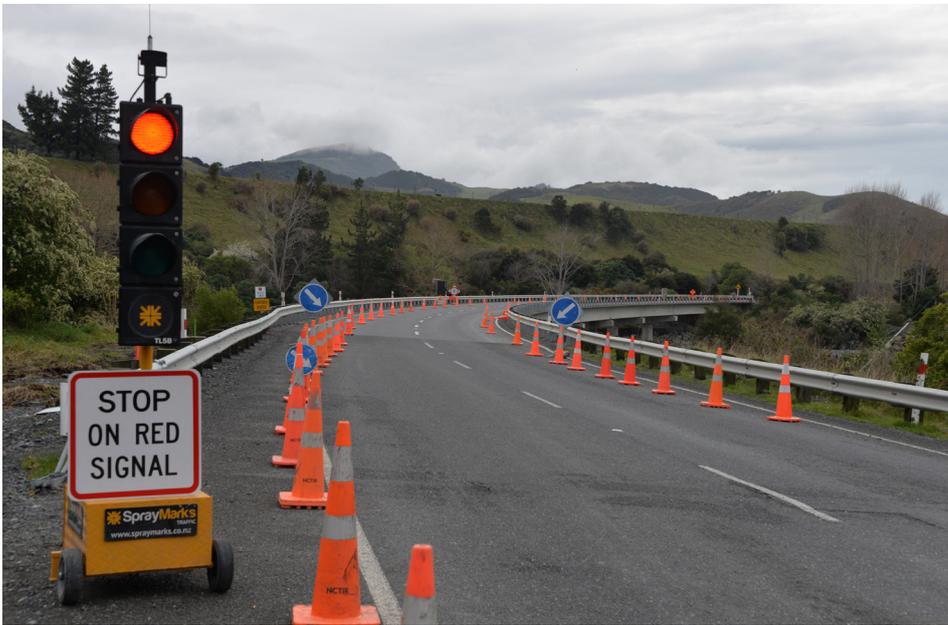
To build the new road, a seawall up to 9.5m high is being constructed on the seaward side. On completion the wall will be nine blocks high, with a total of 634 concrete blocks, with each weighing 8.5 tonnes. On the seaward side of the wall a rock revetment is also being constructed, which is designed to absorb the wave energy and protect the seawall from coastal erosion.

44,000m<sup>3</sup> of aggregate will then be placed in layers to fill the space between the new seawall and the old road. Finally the road carriageway will be formed, sealed and guardrails will be installed.

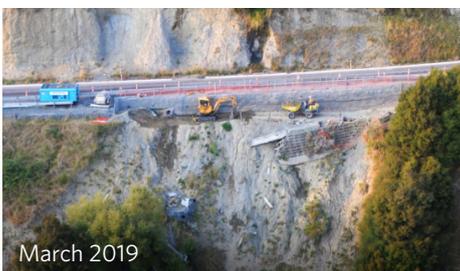
Repairing this section has been a major piece of work as the edge of the road had fallen off. To rebuild it, the NCTIR crew had to create a working platform on the side of the hill, six metres down, and then slowly build up the land to eventually reinstate the second lane. To do this the bank was stabilised by drilling in 37 six-metre-long soil nails. A retaining wall of 63 gabion baskets, four rows high, was built and this was secured with nine-metre-long rock anchors. All this work has been done out of sight of the travelling public down the side of the hillside.

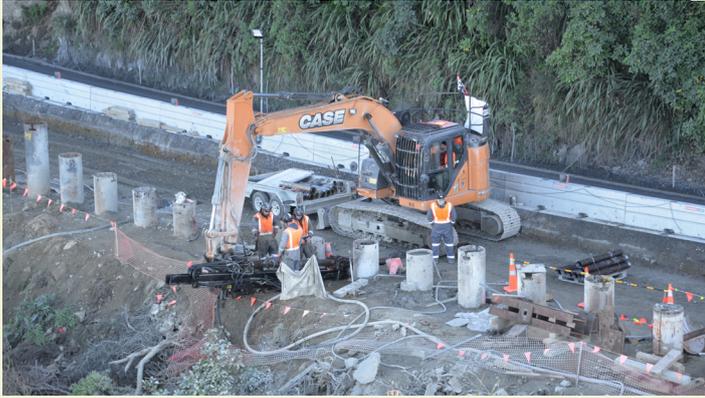
Pre-drilling 18-metre rock anchor holes under the road, and into the rock bank, at angles of 15 and 30 degrees. A fine mist is sprayed to reduce dust.

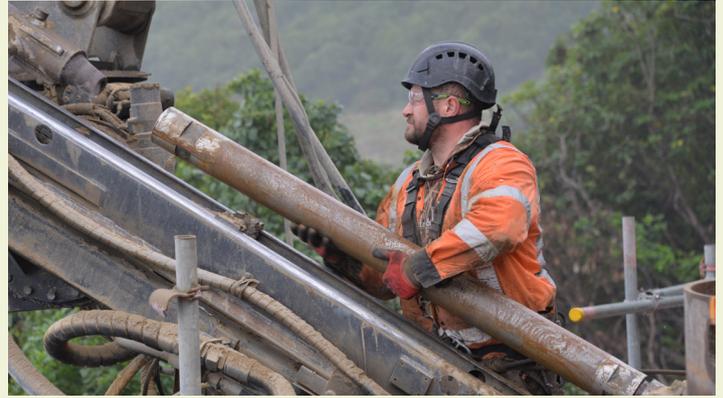
Supervisor Lukis Fuller adding a length of casing to the rock drill.

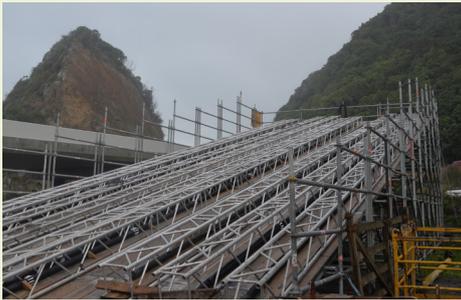
Rock anchors consist of a steel rod grouted inside a plastic tube. This ramp allows grout to be poured into the tubes at the correct 15 degree angle, to secure the rods at the same angle they will go into bank.

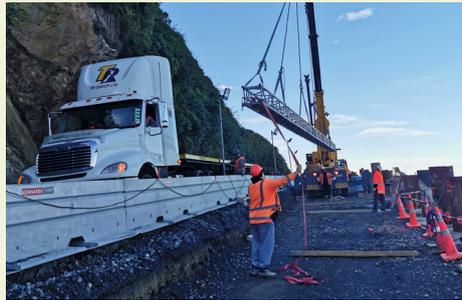
Before work started, a platform was built to hold the machinery, and a crane sourced that would fit the narrow corridor, but is large enough to manoeuvre a rock anchor around into the hillside.

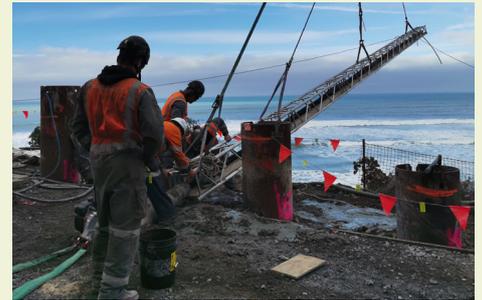
Pre-grouted rock anchors are swung into position by crane, then inserted into the pre-drilled holes.

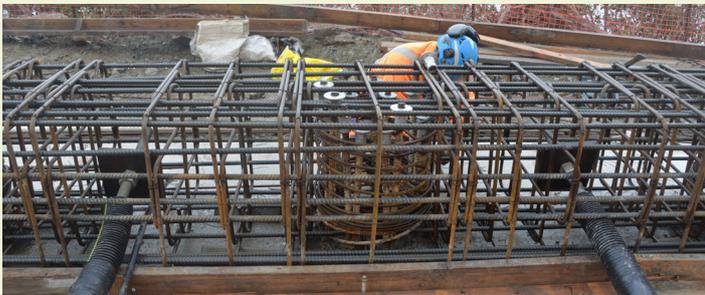
48 reinforced concrete piles were constructed to a depth of 13-22 metres. The concrete at the top of each pier is removed to expose the steel reinforcing rods. These rods, as well as the rock anchor ends, are then tied securely into a complex steel reinforcing cage that will form the skeleton inside the capping beam.

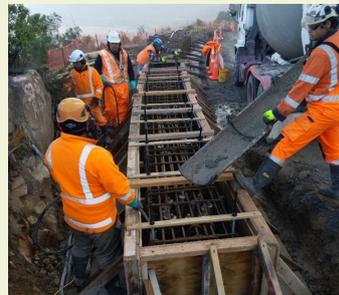
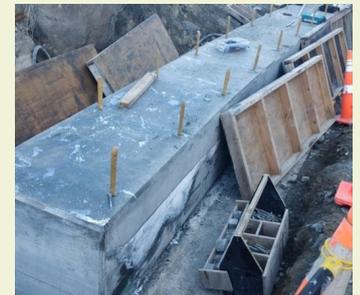
The concrete is poured in multiple sections, with a gap between each segment to allow for earth movement. Once complete, the road can be built up to finished level, and guardrails installed. Road sealing should take place in October, once weather conditions are suitable.

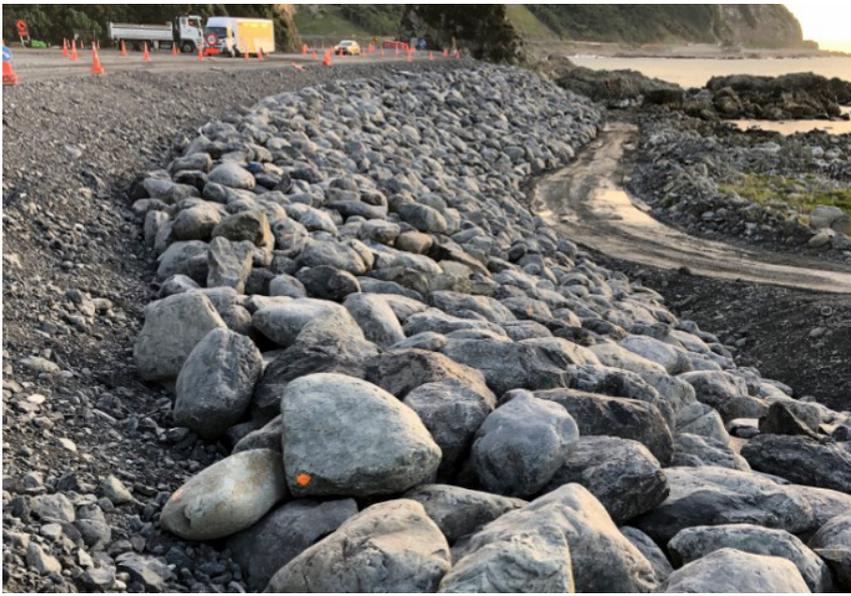
Gurdeep: 'A rock revetment is basically a sloping structure that is placed on a bank in such a way that it absorbs the energy of incoming water. The revetment also works as a supporting structure for the road embankment or seawall.'

Gurdeep & Tim: 'Our revetments are built in two layers. The big rock on top that everyone sees is called 'rock armour' (400mm - 1400mm diameter), and that's what protects the road from the waves - but we also have an underlayer of smaller rocks (150mm - 400mm diameter), which provides the integration between the big rocks and the soil beneath. We have to overlap the rocks in a certain pattern so that we don't have clean joins, because the waves would pull them apart.'
