# The Bulletin Kaikōura earthquake update

## Two-years on from ex-cyclone Gita

# SH1 Kaikōura: Major Gita resilience works

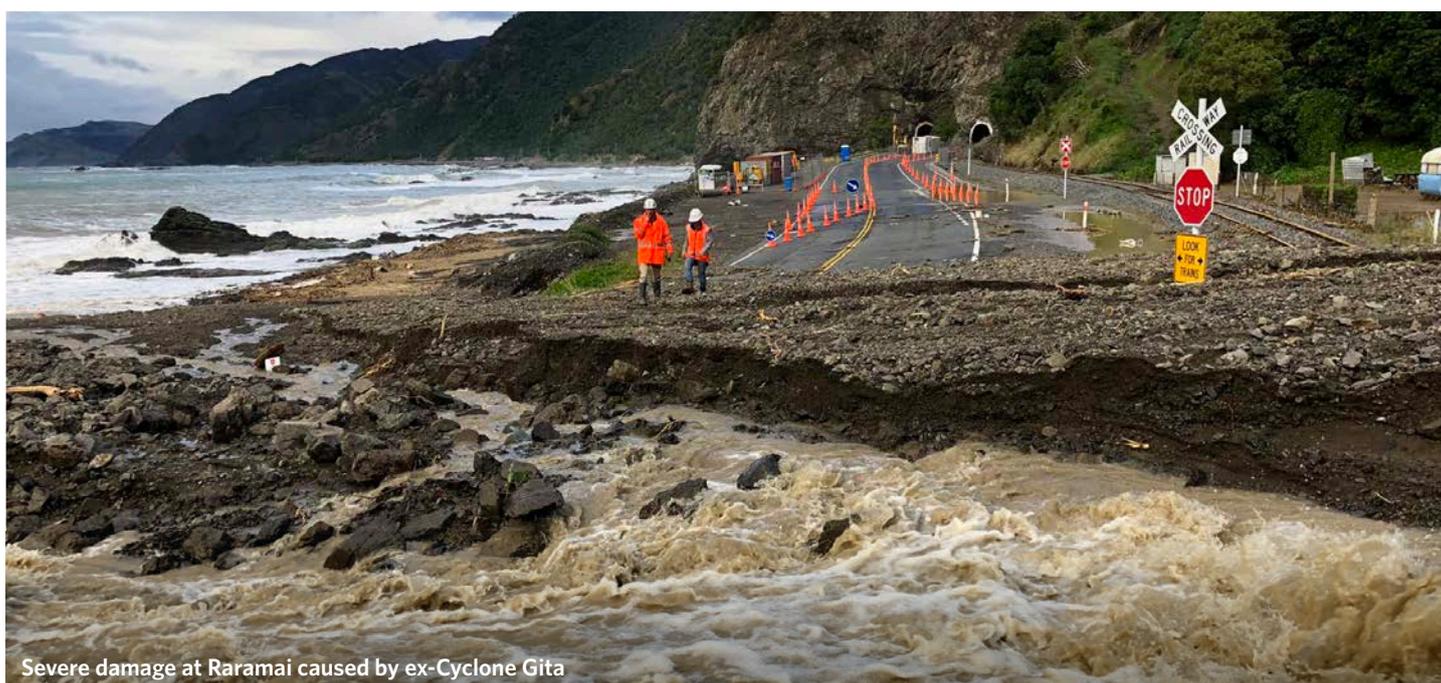
Severe damage at Raramai caused by ex-Cyclone Gita

On 20 February 2018 ex-cyclone Gita wreaked havoc on an already earthquake-affected coast, bringing down 60 slips along the Kaikōura corridor from the Hundalees to just south of Clarence. Over 300,000 cubic metres of material needed to be cleared from the road and rail in order to get the transport networks up and running.

While engineers were pleased with how the existing infrastructure handled the extreme rainfall, Gita exposed additional erosion paths where significant volumes of natural debris remain in the hillsides, and will continue to wash down in heavy rain events.

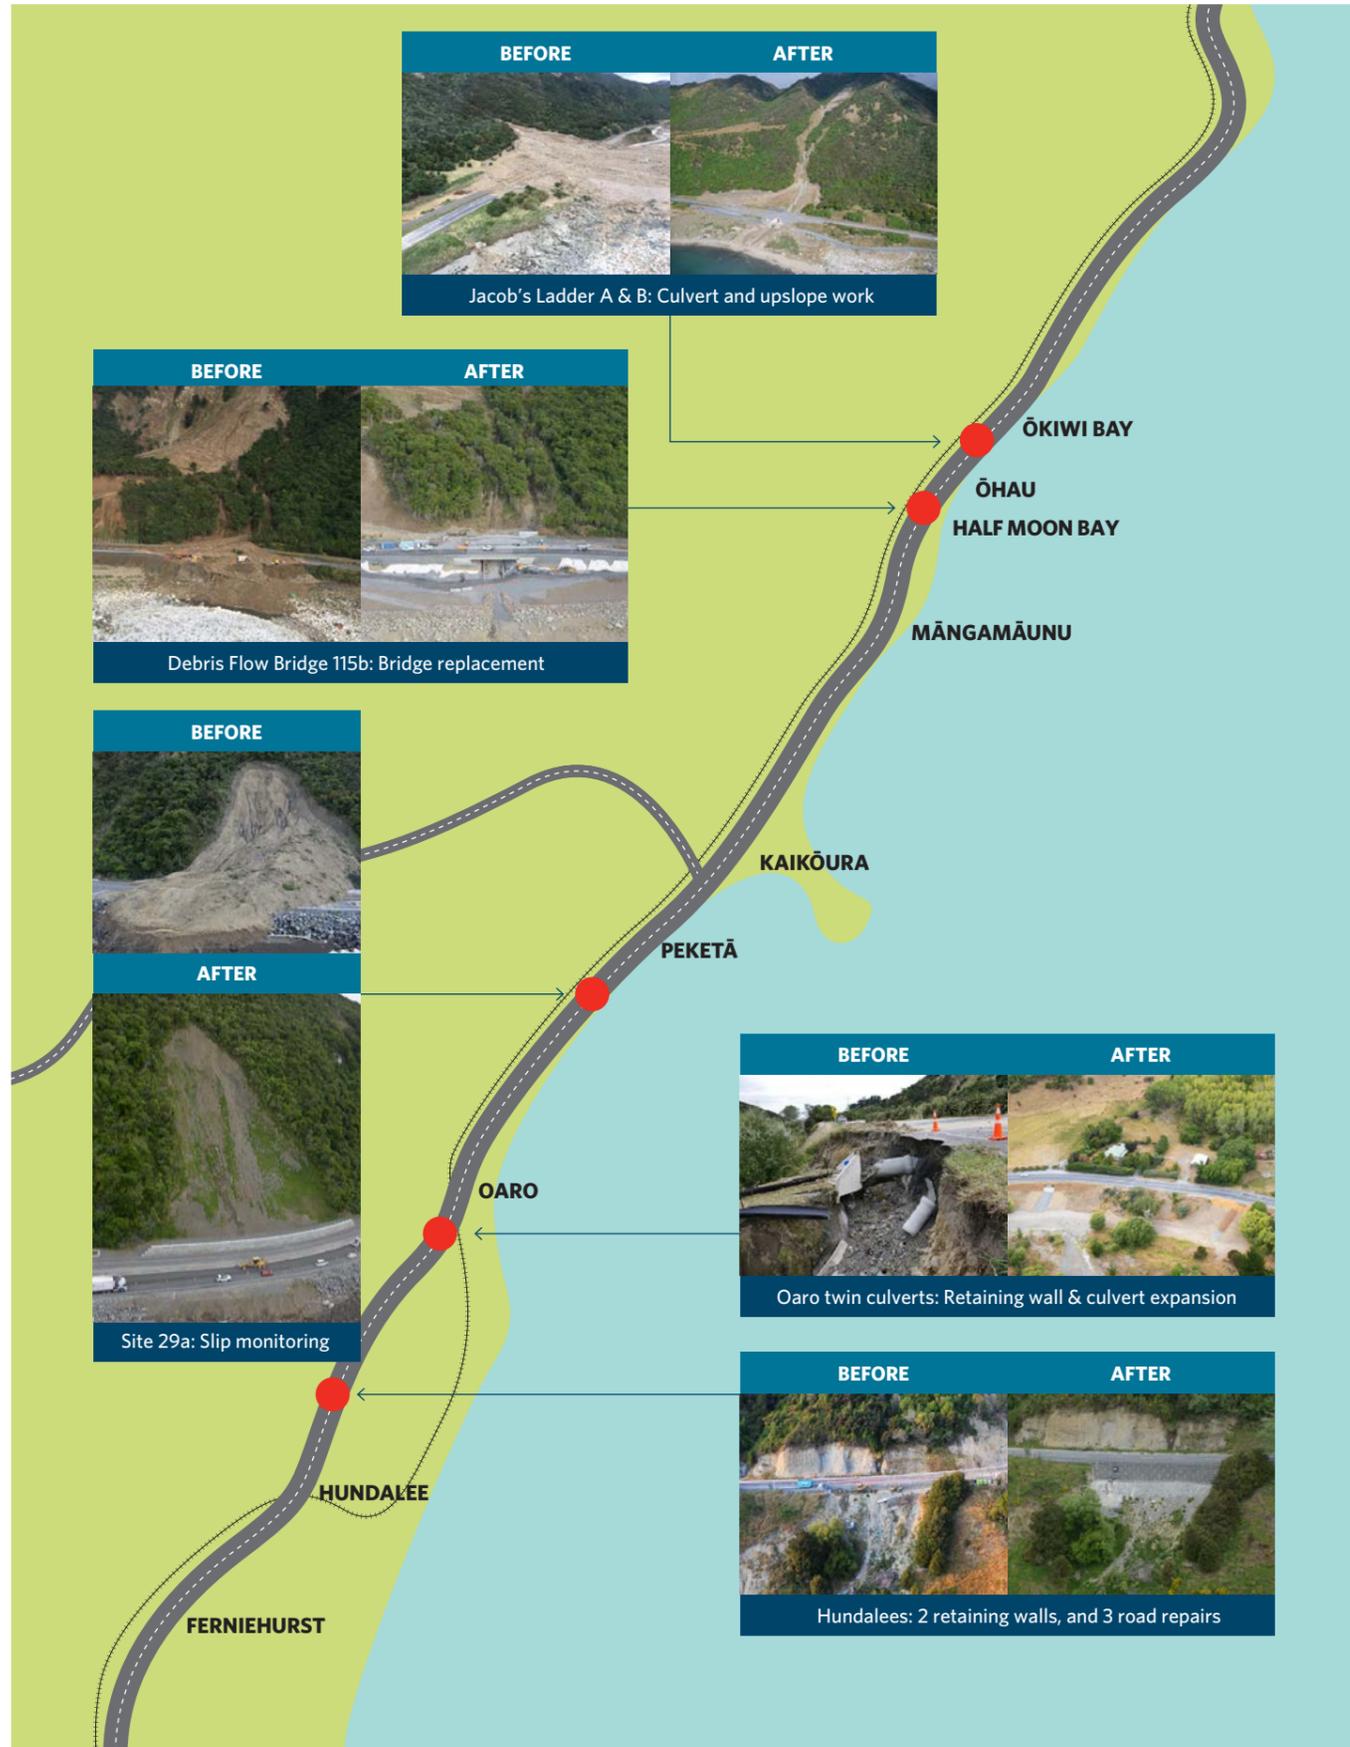
At major Gita-affected sites engineers have focussed on increasing the capacity of infrastructure to create easy -access, low-maintenance design solutions. The newly widened debris flow bridges, culverts and strengthened retaining walls aim to reduce the necessity of road and rail closures in future.

See the map on page 2 for a full overview of all major Gita work.

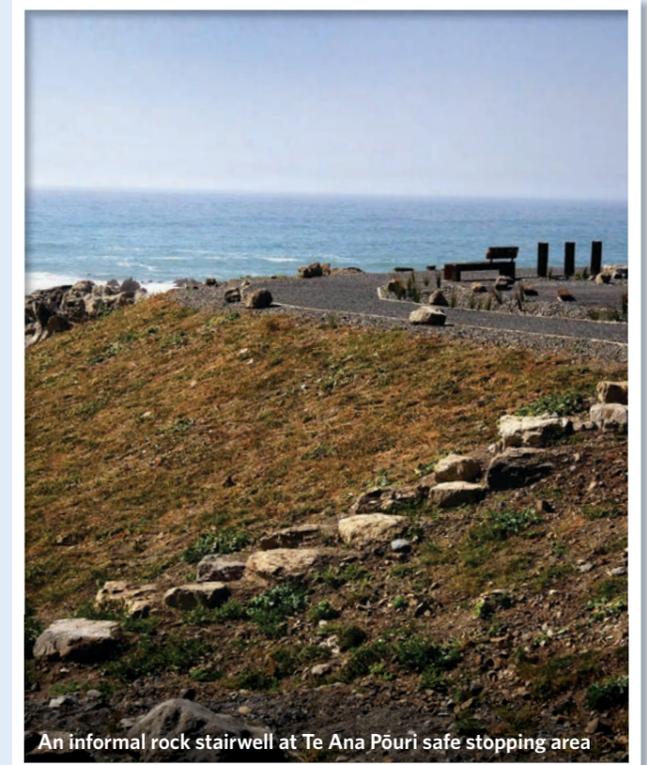
An informal rock stairwell at Te Ana Pōuri safe stopping area

'NCTIR's initial design was to have formal concrete and timber stairwells leading down the revetment to the beach,' Lawrence explains.

'But after discussions with the RLG this design was modified to a more subtle, informal stairwell made from recycled slip rock, which blends with the natural environment. This will blend in even more once the areas have been planted.'

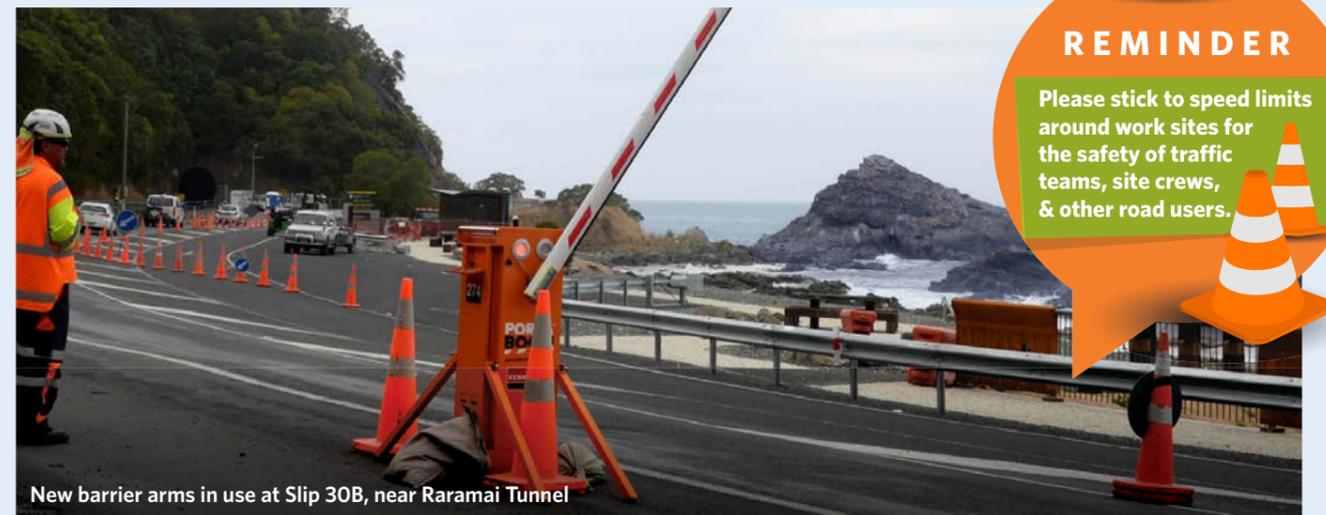
New barrier arms in use at Slip 30B, near Raramai Tunnel

This device was recently approved for use on the New Zealand roading network, and NCTIR is the first in the country to use it to manage live traffic. Two of the arms were installed at the 30B slope repair site, just north of Raramai tunnel.

The device is remote-controlled, and can be operated from up to 75 metres away. This allows Traffic Controllers to stand safely outside of the direct line of traffic, and will reduce incidents associated with fatigue and manual handling.

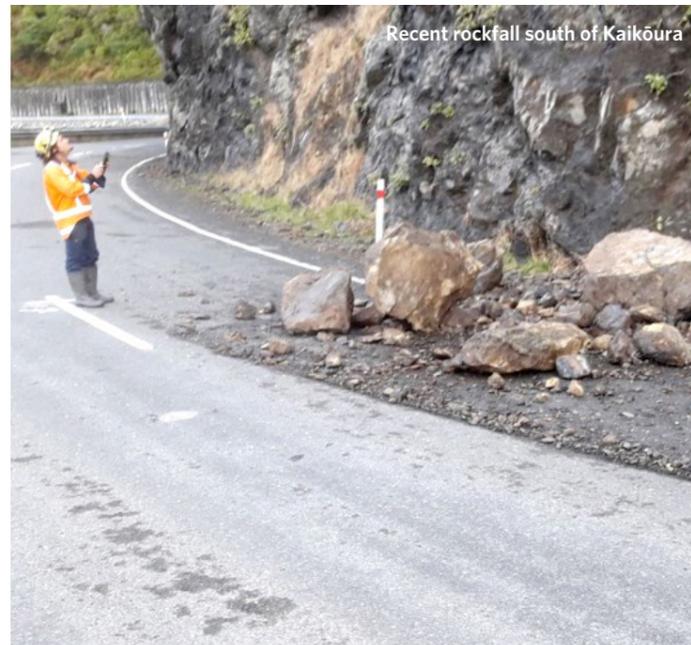
Recent rockfall south of Kaikōura

Rockfall between Peketa and the Parititahi Tunnels was triggered by the rain, and the highway was closed to traffic overnight. The section will remain reduced to a single lane for safety reasons while NCTIR works towards a solution. Rockfall is an ongoing issue at this location, with 72 recorded rockfall incidents there since the 2016 earthquake.

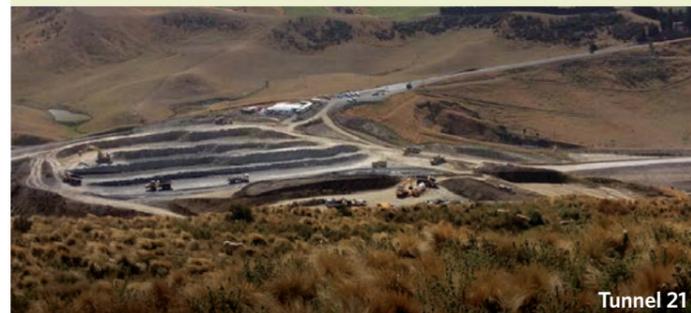
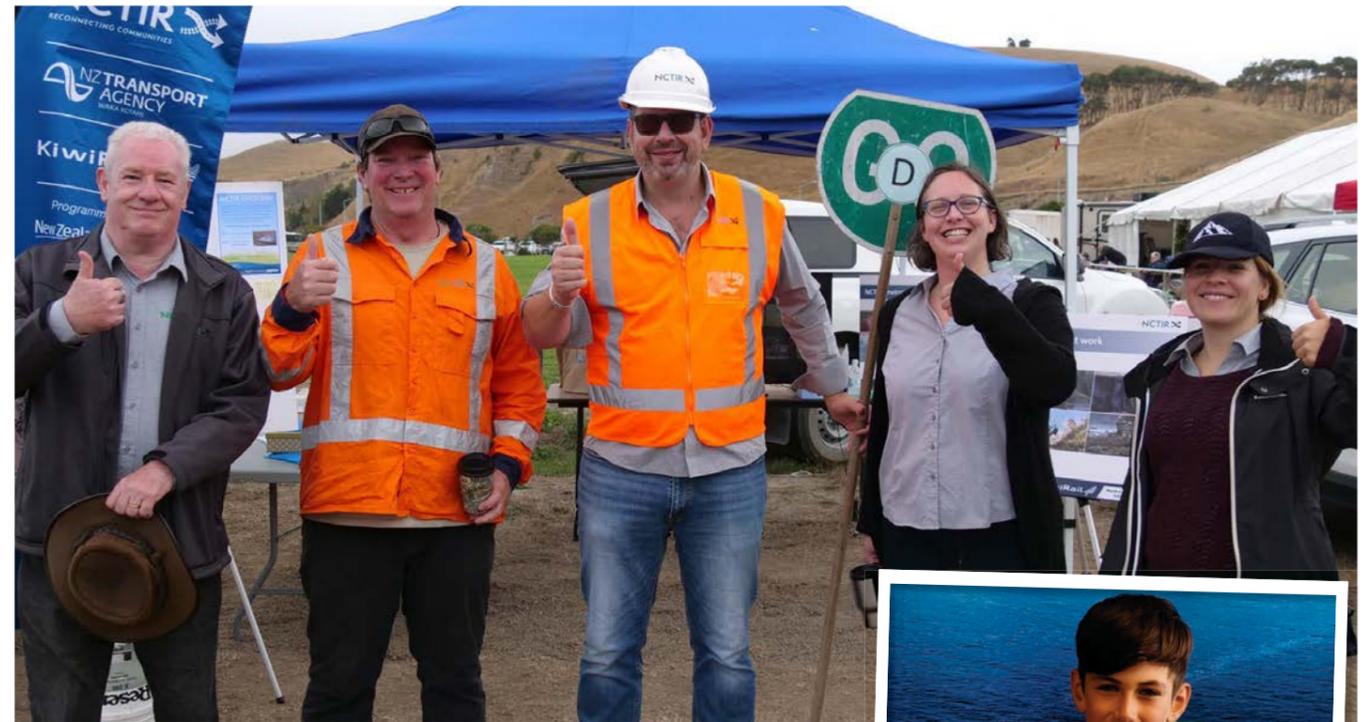
Just south of Ward at Tar Barrel, KiwiRail is undertaking some impressive work at Tunnel 21 to realign the rail and install a new over-bridge for SH1.

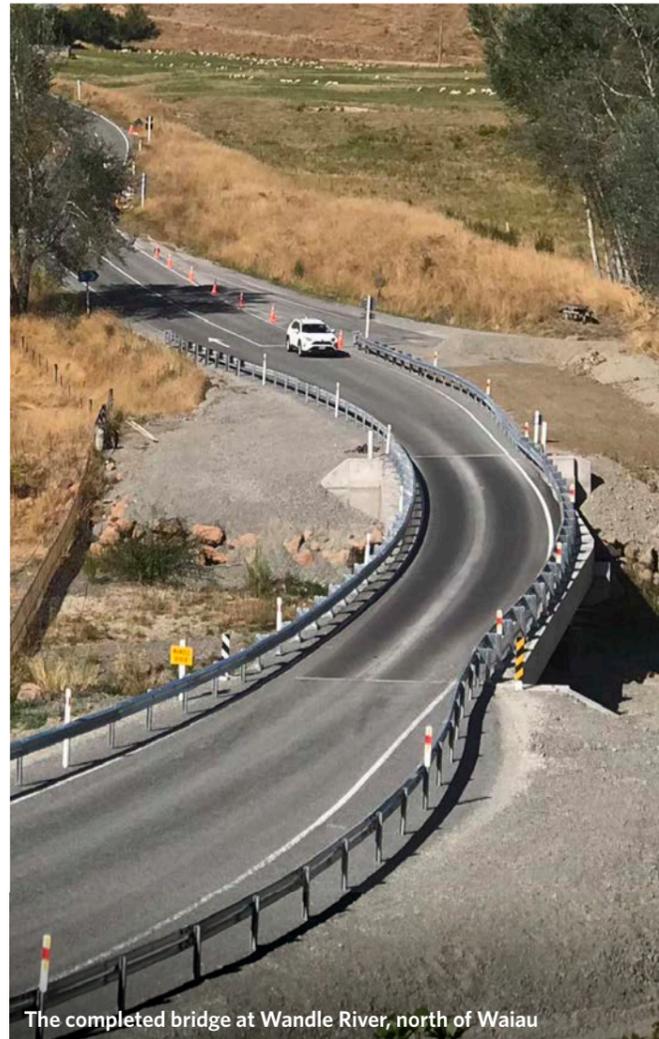
The completed bridge at Wandle River, north of Waiau

The new bridge was completed in approximately four months using a total of 290 cubic metres of concrete, 10 bridge beams, and piles drilled to a depth of up to 24 metres.
