IN THE MATTER OF applications for resource consents and notices of requirement in relation to the Ōtaki to North of Levin Project

ŌTAKI TO NORTH OF LEVIN HIGHWAY PROJECT

TECHNICAL ASSESSMENT I: CONTAMINATED LAND

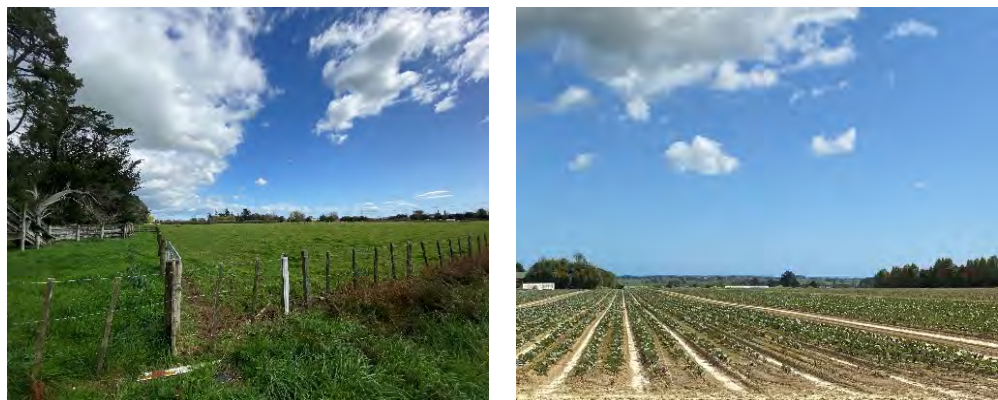
68. The nature of pastoral farming and the presence of several orchards and market gardens implies the use of fertilisers for soil improvements. This activity is likely to have been widespread within the proposed designations. Market gardens and orchards are listed as HAIL A10. There may have been bulk storage and use of persistent pesticides such as DDT and resulting residues that remain in soils of the area.

Figure I.1 Typical land use within the project designation

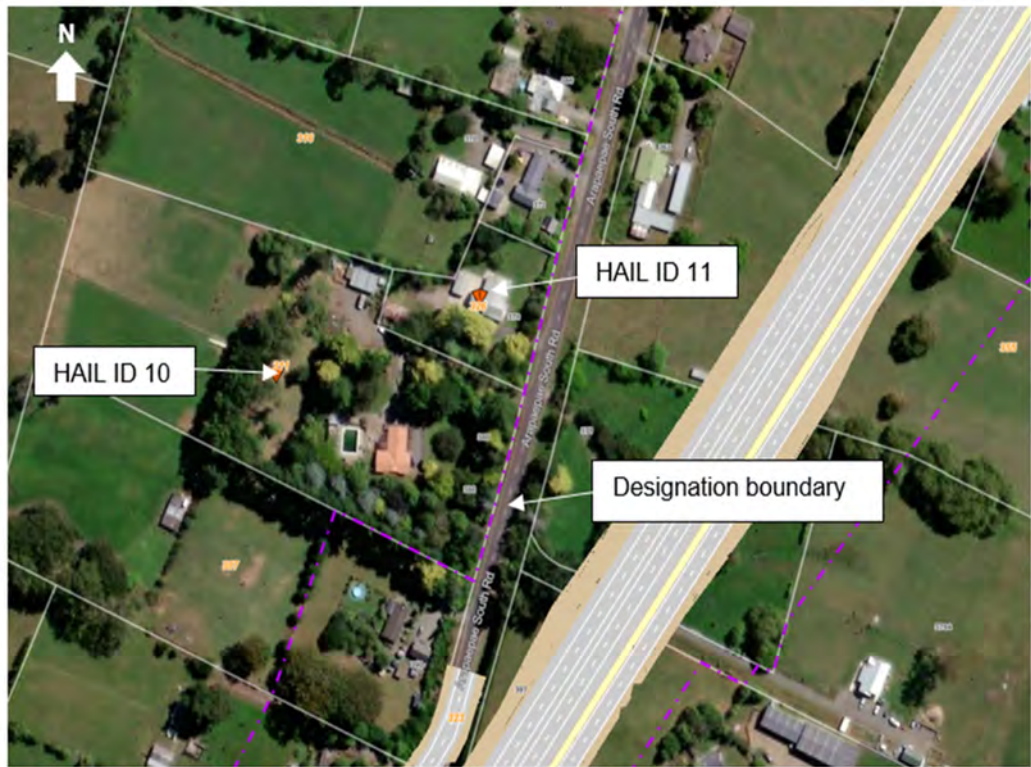
Figure I.2 HAIL sites at 378 and 380-386 Arapaepae Road

77. The HAIL sites at 378 and 380-386 Arapaepae Road, Levin (Figure I.2) were noted as having fuel storage tanks present and therefore the potential losses of petroleum hydrocarbon-based fuels associated with refuelling of farm vehicles to be present within soils. These sites are outside the proposed designation and hydraulically downgradient in terms of groundwater flow direction. Therefore, possible contamination migration from any of these known sites is likely to be away from the proposed works and not influenced by any dewatering that could be required. The likelihood of encountering petroleum hydrocarbon contaminants from these HAIL sites as part of the works is therefore considered to be low.

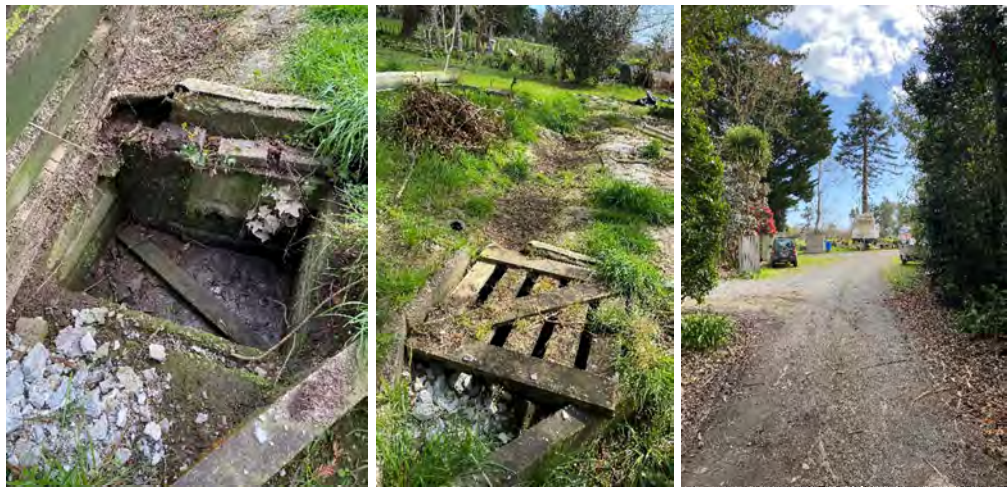
Figure I.3 Sump and soak away area at 380-386 Arapaepae Road (HAIL ID 10)

78. During the September site visit the storage tanks were located at 378 Arapaepae Road. These were in the ground at the northern corner of the site behind the residential building and well away from the designation boundary.
79. The tanks at 380-386 Arapaepae Road were no longer present. The tenant was present at the site at the time of the inspection and confirmed that the fuel storage was associated with a machinery building that used to be located in the northwest corner of the property. The tenant located an old sump (Figure I.3) and soak away area which he believed drained the machinery area. This flowed in a northern direction and away from the Ō2NL Project designation area.

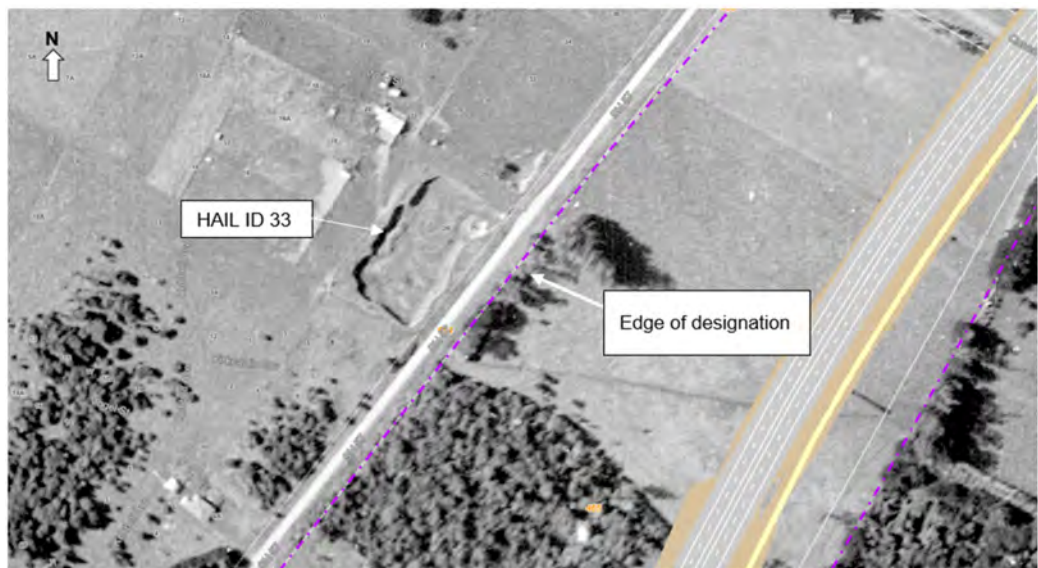
Figure I.4 HAIL Site 26 Arapaepae South Road (source Retrolens imagery 1940)

80. 26 Arapaepae South Road Levin (HAIL ID 33) was recorded to be the location of a historical landfill site. There are no HDC records of the age of the landfill, the quantity of material that may have been deposited here or its composition. There is an area of low ground observed in 1940 (Figure I.4) which is subsequently filled, and a dwelling located on the site. The HAIL site is outside the proposed designation boundary and hydraulically downgradient of the works and will not be disturbed as part of the works.

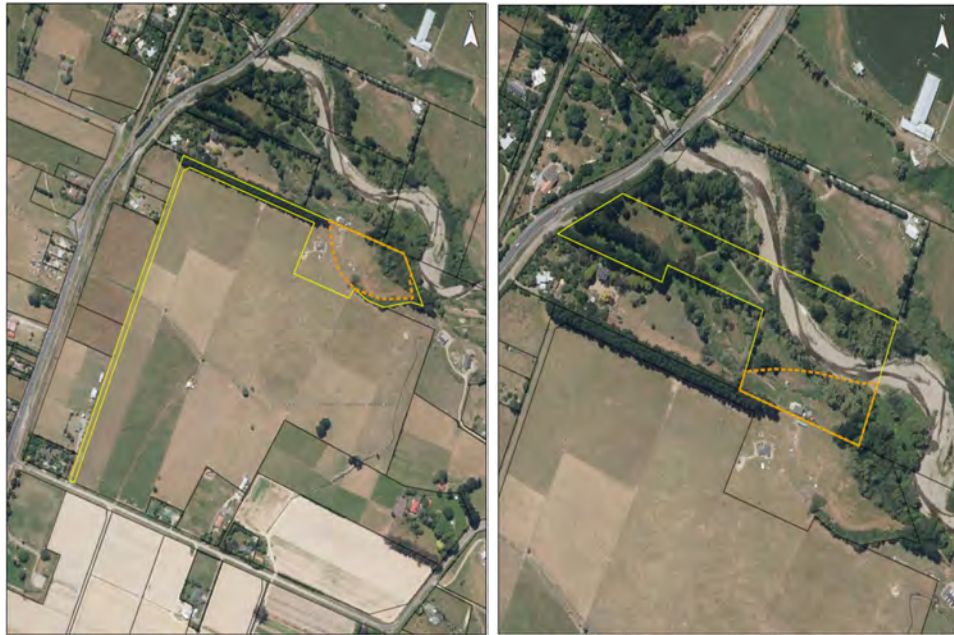
83. The full scale and location of landfill material is unclear from the imagery. Council records note that the site is located within the Waikawa flood plain, the materials dumped here have not been identified but some capping of the site has been undertaken.
84. During the September site visit and discussions with the landowner the extent of the landfill was located within 13 North Manakau Road next to Waikawa Stream and within part of 883 State Highway 1. The landfill is approximately 500m west of SH1.

Figure I.6 Approximate location of the historic next to Waikawa Stream

85. This HAIL site is located downgradient in terms of groundwater flow direction from the material supply site and no excavations are proposed within HAIL site #35.

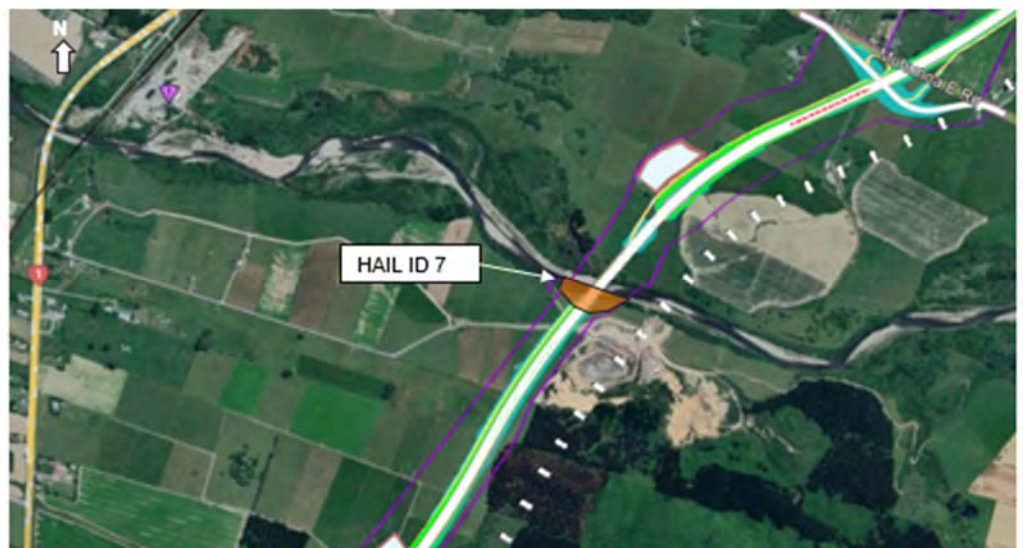
Figure I.7 Location of historical landfill within the southern approach to the Ohau River bridge

95. Preliminary sampling and further investigations carried out by Stantec in 2021 (in respect of HAIL ID 7) found:⁶
 - (a) evidence of landfill material including fence posts, a metal pipe, potentially a mattress, plastic, and bits of wire;

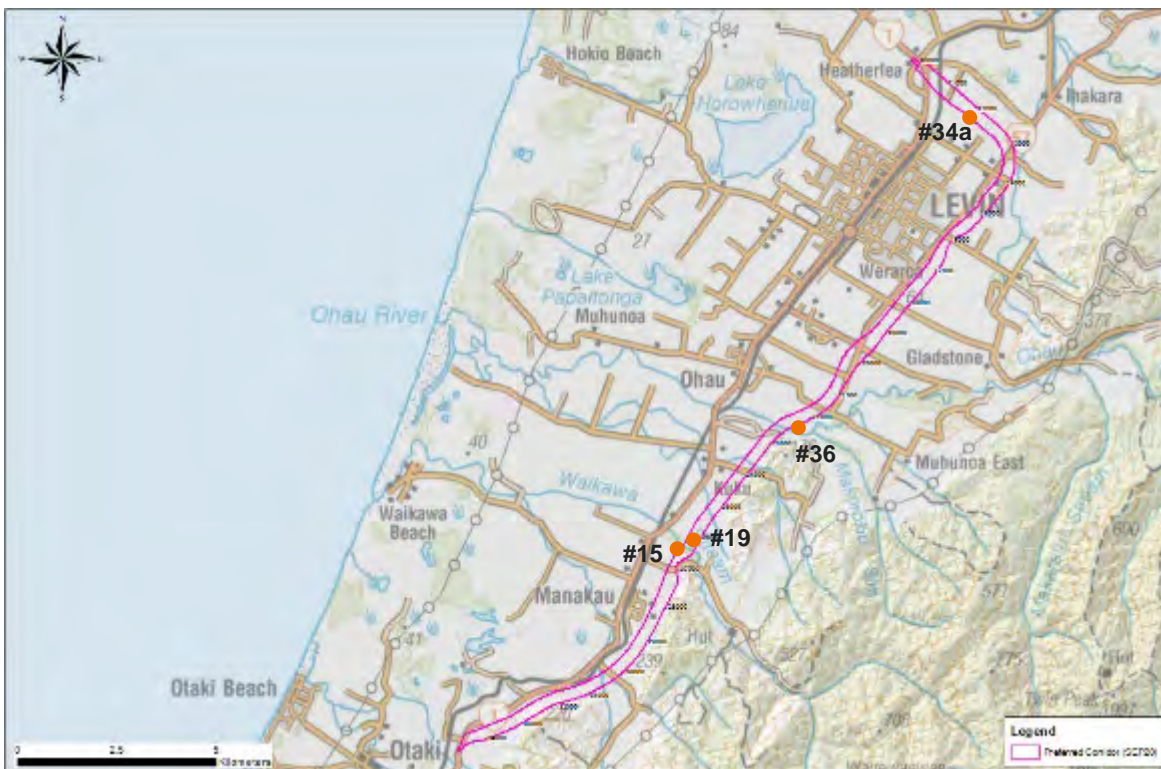
The Ō2NL Project involves the construction, operation, use, and maintenance of approximately 24km of new four-lane, median divided state highway between Taylors Road (to the north of Ōtaki) and State Highway 1 (“SH1”) north of Levin. The proposed Ō2NL Project alignment is shown in Figure 1 and a site plan provided in Appendix C.

Figure 1: Ō2NL preferred alignment and material supply sites in relation to existing SH1.

Material supply sites have also been identified and selected along the route (Figure 1) through a MCA of all options. The selected sites lie outside the proposed designation and are shown in Figure 2 below. This PSI also assesses the current and historical land use of these sites in terms of potential contamination.

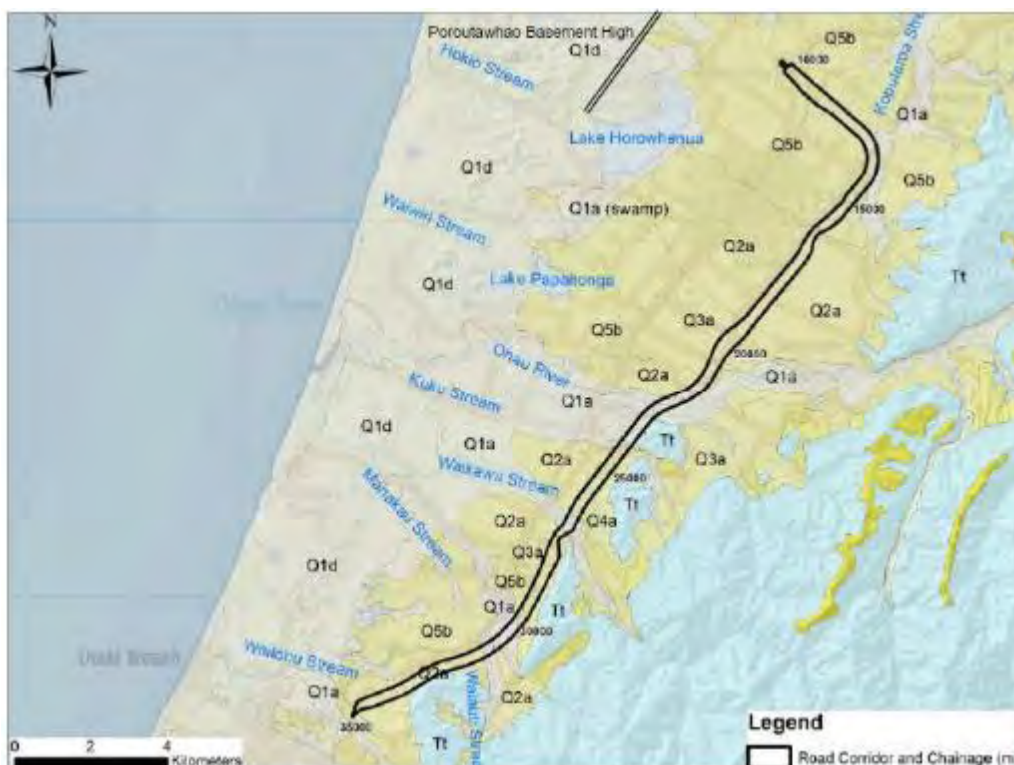
Figure 3 shows the QMap (Heron, 2014), simplified 1:250,000 geological map for the overall area and Table 1 provides a description of each stratum.

Figure 3: Simplified 1:250,000 geological map and road corridor.

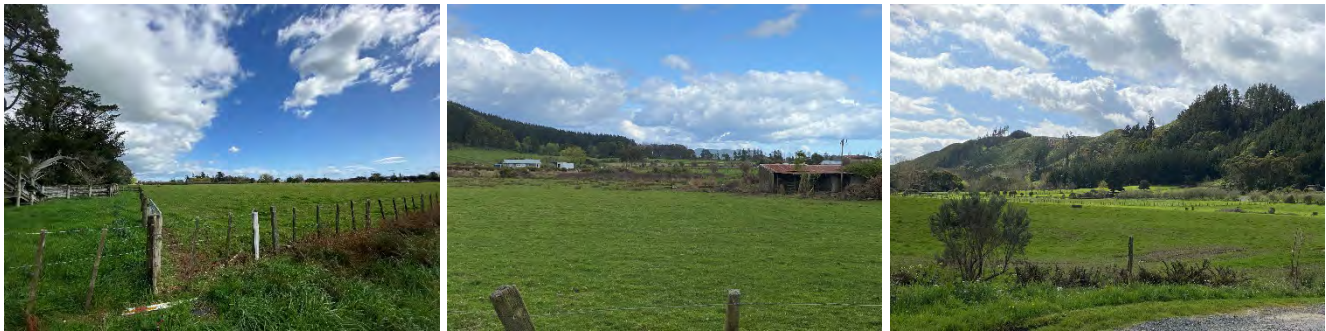
This overview of the route confirmed its general land use as agricultural or horticultural land (Figure 6 and Figure 7). There are a number of rural properties and outbuildings within the Project designation boundary or close by (Figure 8) and the route crosses a number of local roads.

Figure 6 Farm and pastoral land

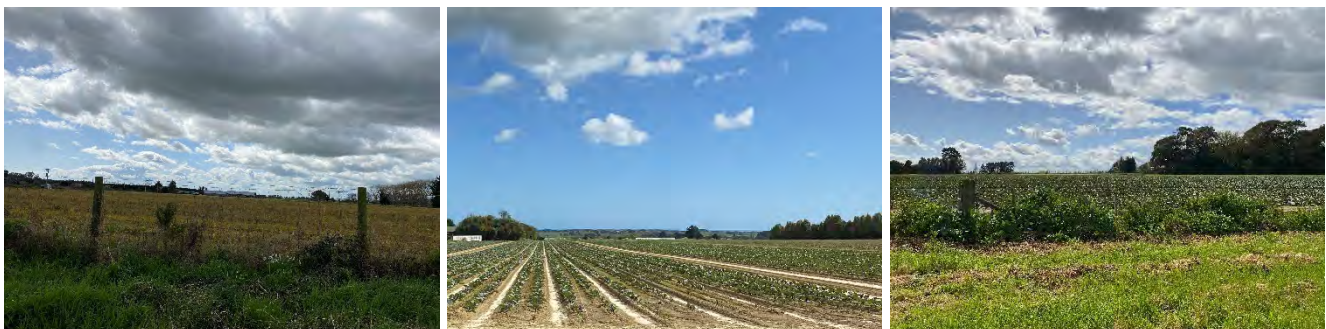
Figure 7 Market Gardens, orchards, berry farms and horticultural land

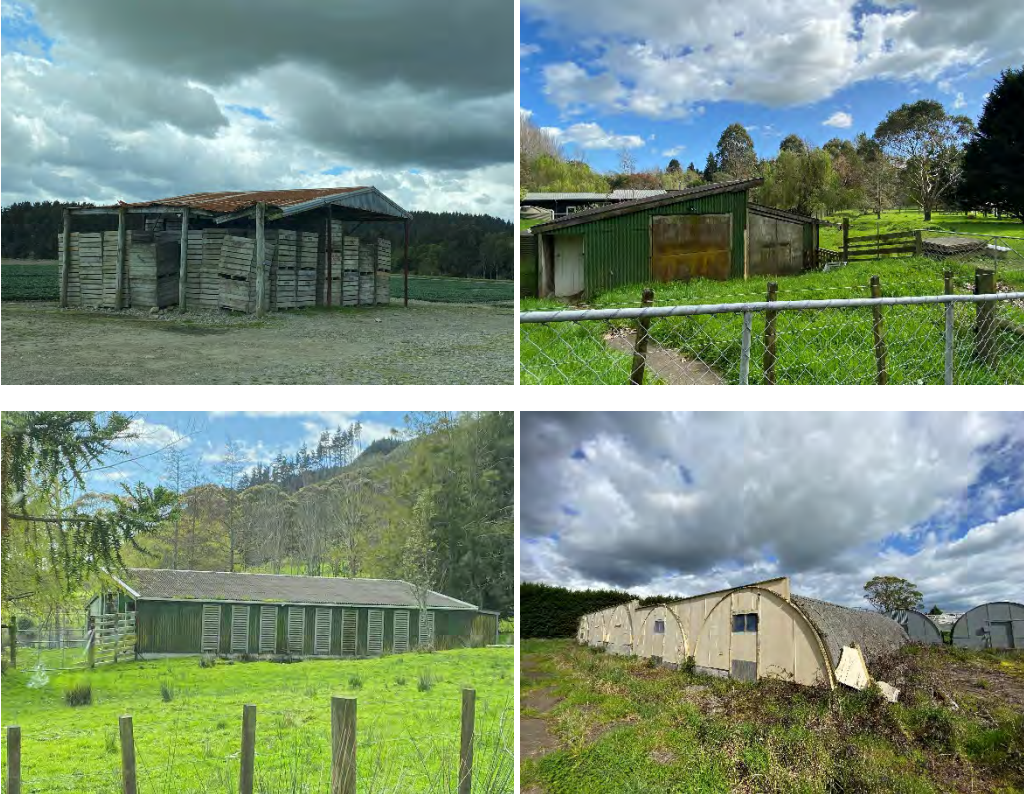
Figure 8 Various buildings located within the Ō2NL Project designation

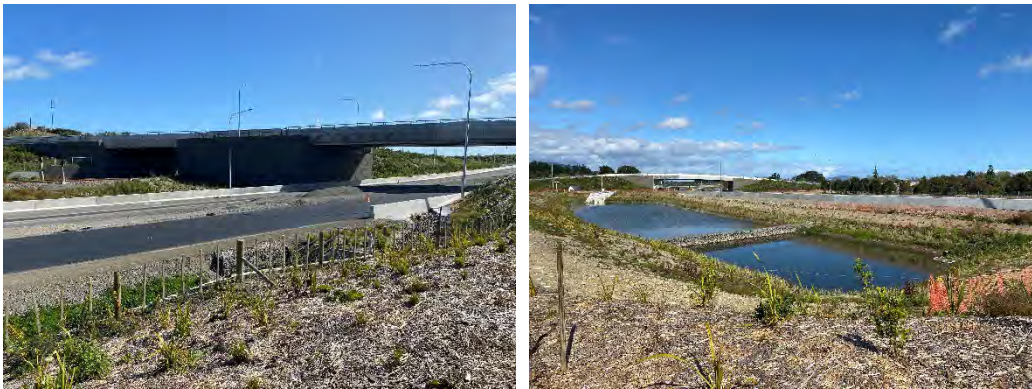
The new road will connect to the current State Highway road improvements being completed south of Ōtaki and have similar features and stormwater management systems (Figure 10).

Figure 10 New State Highway being completed south of Ōtaki

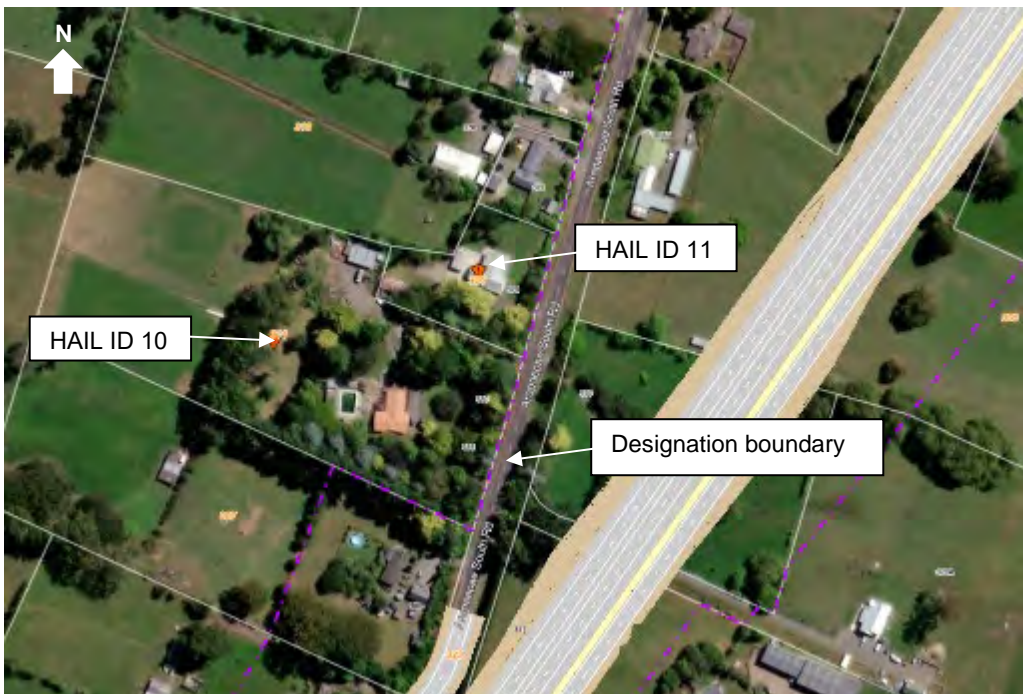
Figure 11: HAIL sites at 378 and 380-386 Arapaepae Road

The HAIL sites at 378 and 380-386 Arapaepae Road, Levin (Figure 11) were noted as having fuel storage tanks present and therefore the potential for losses of petroleum hydrocarbon-based fuels associated with refuelling of farm vehicles to be present within soils. These sites are outside the proposed designation and hydraulically downgradient in terms of groundwater flow direction and therefore the direction of possible contamination migration from any of these known sites is likely to be away from the proposed works. The likelihood of encountering petroleum hydrocarbons contaminants from these two HAIL sites as part of the works is therefore considered to be low.

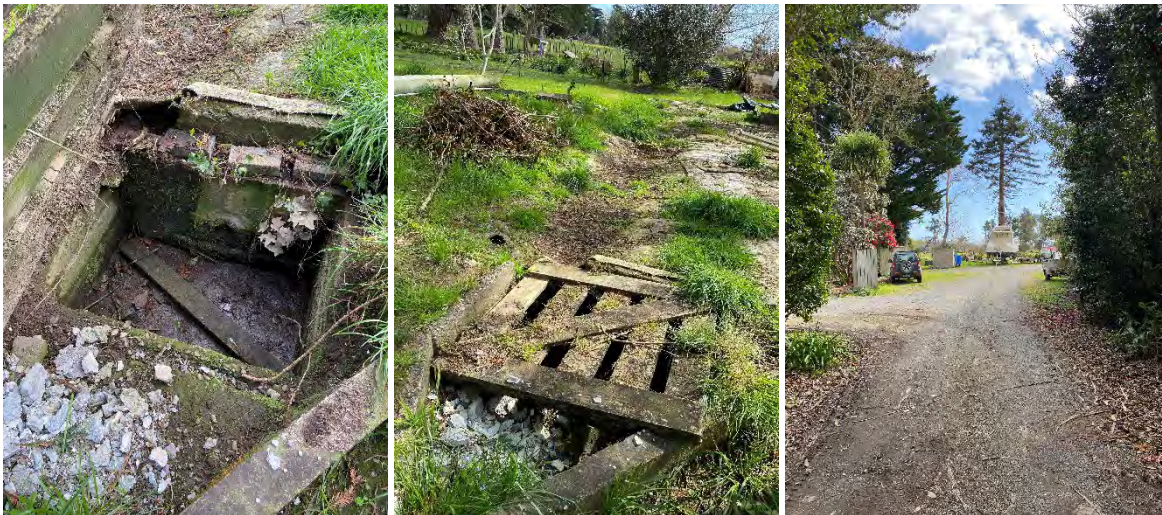
Figure 13 Sump and soak away area at 380-386 Arapaepae Road (HAIL ID 10)

The tanks at 380-386 Arapaepae Road were determined to be no longer present. The tenant was present at the site at the time of the inspection and confirmed that the fuel storage was associated with a machinery building that used to be located in the northwest corner of the property. The tenant located an old sump (Figure 13) and soak away area which he believed drained the machinery area. The sump outlet drained in a northern direction and away from the Ō2NL Project designation area.

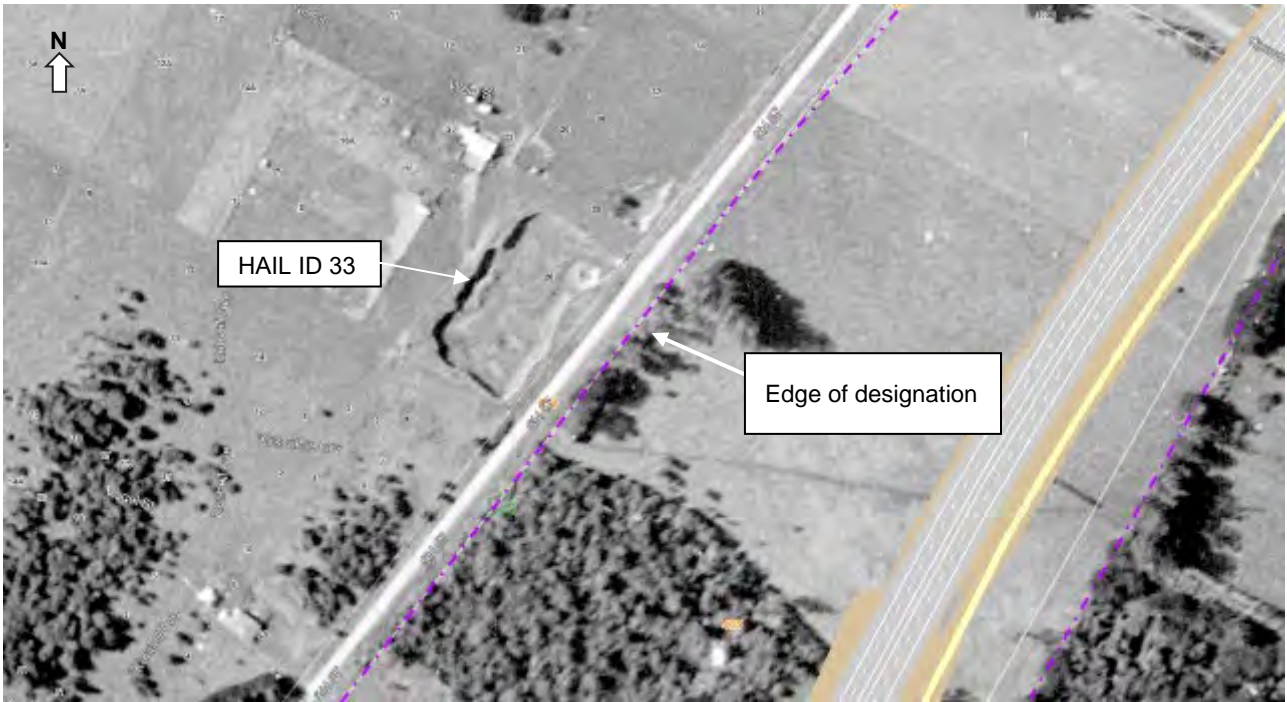
Figure 14: HAIL Site 26 Arapaepae South Road (source Retrolens imagery 1940)

26 Arapaepae South Road Levin was recorded to be the location of a historic landfill site ((HAIL ID 33 on maps in Appendix C). There are no Council records of the age of the landfill, the quantity of material that may have been deposited here or its composition. There is an area of low ground observed in a 1940 aerial photograph (Figure 14) which is subsequently filled, and a dwelling is located on the site in the 1970s. The HAIL site is outside the proposed designation boundary and hydraulically downgradient of the works and will not be disturbed as part of the works.

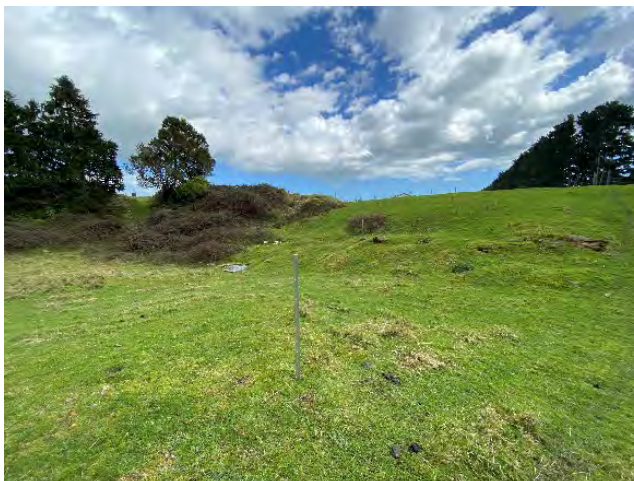
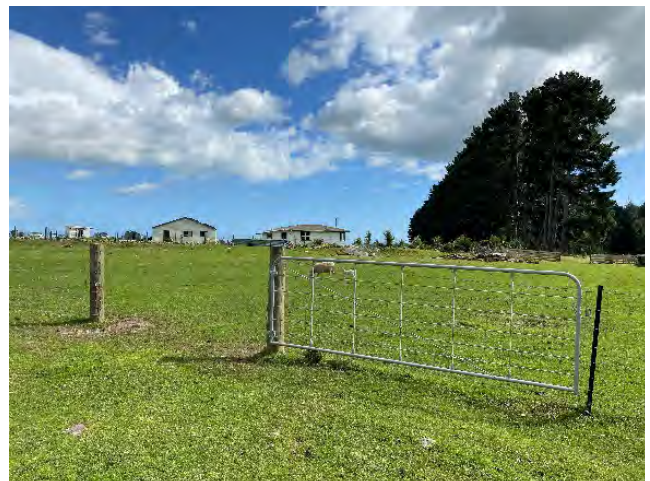
Mr Bolton also noted that the cap was very thin in places and metal could be seen at the toe of the landfill. He currently has sheep grazing the site and has an air rifle shooting range set up on the lower area of the property. Current photographs taken on 16 September 2022 are presented in Figure 18 and Figure 19.

Landfill face

Top of landfill, view west

Figure 18 Closed Landfill located within 13 North Manakau Road

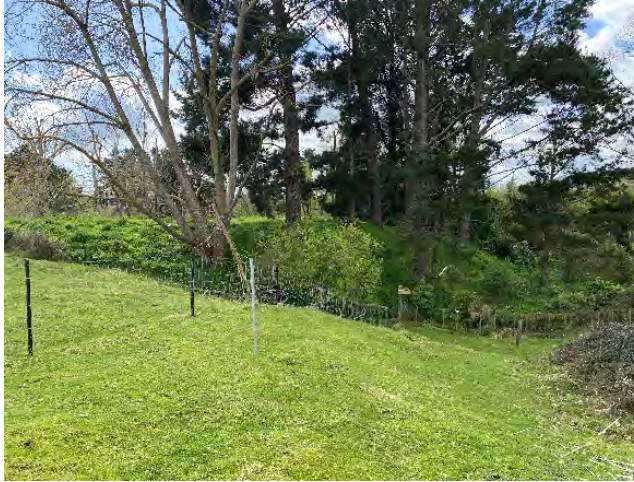
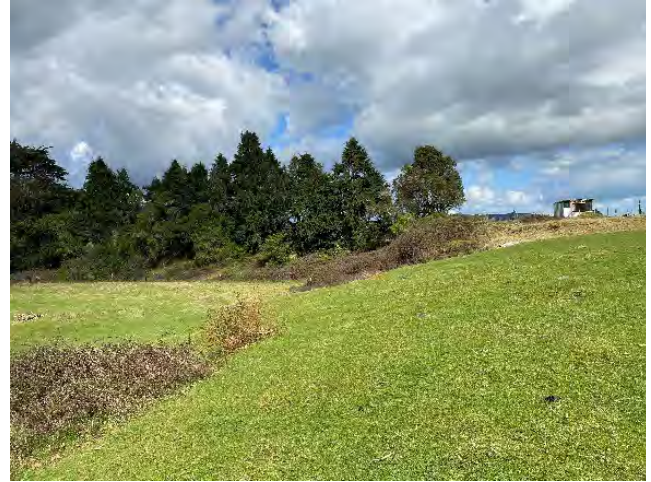
Toe of landfill, view north

Toe of landfill, view south

Figure 19 Closed Landfill toe, 13 North Manakau Road

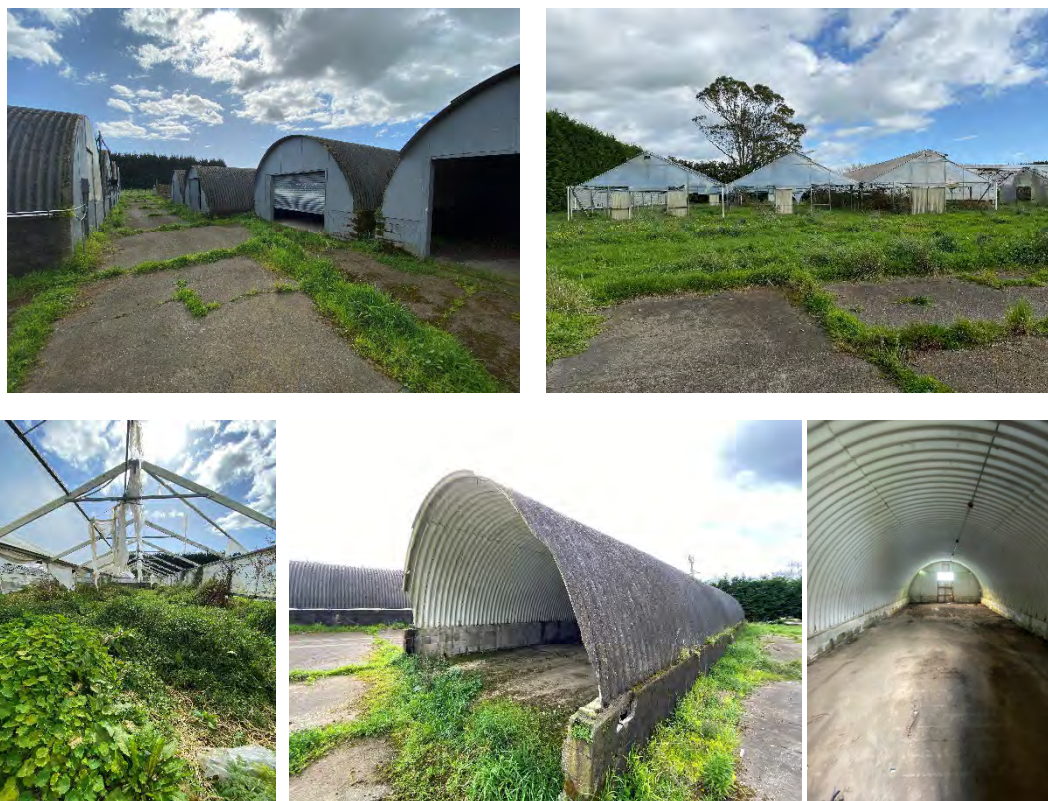
Figure 20 Out buildings located at 101 Waihou Road, Levin

Based on the observations on site there is potential for the roofing of some of these outbuildings to contain asbestos. A sample of the roofing material was taken during the site visit and sent to Hills Laboratories, an accredited lab, to confirm the presence or absence of asbestos. The analysis report identified the roofing material as fibre cement and detected the presence of Amosite (Brown Asbestos), Chrysotile (White Asbestos) and Crocidolite (Blue Asbestos). While left undisturbed the asbestos remains bound within the corrugated asbestos cement roofing material. A licensed asbestos removalist will be required to manage the removal and disposal of these buildings appropriately. This property will also require further DSI once the buildings are removed to confirm any residual levels of contaminants within the soils, including asbestos.

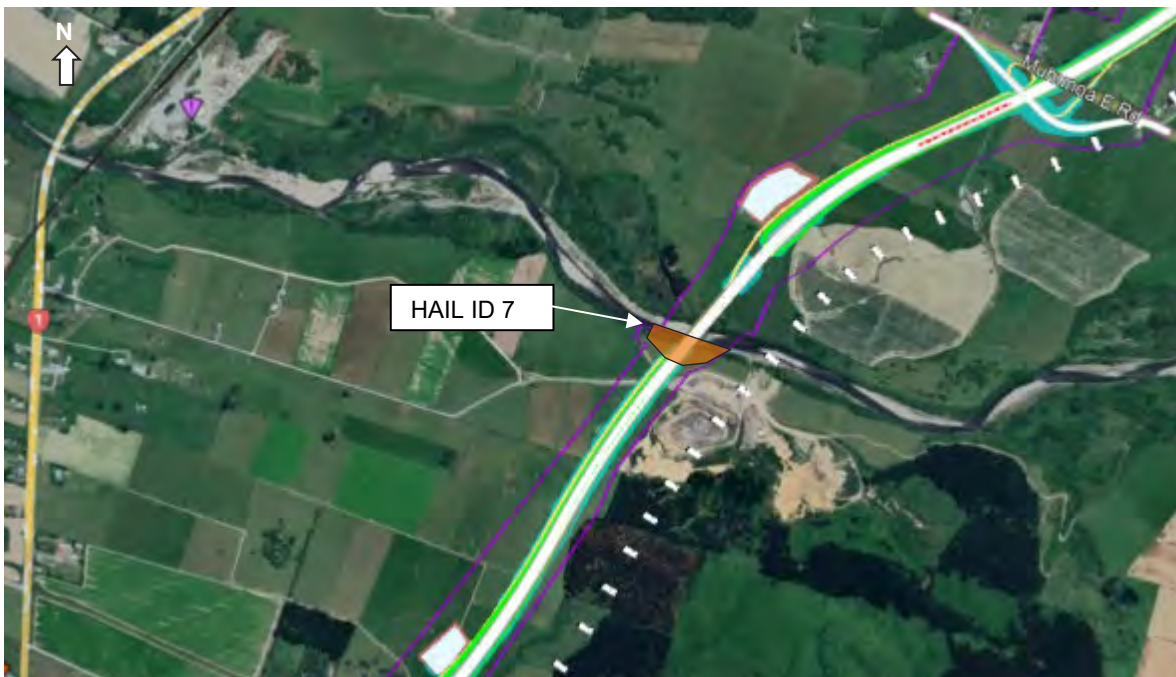
Figure 21: Location of historic landfill within the southern approach to the Ohau River bridge

This site is not on the Council HAIL records. There is no evidence within the historical photos available that show ground disturbance at this location other than for quarry operations. The riverbed can be observed across part of the site in 1940 as the river meandered naturally.

Further investigations of this location were undertaken as part of a geotechnical and contamination assessment in 2021. A summary of the findings is provided in section 3.2 below. The investigation report is presented in Appendix H.

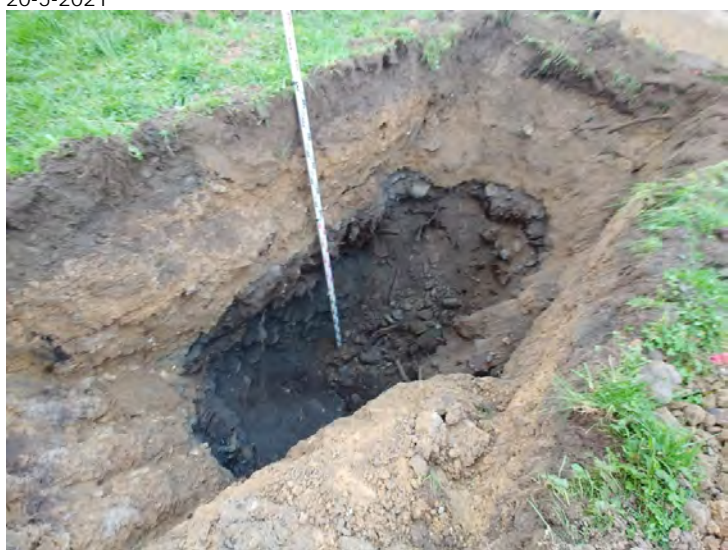
TP235 - Ohau Quarry
 20-5-2021

TP encountered household refuse (mattresses, pipes, fabric) along with green waste (stumps, cut branches) from ~1m to ~2m. Refuse was covered in gravelly clay FILL.

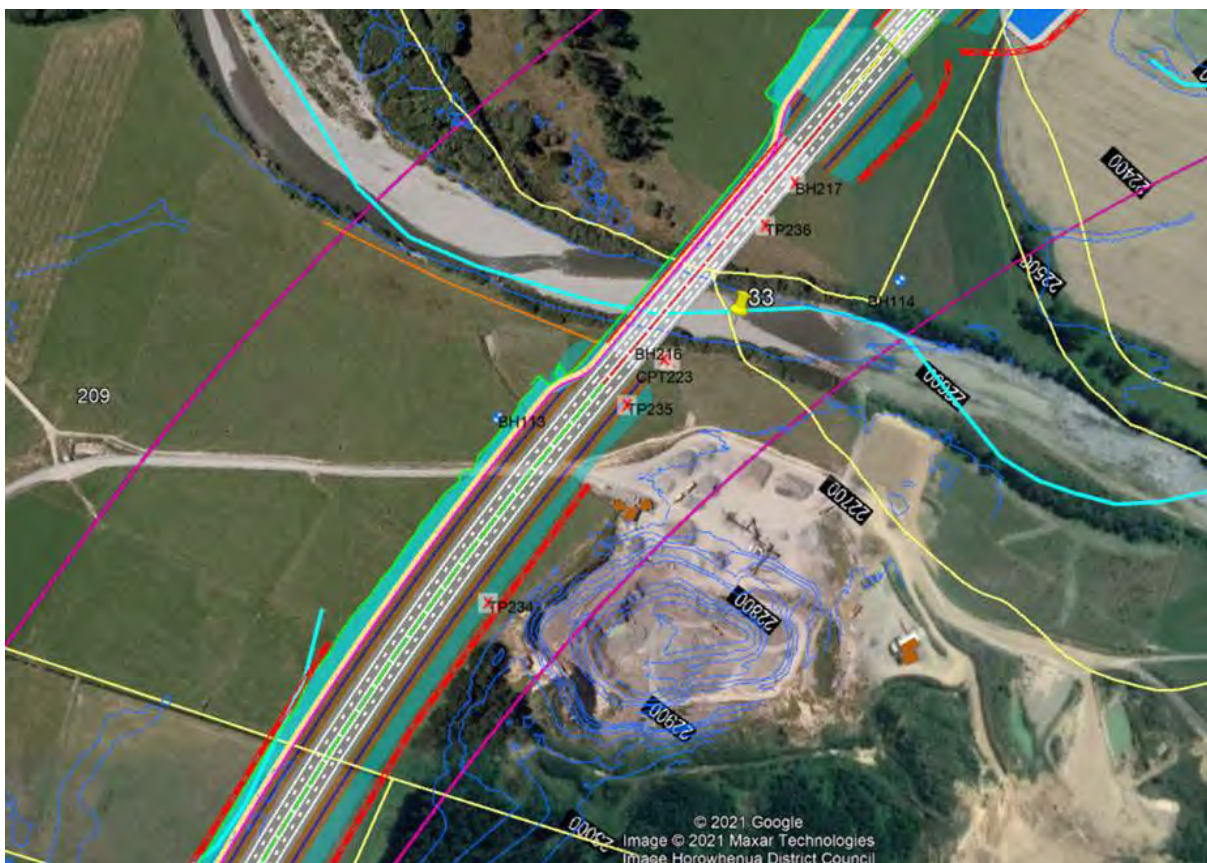
Figure 1-1 Depiction of where the draft alignment for the project intercepts with the potential historical landfill suspected near the south bank of the Ōhau River

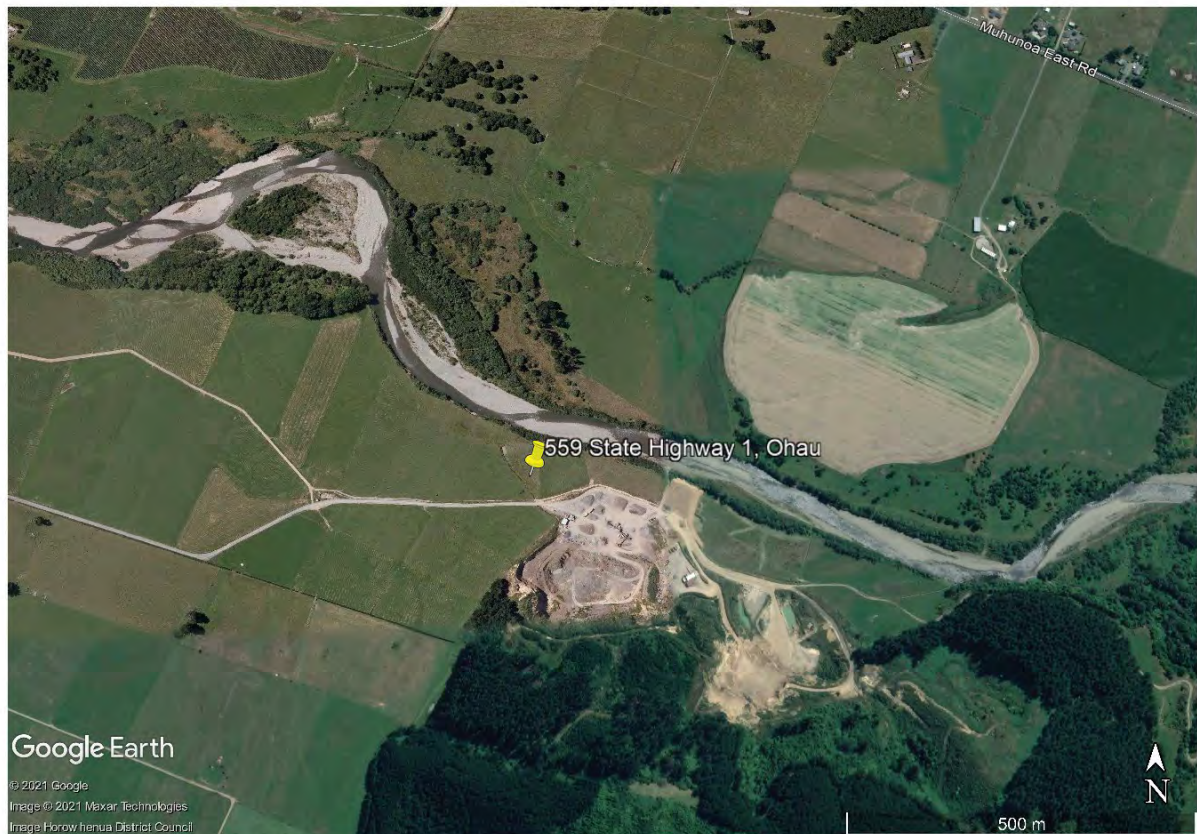
Figure 1-2 Location of sampling sites on the south bank of the Ōhau River

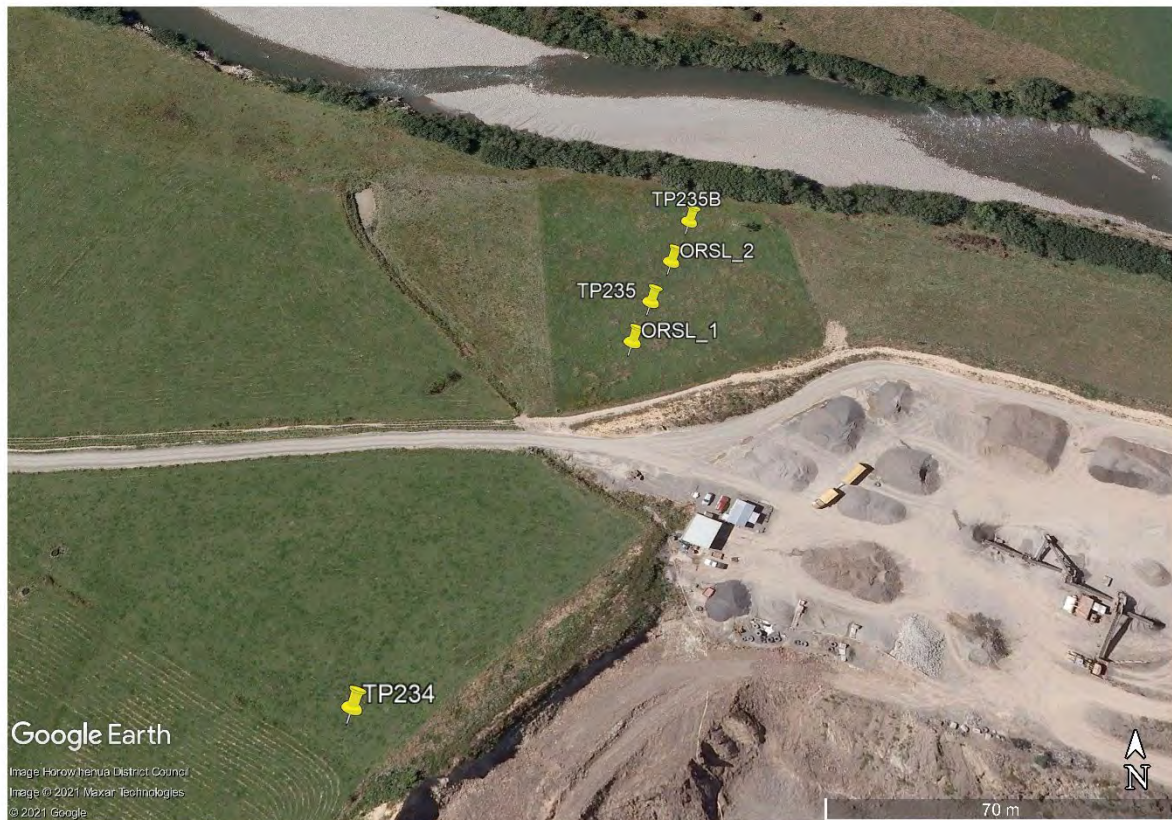
Figure 1-3 Locations of individual samples

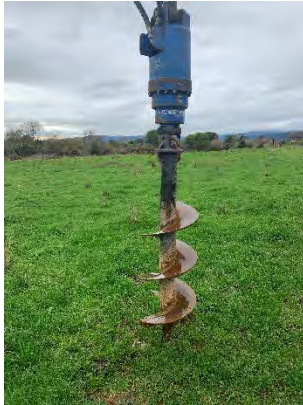
Left image: Clean drill before sampling ORSL1

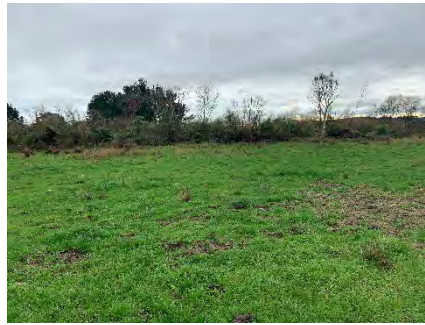
Middle image: Paddock where all samples except TP234 were taken. This is on farmland beside Webb's quarry

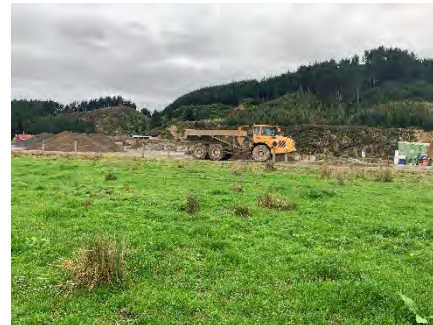
Right image: Webb's quarry beside sampling sites

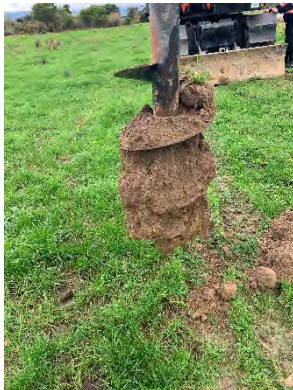
Left image: Site ORSL_1 at 0.4 m depth. The soil is similar in colour throughout.

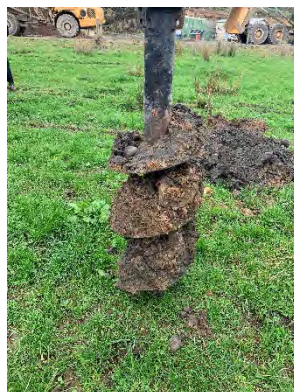
Middle image: Site ORSL_1 at 2 m depth shows a darkening of the soil indicating the presence of disposed material.

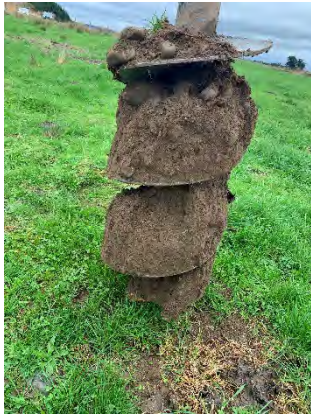
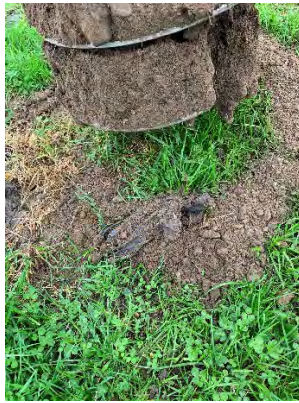
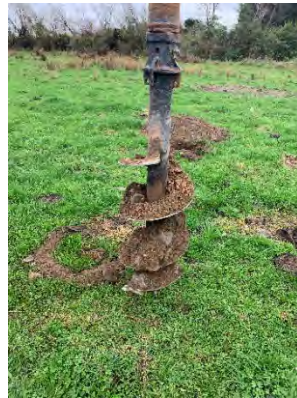
Left image: Site ORSL_2 at 0.5 m depth shows similar soil throughout suggesting it has not been disturbed previously.

Right image: Site ORSL_2 at 2 m depth shows similar soil throughout.

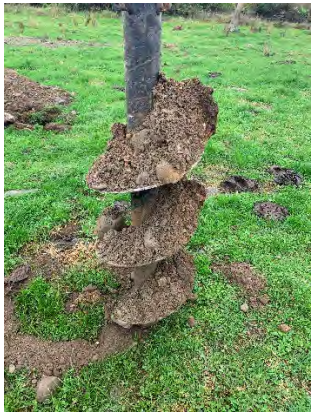
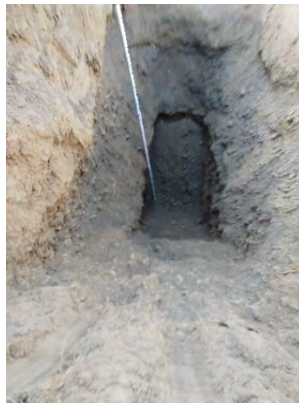
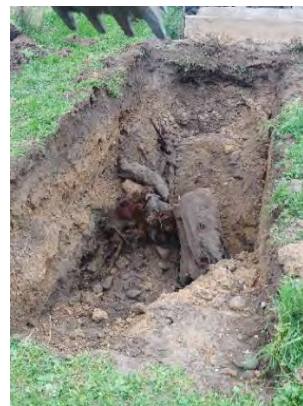
Left image: Site ORSL_2 at 3.5 m depth. No rubbish is seen in the drill flights and the soil is similar throughout suggesting it has not been disturbed.

Right image: Site TP235 showing rubbish found.

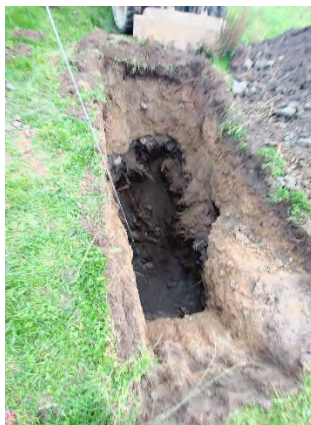
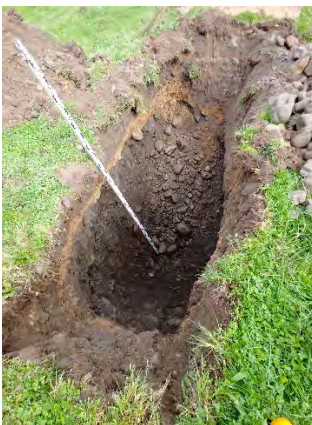
Left image: Site TP235 showing a sudden change in soil colour indicating there may have been disturbance at some point in time.
