State Highway 1 and State Highway 29 Intersection Upgrade

Draft Bat Management Plan

9 November 2021

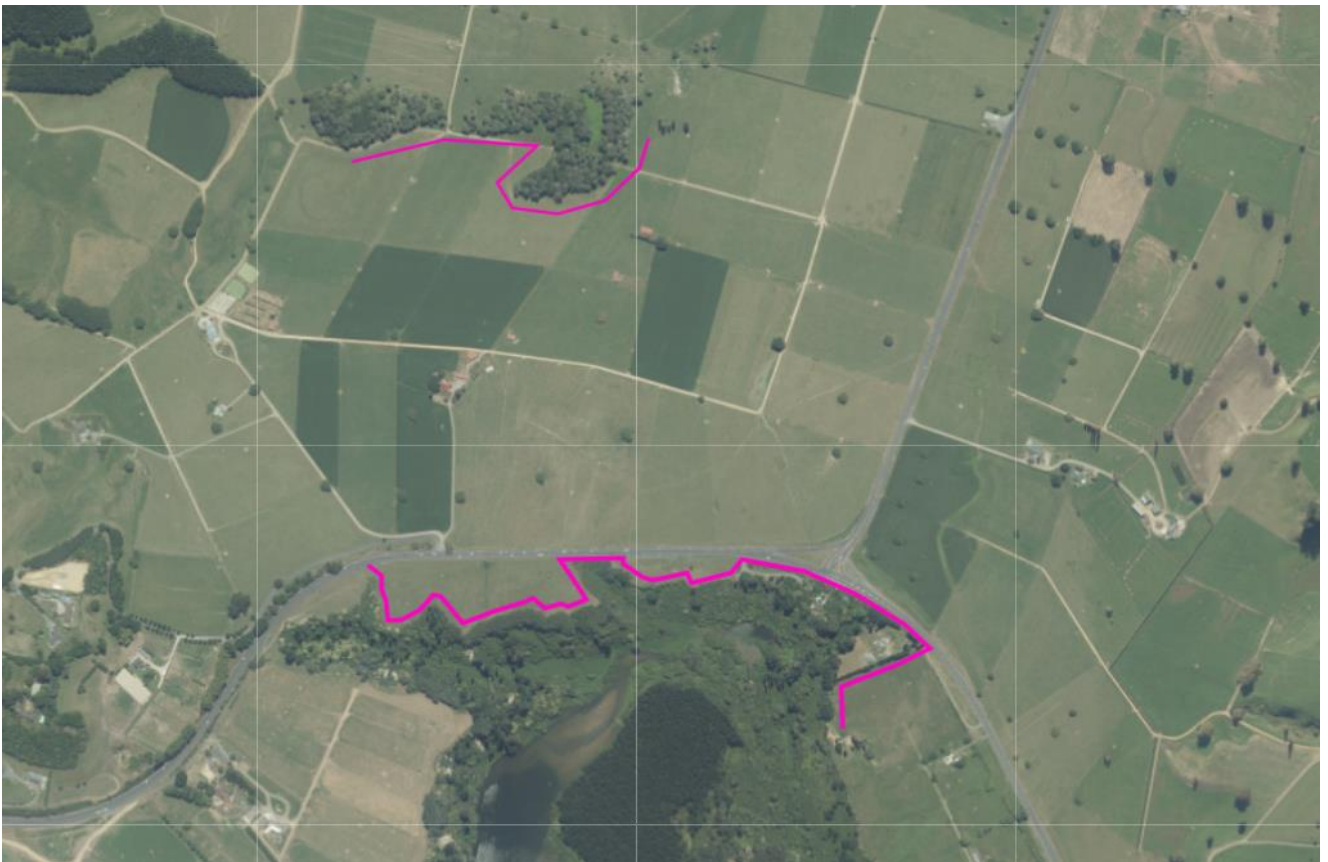
Figure 1. Key bat habitats where light levels will not exceed 0.3 Lux.

- Luminaires shall produce no direct upwards light;
- Luminaires shall have a maximum colour temperature of 2700K (white); and
- Light levels on the boundary of key bat habitats (as presented in Figure 1) will not exceed 0.3 Lux.
