Performance of Linkage Bars for Restraint of Bridge Spans in Earthquakes

New Zealand Transport Agency

Consultancy Services Contract Number: NO 09-554

Final Revision: 20 March 2012

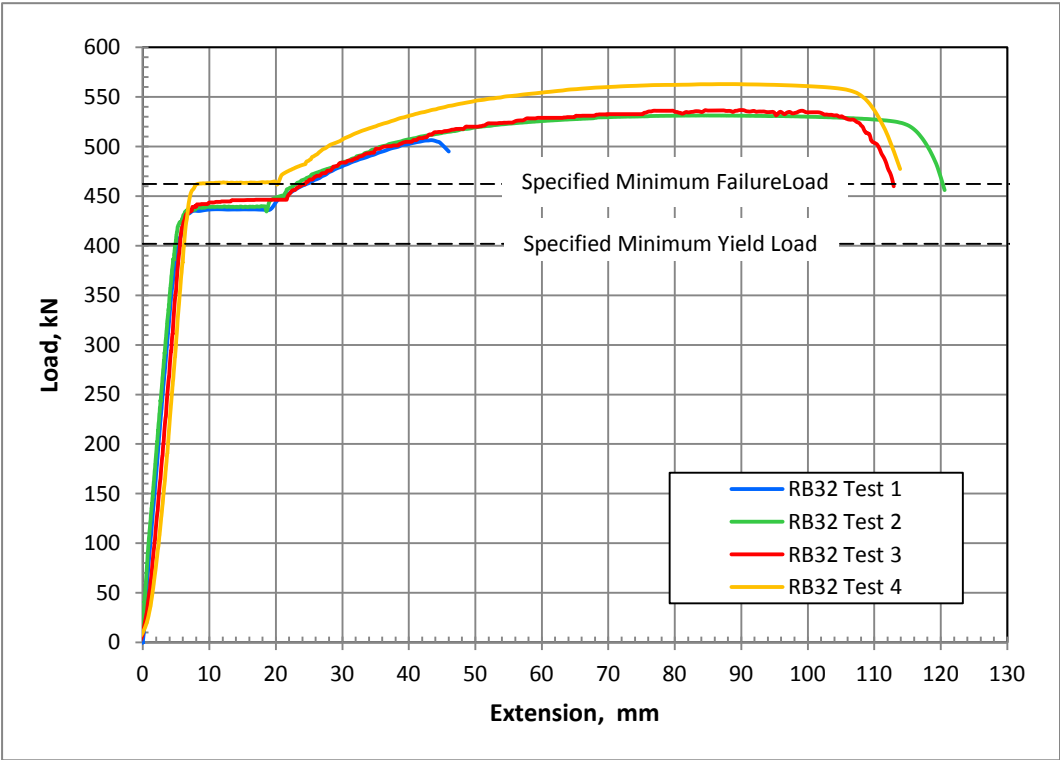
Figure 7. Load versus extension plots for Reidbar RB32 assemblies.

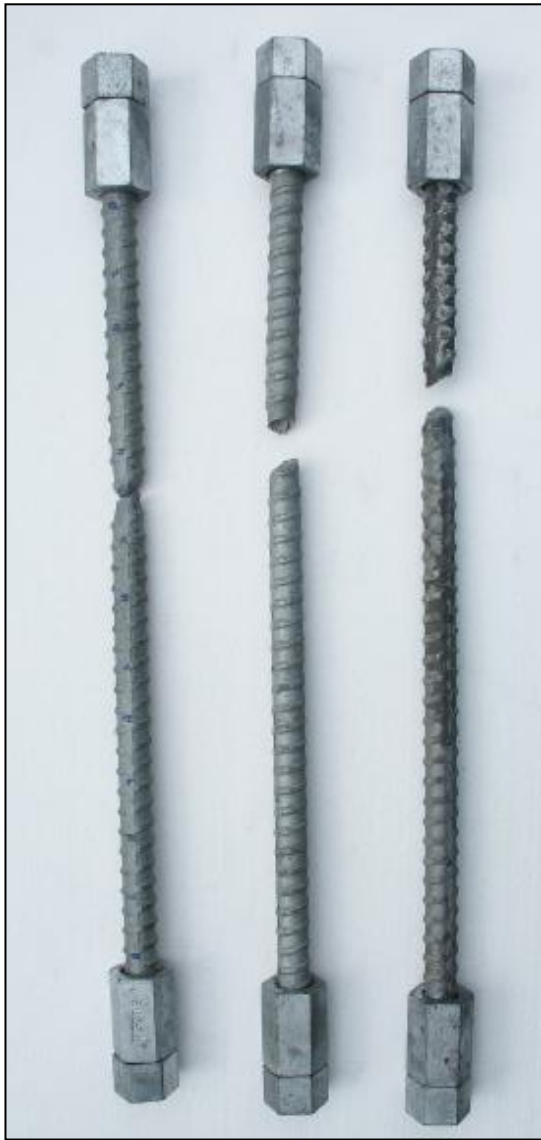
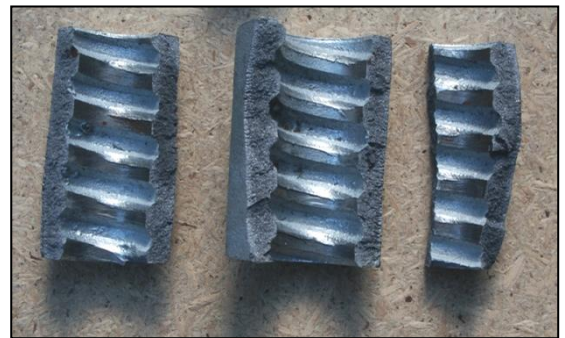
Figure 8. Failure locations in Reidbar RB32 bars (left) and in the nut (Test 1) (above).

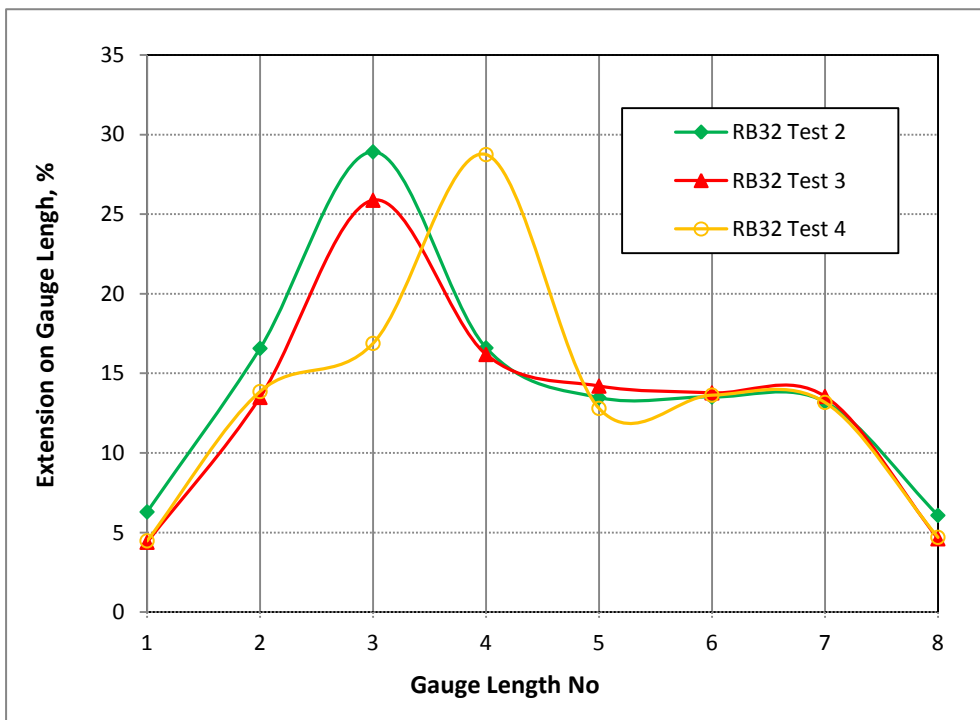
Figure 9. Elongations on Reidbar RB32 gauge lengths.

Plastic elongations measured on the eight nominally 100 mm gauge lengths are plotted in Figure 9 for the final three tests. As shown in Figure 1, Gauge Lengths 1 and 8 were within the sections covered by the nuts. Significant elongation occurs over the total length between the nuts with typical values of 14% on five of the six gauge lengths outside the nut lengths. In the gauge lengths that necked-down and failed the elongation reached between 26% and 29%. Yielding following by strain hardening (see Figure 7) in the failure section results in significant plastic elongation spreading over most of the loaded length.

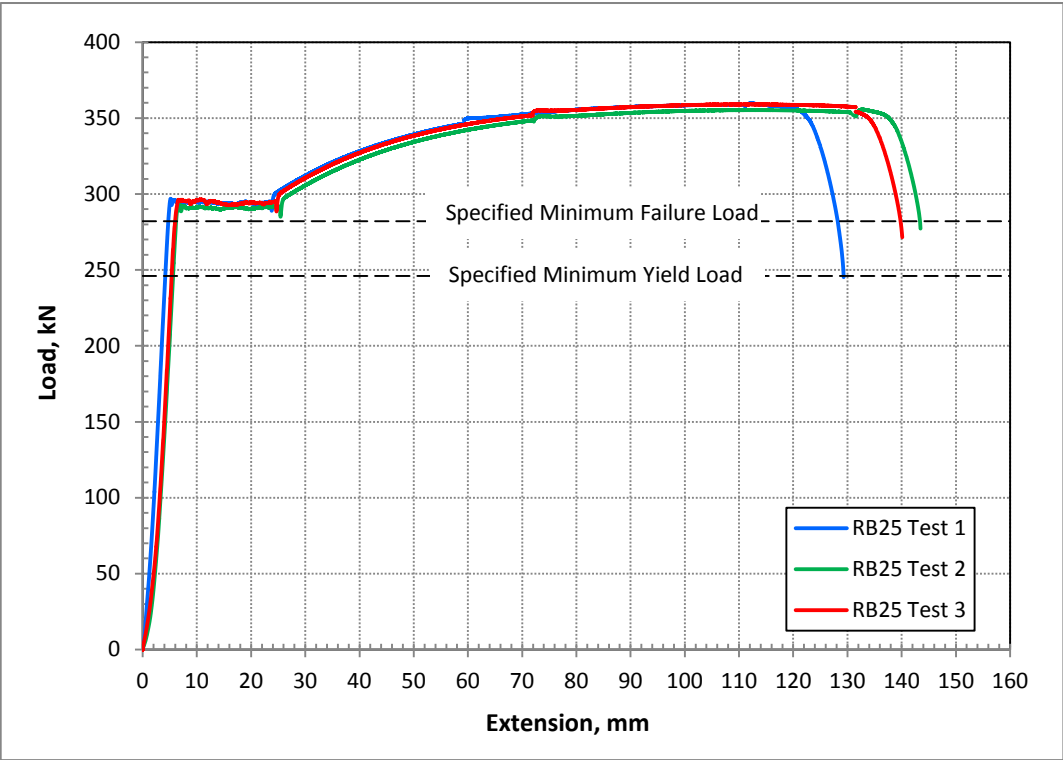
Figure 10. Load versus extension plots for Reidbar RB25 assemblies. Minor unevenness in curves at extensions greater than 58 mm resulted from unloading and reloading to extend the extension range of the jack extension

The total plastic elongation (including elongation under nuts) expressed as a percentage of the loaded lengths varied from 14% to 16%. For the RB32 bars this plastic extension was a little greater at 17% to 18%. However, the loaded length for the RB32 bars was 620 mm which was significantly shorter than the 880 mm length used for the RB25 bars.

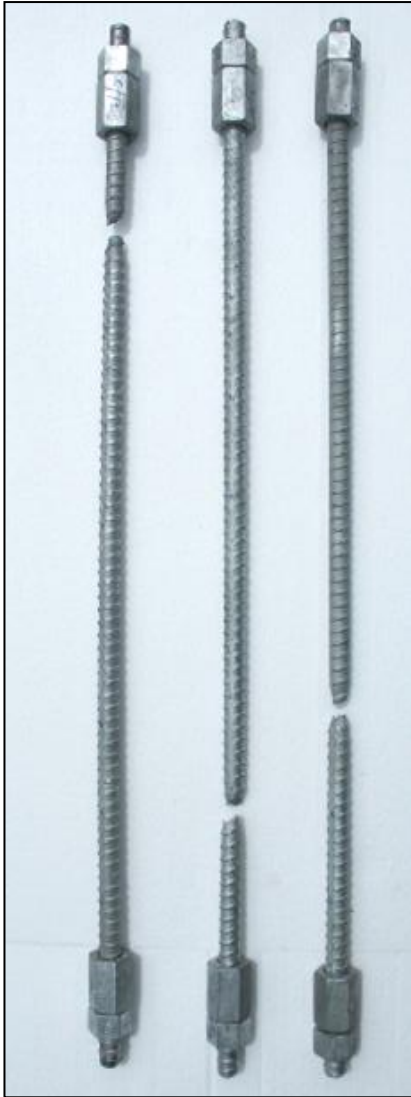
Figure 11. Failure locations in Reidbar RB25 bars.

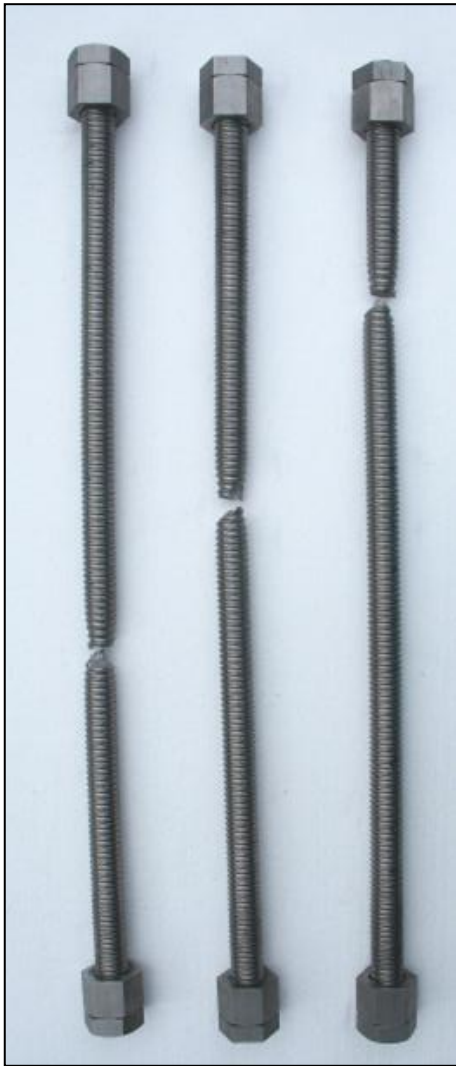
Figure 14. Failure locations on Macalloy MS32 bars.

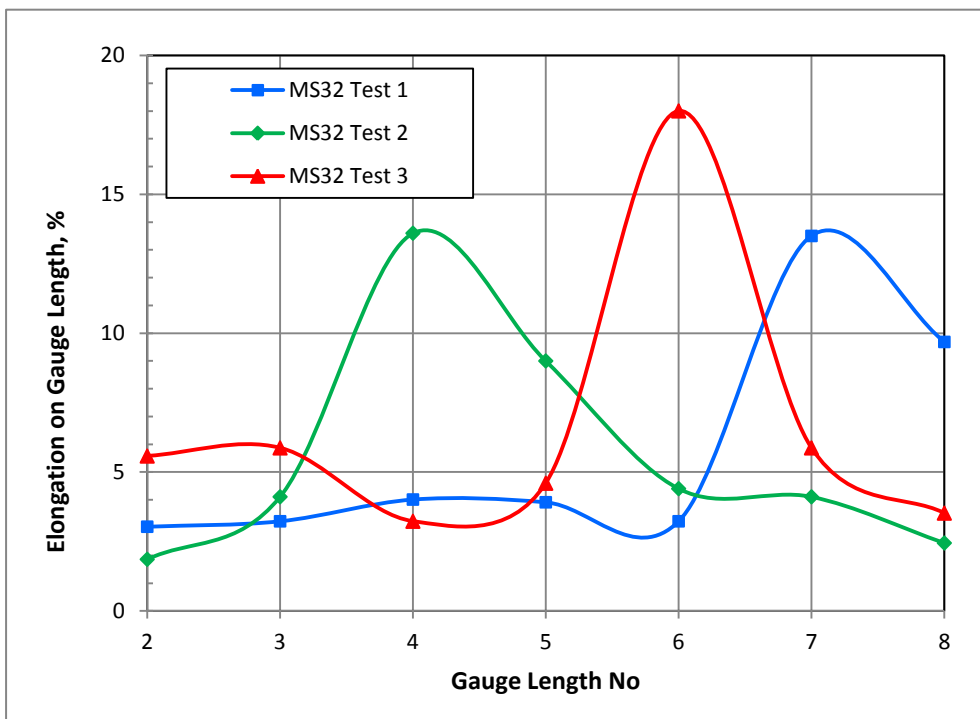
Figure 15. Elongations on Macalloy MS32 gauge lengths.

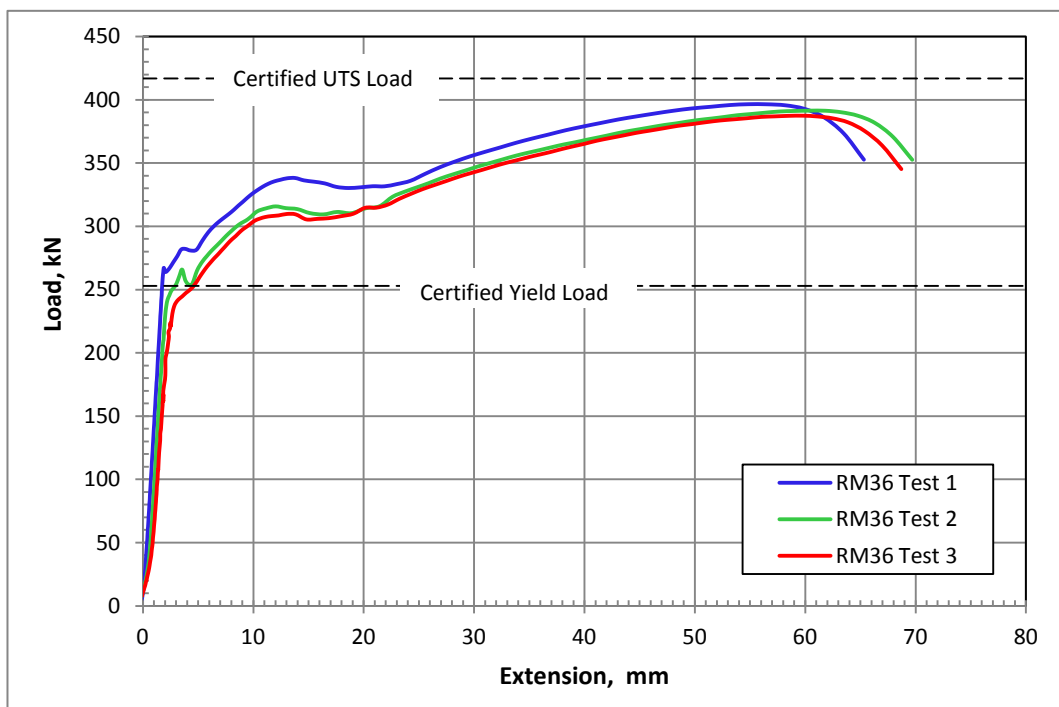
Figure 16. Load versus extension plots for Round Galvanised Mild Steel RM36 assemblies.

Elongations of up to 33% occurred in the threaded failure sections. This elongation was similar to the percentage elongation on the unthreaded gauge lengths in the turned-down sections that failed in the TM30 assemblies (see Figure 33) indicating that the thread geometry did not reduce the elongation by a significant amount. The minimum total plastic elongation (including elongation under nuts) expressed as a percentage of the loaded lengths was 7.9%.

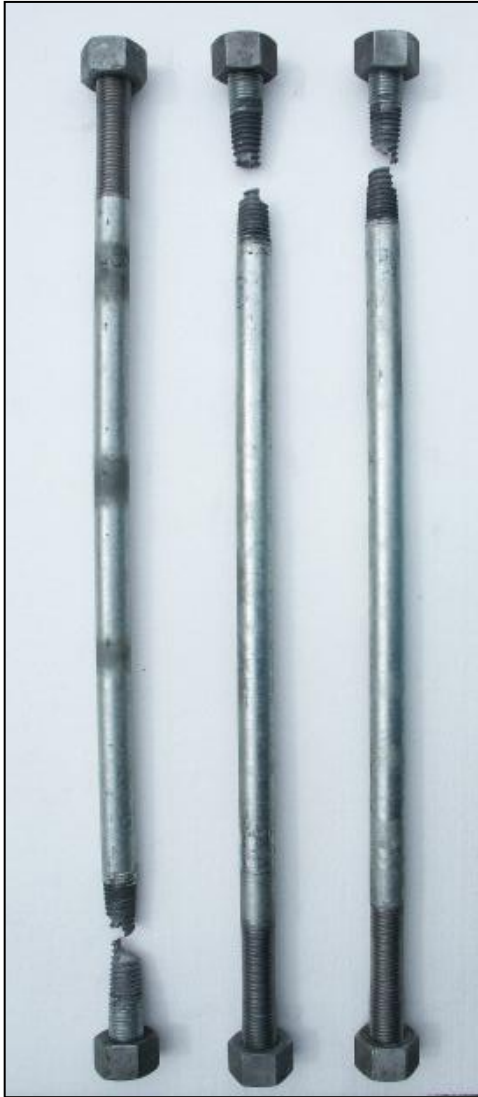
Figure 17. Failure locations on RM36 bars. During testing two nuts were used at either end.

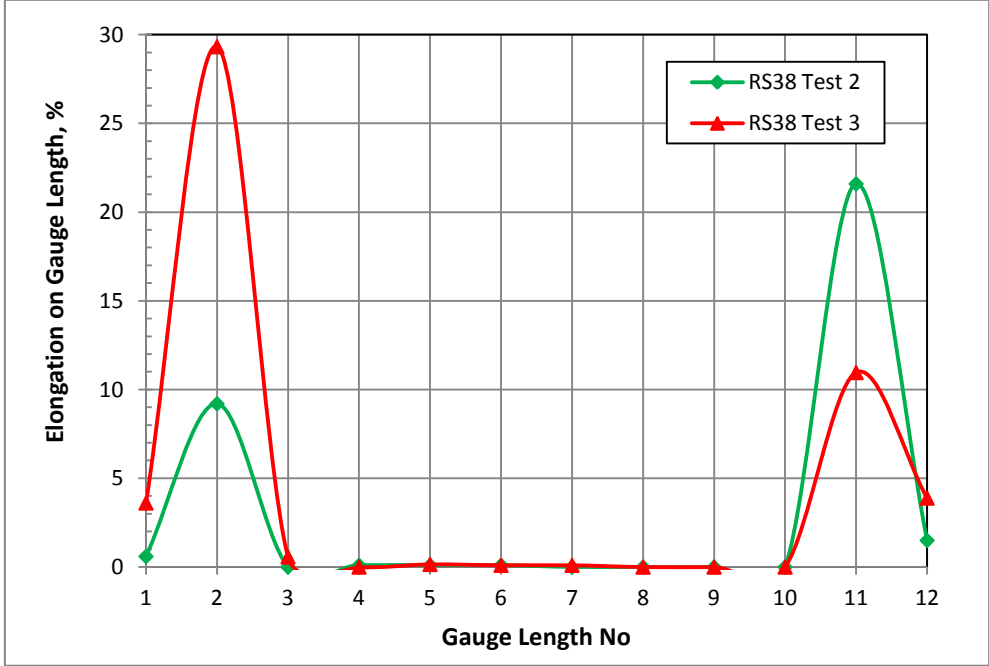
Figure 21. Elongations on Round Stainless Steel RS38 bar gauge lengths.

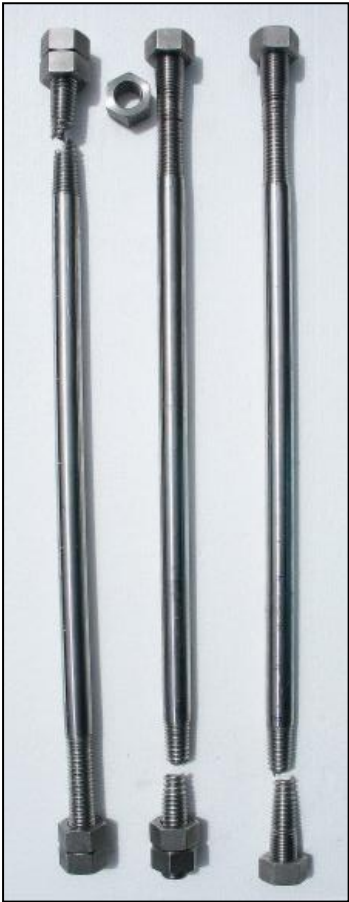
Figure 23. Failure locations on RS36 bars. All bars were tested with two nuts at each end.

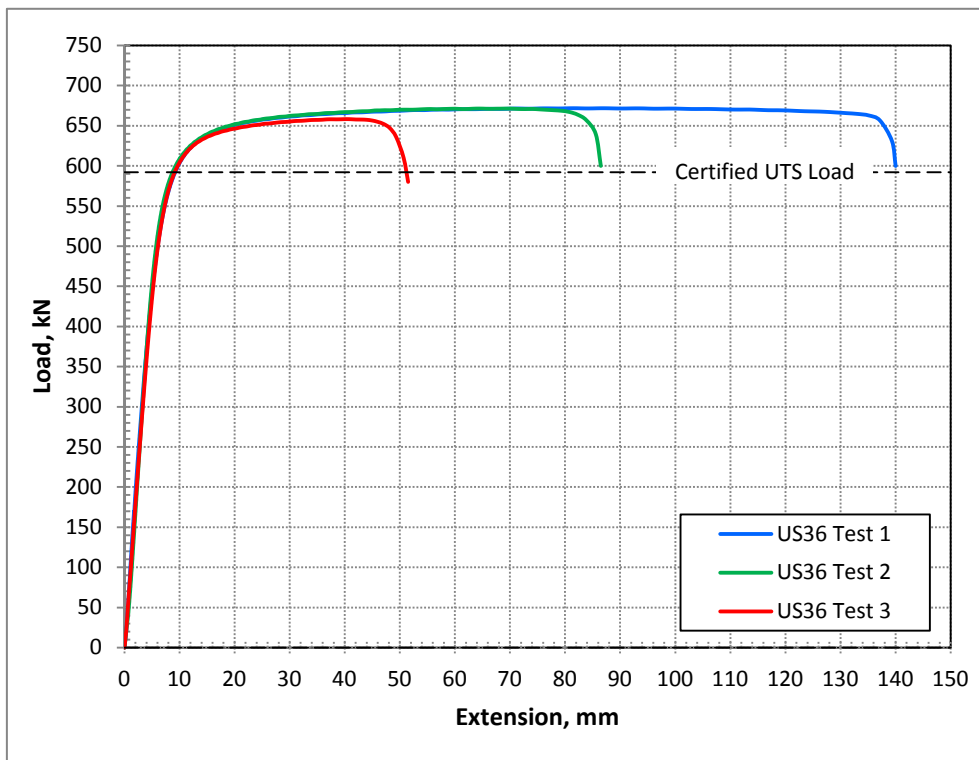
Figure 25. Load versus extension plots for Fully Threaded Stainless Steel US36 bar assemblies.

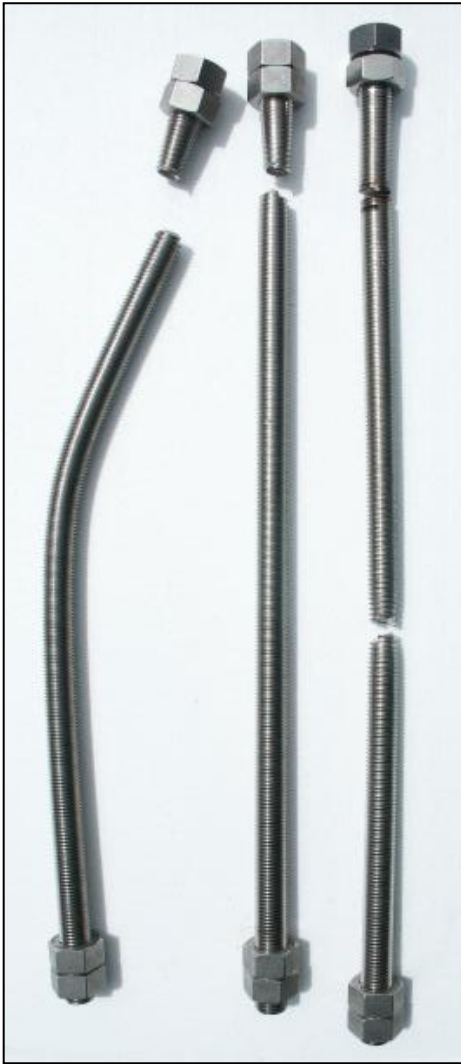
Figure 26. Failure locations on US36 bars.

The bar on the left (Test 3) was bent by a testing machine malfunction after the test was completed.

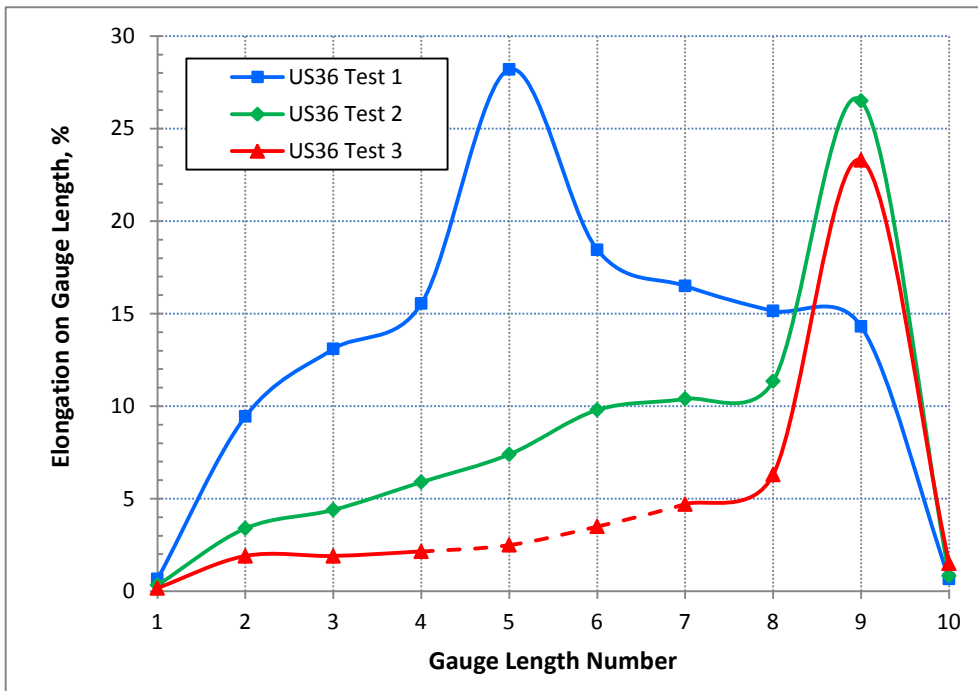
Figure 27. Elongations on Fully Threaded Stainless Steel US36 bar gauge lengths.

Plastic elongations measured on the 10 gauge lengths are plotted in Figure 27. As shown in Figure 1, Gauge Lengths 1 and 10 were fully within the sections covered by the nuts and locknuts. Elongations of up to 28% occurred in the failure sections. The test certificate did not provide elongation results so a comparison could not be made with the measured values. In Test 1, yield commenced near the centre of the bar with strain hardening spreading the plastic elongations in both directions to give a large total elongation. In the other two tests initial yield occurred near one end. This limited the length of spread of the plastic elongation resulting in much smaller total elongations. The minimum total plastic elongation (including elongation under nuts) expressed as a percentage of the loaded length was 5.8%.

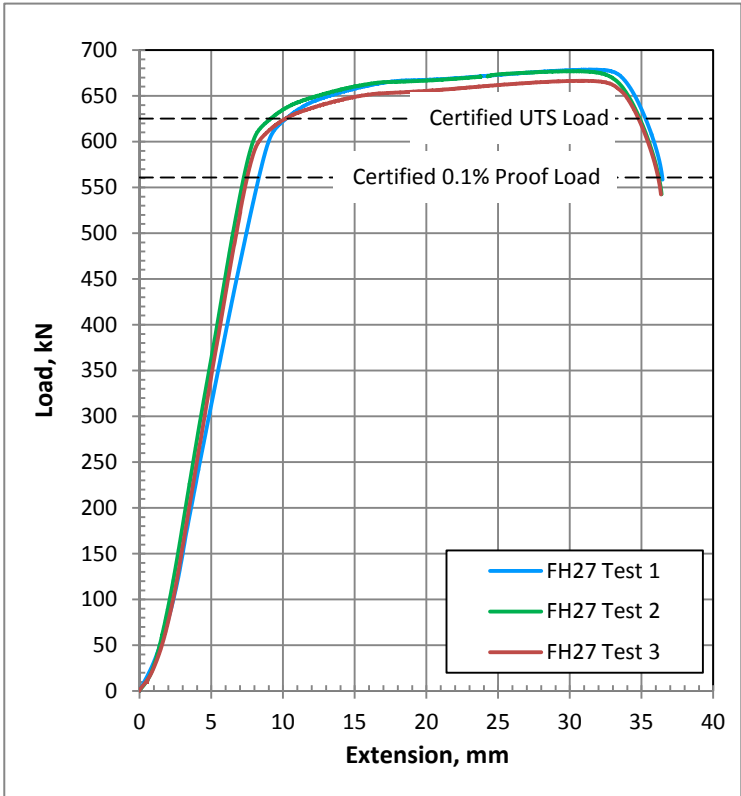
Figure 28. Load versus extension plots for Freyssibar FH27 assemblies.

Elongations of up to 10.5% occurred in the threaded failure sections. This elongation was significantly less than the 16.7% elongation given on the test certificate supplied with the bars indicating that the rolled threads may have caused some reduction in elongation. The minimum total plastic elongation (including elongation under nuts) expressed as a percentage of the loaded lengths was 3.3%.

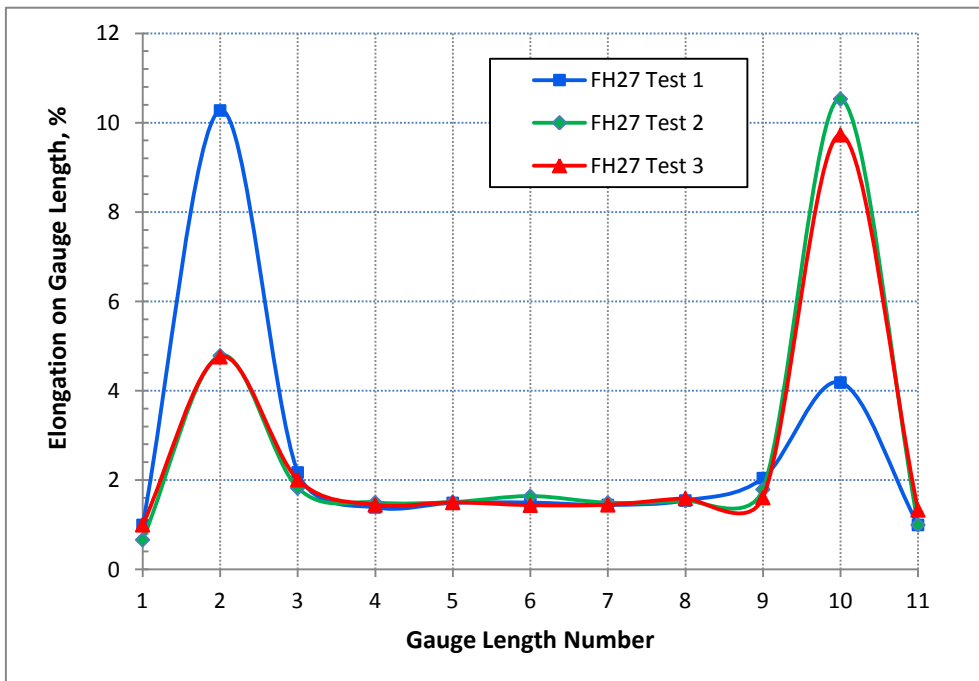
Figure 30. Elongations on Freyssibar FH27 bar gauge lengths.

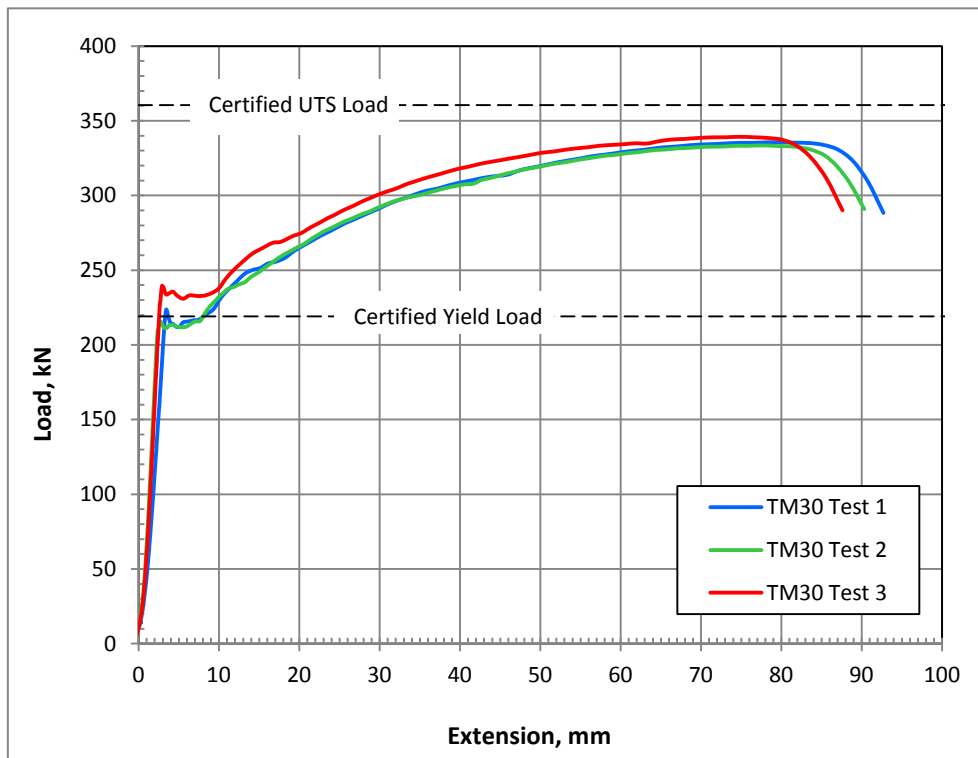
Figure 31. Load versus extension plots for Turned-Down Galvanised Mild Steel TM36 bars.

The results showed that plastic elongations of about 30% were available in the 100 mm gauge length that failed in the turned-down section. This is a little less than the 34% elongation given on the test certificate. The total elongation in the 300 mm long turned-down section expressed a percentage of the turned-down length was about 20%. The minimum total plastic elongation (including elongation under nuts) expressed as a percentage of the loaded lengths was 10.5%.

Comparison of Figure 31 (TM30 assemblies) with Figure 46 (TMO bars) illustrates the benefit of increasing the turned-down section from 300 mm to 650 mm in terms of increasing the total elongation. An elongation of greater than 13% occurred on each of the seven turned-down gauge lengths on the longer TMO assemblies. In comparison the elongation was greater than 15% on the three turned-down gauge lengths of the shorter TM30 assemblies. However, the total elongations of the shorter bars reached a minimum of 88 mm (compared with 144 mm for the TMO assemblies) which would be sufficient in most applications.

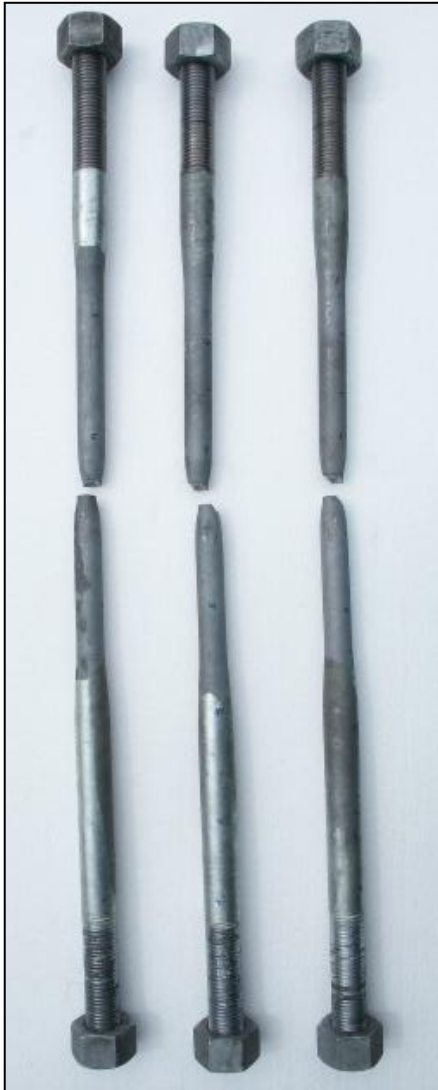
Figure 32. Failure locations on Turned-Down Galvanised Mild Steel TM30 bars. All bars were tested with two nuts on each end.

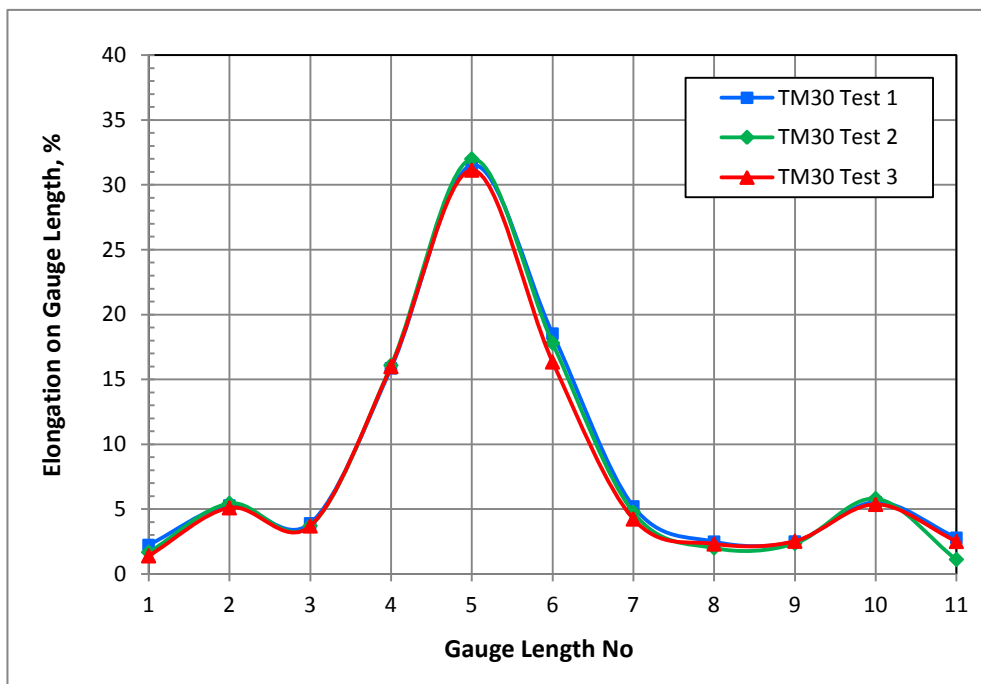
Figure 33. Elongations on gauge lengths for Turned-Down Galvanised Mild Steel TM30 bars. Gauge lengths 4, 5 and 6 were turned-down.

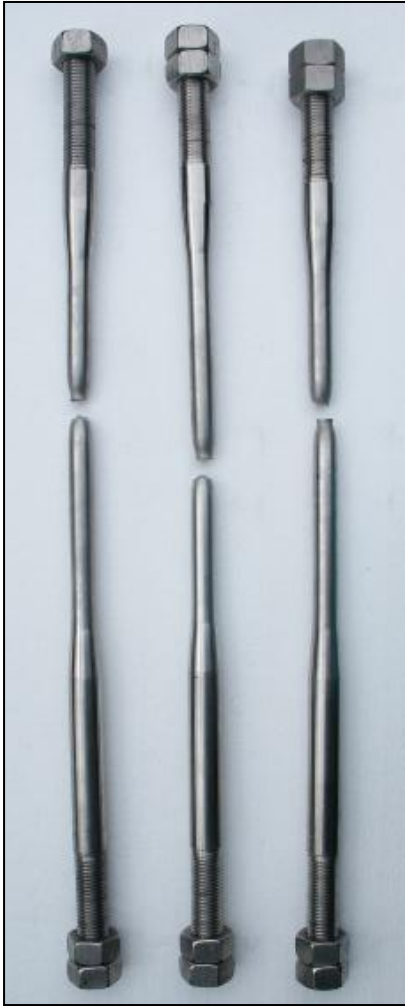
Figure 35. Failure locations on Turned-Down Stainless Steel TS30 Bars.

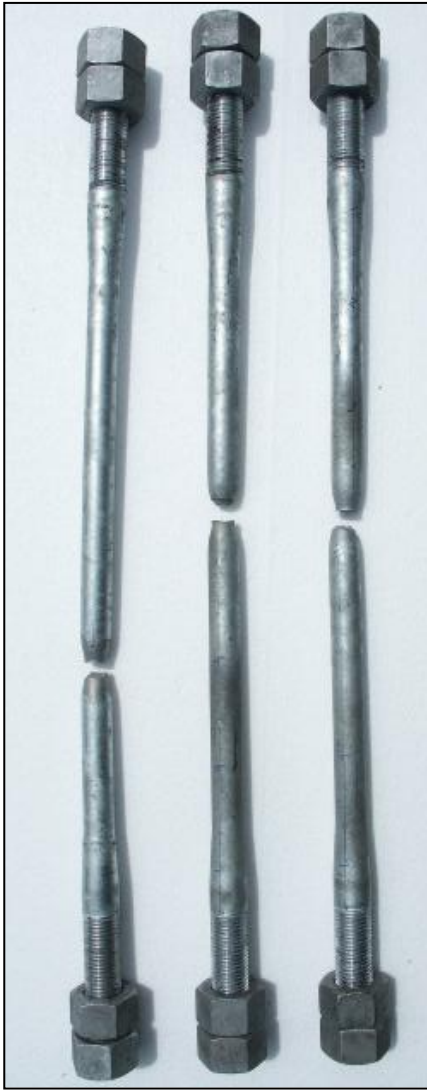
Figure 38. Failure locations on Turned-Down High Tensile Steel TH30 Bars.

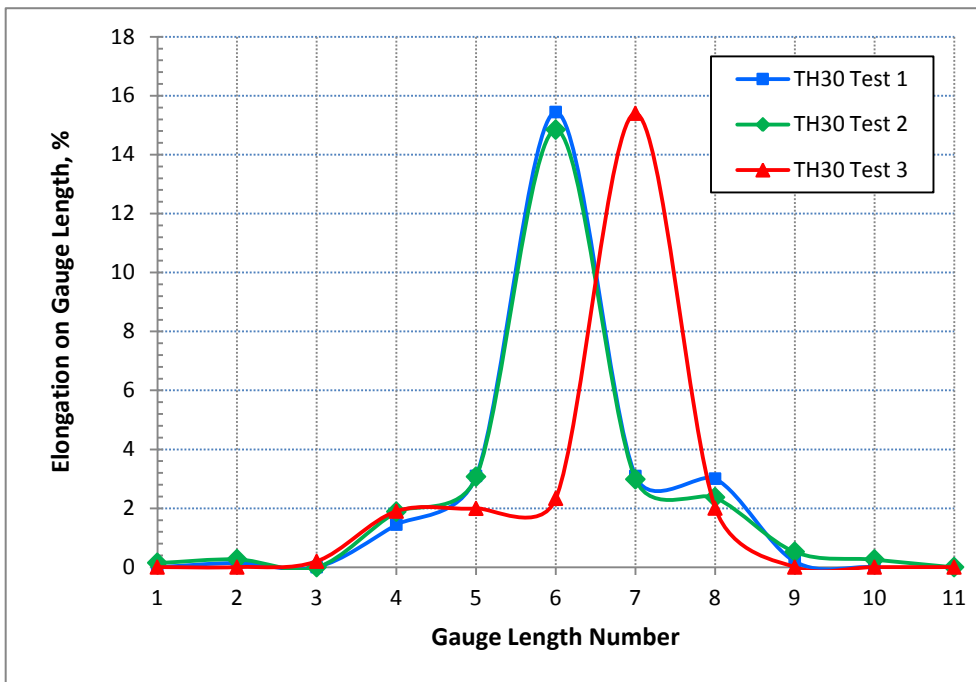
Figure 39. Elongations on Turned-Down High Tensile Steel TH30 bar gauge lengths. Gauge lengths 4 to 8 were turned-down.

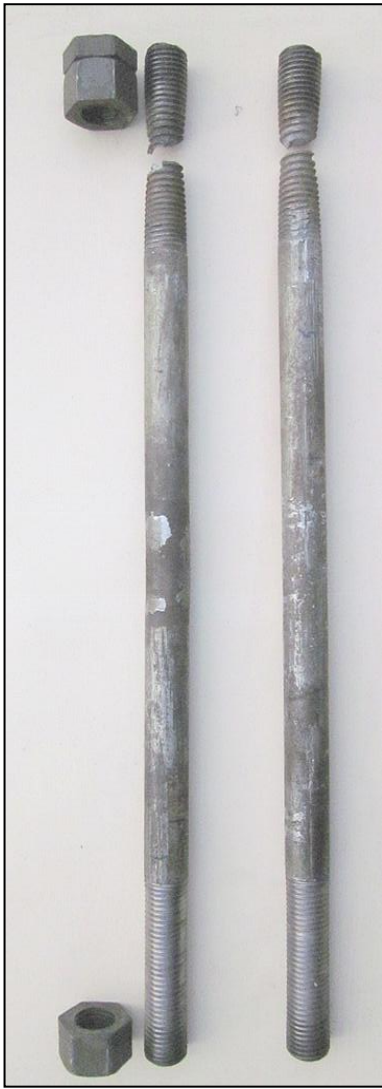
Figure 41. Failure locations on RMK bars.
(Recovered from Kaiapoi Railway River Bridge.)

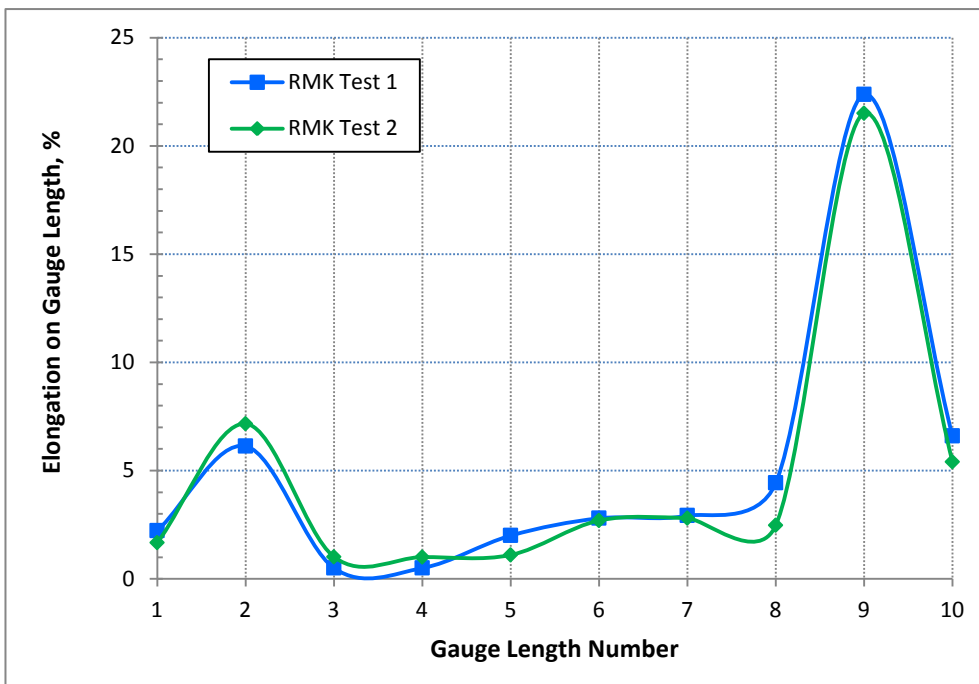
Figure 42. Elongations on Round Galvanised Mild Steel RMK bar gauge lengths.
(Bars recovered from Kaiapoi Railway River Bridge.)

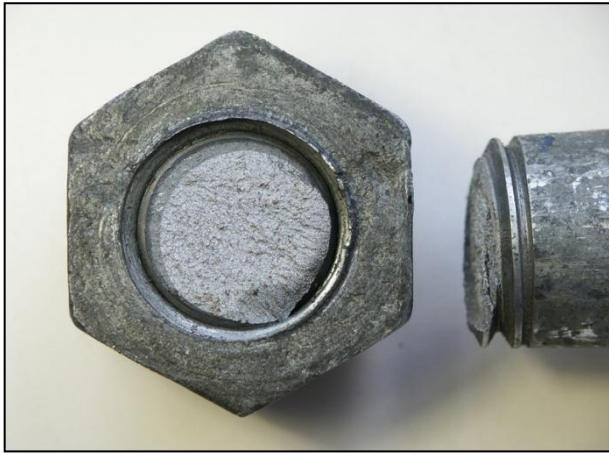
Figure 44. Failure in bar head test.

Failures occurred at the loaded face of the nut on one end of the bar as shown in Figure 44. The ultimate loads for the two bars were 522 kN and 513 kN. These loads were about 15% greater than the loads recorded in the initial tensile tests (see Figure 40). In both tests the location and appearance of the failures were similar to those that occurred in the bars during the 2010 Darfield Earthquake (see Figures 44 and 45).

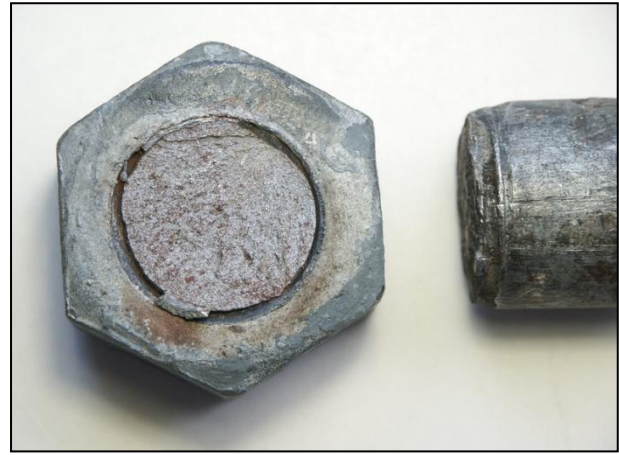
Figure 45. Failure at bar head on bridge.

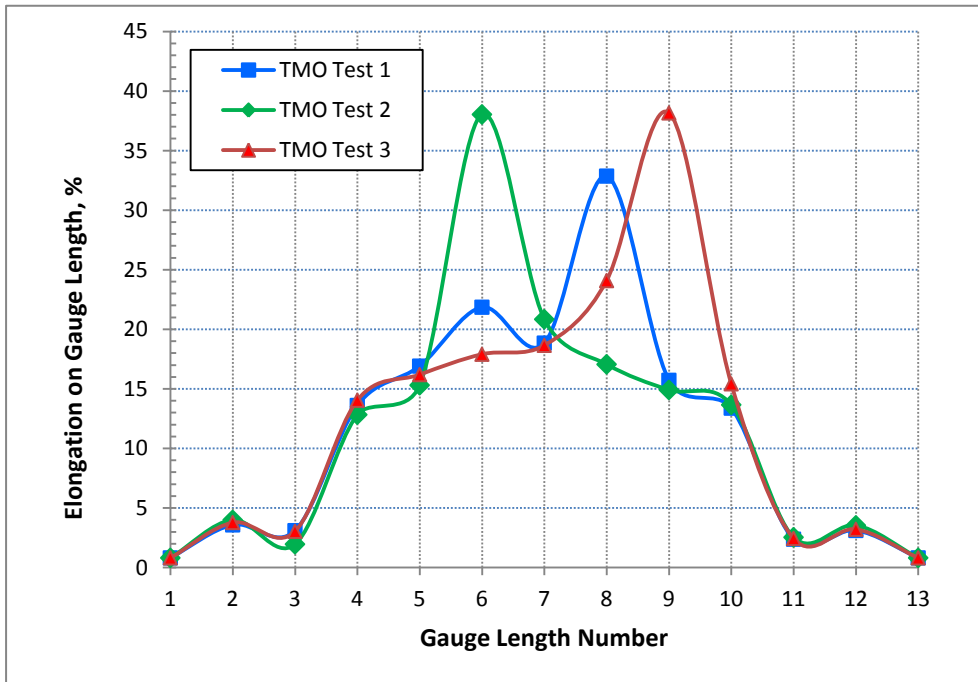
Figure 48. Elongations on gauge lengths for Turned-Down Galvanised Mild Steel TMO bars. Gauge lengths 4 to 10 were turned-down. (Bars recovered from Otaki River Bridge.)

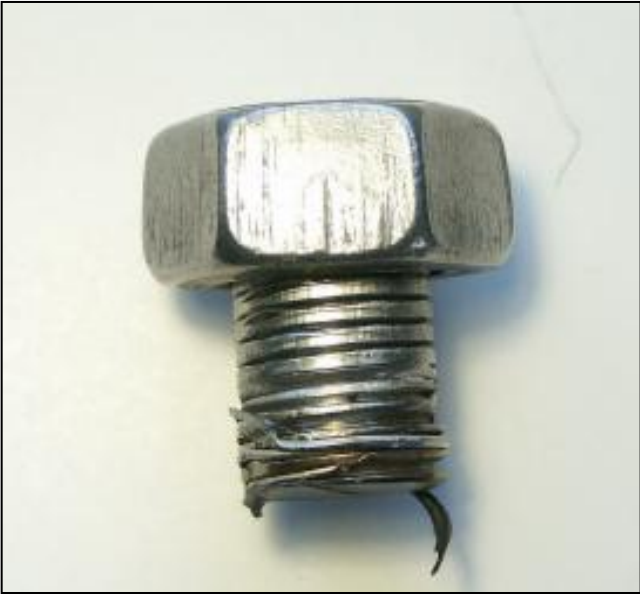
Figure 49. Failure of A4-70 (LE) nut in RS38 assembly test. Note the distortion across the width of the nut

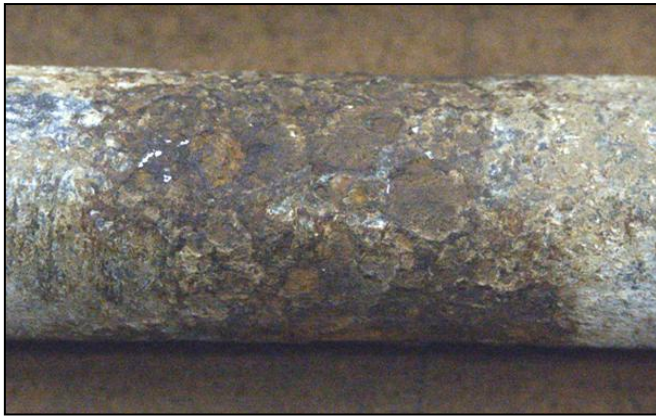
Figure 51. Corroded area on 25.4 mm diameter Linkage bars recovered from the Ahuriri River Bridge.

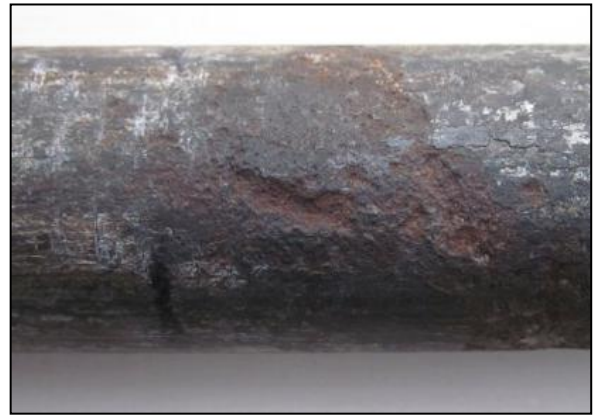
Figure 52. Corroded area on 38.1 mm diameter linkage bars recovered from Kaiapoi Railway River Bridge.

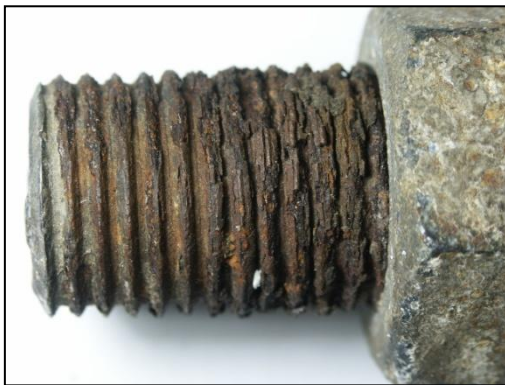
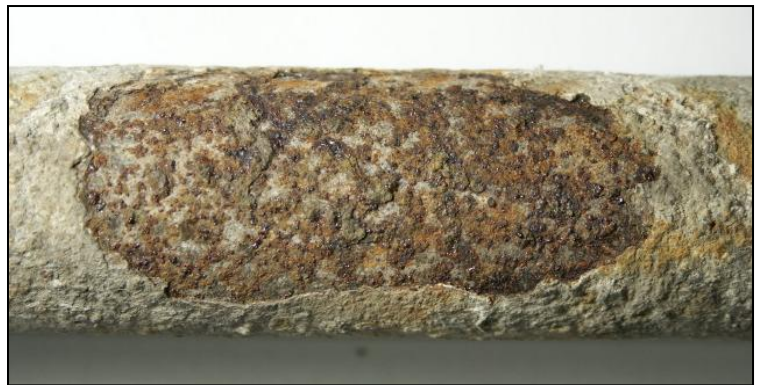
Figure 53. Corroded areas on linkage bars recovered from the Otaki River Bridge. The photo on the right shows an area on the 30 mm diameter turned-down section.

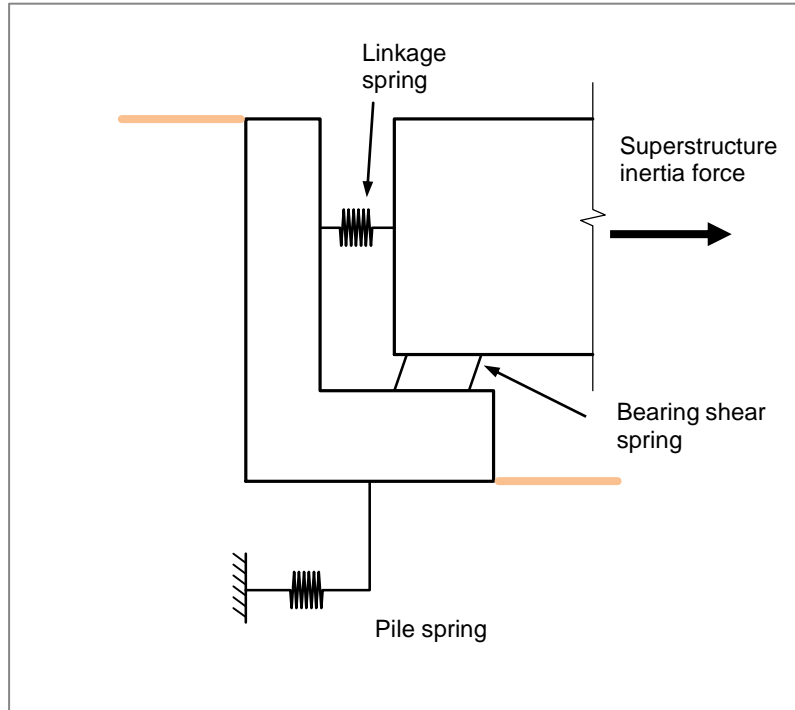
Figure 56. Abutment model for superstructure inertia load forces pulling abutment away from backfill.

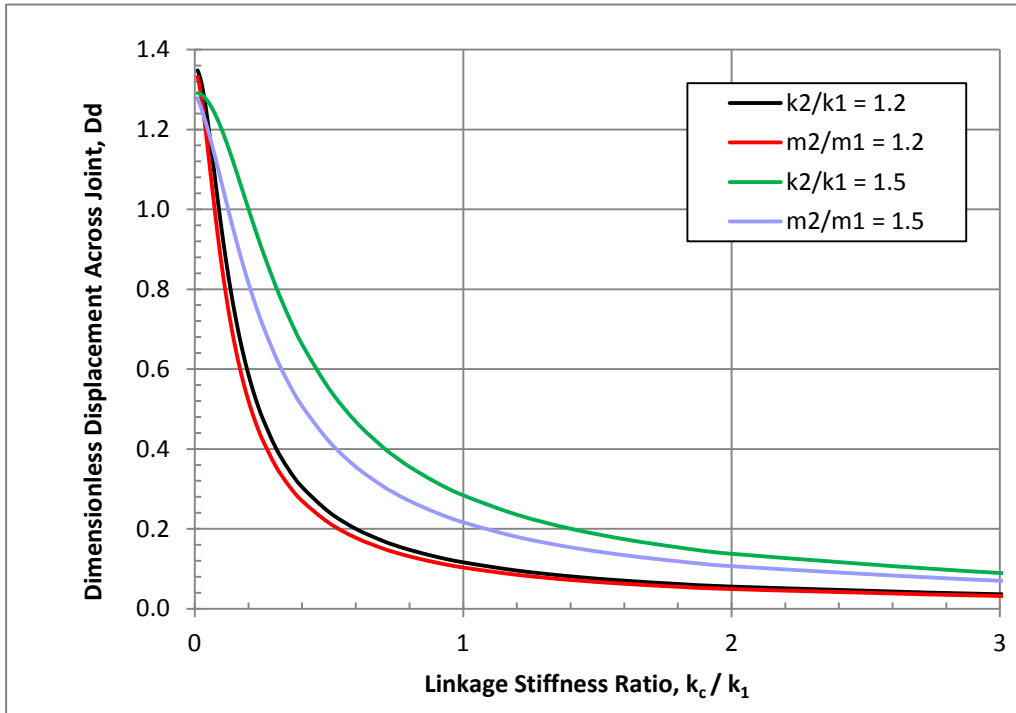
Figure 63. Joint dimensionless displacement from two-degrees-of-freedom model.

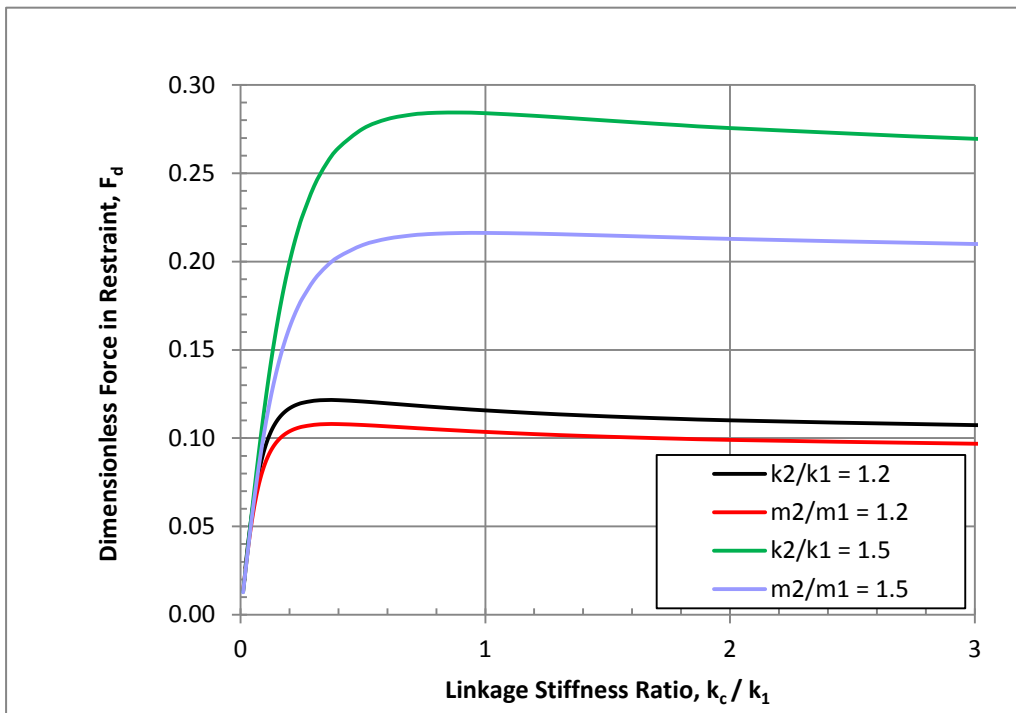
Figure 64. Restrainer dimensionless force from two-degrees-of-freedom model.

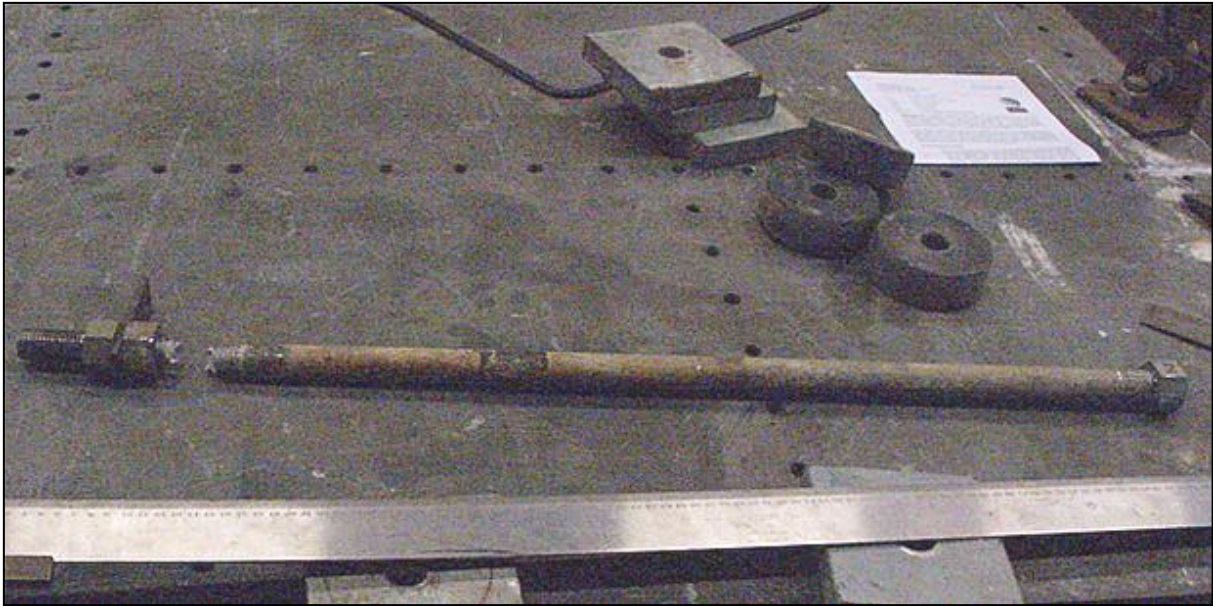
Figure B1. Linkage bolt from Ahuriri River Bridge after tensile testing.

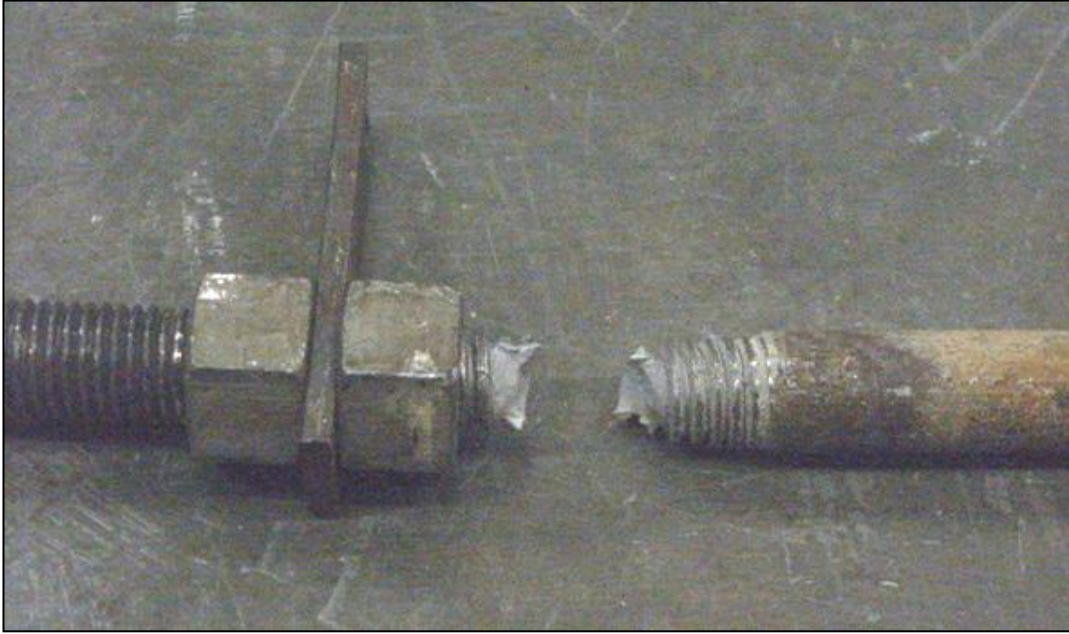
Figure B2. Failure in loaded thread of Ahuriri River Bridge linkage bolt.
