Performance of Linkage Bars for Restraint of Bridge Spans in Earthquakes

New Zealand Transport Agency

Consultancy Services Contract Number: NO 09-554

Final Revision: 20 March 2012

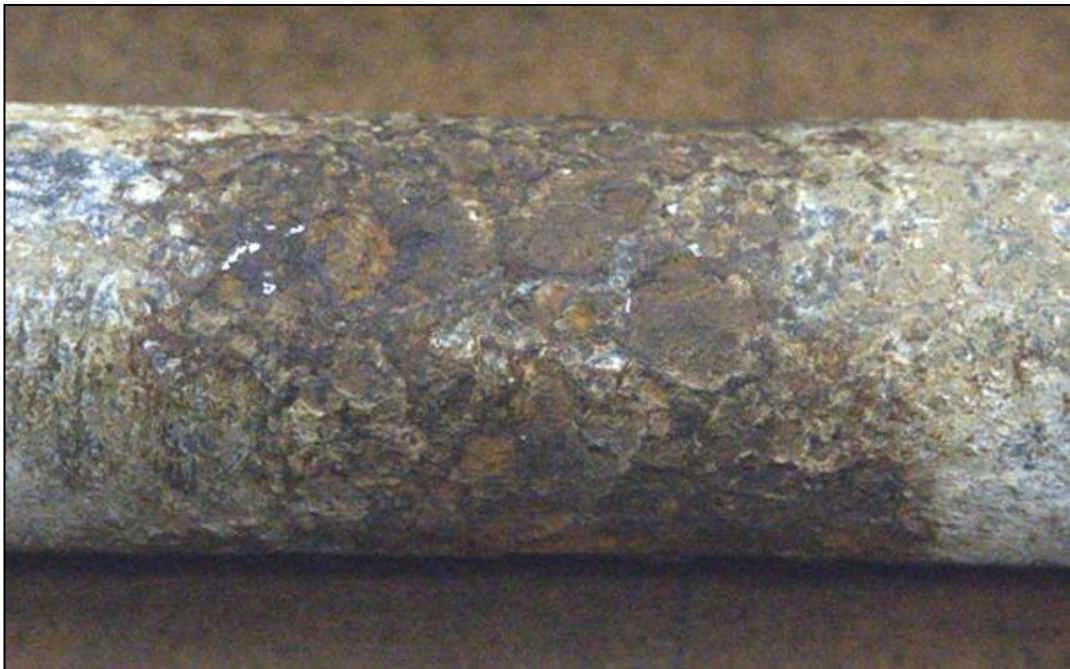
Figure B3. Corrosion on Ahuriri River Bridge linkage bolt.

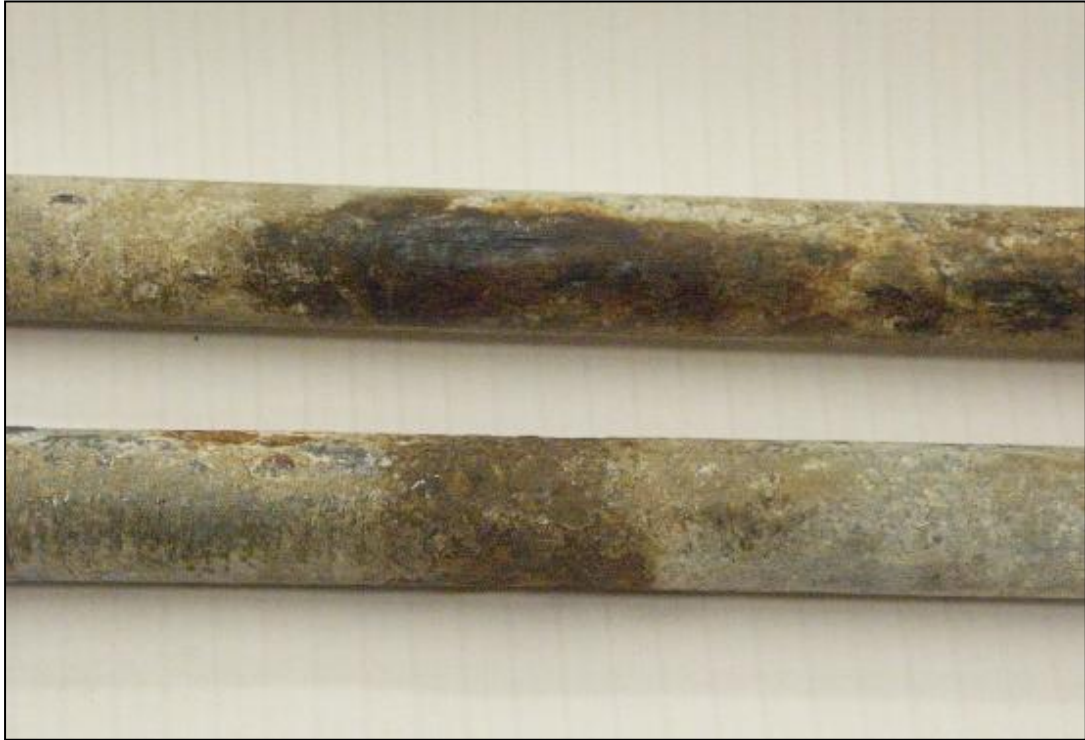
Figure B4. Corrosion on Ahuriri River Bridge linkage bolt.
