**Health Monitoring of
Superstructures of
New Zealand Road Bridges:**

**Bealey (Waimakariri) Bridge,
Canterbury**

Transfund New Zealand Research Report No. 166

R.P. Andersen, W.S. Roberts, R.J. Heywood & T.J. Heldt
Infratech Systems & Services Pty Ltd,
Brisbane, Australia

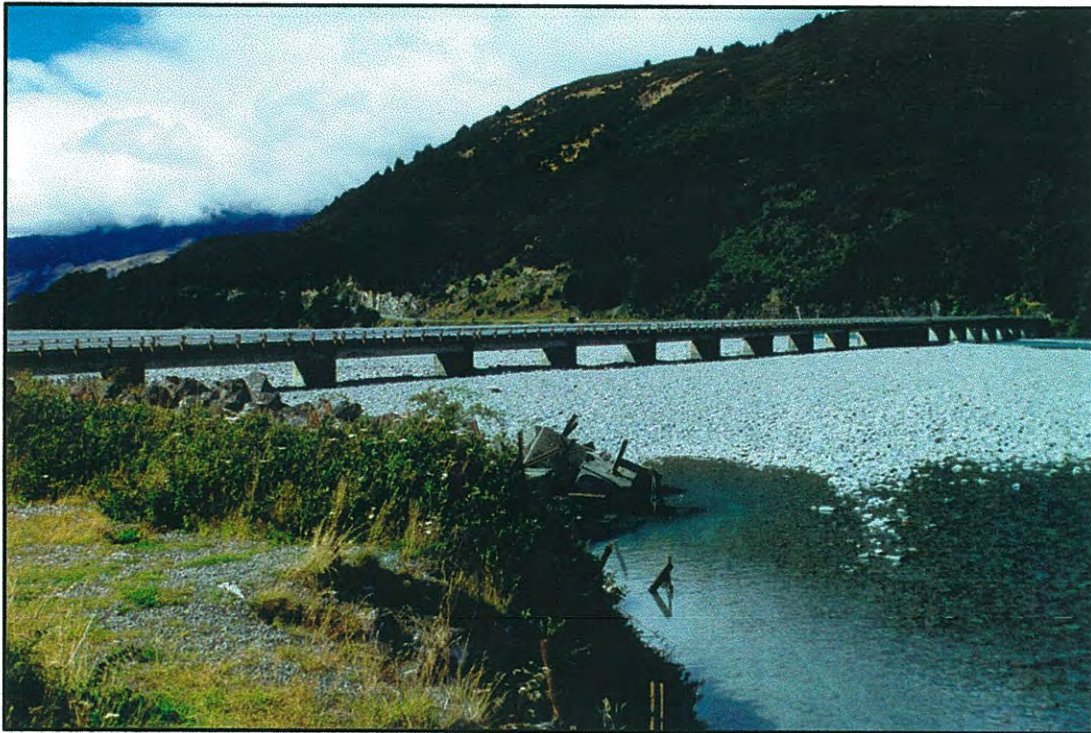
Figure 3.1 Bealey Bridge over the Waimakariri River, Canterbury, South Island.

The Bealey Bridge is located on SH73 where it crosses the Waimakariri River between Bealey and Arthur's Pass, in Canterbury Region. The structure consists of twenty simply supported spans, each with two reinforced-concrete girders, supporting a single-lane, reinforced-concrete deck. The concrete deck has integral kerbs. The typical span length is 13.4 m with the two approach spans being 13.4 m and 13.2 m in length. Construction of the 268 m-long bridge was completed in 1935. The bridge is illustrated in Figure 3.1, and the superstructure of the bridge is illustrated in Figure 4.2.

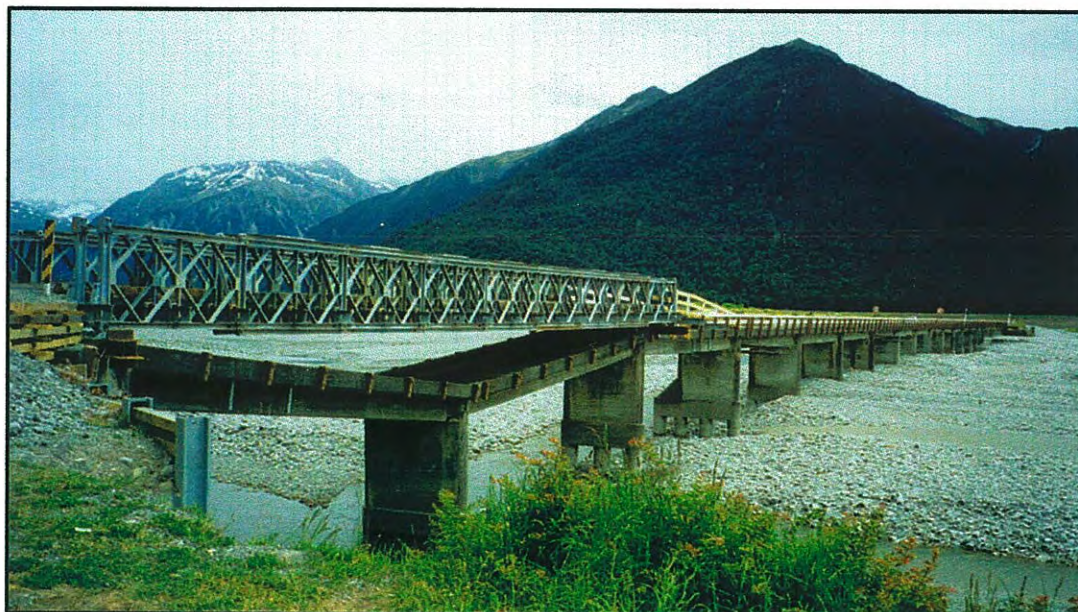
Figure 3.2 Failed spans at the Bealey (eastern) end of the bridge.

One of the piers on the Bealey end of the bridge subsided during the 1990s (Figure 3.2) and the two defective spans were temporarily bridged with Bailey bridge components. The load evaluation and monitoring did not include this span of the bridge, which was replaced in 1999.

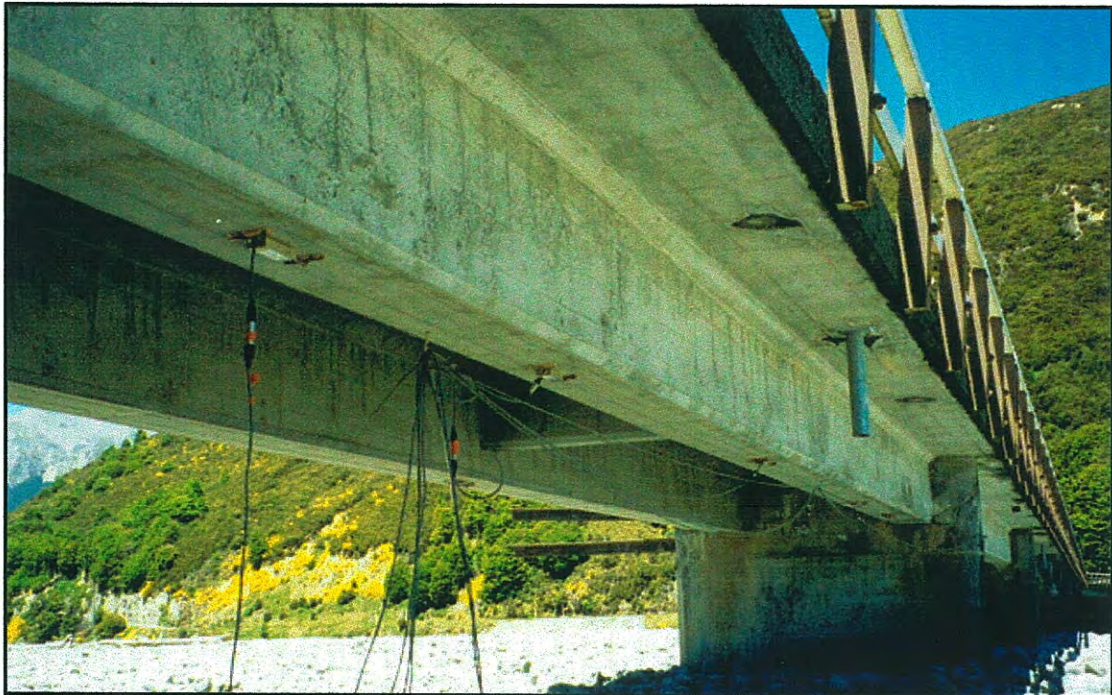
Figure 4.2 Instrumentation on Girder 1, Span 2.

The terminology for the instrumentation is presented in Table 4.1. Figure 4.2 shows the instrumentation installed on Girder 1, Span 2. This girder was instrumented with five Demountable Strain Gauge transducers along its length. This strategy was used to record the variation in strain along the girder length.

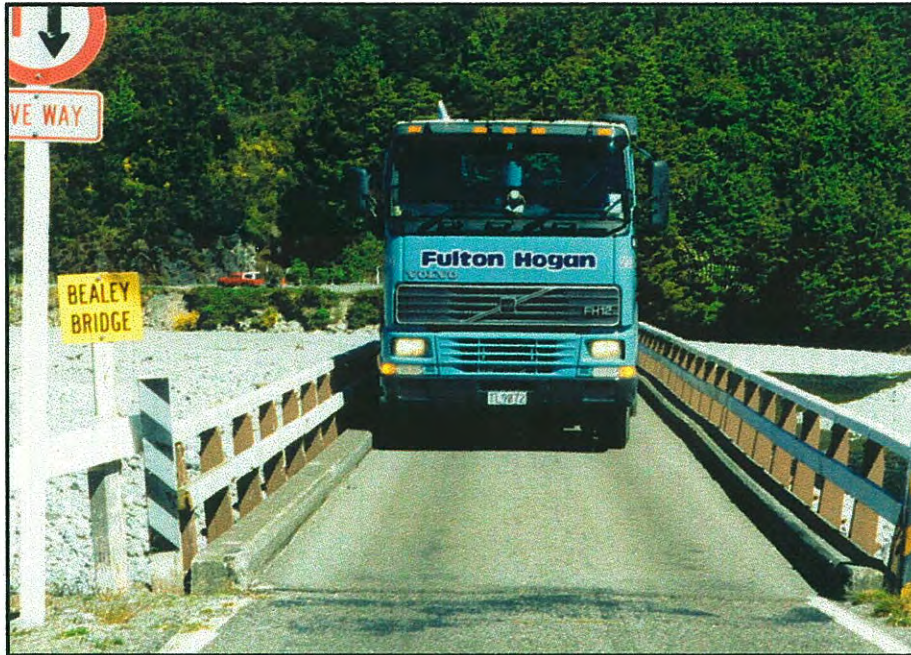
Figure 4.6 Known vehicle on the bridge during testing.

Figure 4.6 shows the known vehicle on the bridge and the small amount of lateral clearance (approximately 420 mm) available for the vehicle on each side. This restricts the path of the vehicle, which in turn limits the variation in the lateral distribution of load into each girder.

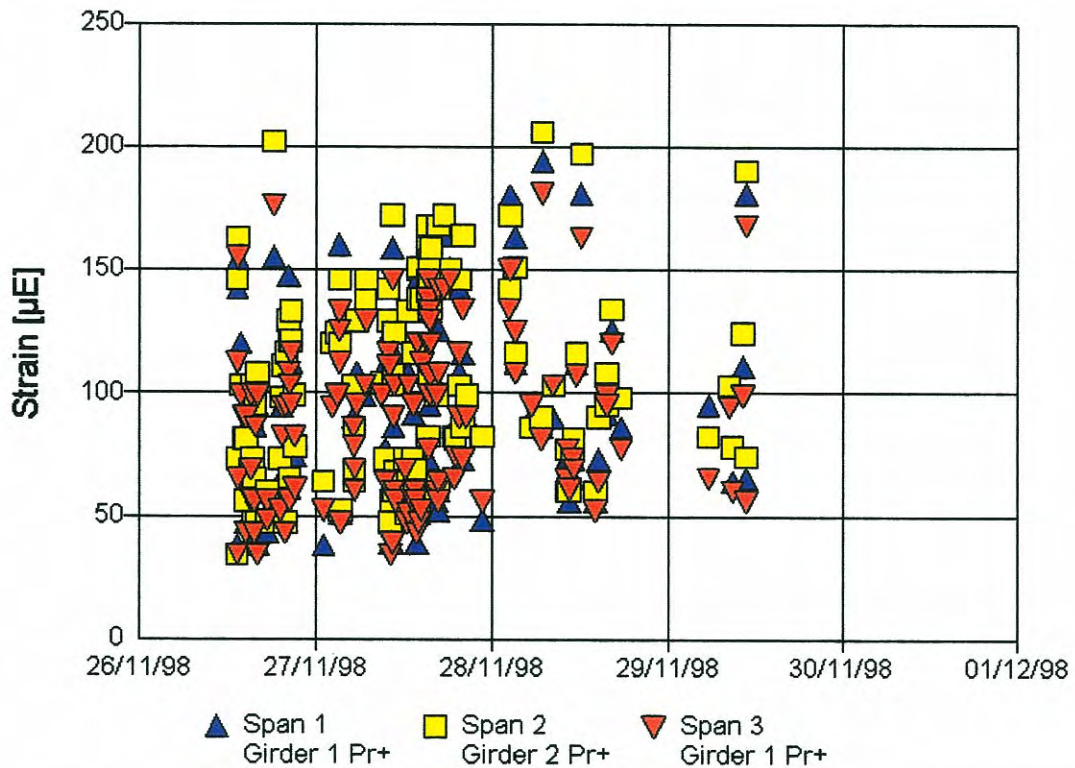
Figure 4.10 Scatter diagram for transducers installed on Spans 1 and 3, Girder 1, and Span 2, Girder 2.

The waveforms for the remaining three transducers in Spans 1, 2 and 3 are illustrated in Figure 4.9. The plot shows the response of the structure as the vehicle travels from Span 1 towards Span 3 (east towards Bealey). The continuity is evident between all three instrumented girders. A scatter diagram for these transducers is presented in Figure 4.10.

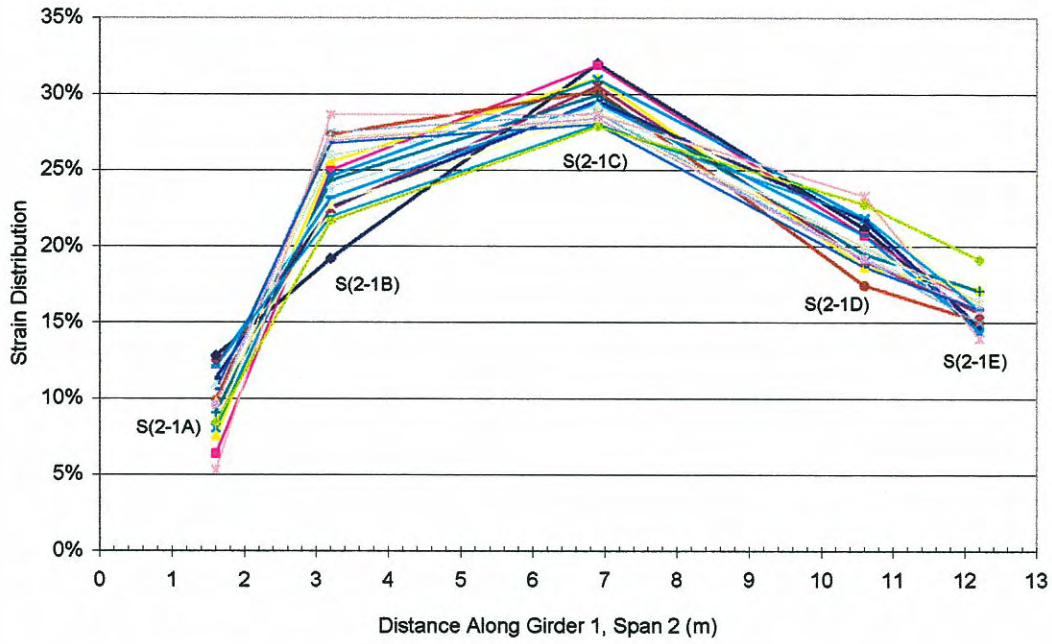
Figure 4.11 Strain distribution along Span 2, Girder 1 of Bealey Bridge.

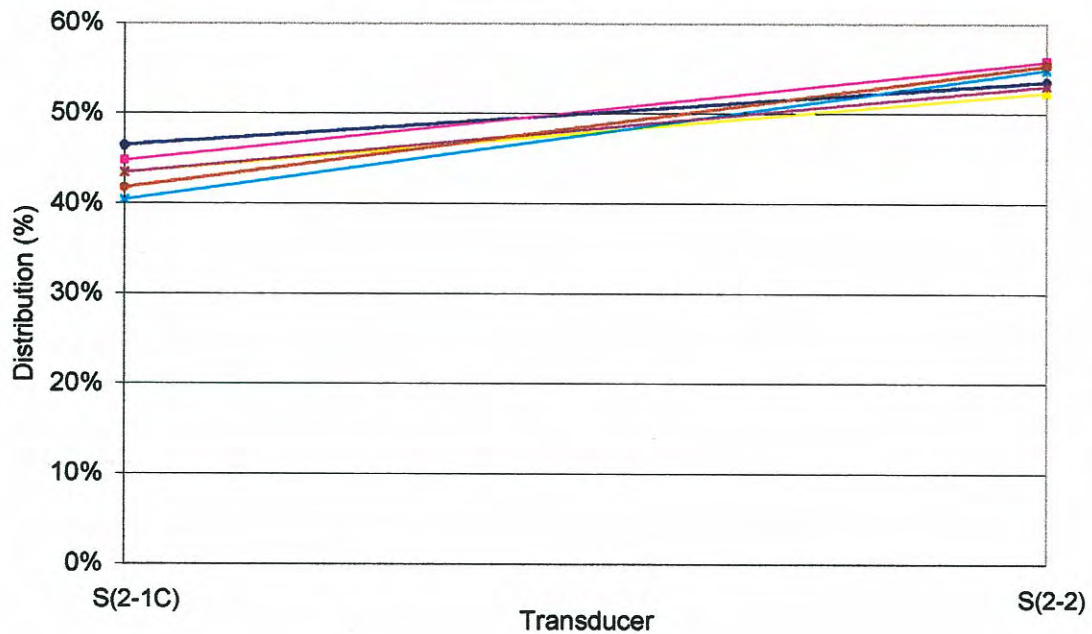
Figure 4.16 Distribution of strains for known vehicle testing.

The dynamic response of the main girders was small because of the relatively slow speeds of the vehicle. The very narrow width of the structure ensures that vehicle speeds are restricted to less than 40 km/h. The driver of the known vehicle commented that it was very difficult to achieve speeds in excess of 40 km/h because of the narrow bridge width.

The free vibration response is small, being approximately 3% of the maximum response. Because this response is small the level of damping could not be determined. The natural frequency of the superstructure is around 7 Hz. Higher resolution settings on the monitor may have given better signals to allow this frequency to be determined more accurately.

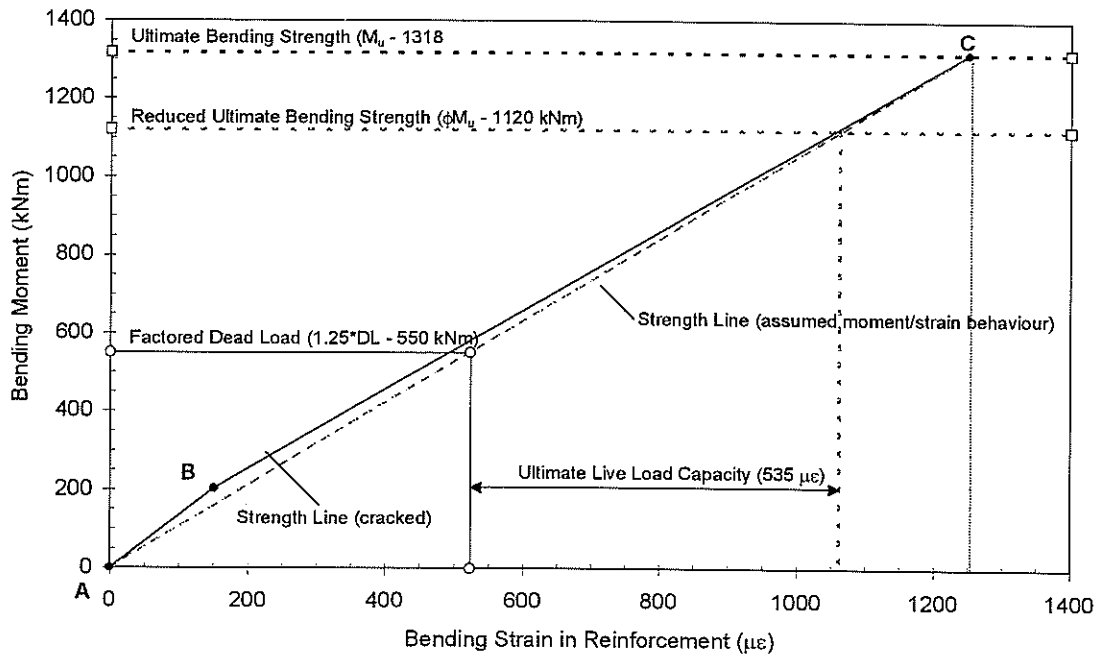
Figure 5.1 Theoretical moment versus strain relationship for the Bealey Bridge.

The Line AB on Figure 5.1 represents the linear elastic behaviour of the concrete girder section before cracking occurs. Point B represents the point at which the concrete cracks. At this point the concrete begins to follow Line BC which represents the behaviour of the concrete girder section in the cracked state.

A conservative assumption of the behaviour for the concrete beam action is characterised by (dashed) Line AC. Because the girder is already cracked under service loads, the actual relationship between moment and strain for the girder is expected to be similar to the Line AC.
