**Health Monitoring of
Superstructures of
New Zealand Road Bridges:
Wanganui Bridge, Wanganui**

Transfund New Zealand Research Report No.172

R.P. Andersen, W.S. Roberts, R.J. Heywood & T.J. Heldt
Infratech Systems & Services Pty Ltd,
Brisbane, Australia

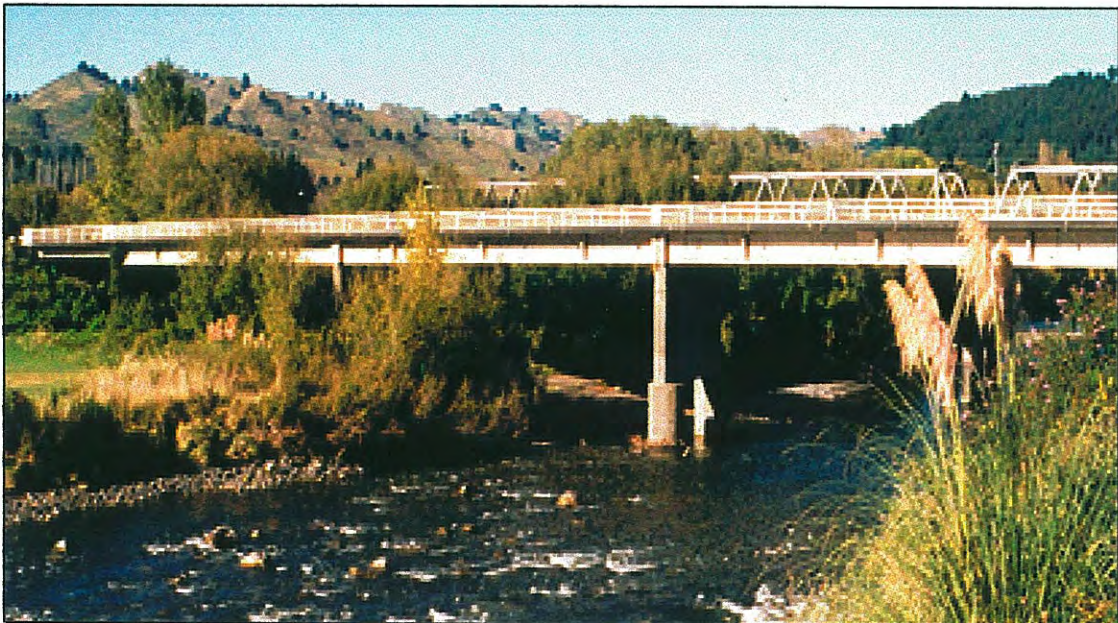
Construction of the 140 m-long bridge was completed in 1962. The bridge is illustrated in Figure 3.1, and a typical cross section of the 30.5 m spans is illustrated in Figure 3.2.

Figure 3.1 Wanganui Bridge, central North Island, New Zealand.

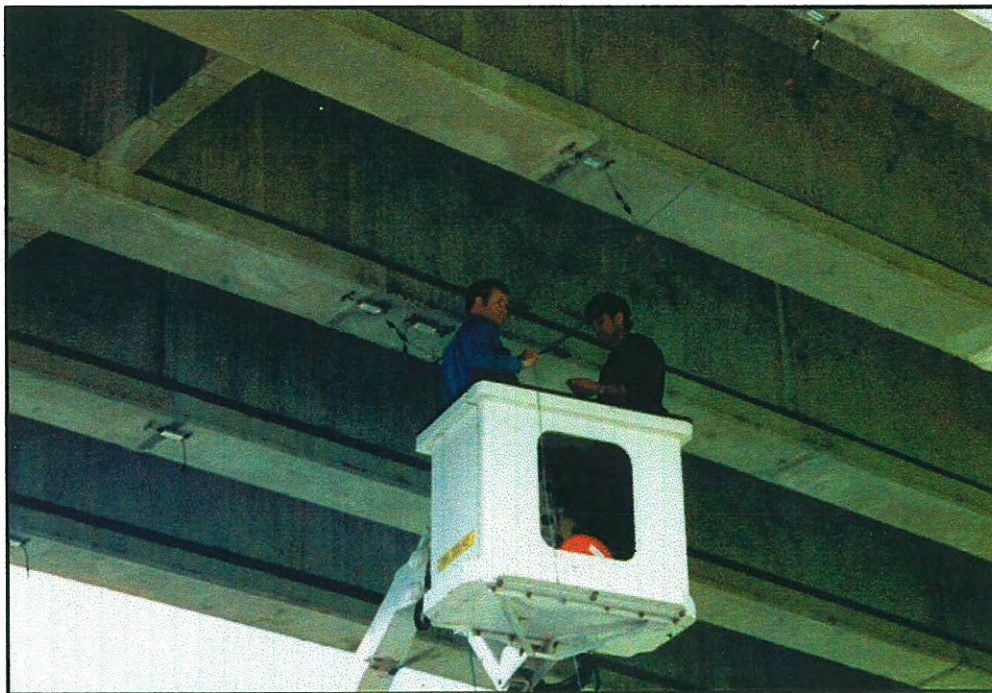
Figure 4.3 shows the installation of the demountable strain gauges on the girders at midspan.

Figure 4.3 Installation of instrumentation on girders of the Wanganui Bridge.

The demountable strain gauges (gauge length is 230 mm) used to measure strain in the soffit of the girders measure strain at a point 20 mm below the soffit. The results have been corrected to represent the strain in the soffit of the girders. The sign conventions used throughout this report include positive values for tension strains and negative values for compressive strains.

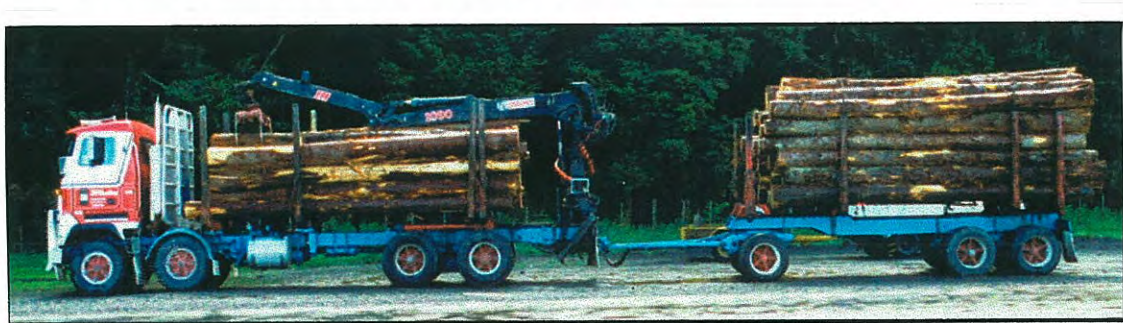
In order to provide a control for all the data gathered during the entire monitoring period, the behaviour of the bridge in response to a known load (i.e. a heavy vehicle of known mass and dimension) was measured. This component of the Health Monitoring programme was conducted on Monday 5 October, 1998. The vehicle used for the testing, shown in Figure 4.4, was a seven-axled heavy vehicle of known mass (45.2 tonnes) and dimensions (Figure 4.5).

Figure 4.5 Axle mass and configuration of the known vehicle.

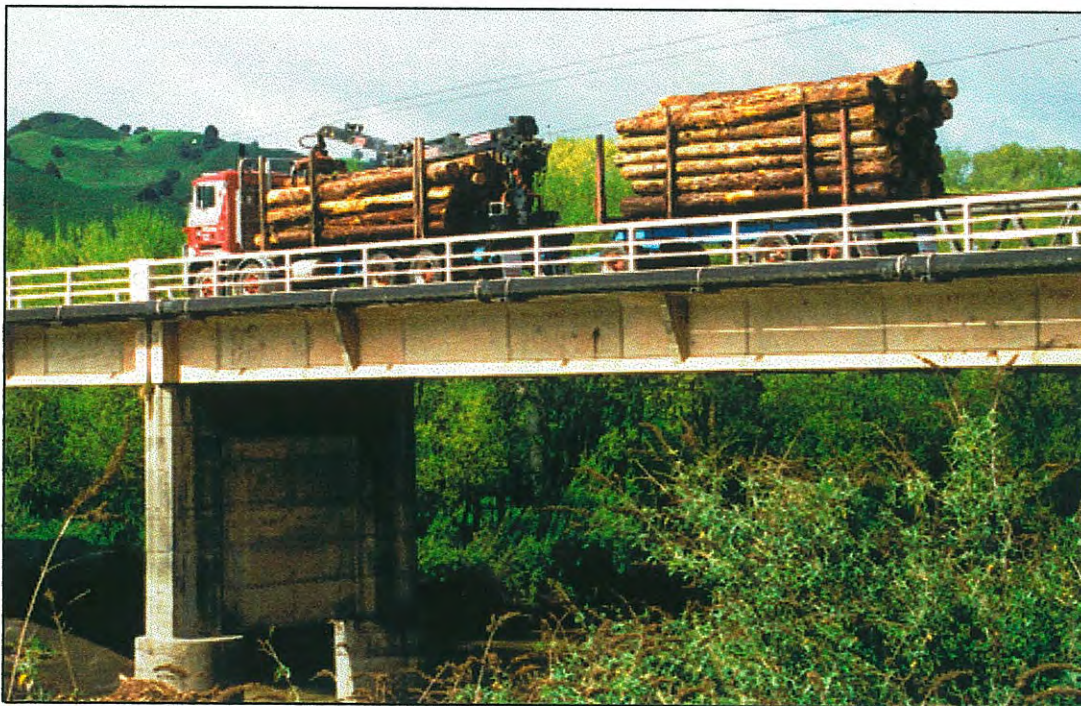
The testing with the known vehicle was conducted by recording the response of the bridge to the vehicle as it passed over the bridge at different speeds. The tests were conducted with the vehicle travelling in both directions (south and north) from a crawl (20 km/h) to 80 km/h, in increments of 10 km/h. The lateral position of the known vehicle was in the normal lane for each direction. Testing was completed by slowing the traffic in each direction or in some cases stopping it for a few minutes at a time. This ensured minimal traffic interruptions and also allowed the continuous monitoring of ambient heavy vehicles between the test runs with the known vehicle. Figure 4.6 illustrates the vehicle on the bridge during testing, and the segments in the girders are clearly visible in this figure.

Figure 4.6 The known vehicle on the bridge during the testing.

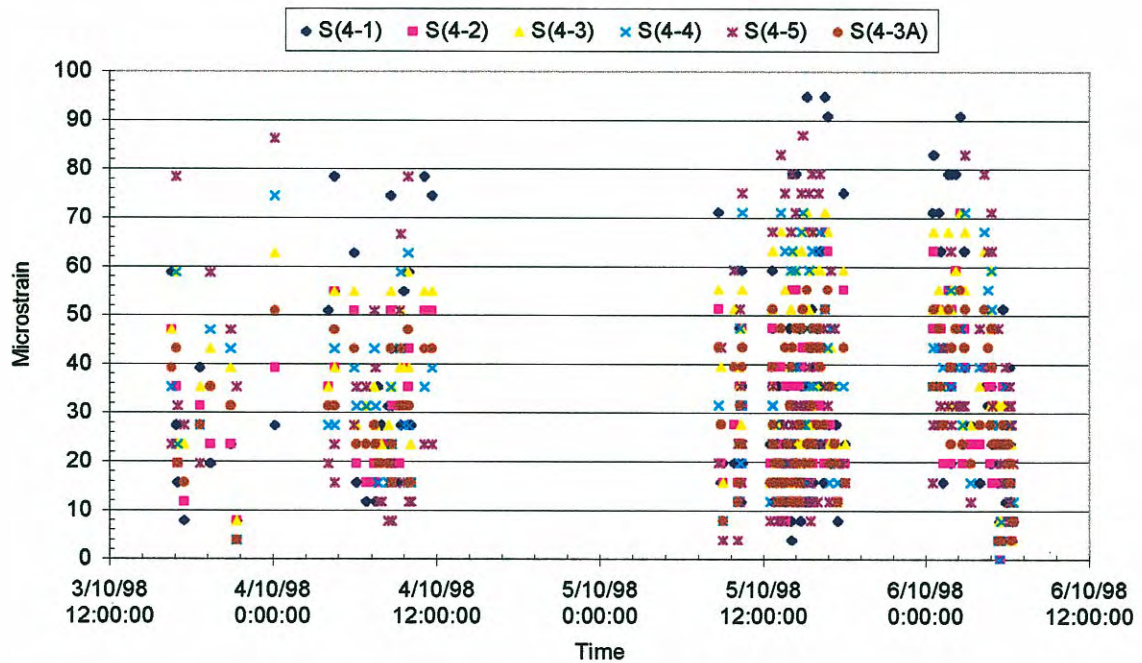
Figure 4.8 Scatter diagram for midspan bending strains.

The scatter diagram in Figure 4.8 represents the maximum bending strains recorded during the passage of each heavy vehicle for the entire Health Monitoring period.

This plot gives an indication of the characteristics of the heavy vehicles travelling over the bridge, including the distribution of mass and the number of heavy vehicles travelling this route. The large gap in the data occurred during monitor downtime, and is not due to an absence of traffic.

The scatter diagram (Figure 4.8) displays consistently higher responses from transducers S(4-1) and S(4-5) which are located on the edge girders. Figure 4.9 presents a comparison of the transducers installed approximately 500 mm apart on Girder 3. Transducer S(4-3A) is plotted on the y-axis and transducer S(4-3) is plotted on the x-axis. If a one-to-one relationship existed between the two transducers, a line with a slope of 1.0 would result. The information in this figure indicates that the strain in the soffit of the segment is approximately 75% of the strain across the joint between segments. This difference is to be expected as the segments have additional conventional reinforcement which would make the segments stiffer than the joints which have only post-tensioning.

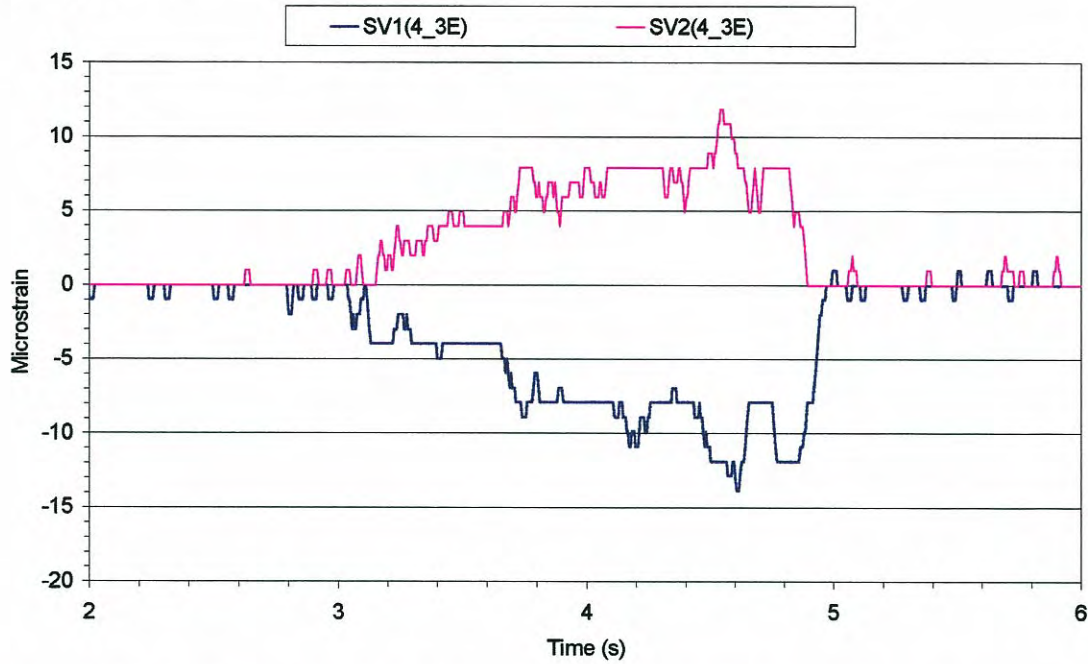
The response of the transducers that measured web shear effects are presented in Figure 4.10. These waveforms are not smooth because of the very small strains being recorded. Higher resolution settings on the monitor would overcome this problem. The scatter diagram for these transducers is presented in Figure 4.11, in which the data show that transducer SV1(4-3E) measured compression, while transducer SV2(4-3E) measured tension. Note the classical shape of a shear influence line from a heavy vehicle.

Figure 4.10 Waveform for transducers measuring web shear effects in Girder 3 for event recorded at 10.24am, 5 October 1998.

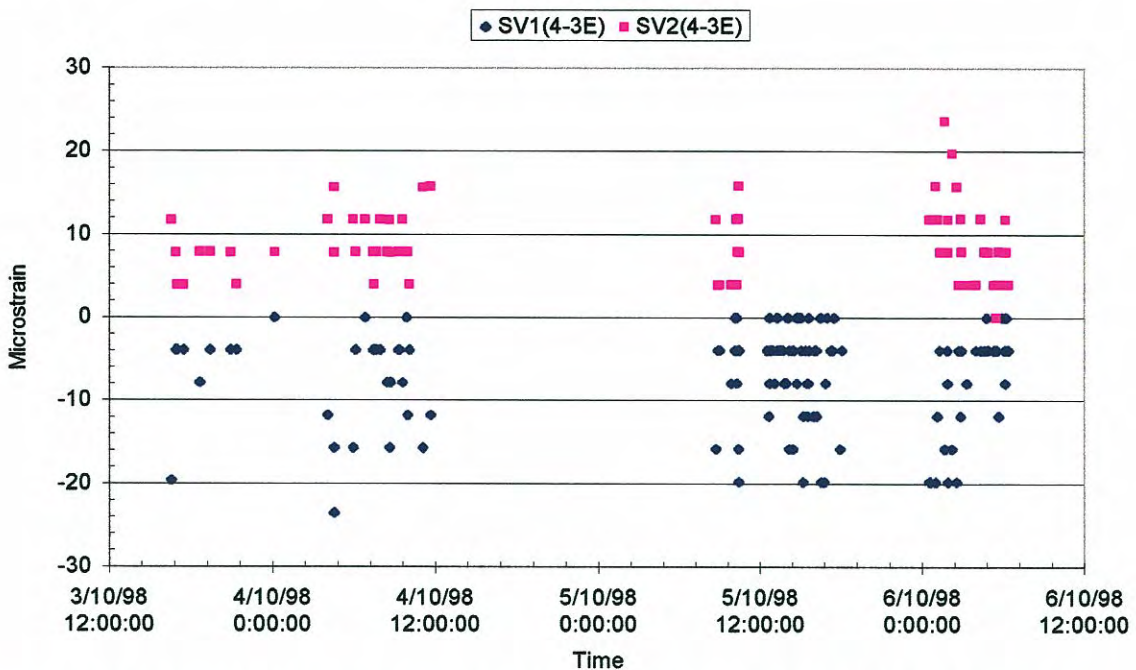
Figure 4.11 Scatter diagram for transducers measuring web shear effects in Girder 3.

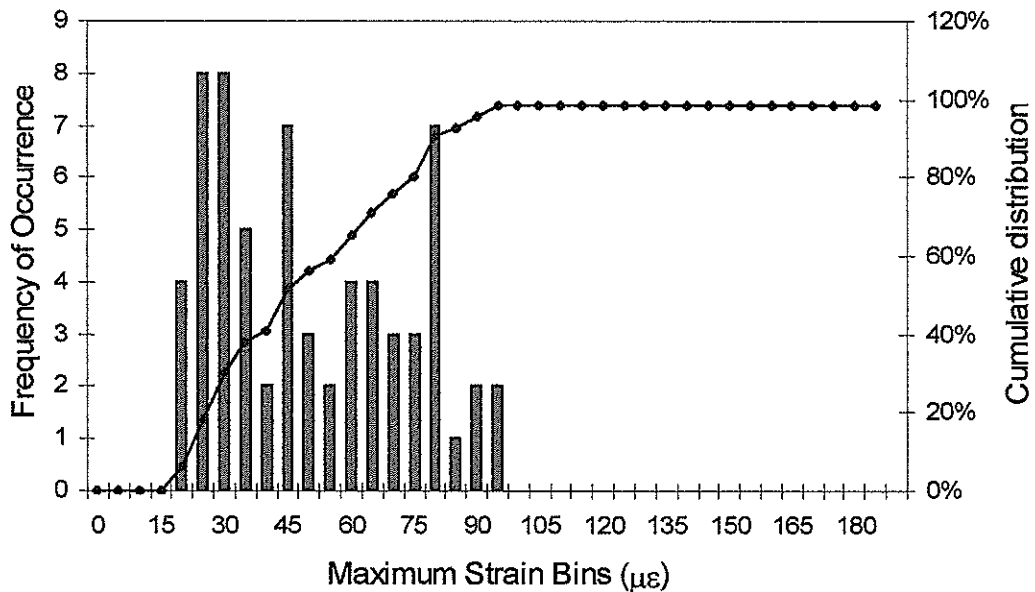
The data from the scatter diagrams can also be plotted on a histogram that incorporates a cumulative distribution. An example is presented for transducer S(4-1) in Figure 4.12. The histogram illustrates two separate sections or populations of data. This is characteristic of traffic travelling in opposite directions on different sides of the bridge. By separating the data into directions, the data relevant to each transducer can be plotted and a more accurate indication of the traffic can be determined for each girder.

Figure 4.12 Histogram and cumulative distribution function for transducer S(4-1).

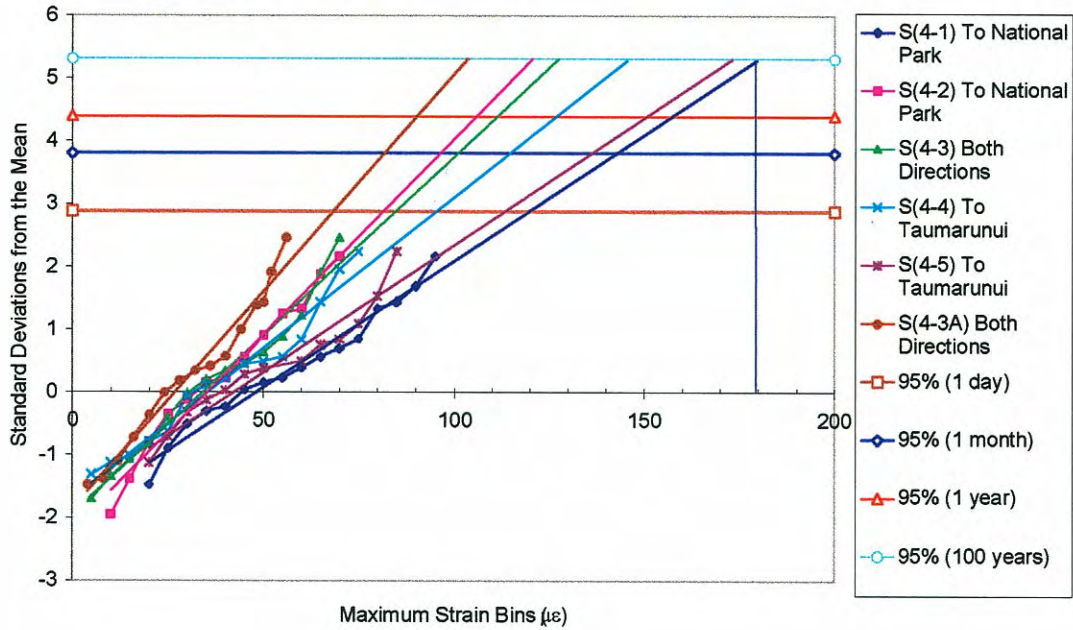
The cumulative distribution function can then be plotted on a probability scale known as an “inverse normal scale”. The inverse normal plot for each of the transducers measuring midspan bending strain is presented in Figure 4.13. In this figure, the data are separated into opposite directions for all transducers, except S(4-3) and S(4-3A). These transducers are equally affected by the traffic in both directions as this girder is in the centre of the bridge. On this graph the vertical scale represents the number of standard deviations that each point is away from the mean. The horizontal scale is the maximum strain recorded for each event. The point at which a data plot crosses the horizontal axis represents the average (mean) strain. A straight line represents a normally distributed sample of data.

Figure 4.13 Inverse normal plot for strain transducers installed at the midspan of Span 4 girders.

Horizontal lines representing the expected position of the 95% confidence limit for the data for 1 day, 1 month, 1 year, and 100 years have been plotted. Extrapolating the recorded data allows estimates of strain for these longer return intervals. The strain extrapolated for the 95% confidence limit for 100 years represents the ultimate traffic load effect for the Fitness for Purpose Evaluation, as outlined in section 2 of this report.

The inverse normal plot (Figure 4.13) shows that the strain extrapolated for the 95% confidence limit for 100 years (ultimate traffic load effect) is the greatest for the midspan transducer S(4-1). The extrapolated value is approximately 180 $\mu\epsilon$. Typically the edge girders (Girders 1 and 5) are experiencing the highest strains.

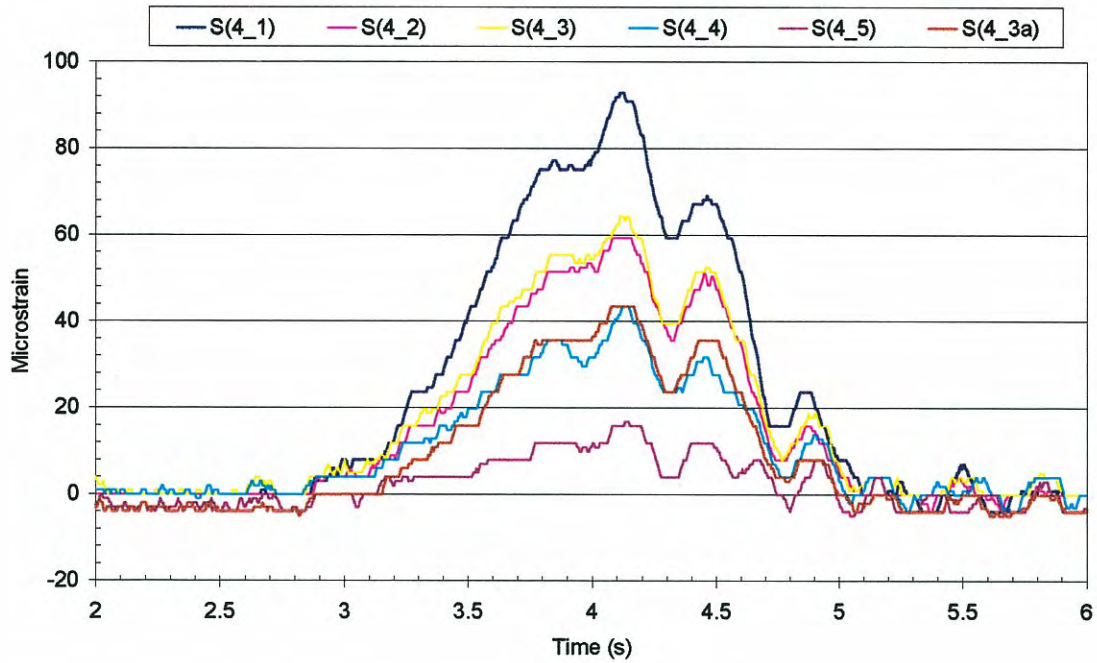
Figure 4.15 Typical waveform for the known vehicle travelling at 70 km/h east from Taumarunui, towards National Park.

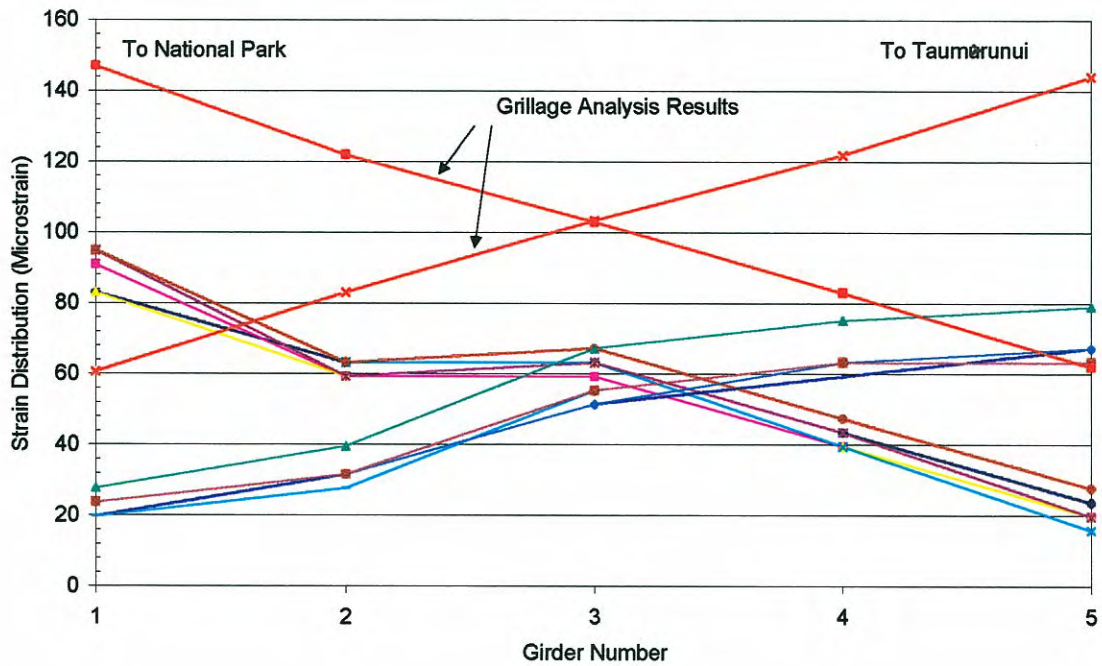
Figure 4.16 Strain distribution for known vehicle testing.

The distribution of strain into each of the girders from the known vehicle data is presented in Figure 4.16. The distribution presented is consistent with the data collected from health monitoring of the ambient heavy vehicle traffic, with higher strains recorded in Girder 1 for vehicles travelling to National Park (east). However, for vehicles travelling to Taumarunui (west), the maximum strain was recorded in Girder 5.

Figure 4.16 also illustrates the results from the grillage analysis using the known vehicle. This grillage analysis included the effects of the kerb but not the guardrail. The vehicle position for the grillage was 600 mm out from the kerb. The differences between the theoretical and recorded results indicate that the actual response of the bridge is significantly less than that predicted by the grillage analysis. These differences may be related to bearing restraint effects or to differences between actual and assigned material properties.

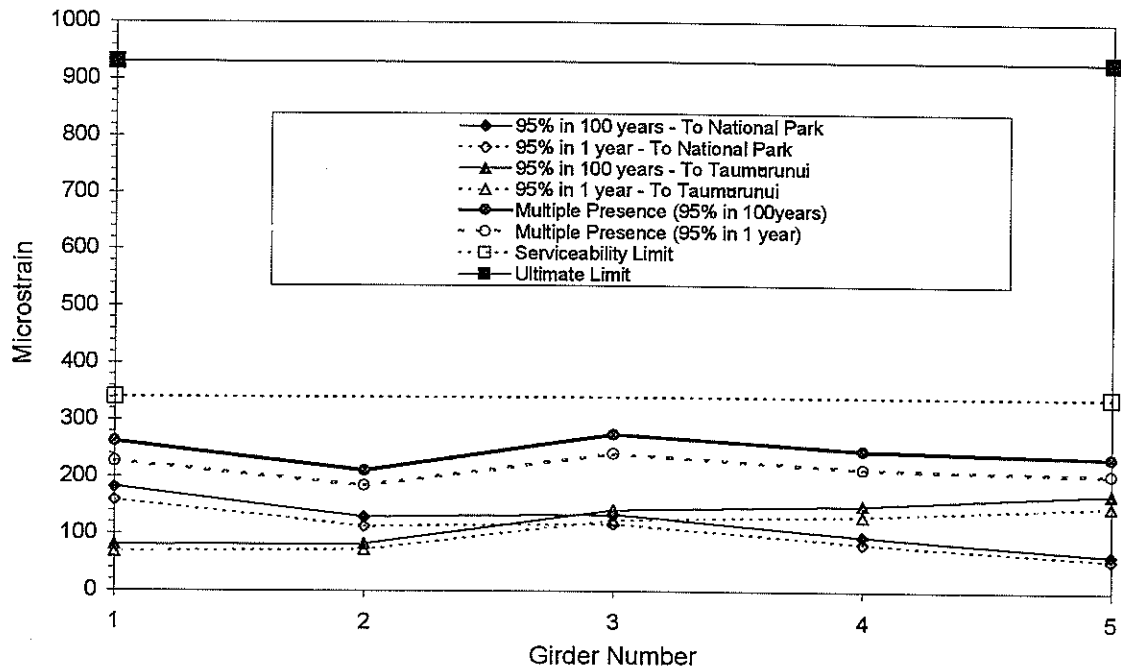
Figure 5.1 summarises an assessment of the multiple presence effects for midspan bending strain. The diagram is based on the health monitoring data using a method that is consistent with the Bridge Manual. The distributions of strain presented in Figure 5.1 are based on the distribution factors from the known vehicle and the extrapolated health monitoring data. The diagram shows a transverse distribution of strain for each direction and the sum of these two distributions. This has been completed for both the 95% in 1 year (serviceability) event and the 95% in 100 year (ultimate) event. The data show that the highest strain related to a multiple presence event occurs in Girder 3. The maximum strains include 240 $\mu\epsilon$ for the serviceability limit state (95% in 1 year) and 275 $\mu\epsilon$ for the ultimate limit state (95% in 100 years). Also on this diagram is the limiting strain for each of these cases. These strains are derived in section 5.1.2 of this report. The actual strains that would be created from the multiple presence events are well below these limiting strains.

Figure 5.1 Multiple presence effects using the approach that is consistent with the Bridge Manual.

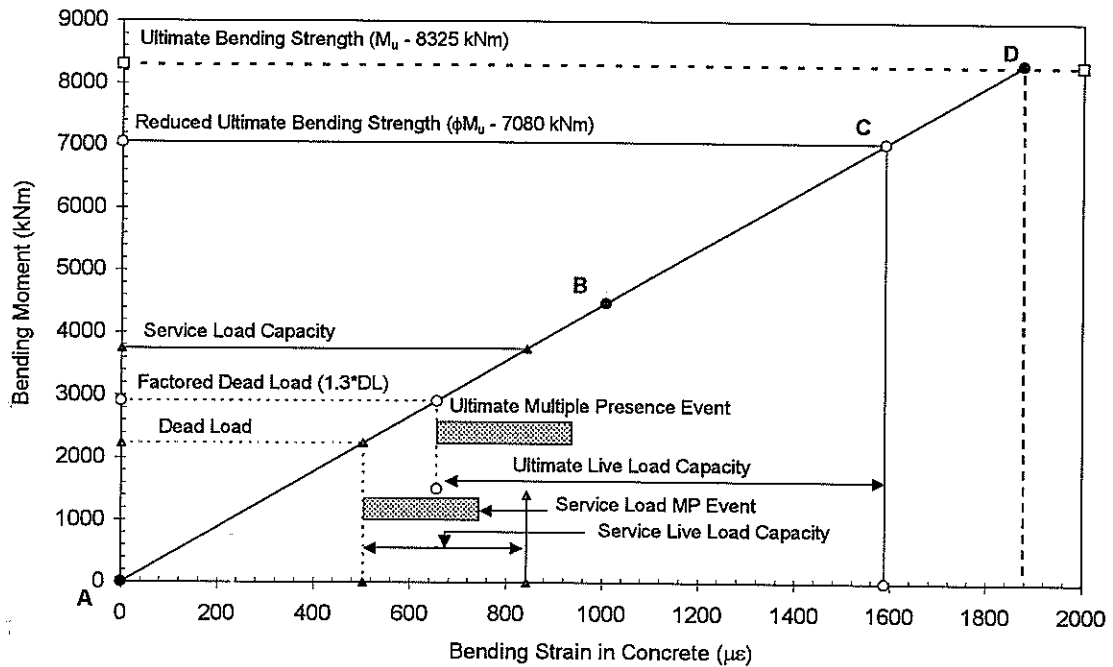
Figure 5.2 illustrates a theoretical moment versus strain curve for a typical girder of the Wanganui Bridge. The graph presents the method used by Infratech to obtain a relationship between bending moment and strain in the soffit of the girder. Because the girders have not cracked in service, this relationship is presented for the girder behaving as an uncracked linear elastic section, even at ultimate capacity. This relationship is, however, a conservative approximation, and has not been confirmed experimentally.

Line AB on Figure 5.2 represents the linear elastic behaviour of the concrete. Point B represents the point at which the concrete would crack, and at which the behaviour of the girder would normally change. However, as the relationship is presented as a linear elastic relationship, the behaviour remains linear. The line BCD represents the linear elastic representation of the behaviour to ultimate bending strength.

Superimposed on Figure 5.2 is the reduced ultimate moment capacity and the service load capacity, and the corresponding strains. The service load capacity corresponds to the decompression moment, the calculation of which assumes post-tensioning losses of 30%. The dead load, factored dead load, and the corresponding strains are also illustrated, as are the ultimate multiple presence event and the service load multiple presence event represented by shaded rectangles. The diagram shows some capacity reserves for the service load case and significant capacity reserves for the ultimate load case.

Figure 5.2 Moment versus strain relationship, and summary of Fitness for Purpose for Girder 1.
