# **The mechanisms and types of non-motor vehicle injuries to pedestrians in the transport system and indicated infrastructure implications**

## **December 2010**

Frith, W and J Thomas (2010) The mechanisms and types of non-motor vehicle injuries to pedestrians in the transport system and indicated infrastructure implications. *NZ Transport Agency research report 431*. 104pp.

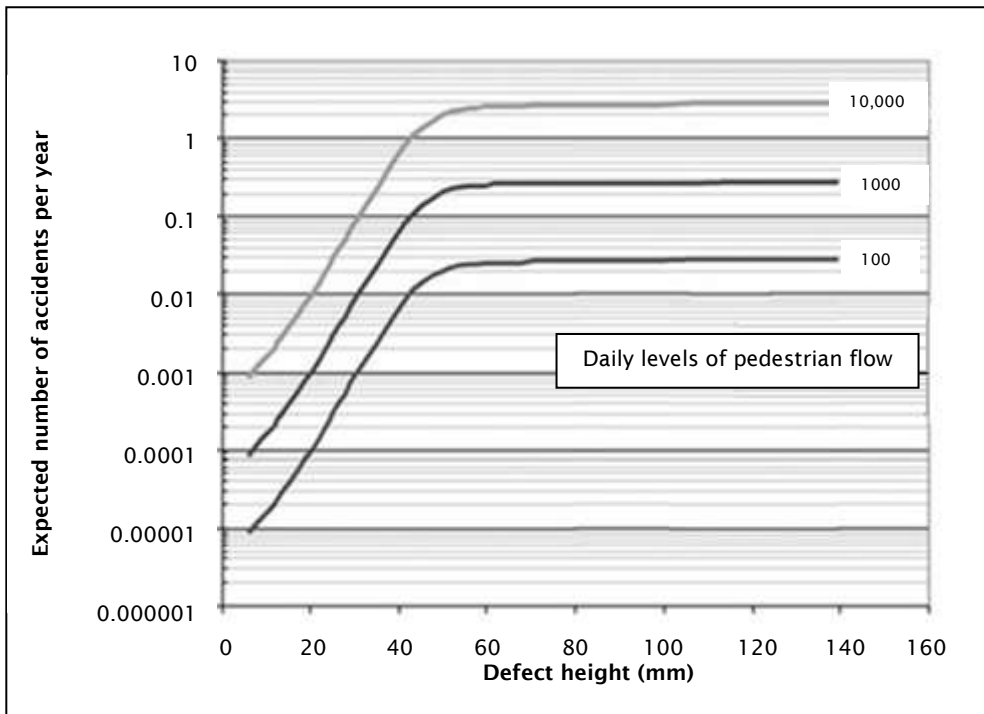
**Figure 2.4 Comparison of the expected number of pedestrian accidents across defect height for different levels of pedestrian traffic flow (adapted from Bird et al 2007)**

*...the probability of an accident occurring increases logarithmically until a defect height of about 40mm, after which the probability remains constant. At higher step heights the defect is more likely to be noticed so the risk does not increase further.*

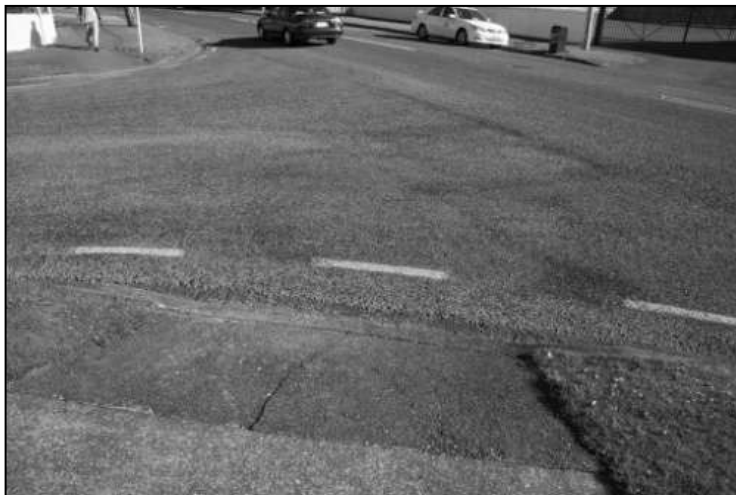
**Figure B1** Long-shot view of accident site 1

### B1 Site 1: loose gravel (residential)

Site characteristic	Mean*
Pavement quality	4.33
Slip resistance	2.17
Slope/gradient	3.33
Trip hazards	5.33
Obstructions	1.00
Collision potential	1.67
Contaminants (eg litter)	1.67
Disabled/impaired access	3.33
Footpath width	1.00
Pathway continuity	1.67
Hazard conspicuity	1.67
Pedestrian design	4.33

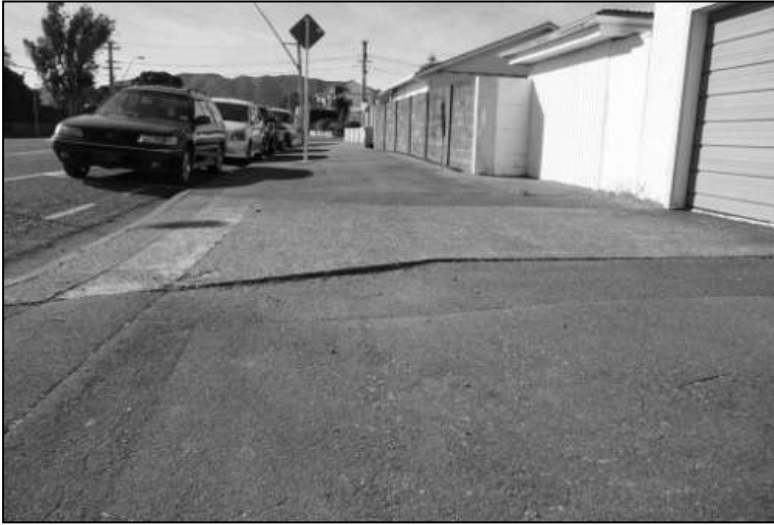
## B2 Site 2: uneven surface (residential)

This was a classic case of deteriorated footpath, where the asphalt developed a hole and the concrete driveway maintained its design, creating an obstacle. This hole was also apparently marked for repair with yellow paint. It had been 18 months since the accident, and the hazard had not been fixed. Special mention needs to be made that the person was preoccupied with carrying a jacket, which was not heavy or bulky, but just prevented protection in the fall.

**Figure B3** Long-shot view of accident site 2

**Figure B4** Close-up view of accident site 2

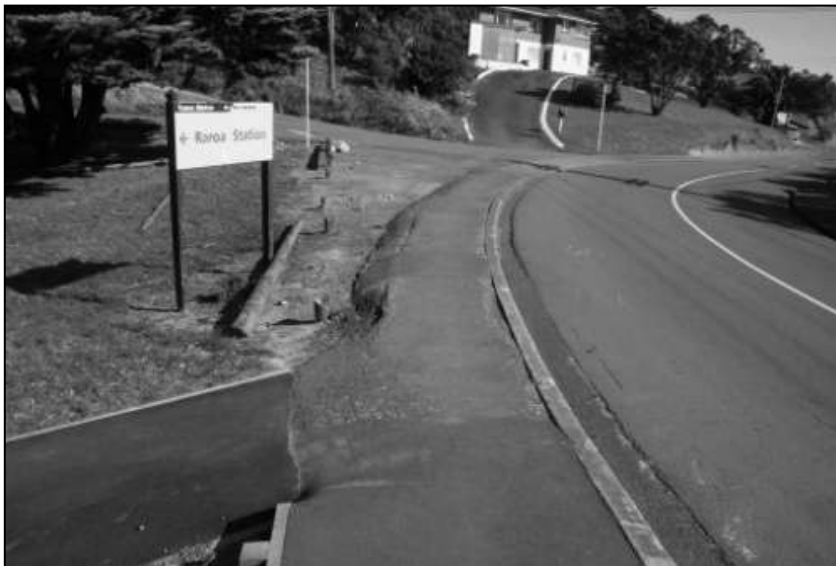
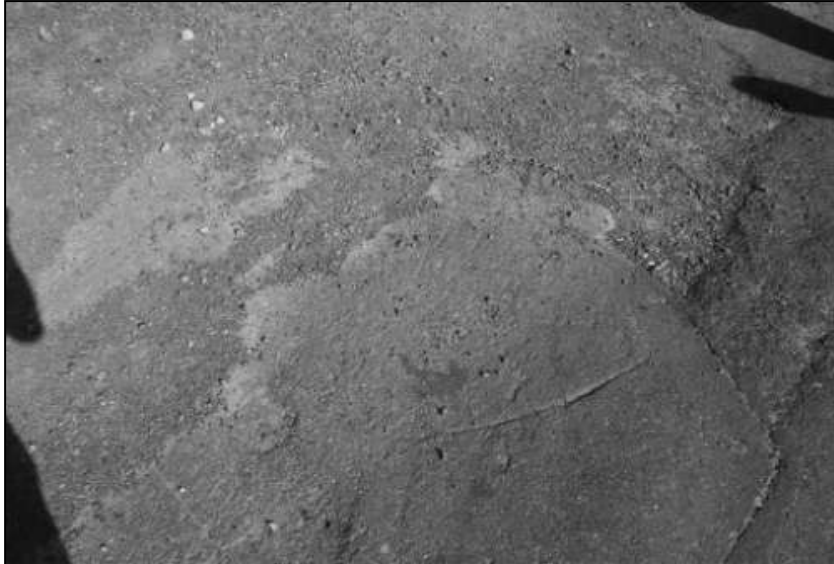
### B3 Site 3: uneven construction (residential)

This path had a rocky surface with gravel. The path needs an upgrade, as it is well used.

**Figure B5** Long-shot view of accident site 3

**Figure B6** Close-up view of accident site 3

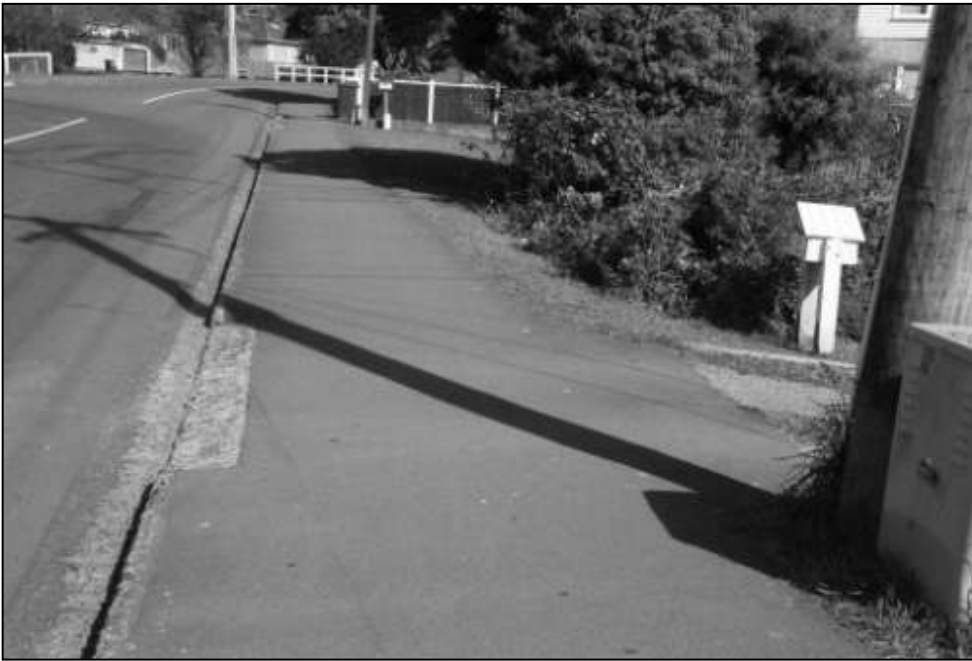
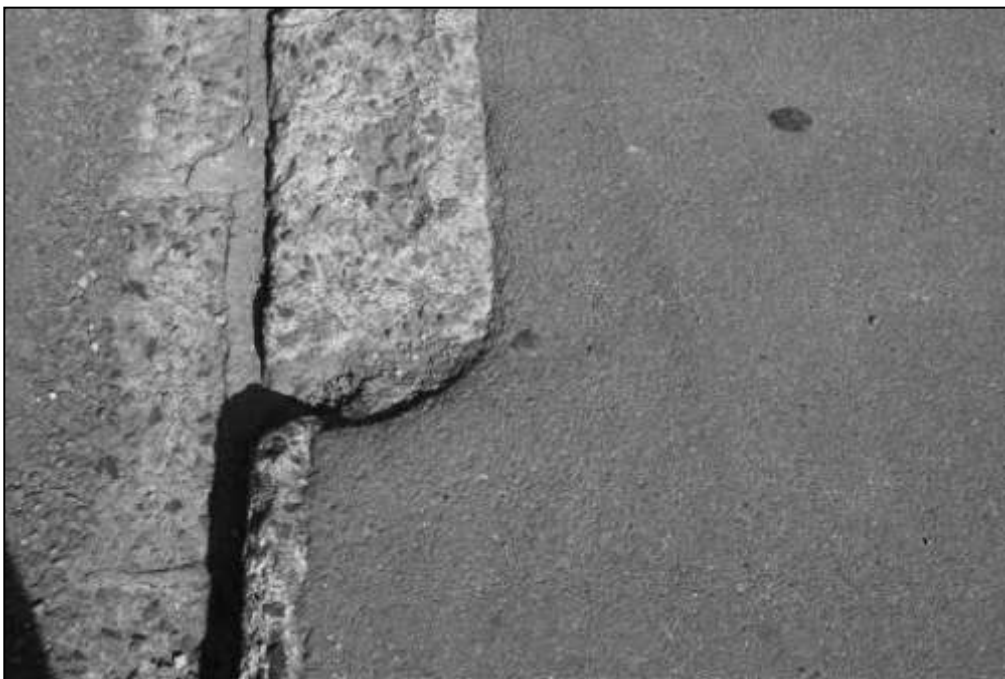
## B4 Site 4: uneven construction (residential)

The uneven footpath contributed to this accident.

**Figure B7** Long-shot view of accident site 4

**Figure B8** Close-up view of accident site 4

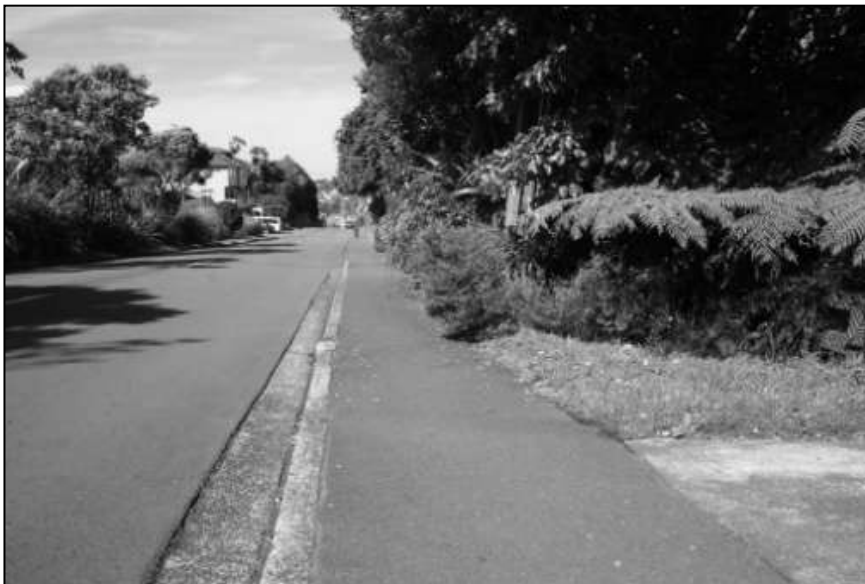
## B5 Site 5: kerb (residential)

While rushing to the bus stop in light rain, the subject slipped off the kerb. The person was rushing because of the weather.

**Figure B9** Long-shot view of accident site 5

**Figure B10** Close-up view of accident site 5

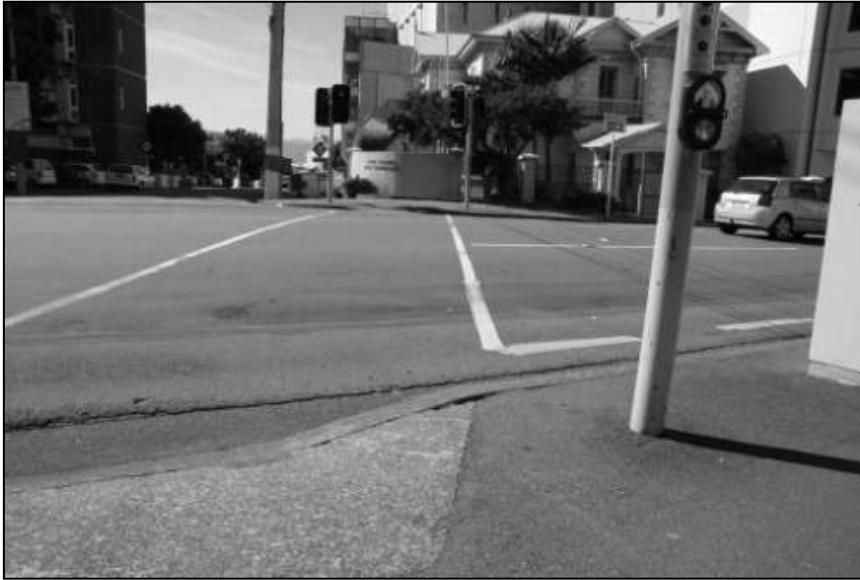
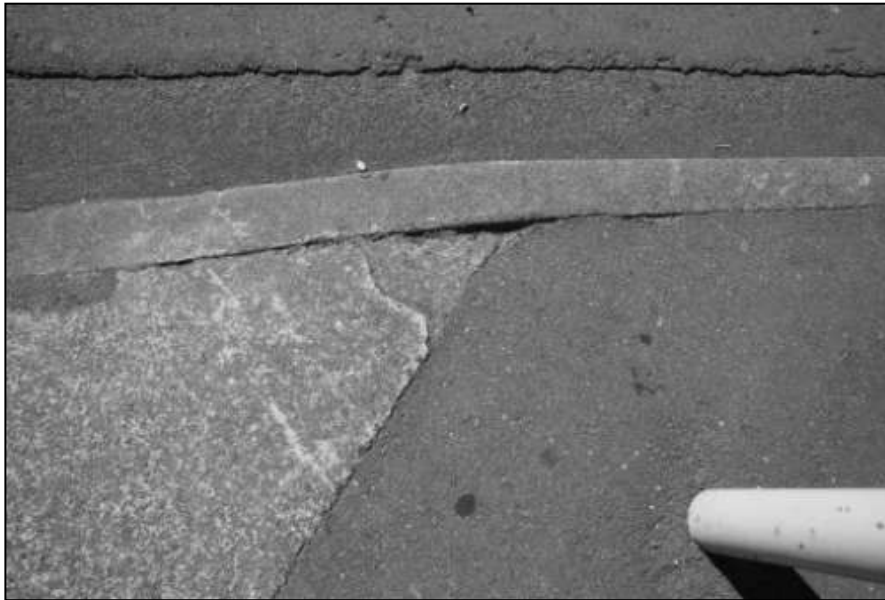
## B6 Site 6: uneven construction (CBD)

While the subject was crossing the road, the signal 'red man' started flashing. The subject picked up his pack and rolled his ankle on the deformed footpath.

**Figure B11** Long-shot view of accident site 6

**Figure B12** Close-up view of accident site 6

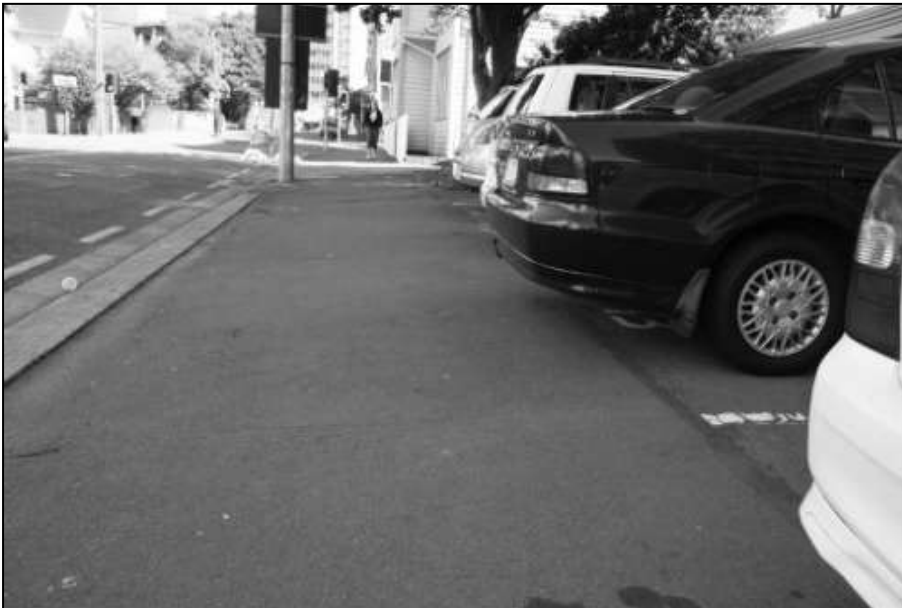
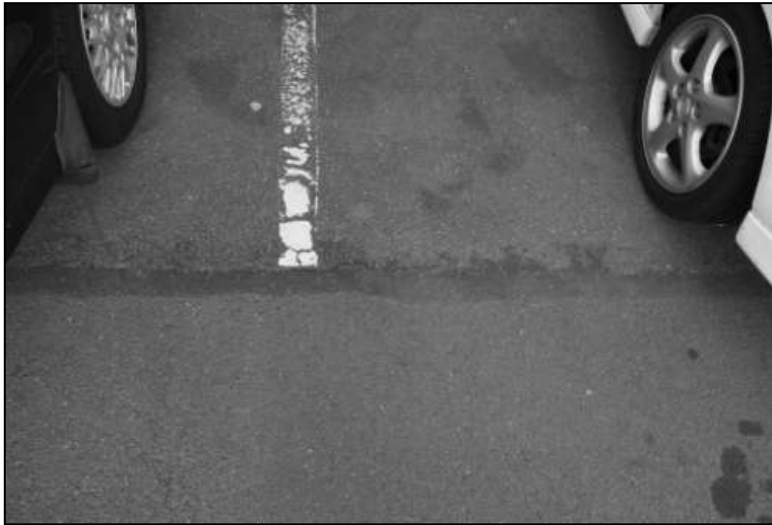
## B7 Site 7: uneven construction (CBD)

The footpath and parking lot are at different levels. The subject tripped on this hazard.

**Figure B13** Long-shot view of accident site 7

**Figure B14** Close-up view of accident site 7

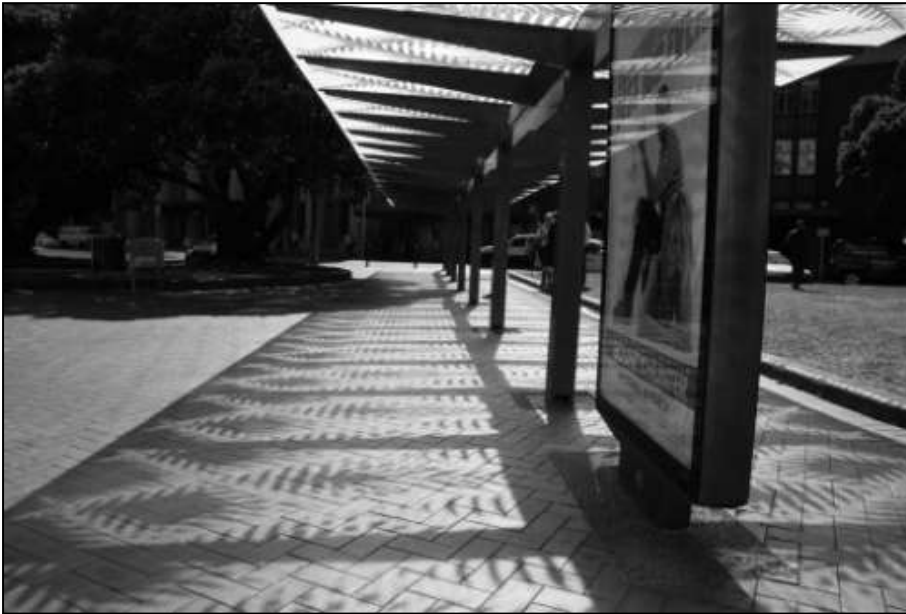
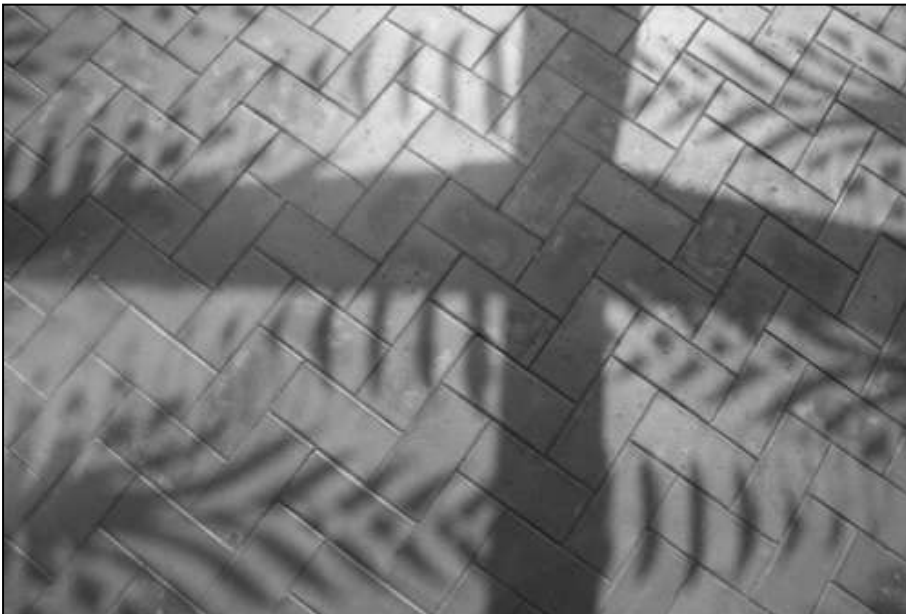
## B8 Site 8: tiled surface (CBD)

The subject slipped on paving bricks on the footpath near the train station; it was poorly lit, raining and the footpath had heavy pedestrian traffic.

**Figure B15** Long-shot view of accident site 8

**Figure B16** Close-up view of accident site 8

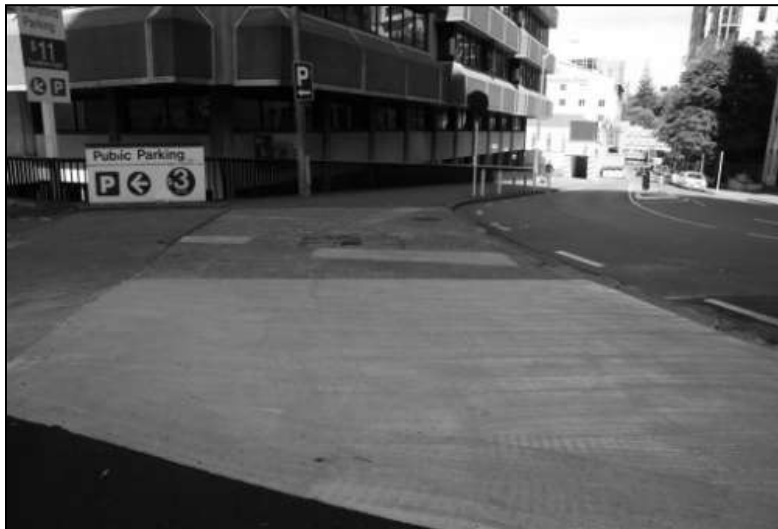
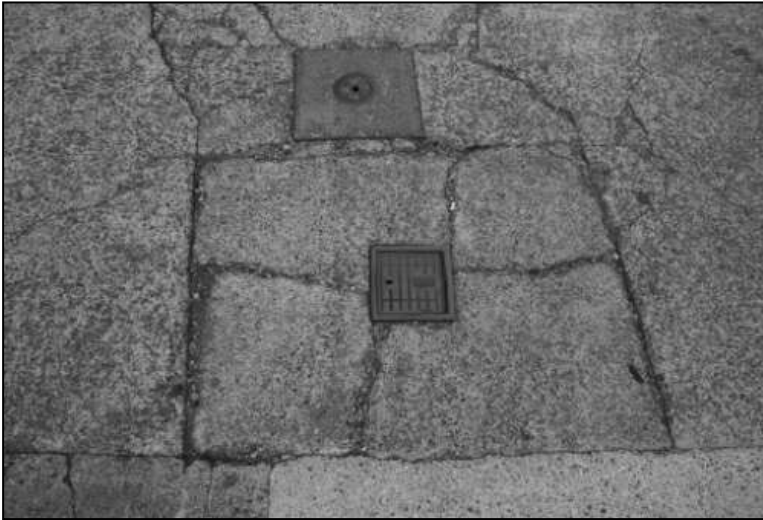
## B9 Site 9: crack in surface (CBD)

While looking for a particular building, the subject did not see the hazard on the footpath and tripped.

**Figure B17** Long-shot view of accident site 9

**Figure B18** Close-up view of accident site 9

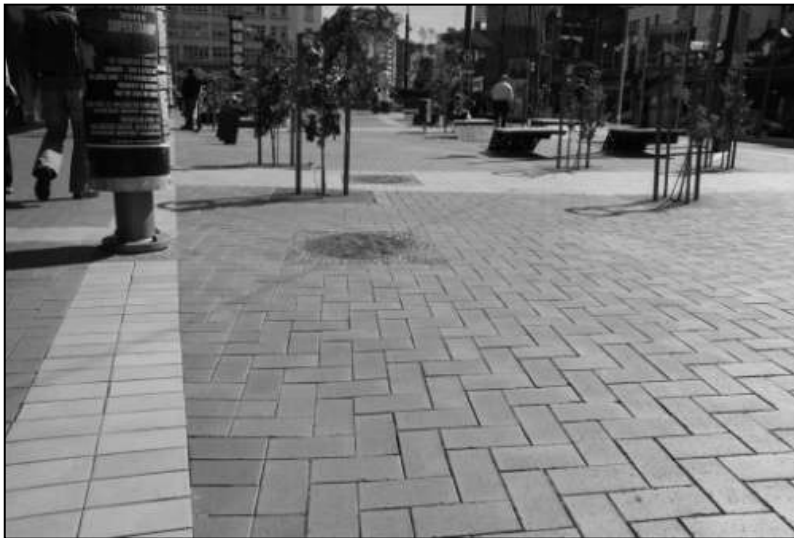
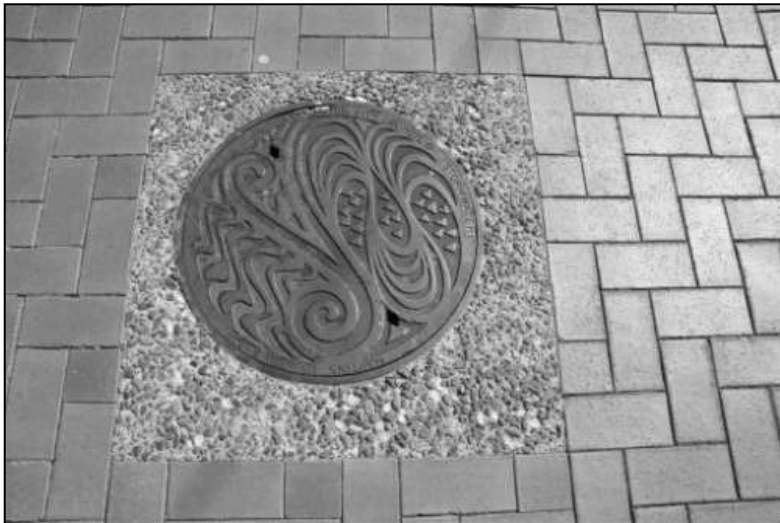
## B10 Site 10: service cover (CBD)

**Figure B19** Long-shot view of accident site 10

**Figure B20** Close-up view of accident site 10

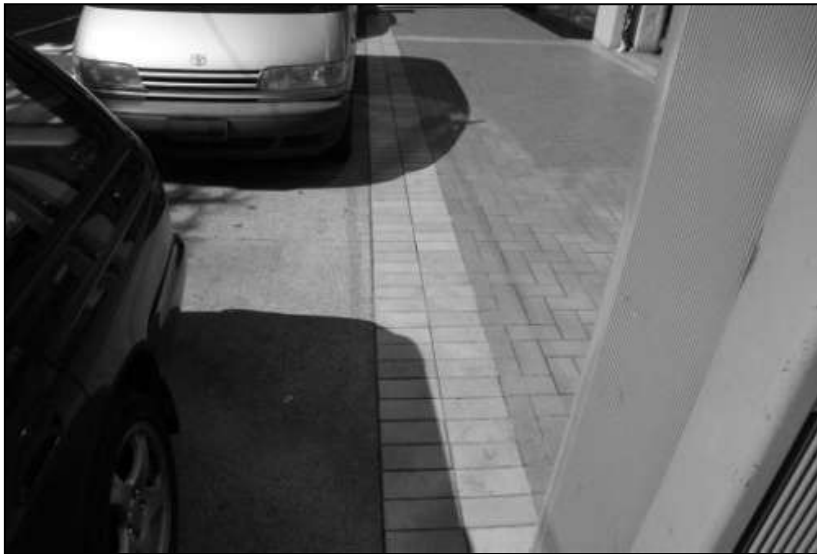
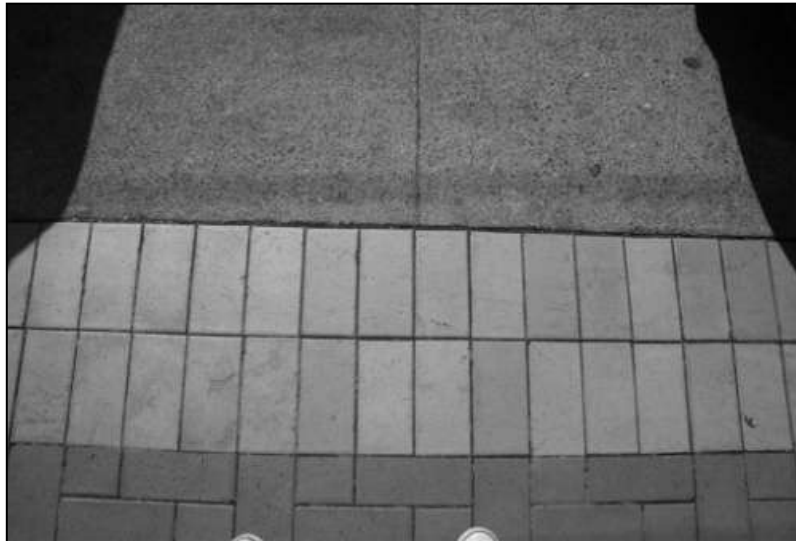
## B11 Site 11: kerb (CBD)

The subject was having a night out, and took a step backward, tripping on the gutter and hitting their head.

**Figure B21** Long-shot view of accident site 11

**Figure B22** Close-up view of accident site 11

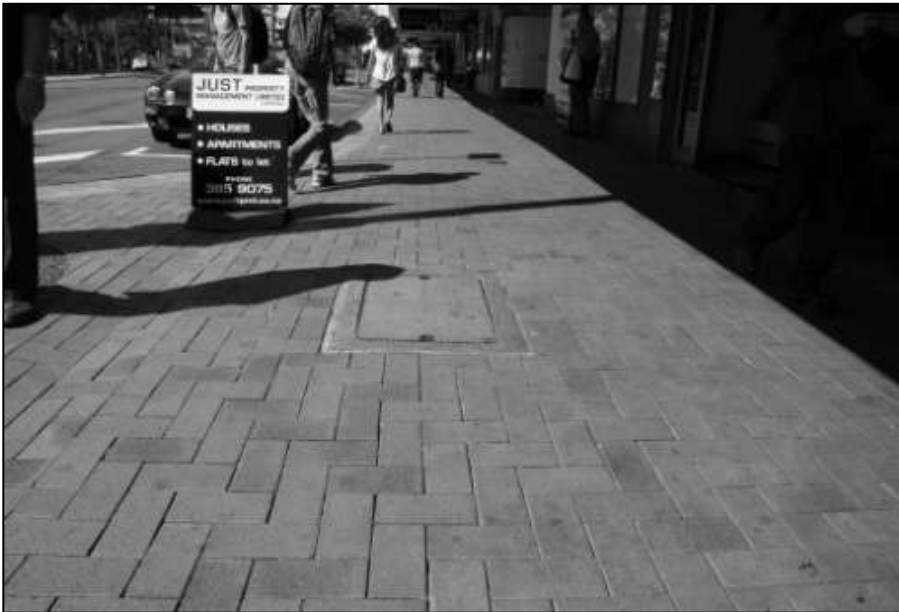
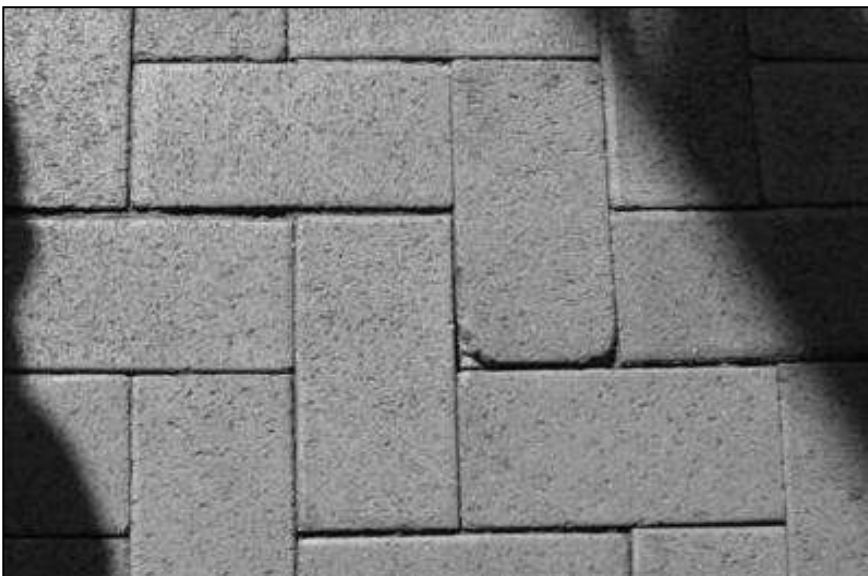
## B12 Site 12: tiled surface (CBD)

Figure B23 Long-shot view of accident site 12

Figure B24 Close-up view of accident site 12

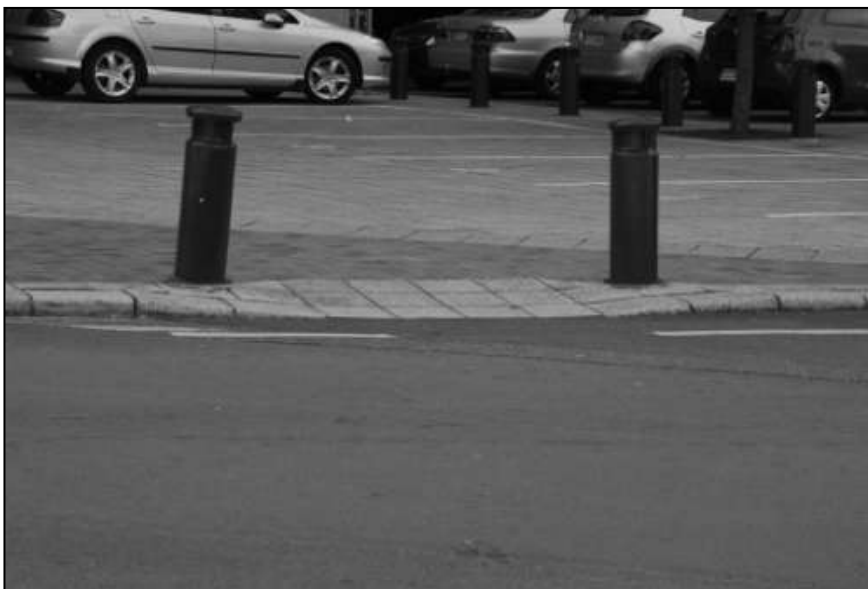
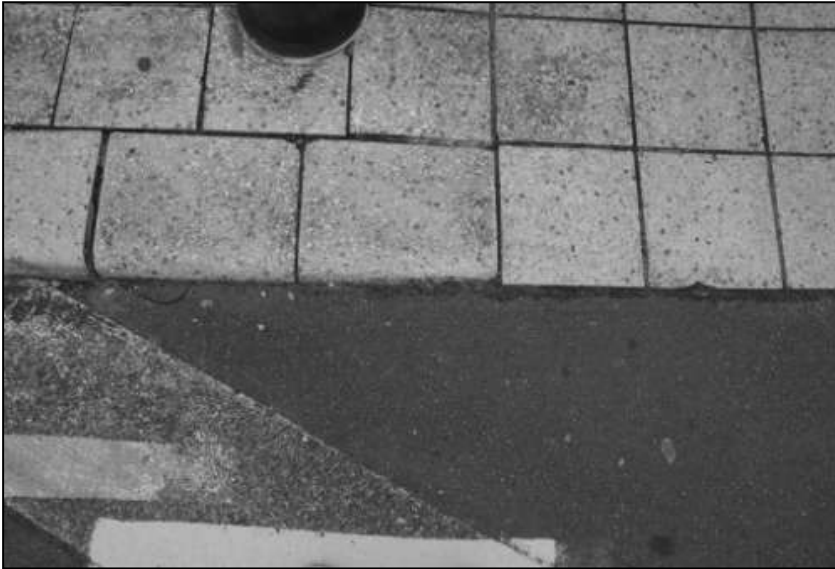
## B13 Site 13: kerb (CBD)

**Figure B25** Long-shot view of accident site 13

**Figure C26** Close-up view of accident site 13

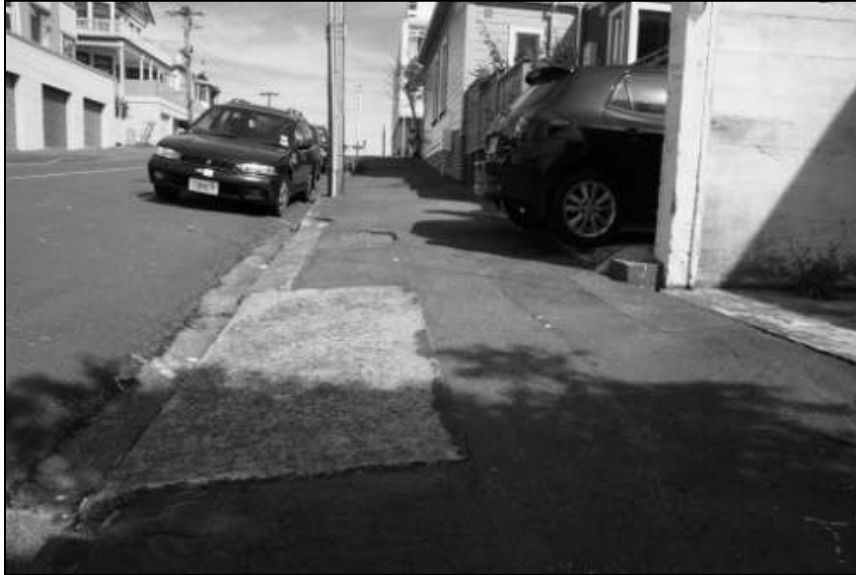
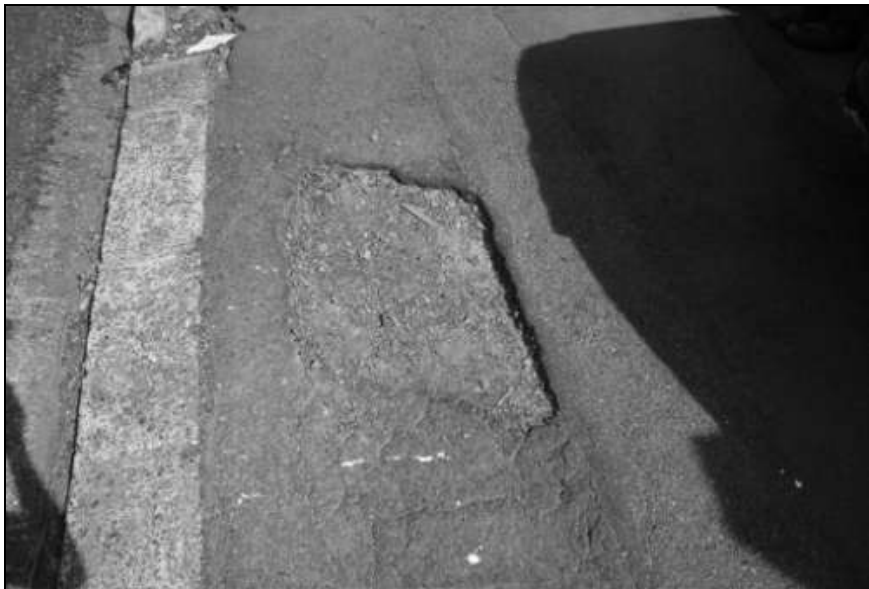
## B14 Site 14: crack in surface (residential)

**Figure B27** Long-shot view of accident site 14

**Figure B28** Close-up view of accident site 14
