# **Benefits of new and improved pedestrian facilities – before and after studies**

**May 2011**

S Turner, R Singh, P Quinn, T Allatt  
Beca Infrastructure Ltd, Christchurch

Turner, S, R Singh, P Quinn and T Allatt (2011) Benefits of new and improved pedestrian facilities – before and after studies. *NZ Transport Agency research report 436*. 142pp.

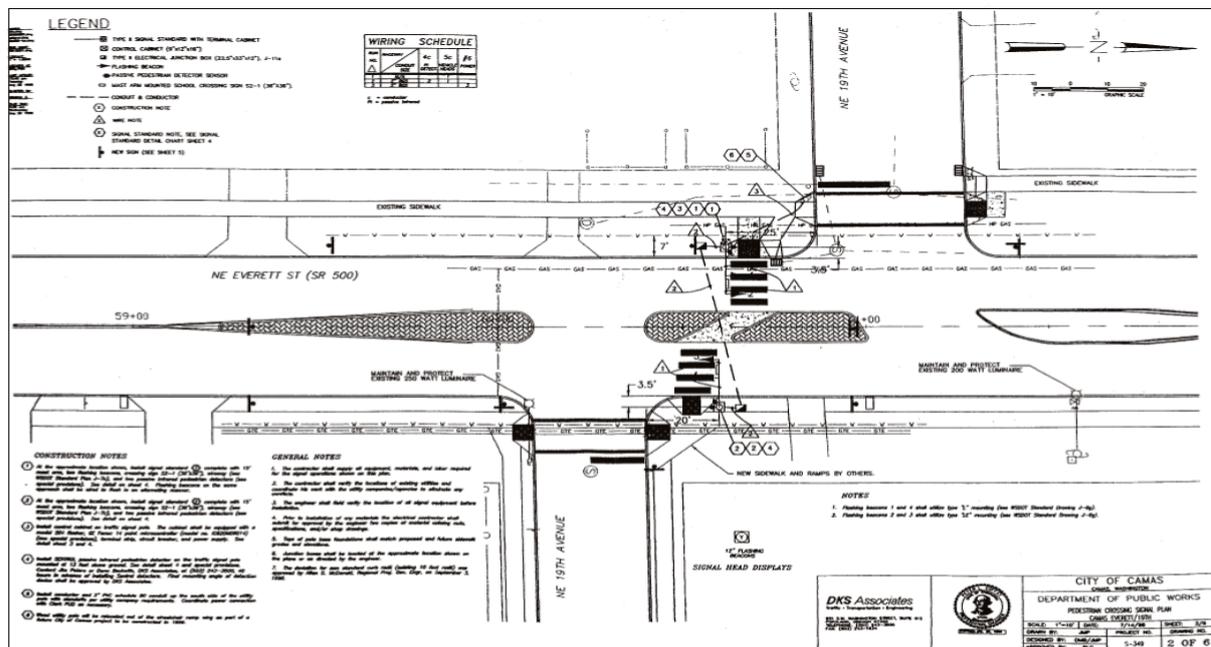
Figure 2.1 – Site plan showing the location of the crosswalk on Everett St (City of Camas 1999)

Table 2.1 shows the results from a before and after comparison survey undertaken at the site. The study found that construction of the crosswalk led to an increase in the number of pedestrians using the facility. A decrease in the percentage of people crossing at other locations on Everett St was observed, although the number of pedestrians crossing at adjacent intersections was found to increase.

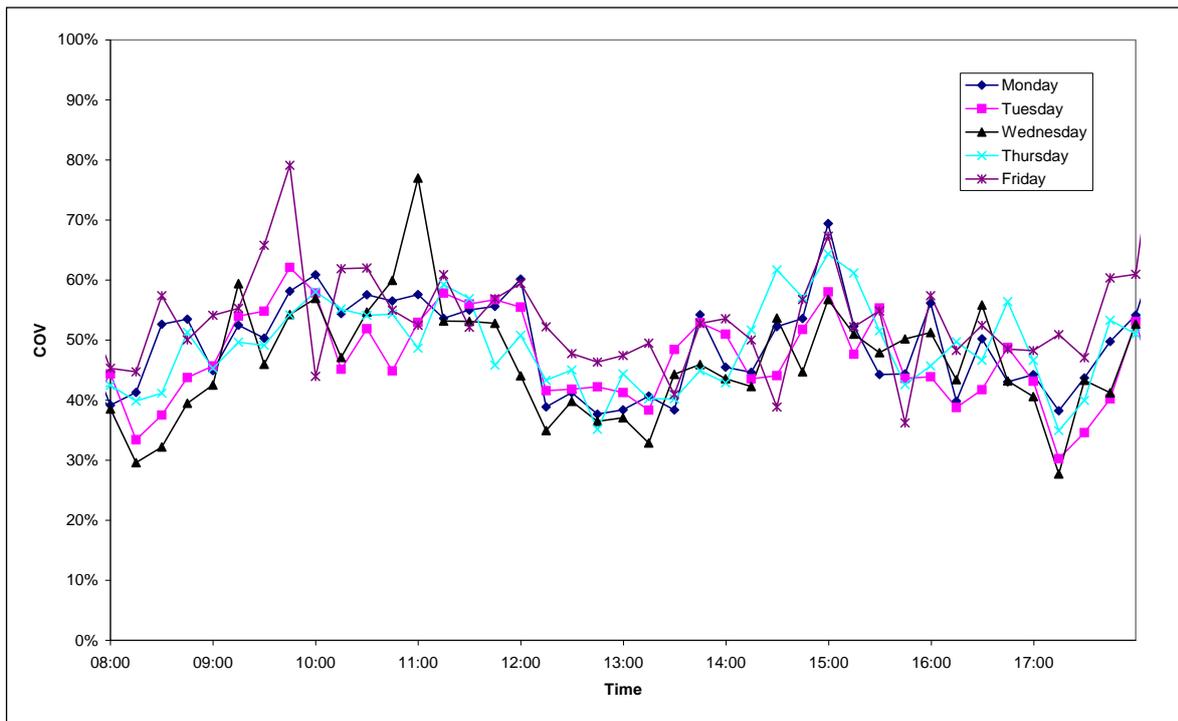
**Figure 3.1** Coefficient of variance between quarter-hour counts on weekdays

Generally, outside of the time period 8am–6pm, pedestrian counts were extremely variable, with the coefficient of variance (COV) exceeding 500% at some times. To reduce variability, it is usually best to survey within this time period; however, we found that some times within this period were better than others, as outlined below.

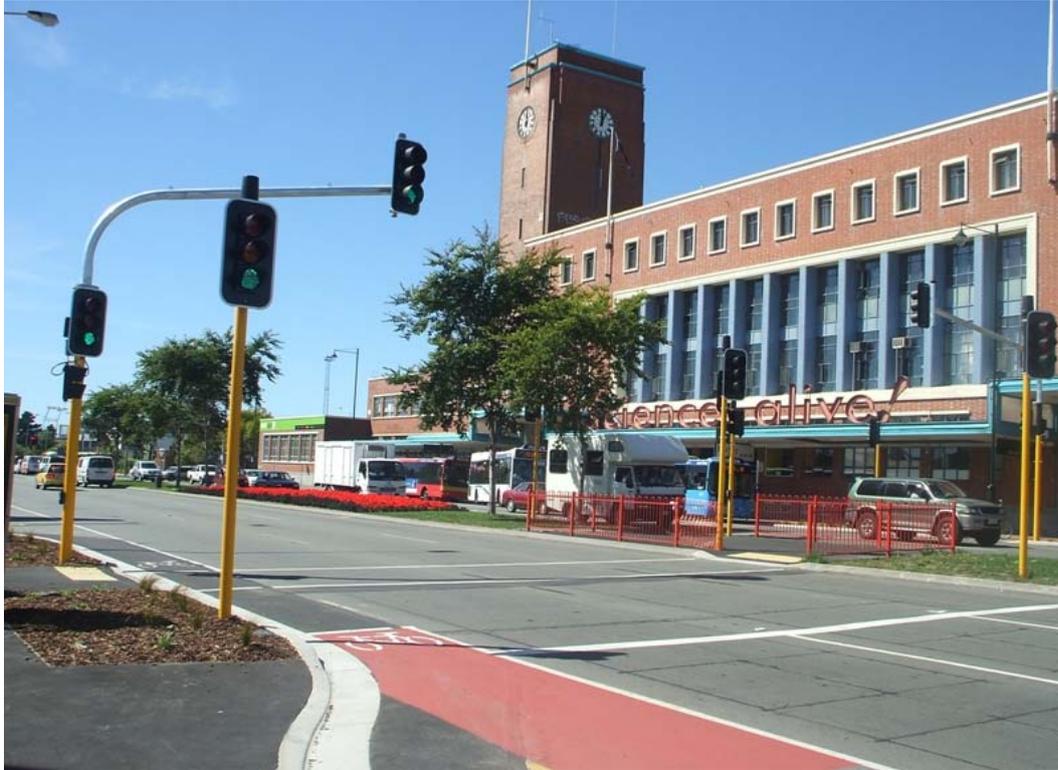
Figure 4.3 The new pedestrian crossing facility on Moorhouse Ave

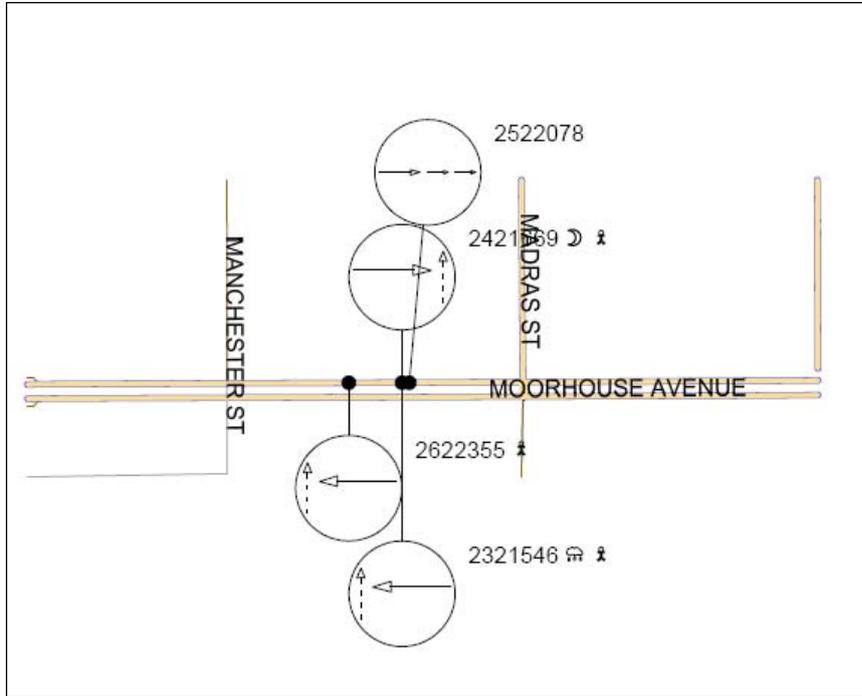
Figure 4.4 Crashes at the Moorhouse Ave/Science Alive! site (2003–2007)

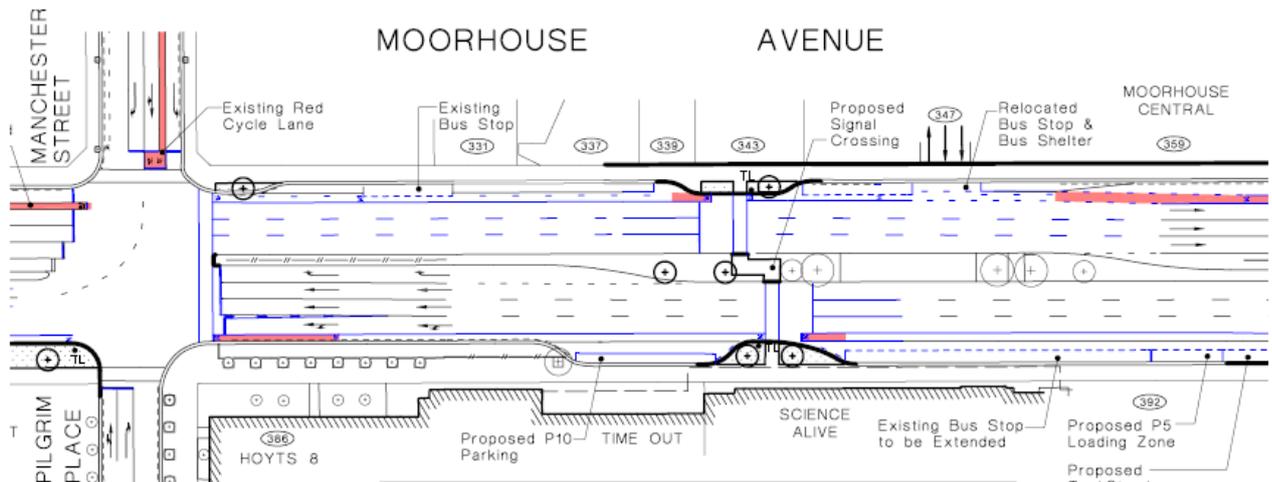
Figure 4.5 Moorhouse Ave pedestrian facility layout plan

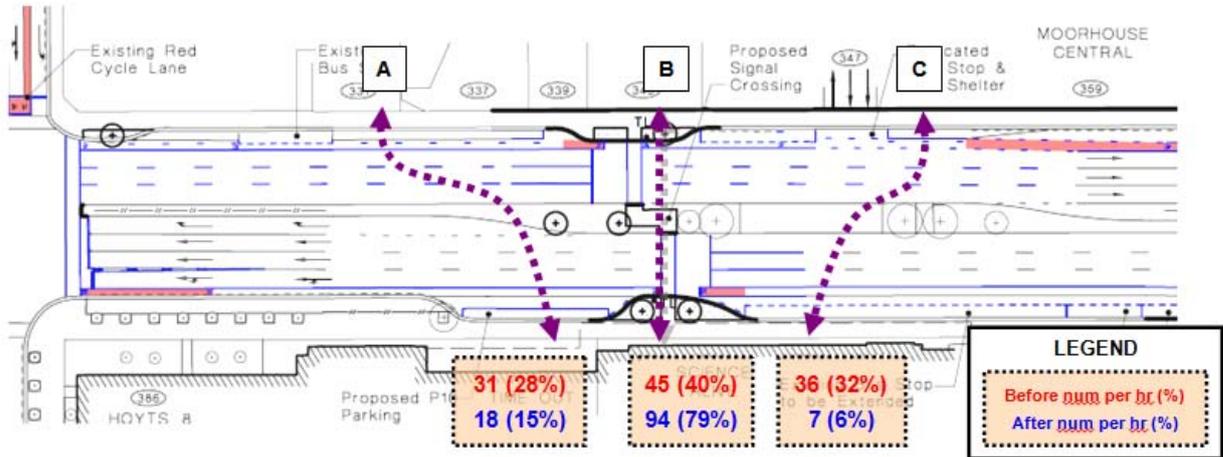
Figure 4.7 Pedestrian desire lines at Science Alive!

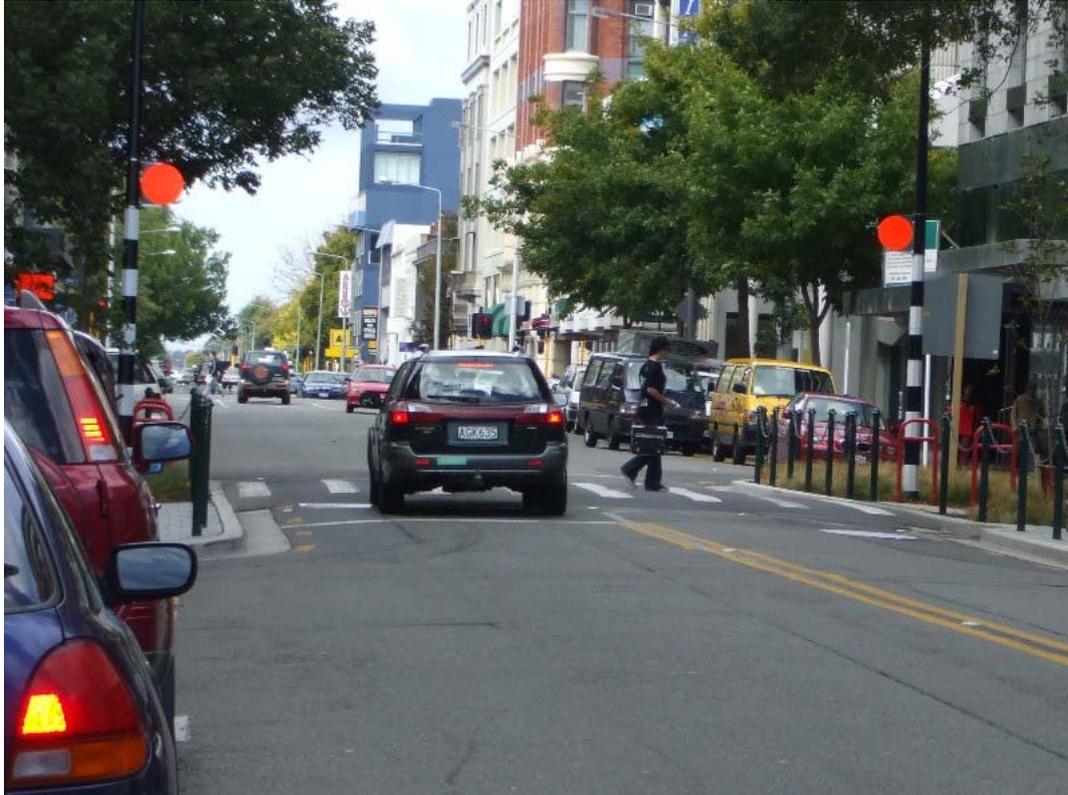
**Figure 4.11** Picture of the Hereford Rd pedestrian crossing facility

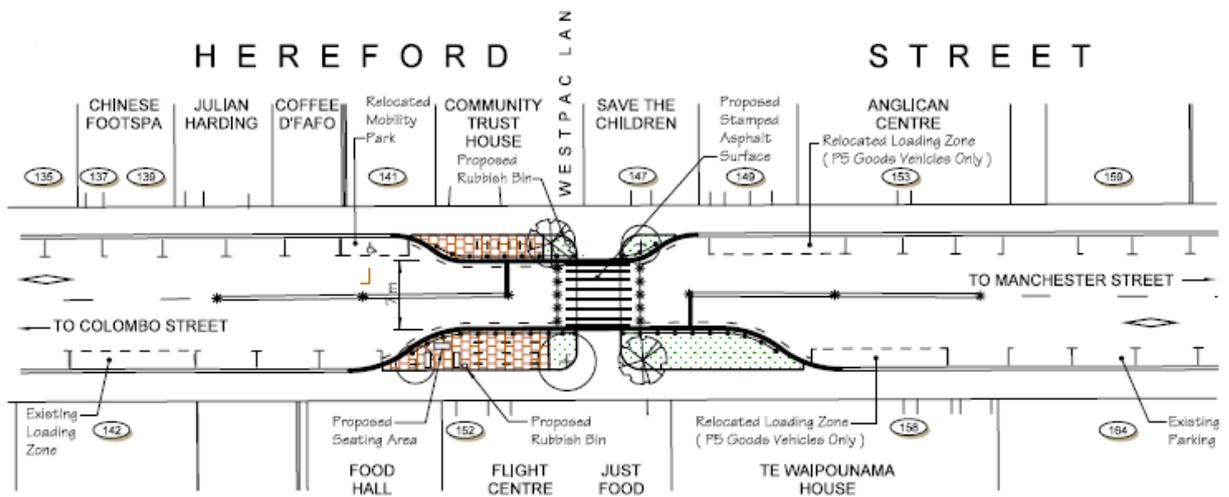
Figure 4.13 Hereford St pedestrian facility layout plan

When Christchurch Community House requested a pedestrian crossing facility in 2003, council investigations found that this section of Hereford St met the Ministry of Transport's 'Warrant for pedestrian crossing'. The council consulted with business occupiers and owners on Hereford St about the need for a pedestrian crossing facility, noting that:

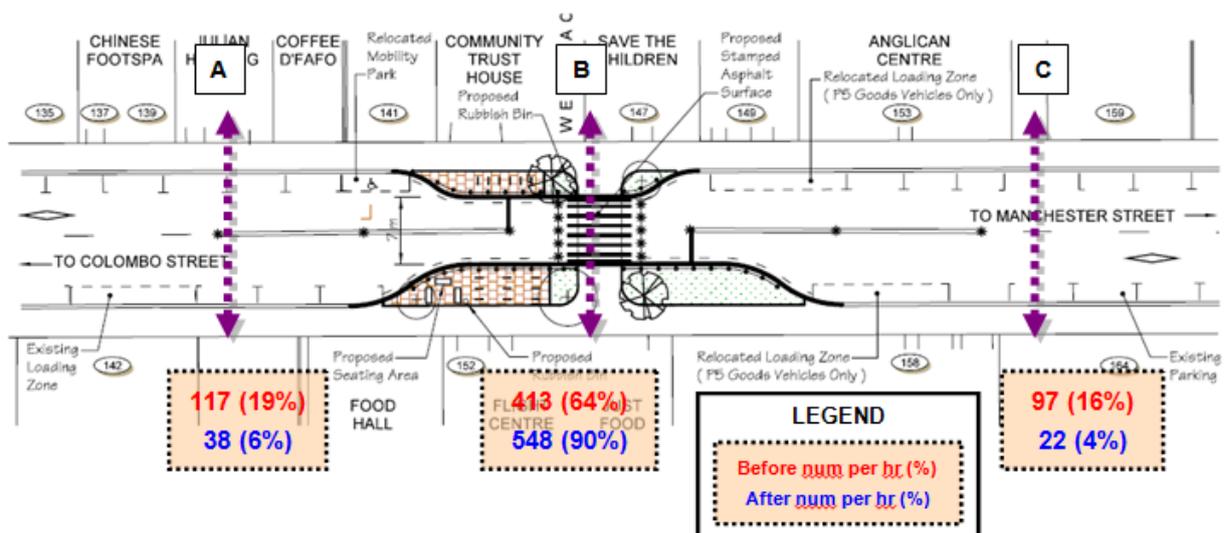
Figure 4.15 Pedestrian desire lines at Westpac Lane/National Mutual Arcade

A key finding from this analysis was that after the implementation of the warning lights, the number of pedestrians within the study area who chose to cross at the facility increased from 413 to 548/hour, ie an increase from 66% to 90%, a significant majority.

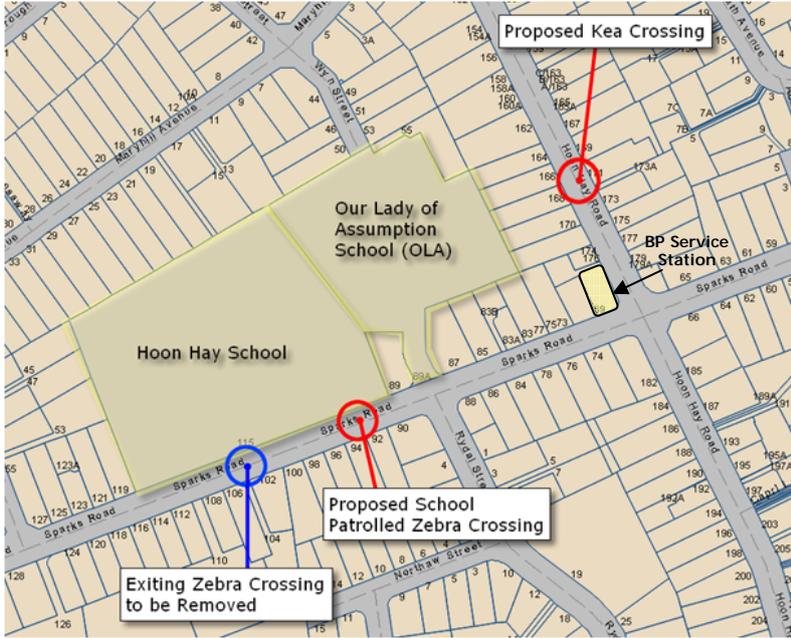
Figure 4.18 Pedestrian facility improvements in Hoon Hay

This project was undertaken by the CCC in response to advice by the OLA School that their pupils were finding it difficult to safely cross Sparks and Hoon Hay Rds on their way to and from school. Following an analysis of the issues at the site and consultation with the schools and local residents, CCC decided to construct a new pedestrian facility in each of these roads (see figure 4.18).

The pedestrian facility improvements on Sparks Rd are described in this case study, and the improvements on Hoon Hay Rd are described in the next case study.

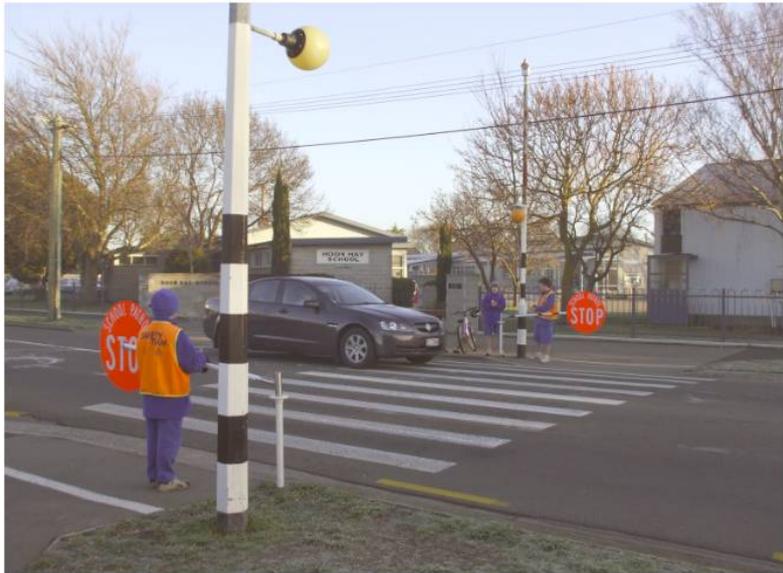
Figure 4.19 Before the change – the school-patrolled zebra crossing outside Hoon Hay School

The improvements made on Sparks Rd involved removal of the existing zebra crossing close to the entrance to Hoon Hay School, and construction of a new school-patrolled zebra crossing midway between the two school entrances.

Figures 4.19 and 4.20 show the crossing facilities on Sparks Rd, before and after implementation of the improvement projects.

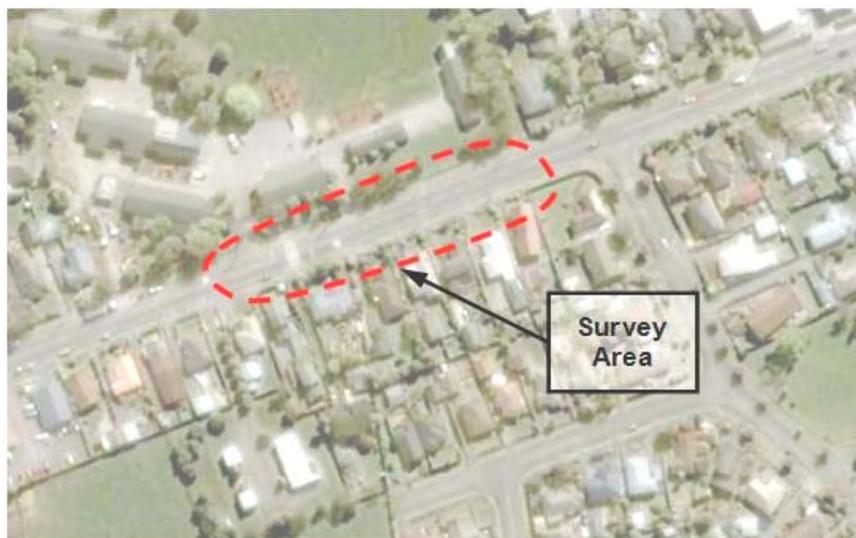
Figure 4.22 Survey area for Sparks Rd

Before and after pedestrian counts were undertaken at the site during June/July 2008 and November/December 2008 respectively. Because of the close proximity of the site to schools, count surveys were conducted for one hour each in the morning (8–9am) and afternoon (2:30–3:30pm) to accurately record the number of crossing pedestrians during the period of maximum usage. The survey area extended from 110m to the west of the proposed school-patrolled zebra crossing, to 80m to its east (see figure 4.22).

The results showed a significant increase in the number of pedestrians crossing within the surveyed area on Sparks Rd after the improvements – from 148 (before) to 228 (after). This represented an increase of more than 50%, and suggested that the removal of the existing zebra crossing and subsequent installation of the school-patrolled zebra crossing made this site more attractive for pedestrians in general, and school students in particular since they derive considerable safety benefits from utilising the patrolled zebra crossing.

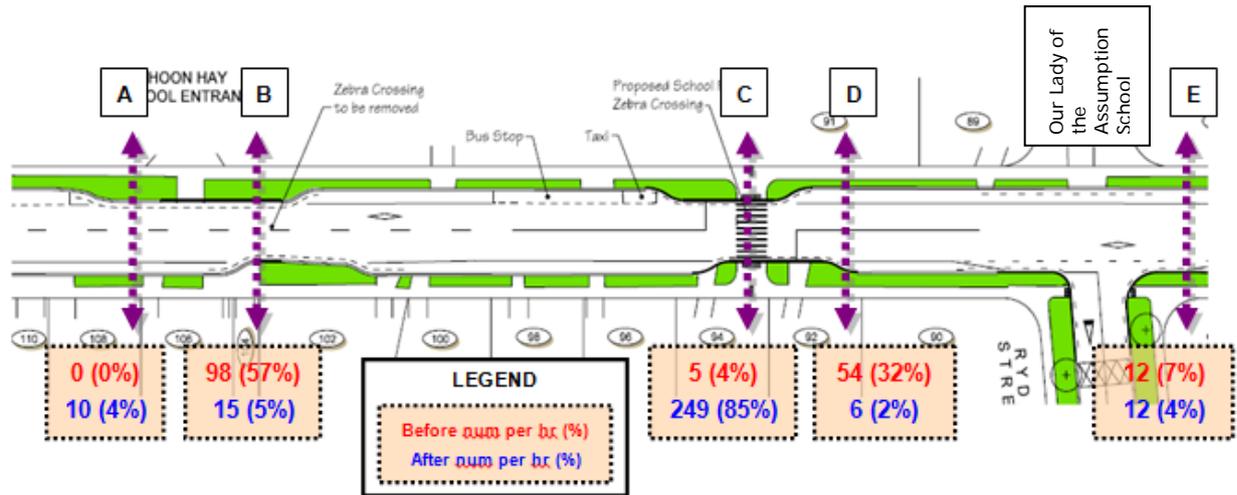
Figure 4.24 Pedestrian desire lines – afternoon period

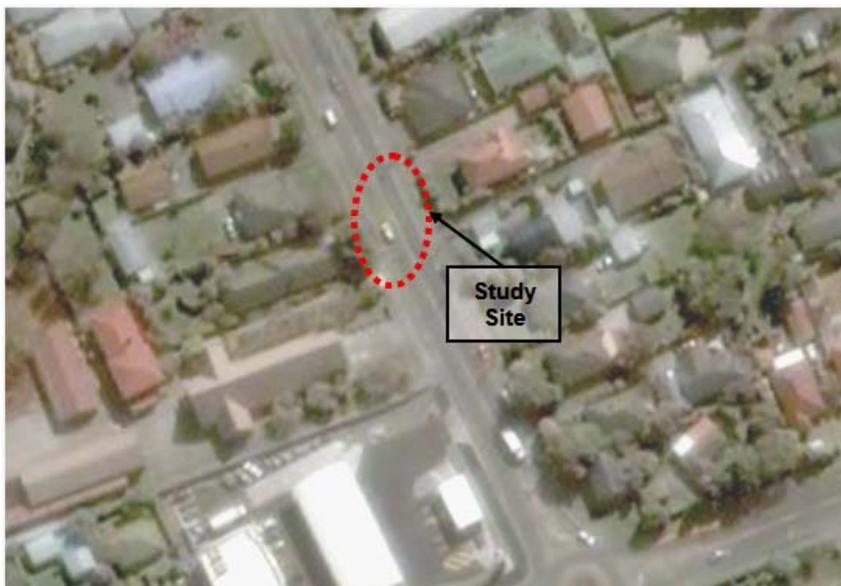
**Figure 4.26** Location of the kea crossing facility on Hoon Hay Rd

The improvements at the site on Hoon Hay Rd involved the construction of kerb extensions and a kea crossing near the entrance to OLA School (see figure 4.26).

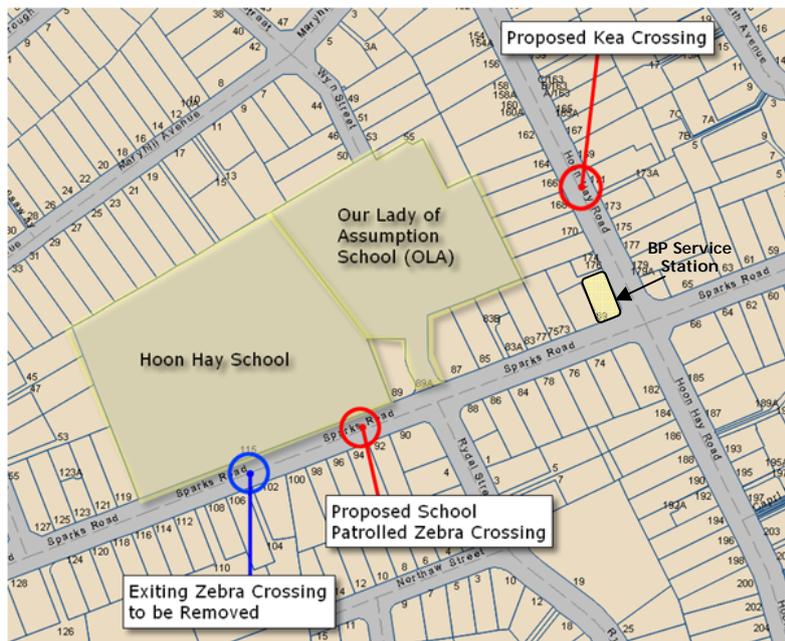
**Figure 4.27 Pedestrian facility improvements in Hoon Hay**

Figure 4.27 shows the locations of pedestrian facility improvement projects in the wider area on Hoon Hay and Sparks Rds, and the location of the two affected schools.

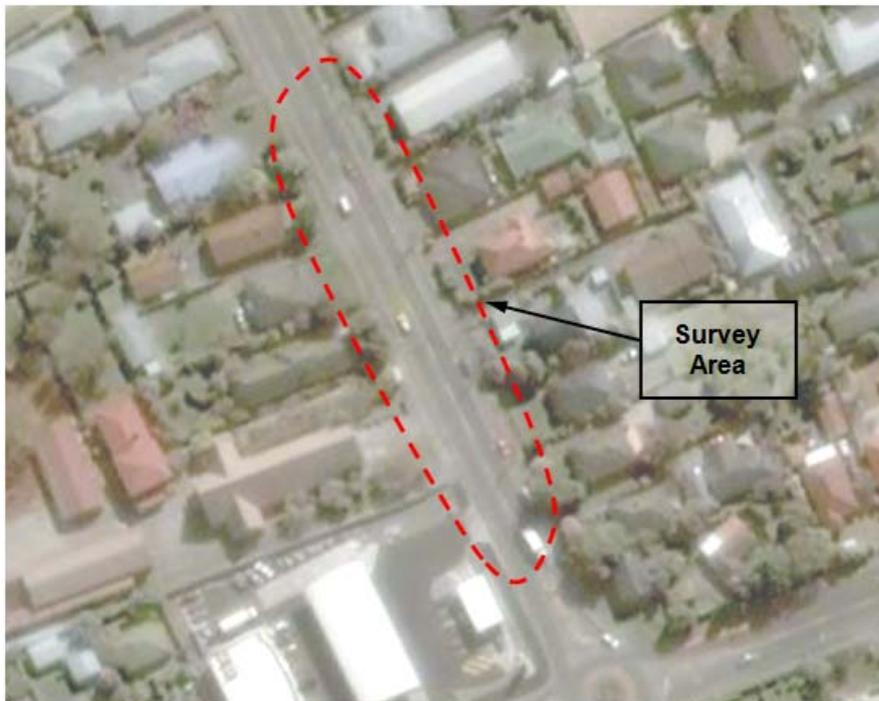
**Figure 4.30** Survey area on Hoon Hay Rd

Before and after pedestrian count surveys were undertaken at the site during June/July 2008 and November/December 2008 respectively. Since the proposed kea crossing would experience significant usage at school opening and closing times, count surveys were conducted for one hour each in the morning (8–9am) and afternoon (2:30–3:30pm) to accurately record the number of crossing pedestrians during the period of maximum usage. The survey area covered a distance of 60m on both sides of the proposed kea crossing (see figure 4.30).

The results showed a significant increase in the number of pedestrians crossing within the surveyed area after the improvements – from 43 (before) to 64 (after). Although the number of pedestrians utilising this crossing facility was low, compared with the other sites that were analysed for this project, this still represented an increase of approximately 50% and suggested that the construction of kerb extensions and the addition of a kea crossing had made this site more attractive to the predominantly student users of this facility.

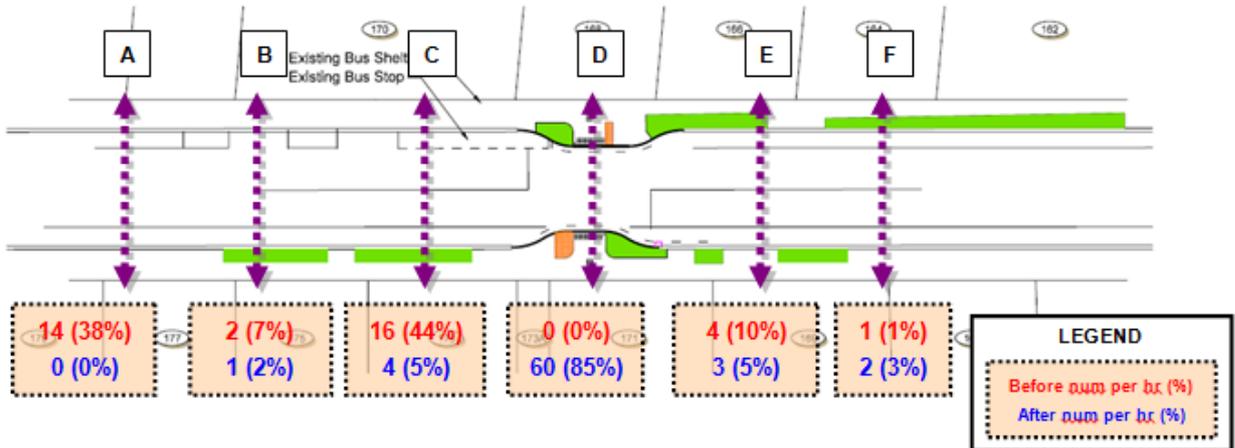
Figure 4.32 Pedestrians’ desire lines – afternoon period

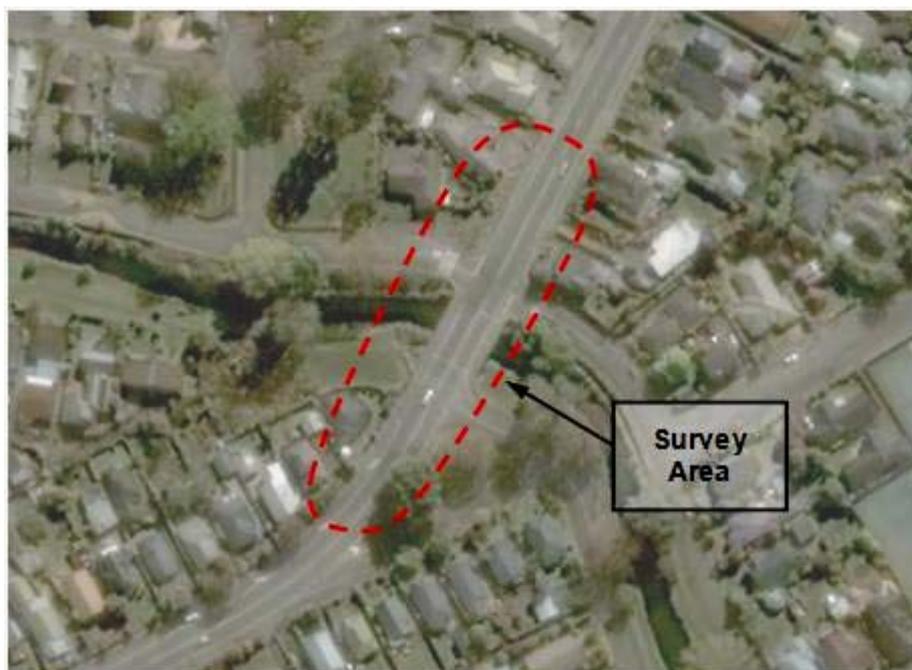
Figure 4.39 Survey area

Pedestrian counts and a questionnaire survey were undertaken at the site in November 2008 (the before survey) and June/July 2009 (the after survey) for a 1.5 hour period (12–1:30pm). The survey area covered a length of Ensors Rd where pedestrians crossed near the proposed pedestrian facility, covering an area of 80m to the south-west of the Ensors Rd/Fifield Tce intersection, and 60m to its north-east (see figure 4.39).

Results of the before and after pedestrian count surveys indicated similar (low) numbers of crossing pedestrians, with seven pedestrians/hour during the before surveys and eight pedestrians/hour during the after surveys.

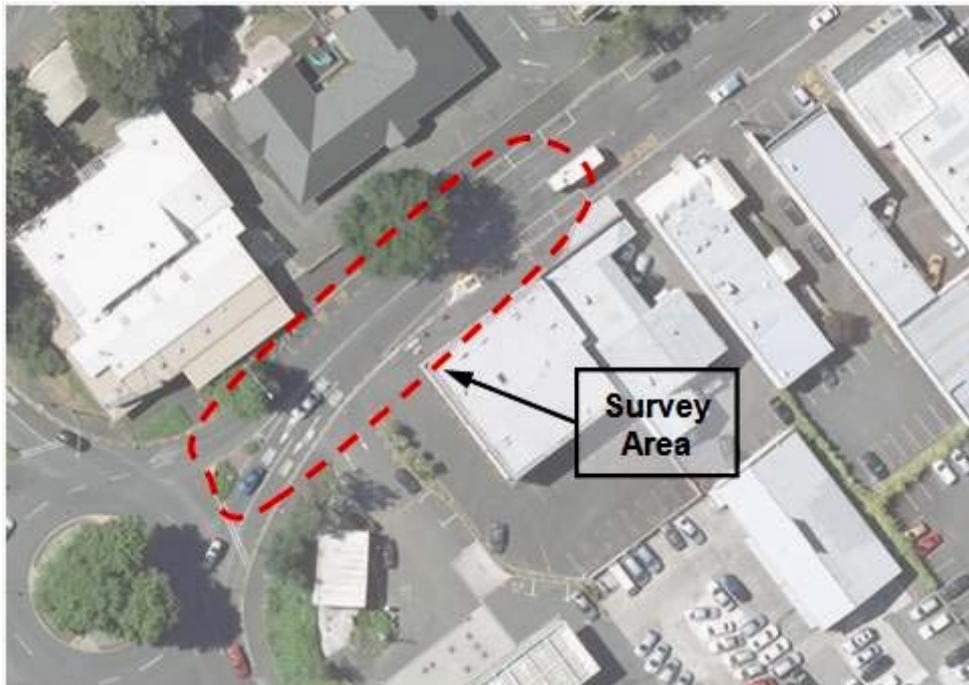
Figure 4.47 Survey area

Pedestrian counts and a questionnaire survey were undertaken at the site in February and October/November 2007. The count surveys were conducted over 1.5 hours during the lunch-time period (12–1.30pm). The survey area covered the length of Collingwood St in the vicinity of the pedestrian facility, and also included the median splitter island (located near the roundabout) that was utilised by some pedestrians while crossing (see figure 4.47). Frequent crossing activity was observed along Collingwood St within 40m to the west and 30m to the east of the crossing facility.

After construction of the facility, the survey counts showed a significant increase in the number of pedestrians crossing within the observation area – effectively doubling from 30 pedestrians/hour during the before survey (February 2007) to 57 after (October/November 2007). This confirmed that the facility was an attractive crossing for pedestrians.

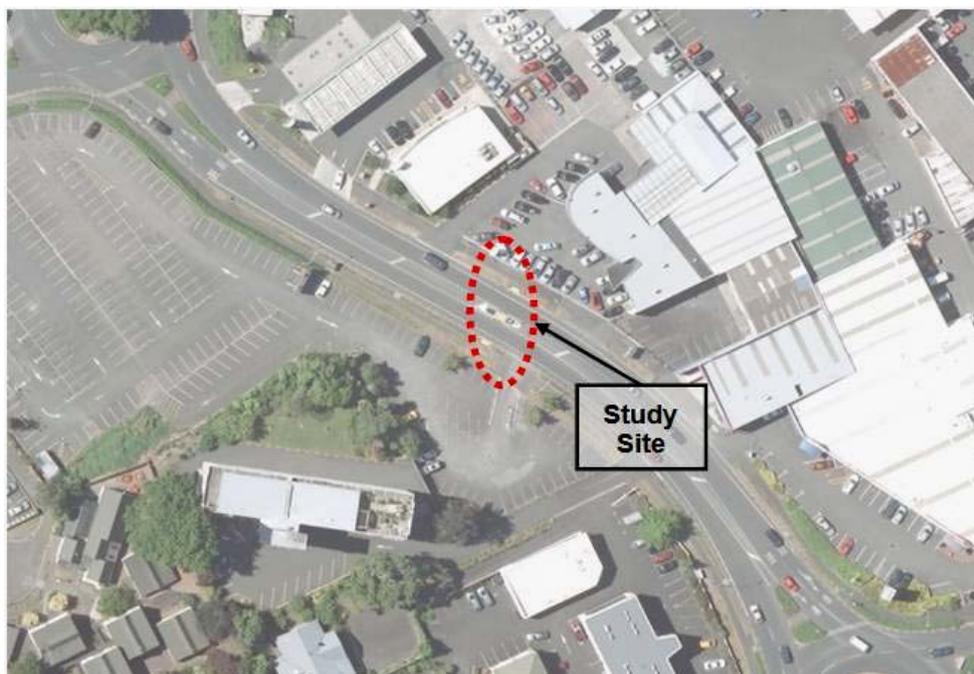
Figure 4.50 Location of study site

Tristram St is a minor arterial road carrying an average daily volume of 21,000 vehicles. The case for a pedestrian crossing facility at this site was part of an 'area work package' to address an identified street-crossing safety issue for pedestrians. The pedestrian route and street crossings of concern, which are on a popular walking route from the Wintech car park to the campus, are shown in figure 4.50, and figure 4.51 depicts the surrounding land use.

The crossing was listed as a high priority on HCC's Minor Traffic Improvements warrant list for the 2005–06 financial year, and the council constructed a refuge island on Tristram St, opposite Garry Keith Motors, to provide a safe crossing point.

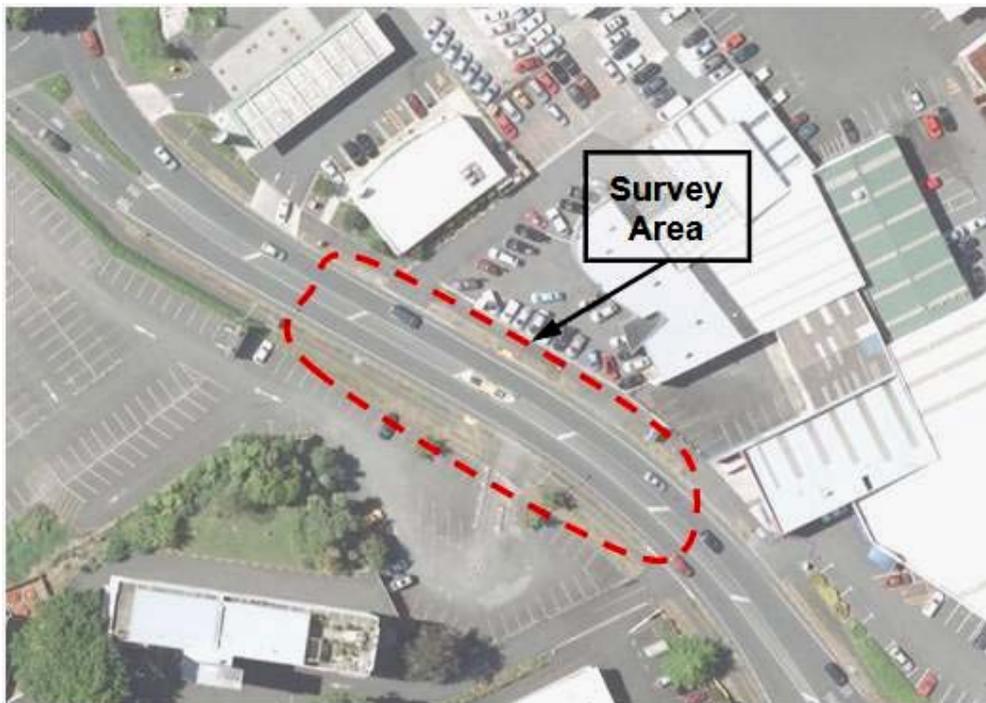
Figure 4.55 Survey area

Pedestrian counts and a questionnaire survey were undertaken at the site in February and August/October 2007 for a 1.5 hour period (12–1:30pm). The survey area was a length of Tristram St where pedestrians crossed near the proposed pedestrian facility, covering an area of 30m to the north-west of the crossing facility towards the Tristram and Collingwood Sts roundabout, and 40m to the south-east along Collingwood St (see figure 4.55).

The results showed a significant increase in the number of pedestrians crossing within the observation area, from 25/hour (before the improvements) to 46 (after) – ie the rate almost doubled, confirming the facility's attractiveness to pedestrians.

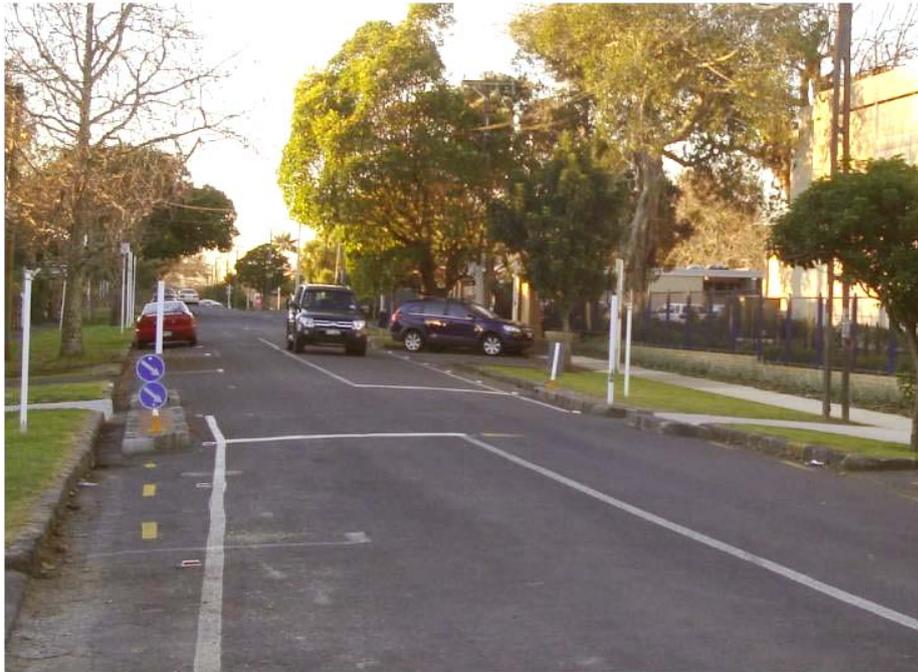
**Figure 4.59** Margot St kea crossing

of the school and the level of roadside activity. Before the construction of the kea crossing, there were on-street parking spaces that were usually occupied during peak times. Double-parking was also common, meaning that traffic in one direction was often blocked. These on-street parking spaces were removed to allow the construction of the kea crossing (see figure 4.59).

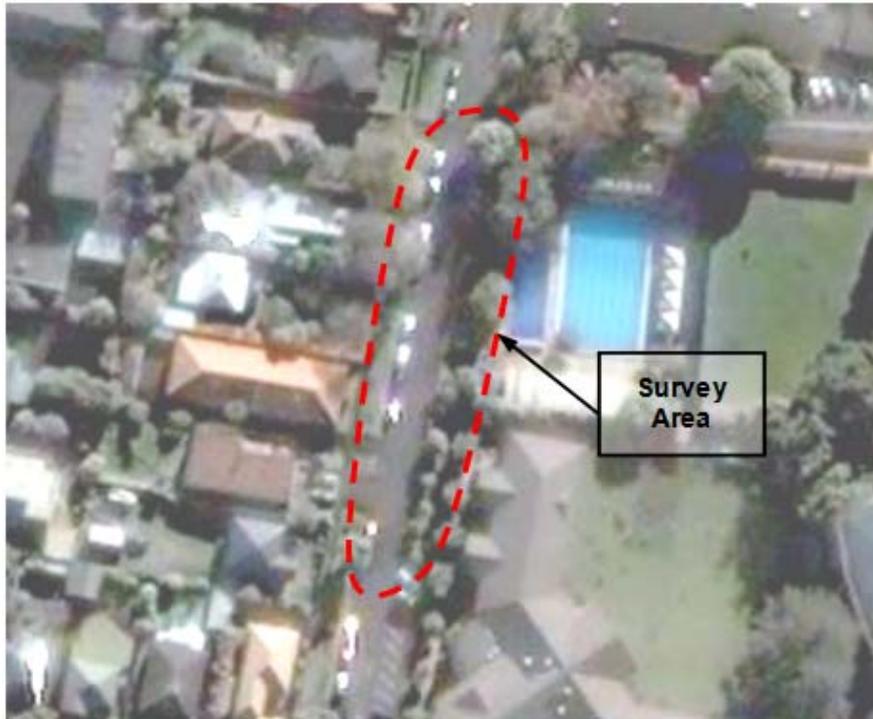
Figure 4.61 Survey area

Before and after pedestrian count surveys were undertaken at the site during October 2008 and June 2009 respectively. Since the proposed kea crossing would attract significant usage at school opening and closing times, the surveys were conducted for one hour both in the morning (8–9am) and afternoon (2.30–3.30pm) to accurately record the number of crossing pedestrians during the period of maximum usage. The survey area covered a distance of 50m on both sides of the proposed kea crossing (see figure 4.61).

The results showed a significant increase in the number of pedestrians crossing within the surveyed area after the improvements. The total number of pedestrians using the site per hour over the two periods (morning and afternoon) increased from 69 (before) to 98 (after). This represented an increase of approximately 42%, suggesting that the construction of the kea crossing and associated side islands and footpath accesses had made this facility more attractive to pedestrians (mostly students) at school opening and closing times.

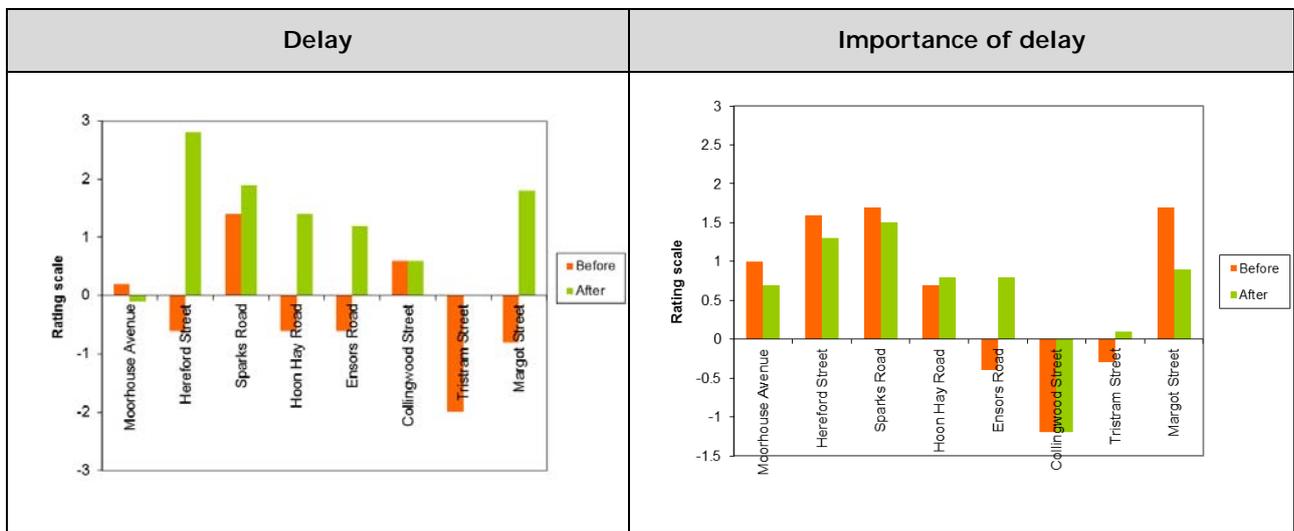
It is clear from the above figure that the implementation of new pedestrian facilities resulted in shorter waiting times for crossing pedestrians at all but two of the locations analysed – Moorhouse Ave (Christchurch) and Collingwood St (Hamilton).

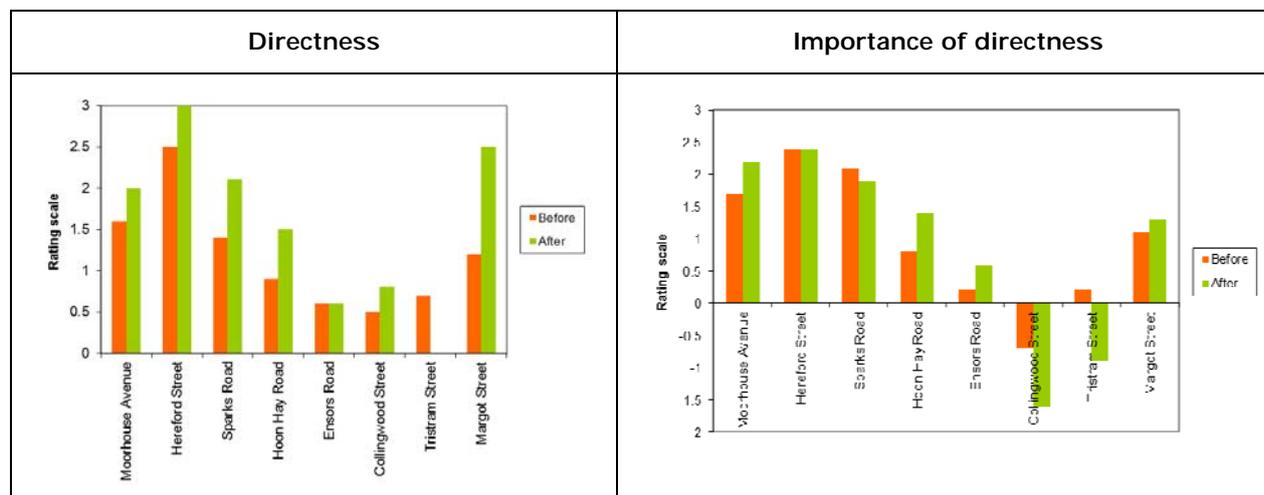
The above figure for directness shows that the improvements at six out of the eight sites provided a more direct crossing path for pedestrians. The exceptions were the refuge islands and kerb extension at Ensors Rd, where pedestrians did not report a change in directness, and the refuge island at Tristram St, where pedestrians reported that the new facility did not lie on the most direct path that they would otherwise have chosen.
