# **Investigating the contribution of sealing chip application rates to the early failure of chipseals**

## **June 2011**

JC Waters  
Fulton Hogan Ltd, Christchurch

Waters, J (2011) Investigating the contribution of sealing chip application rates to the early failure of chipseals. *NZ Transport Agency research report 445*. 86pp.

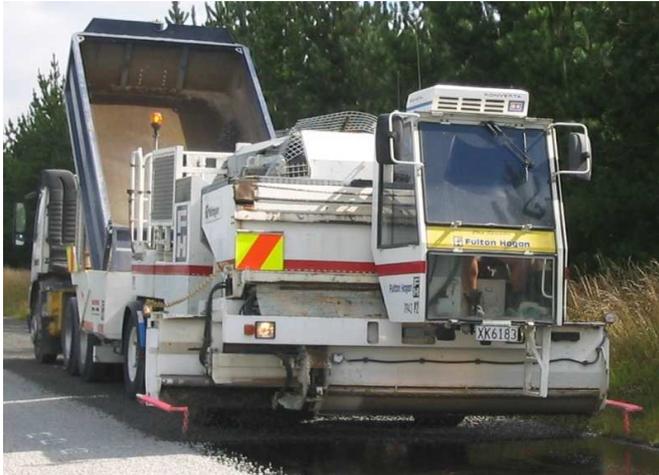
Figure 3.6 Wirtgen applying chip on the Telegraph Rd site

The telescopic spreader box and good control by the operator meant that there was virtually no double application of chip at the joins.

The Wirtgen operator had a numerical target setting that was used for the chip application on the normal section and subsequently on the control section. Variations of the numerical setting were chosen as the targets for the other application rates and the operator changed to these on the run; the only issue was that it took a relatively large distance before the rate changed through the machine, and this resulted in most of the actual application rates being heavier than the target rates.

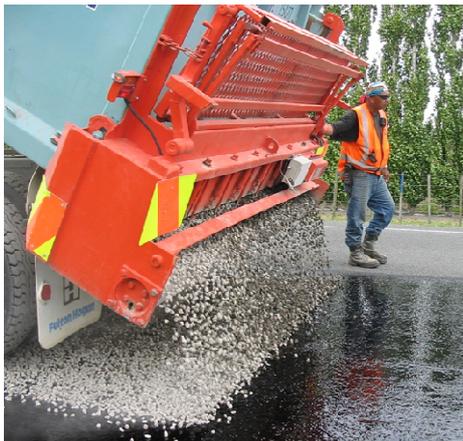
The Bell Rd chip was applied using roller spreaders that could not cover the full lane width. This meant it was spread in two runs to cover the lane, resulting in an occasional double-up of chip application in the overlap area.

**Figure 3.9 Bell Rd site roller spreader application of the grade 2 chips**

Marks were painted on the side of the road and the operator was asked to apply the grade 2 chips at his normal ‘racked-in’ first chip application rate – this created the control section. Then he was asked to increase the rate for 100m, and then apply it at the ‘normal’ rate for the next 100m, then apply it at a ‘light’ rate for the next 100m. The construction direction was towards Napier.

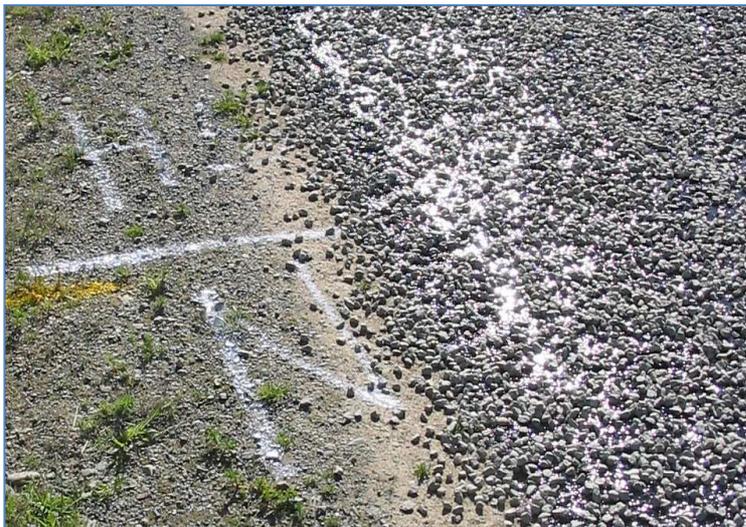
Figure 3.11 Target application rate for grade 3 chip bottom coat

Three target chip application rates for the grade 3 first chip layer were agreed on and called 'light', 'normal', and 'heavy'. The start of each of these sections was marked on the seal and the side of the road (see figure 3.11). It took 10 or 20m for the speed to change on the chipmaster, but once it changed the application rate was reasonably consistent and on target. The sections were constructed so that the site with the 'light' application of grade 3 chip first increased to 'normal' and then to 'heavy' in the direction of the traffic, in case the grade 3 chip moved around.

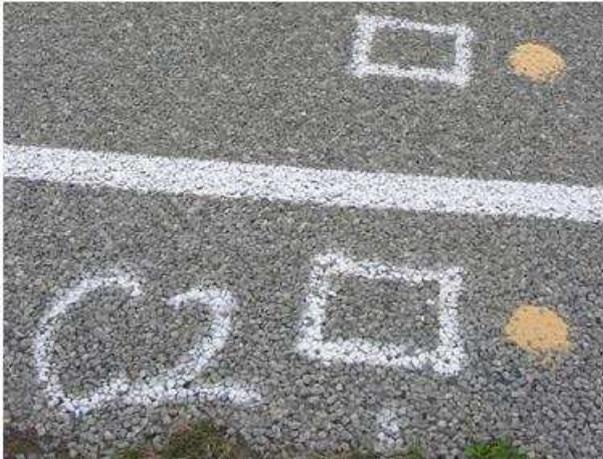
**Figure 5.1** Motukarara C2 shoulder and OWP monitoring frames and sand circles

Texture monitoring was carried out adjacent to each of the monitoring frames, taking care not to test any area that had been affected by previous testing. On some sites where there was residue sand left from the previous testing, the sand circle testing was completed adjacent to the previous test patches on areas that looked similar in texture and level of retained chip.

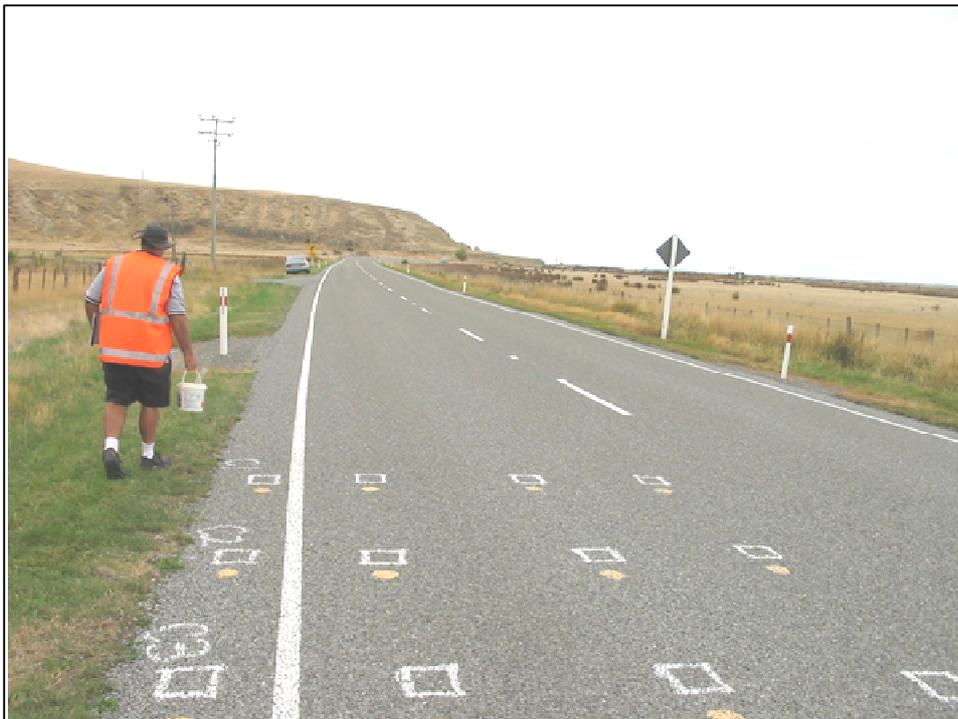
**Figure A1** Sand circling at the Motukarara site

Sand circles should be taken at S, OWP, BWP and IWP, beside the frames.

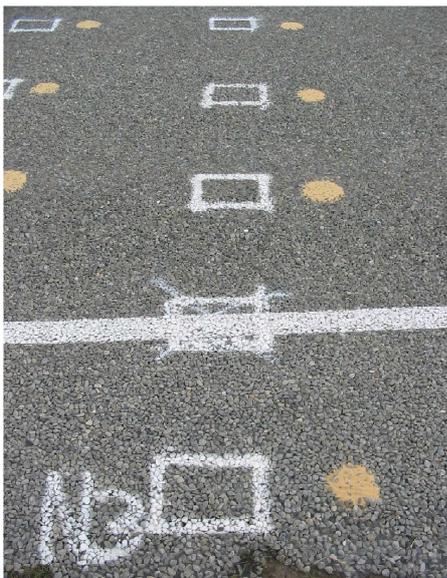
**Figure C1 Roadmarking paint obscuring a frame – photo taken 2 April 2007**

Nine of the frames had to be shifted, as 3 sections were located too wide and 9 OWP frames were painted over with the edgeline (see figure C1). To solve this problem, the original 9 BWP frames became OWP, the original 9 IWP frames became BWP, and 9 new IWP frames had to be established a week after construction. Unfortunately this meant there were no original photos of the initial chip application rate for these 9 new frames, so this was estimated.
