Stormwater Swale Planting Improvements - 2011

Newton Swale Planting Trial (March 2011)

Executive Summary

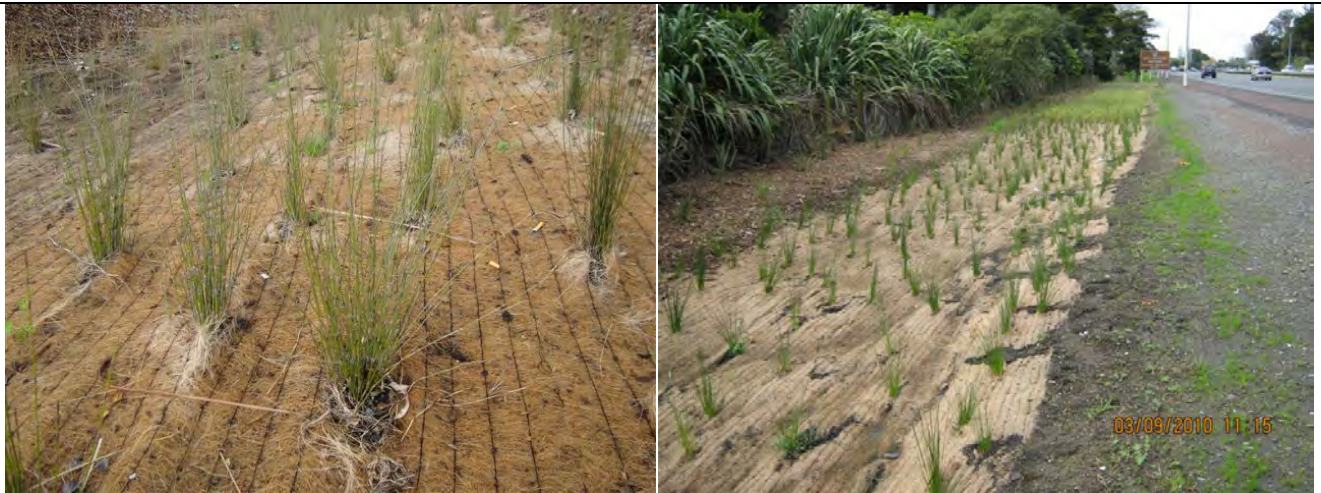
Newton, with significant pre-spraying, had the least weed invasion (Figure 2). Alfriston, with a moderate level of spraying, experienced a moderate amount of weed invasion (Figure 2). Silverdale experienced a significant infestation of Kikuyu and weeds. The results from the stage 1 sites indicate a robust pre-spraying of the weeds before planting of swales needs to occur. Discussions with landscape architects and maintenance contractors suggest that a 5, 3 and 1 week pre-spraying regime would be the ideal for most sites.

Figure 2: a) Newton site showing excellent weed suppression 4 months after installation; b) Alfriston showing only limited weed growth 3 months after installation

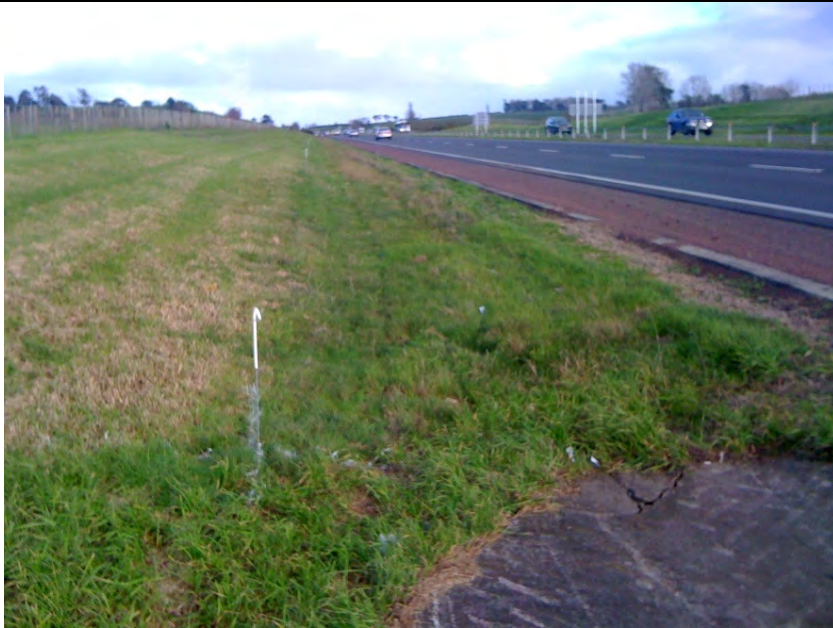
Figure 3: Set-out of the Silverdale swale site

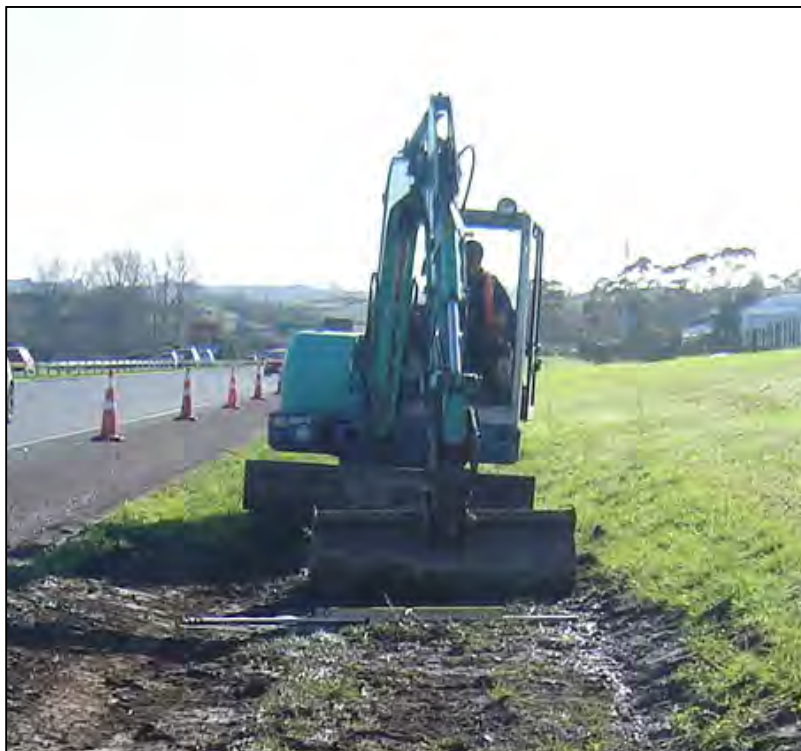
Using a level staff the operator set the level in front of the machine and shaped the base and side slopes of the swale. This methodology is considered appropriate for the level of accuracy required for a swale. Minor variations to the cross-section of a swale will not have a significant impact on the ability of swales to convey water. It should be noted however that an experienced operator should be used in all instances, for better accuracy and speed of construction. All of the stage 1 sites were constructed to the specified dimensions and to date have not required any repair to their shape.

Figure 4: Excavator shaping the Silverdale swale

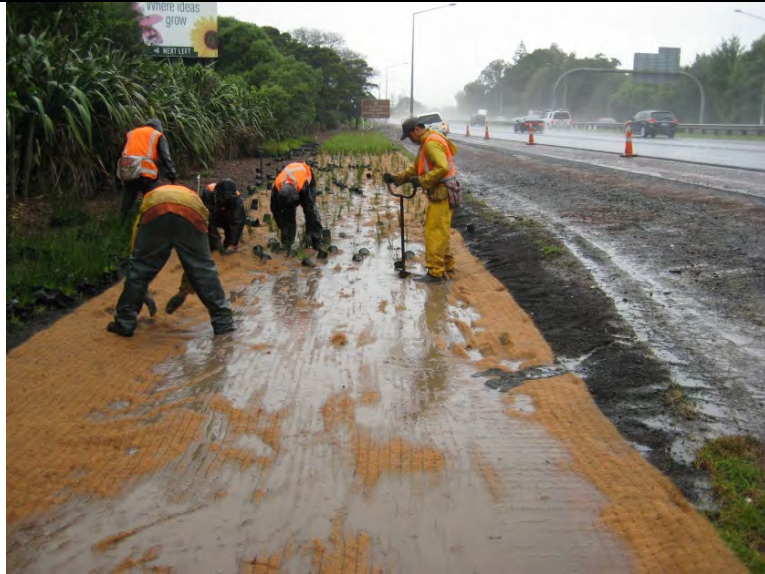
Mats should not ideally be installed or worked on during wet weather as operators walking on the mat in wet weather can cause the mat to bunch and channelisation and ponding can occur. This is undesirable and it is recommended that installation of the weed mats and planting occurs during fine weather. Time constraints meant that the Silverdale and Alfriston sites were planted during inclement weather, which reduced the initial quality and effectiveness of the finished swale. Over time the mat has settled and formed as per the original specification. Swale establishment and planting should take place between October and March.

Figure 6: Operators planting the trial species during wet weather

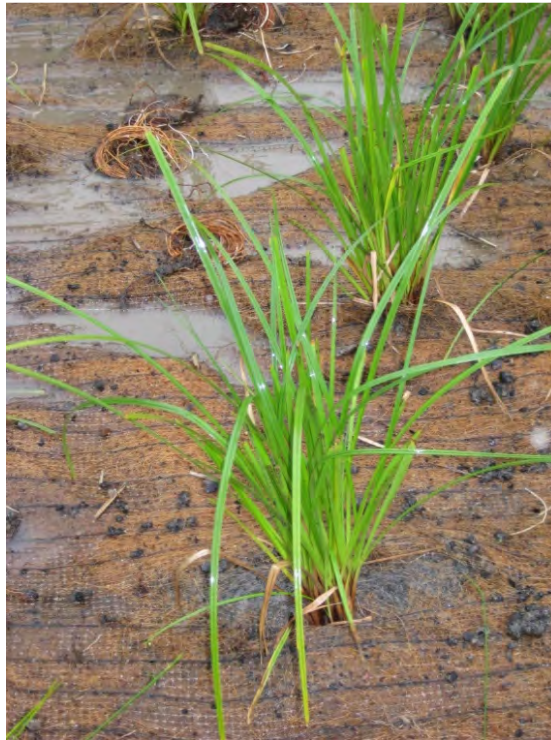
Figure 7: *Cyperus ustulatus* – minor ponding on the coconut mat after planting

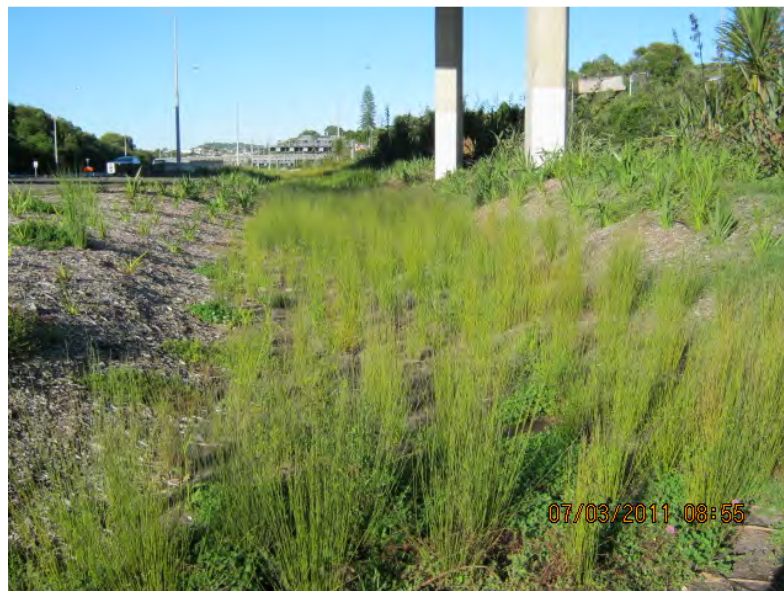
Figure 8: Minor infestation of weeds at the terminal point of the swale (foreground)

The weeds that did invade the site were limited in both number and location. At the downstream end of the site the weed mat experienced minor degradation which allowed a small infestation of weeds to establish. Weeds also

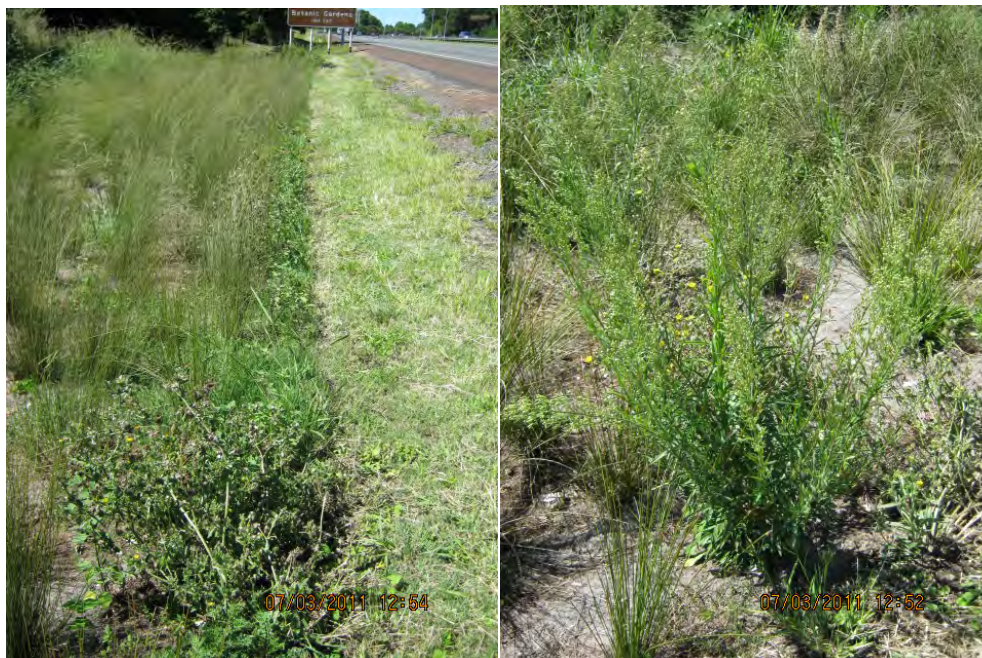
Whilst there was weed infestation at the Alfriston site it was restricted mainly to the edges of the site (Figure 10) and only present in the *Ficinia* and *Apodasmia* species. Some weeds also grew within the swale cross-section but they did not dominate the site. The weeds that grew within the swale tended to be isolated species which grew very tall, making them easy to identify for removal. The *Cyperus* was able to almost completely suppress any weed growth, except in areas where the swale was not covered by the canopy.

Figure 10: Weed infestation along edge of coconut mat and tall individual weeds within swale

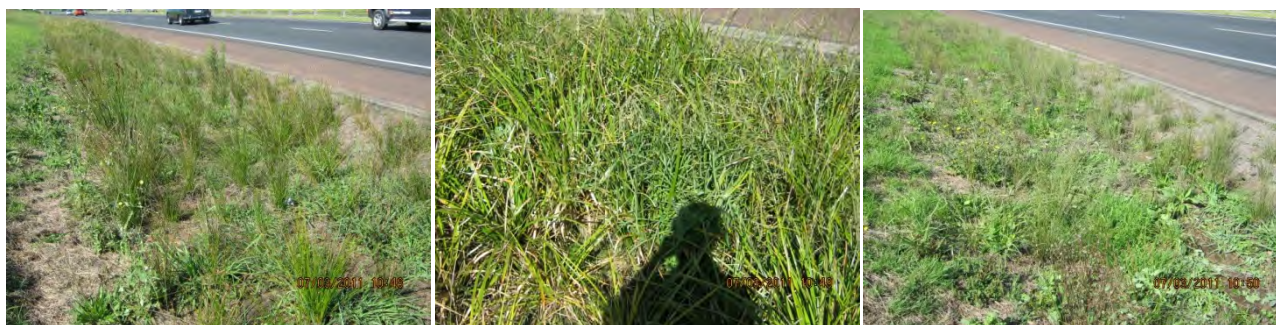
Silverdale was the worst performing of the three trial sites, with significant weed infestation (Figure 11). The main weed culprit is the *Kikuyu* species, which is prevalent throughout the northern motorway network. Weeds were present throughout all of the species; even the *Cyperus*, which elsewhere was able to effectively suppress any weed growth. Of all the sites, the weed mat is also in the worst state of repair with much of the mat degraded. This site took only slightly longer than the other two sites to maintain, but discussions with the maintenance contractors revealed that the original maintenance actions undertaken in November 2010 were significantly longer, requiring a total of 3.5 hours of work. The weed growth was so bad that the trial species had to be first physically separated from the weeds before they could be safely cut.

Figure 11: *Ficinia nodosa* (photo 1), *Cyperus ustulatus* (photo 2) and *Apodasmia similis* (photo 3) species, showing weed growth before maintenance activities

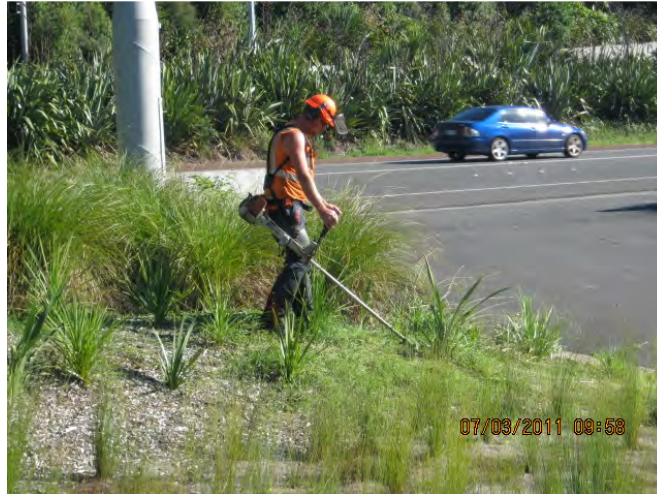
The two operators arrived on site and required 15 minutes to set up their equipment. The first step in the process was to use motorised weed cutters (Figure 13) to cut off the tops of the visible weed species. The close proximity to the trial species of some weeds required particular care to be taken by the operator. Discussion with the operators reveals that some of the longer weed species can entangle the blades and cause jamming. It is however a simple procedure to untangle the weed and continue. This entire maintenance process will typically cover 2 – 3 m/min for each of the three sites.

Figure 13: Operator cutting weeds with motorised blades

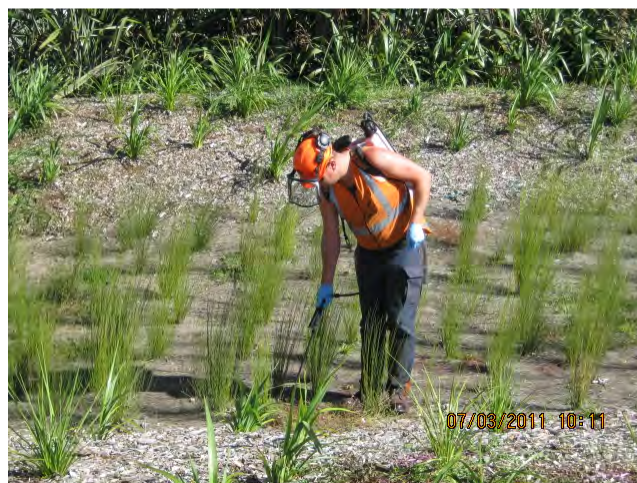
The second phase of the maintenance process is to spray the exposed weeds with a solution of glyphosphate mixed with a dye (Figure 14). The dye enables the operators to spray close to the stems of the trial species without poisoning them by allowing them to see where the spray is being applied. The three selected species are also resistant to the glyphosphate weed spray so small amounts of the solution will not significantly affect them. It takes up to about 1 week for the weeds to completely die away following spraying.

Figure 14: Operator applying glyphosphate to weeds

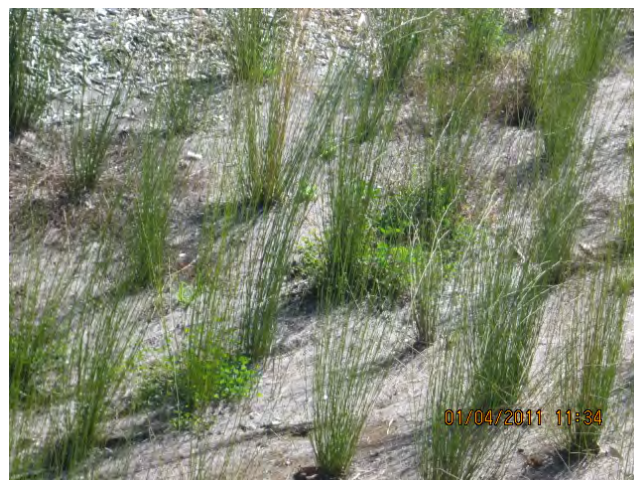
It took approximately one month for weeds to resurface in the site after the maintenance activities. The weeds were located around the base of the *Ficinia* and *Apodasmia* at holes in the coconut mat (Figure 15). This re-growth has spread slowly with only 5% of the swale base being covered by weeds in the *Apodasmia* section after three autumn/winter months. The *Ficinia* is performing slightly better with only around 3% of the swale base covered by weeds. The *Cyperus* was able to completely suppress any re-growth of weeds during the trial period. This characteristic is attributed to the dense canopy created which does not allow any significant amount of light to reach the swale base and therefore does not allow weeds to propagate.

Figure 15: Minor weed growth on Newton site

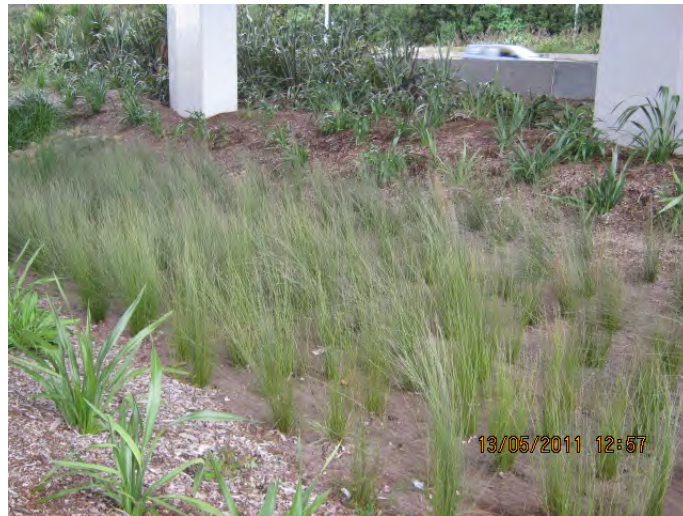
species. In terms of canopy cover, the *Cyperus* performed the best, covering 100% of its section. Both *Ficinia* and *Apodasmia* also performed well, achieving approximately 80% of canopy closure by the end of the inspection period, 1 year after initial planting (Figure 16).

Figure 16: Good canopy cover by *Apodasmia similis*.

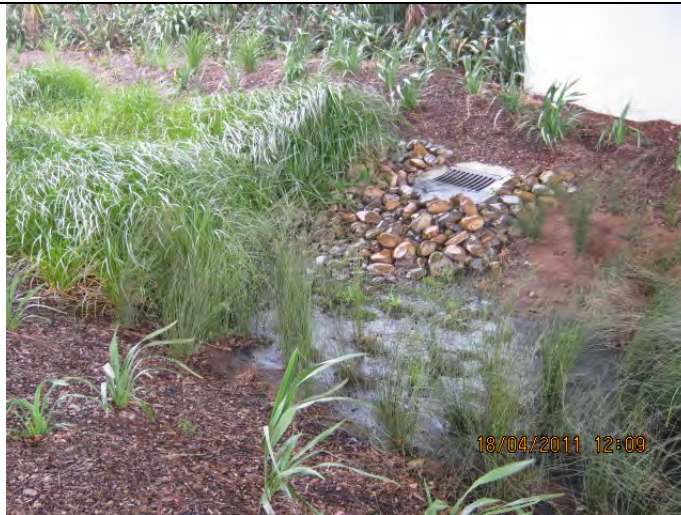
Another peculiarity to the Newton site is the presence of a cesspit, which is located at the transition between the *Cyperus* and *Apodasmia* species (Figure 18) and receives contaminated stormwater from the bridge above. There may have been some hindrance to the *Apodasmia* growth immediately adjacent to the catchpit, but the plants still appear healthy.

Figure 18: Localised ponding around catchpit

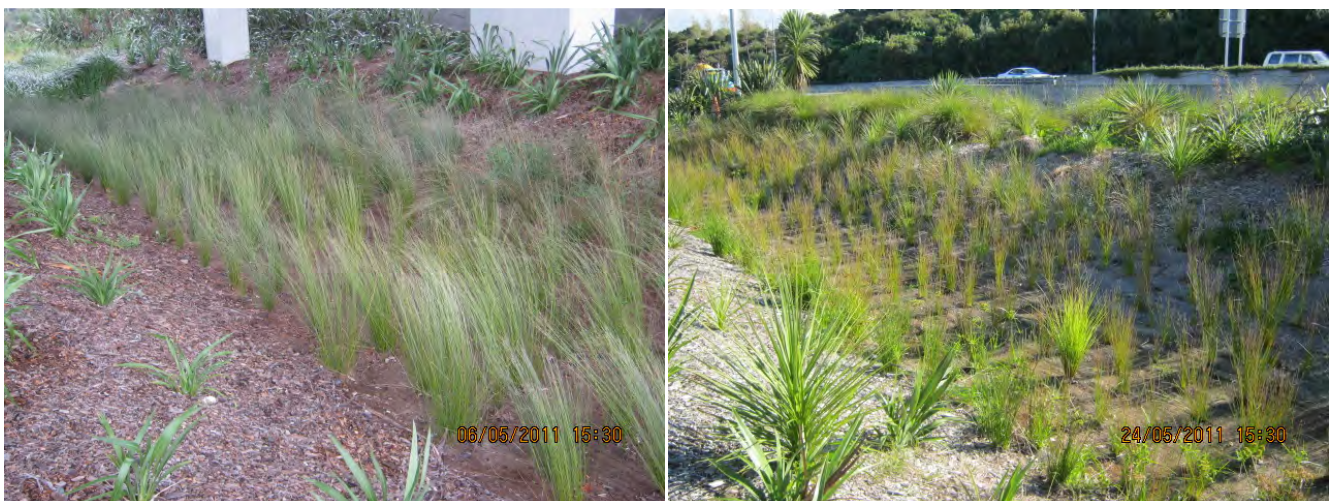
The major difference between the three species at the Newton site is aesthetic. The *Apodasmia* species provided a significant visual impact upon entering the site (Figure 19). The *Ficinia* species also provides an excellent visual display, but the less supple leaves do not give the same impact as the *Apodasmia*. The *Cyperus* species appears perhaps the worst of the three; its excellent growth rate does not lead to a visually appealing site in the same way as the others, giving an unkempt or messy impression.

Figure 19: *Apodasmia* vs. *Ficinia* visual aspects

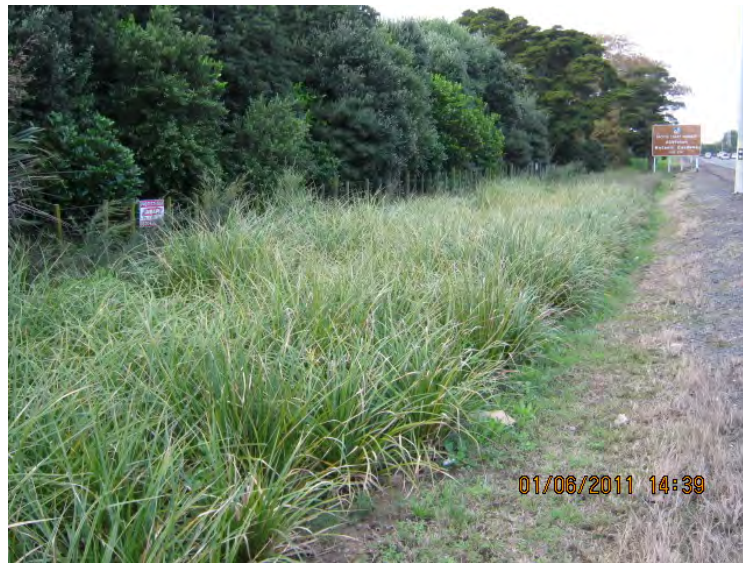
Figure 20: *Cyperus ustulatus* species, limited weed growth

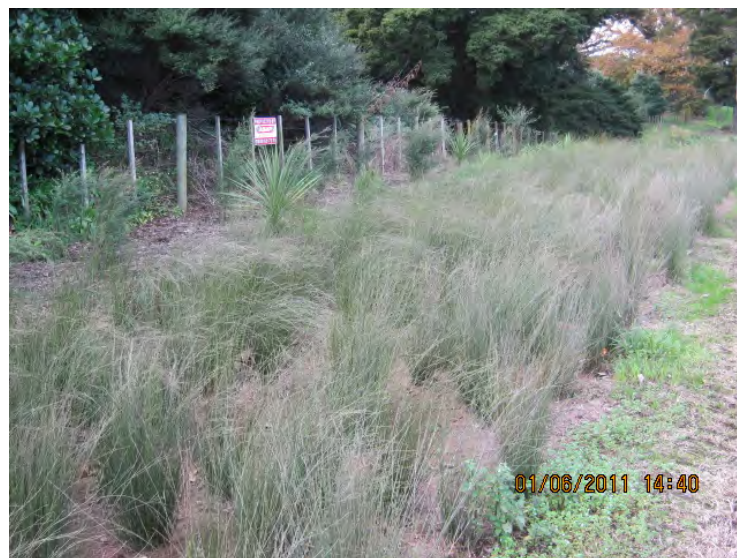
Figure 21: Good delineation and aesthetic of *Apodasmia similis* species

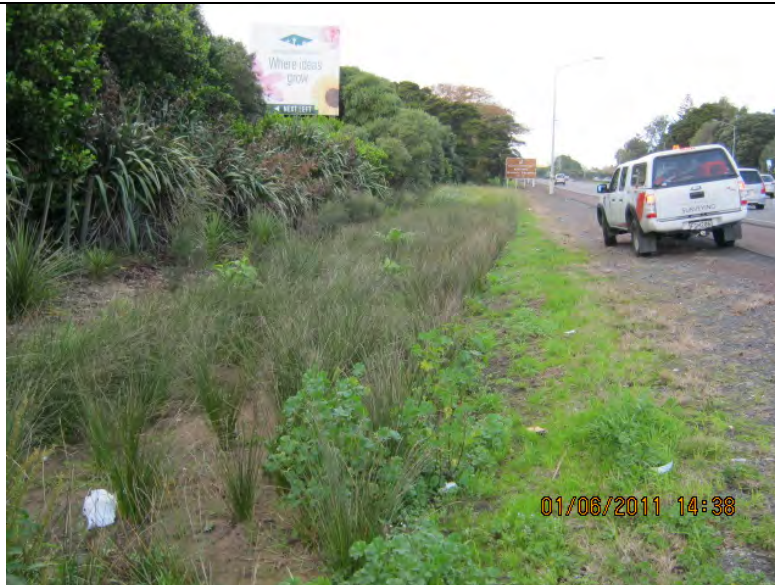
The variety of weed species at the Alfriston site is different to both the Newton and Silverdale sites. They tend to grow taller than the trial species, and although the number of them is low they are highly visible (Figure 22) and detract from the visual quality of the site. Also, the majority of the weed growth occurred at the downstream end of the site within the *Ficinia* species. This is most likely to be due to the downstream end of the site containing more water than the other sections, thus providing a better environment for weed growth.

Figure 22: Weeds visible through the *Ficinia similis* species

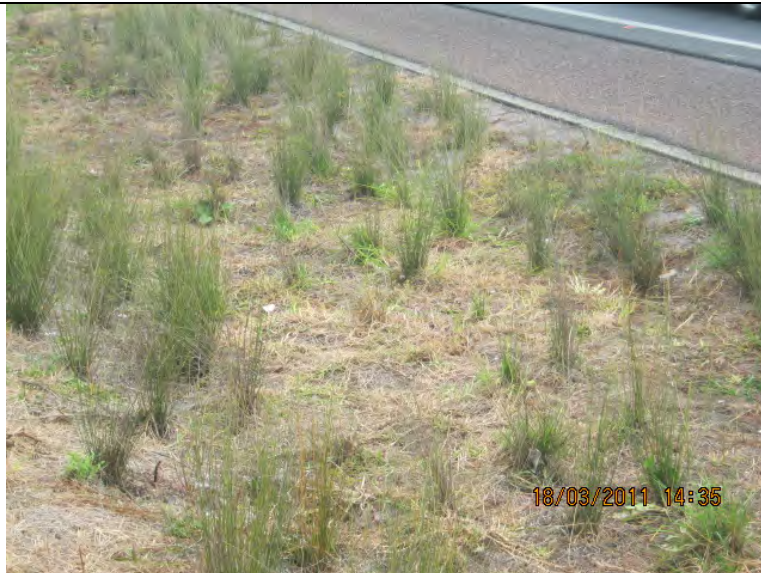
The weeds at the Silverdale site were able to quickly re-establish themselves despite the maintenance activities. Figures 23 to 25 show the weed growth in the *Apodasmia* species was rapid and highly invasive. It only took one week before new weed sprouts were visible and only two months before the weeds had established and dominated the section. This was not the case for the *Cyperus* species which still managed to suppress weeds.

Figure 23: *Apodasmia similis* 1 week after maintenance activities (18/03/2011)

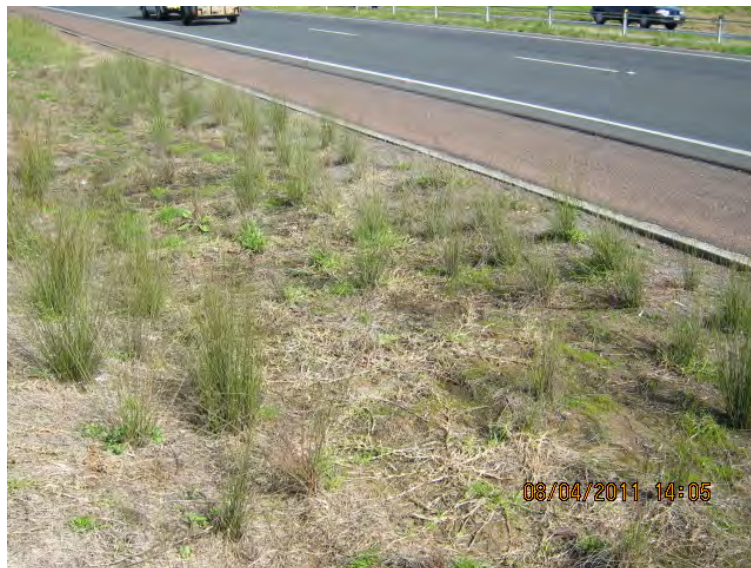
Figure 24: *Apodasmia* species 1 month after maintenance activities (08/04/2011)

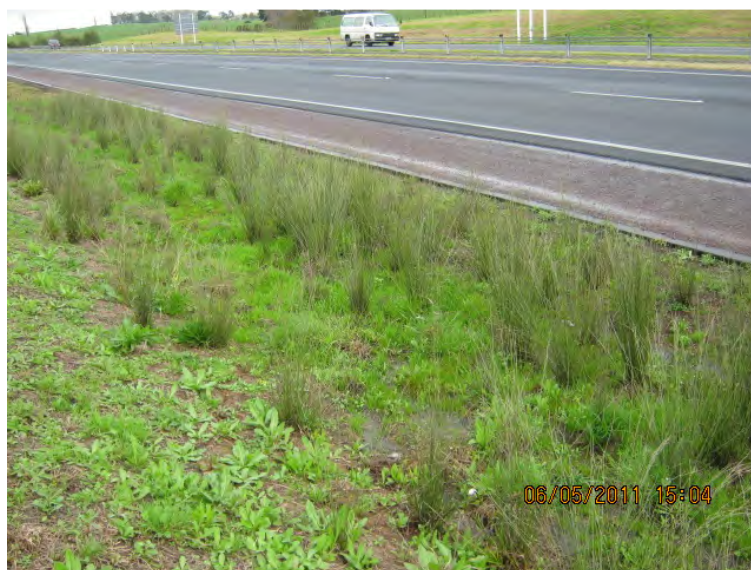
Figure 25: *Apodasmia* species 2 months after maintenance activities (06/05/2011)

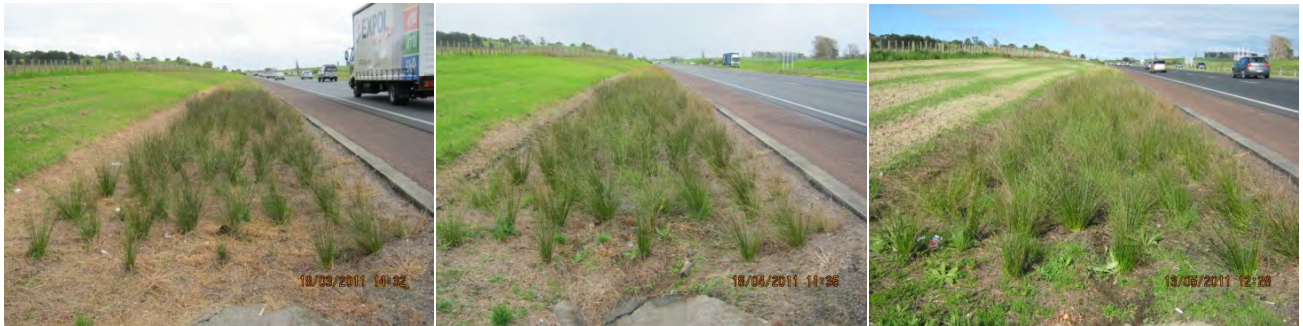
What is positive about the selected species is that despite the hardships of the sites, those remaining plants did continue to grow. Figure 26 shows that the surviving plants continued to grow and improve in health despite the difficulty of the site. This suggests that with more regular care, eventually these plants may dominate the site and prevent any weed growth.

Figure 26: Despite hard ship the *Ficinia nodosa* continues to grow in Silverdale site

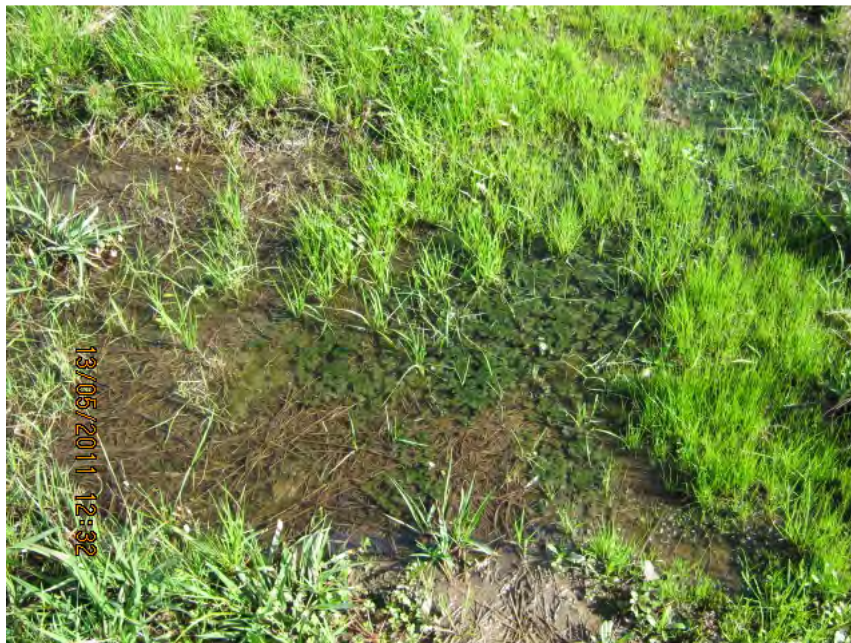
The ponding and stagnation of water at the upstream end of the site within the *Apodasmia* species is due to the longitudinal gradient of the site being too shallow. This stagnation is the prime cause of the algae growth in the swale (Figure 27). The trial species are well-suited to growing in wet conditions, so the ponding should not have significantly hindered plant growth.

Figure 27: Stagnant water and algae growth

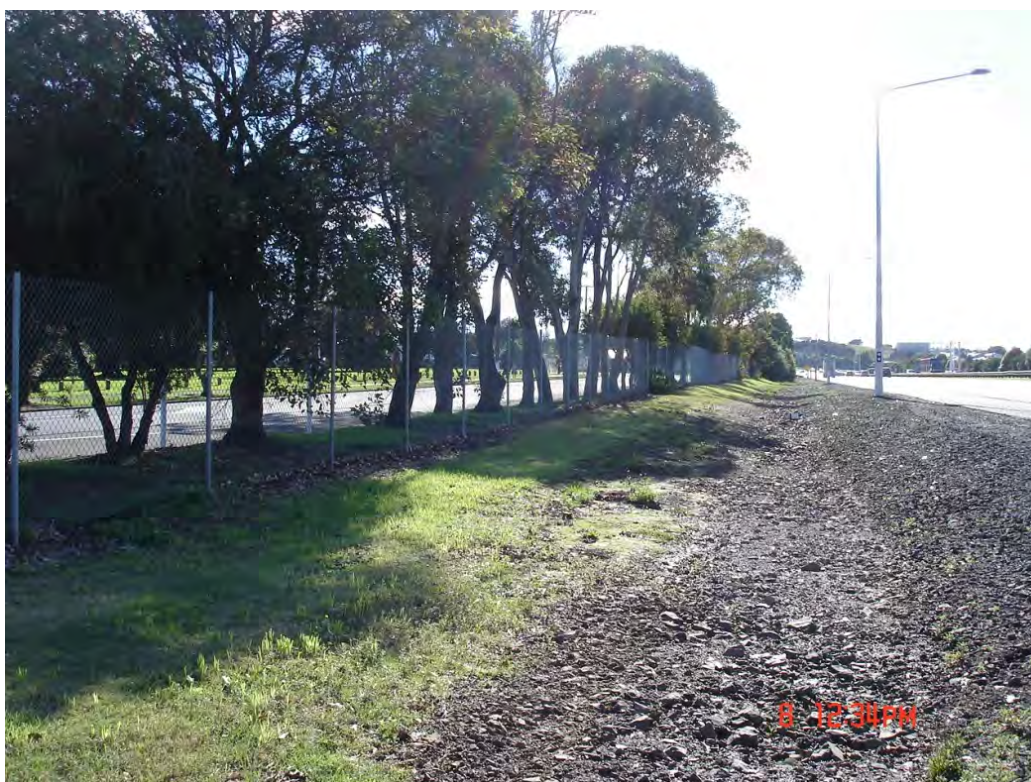
Figure 29: Picture of noise-wall and swale trial planting site before construction

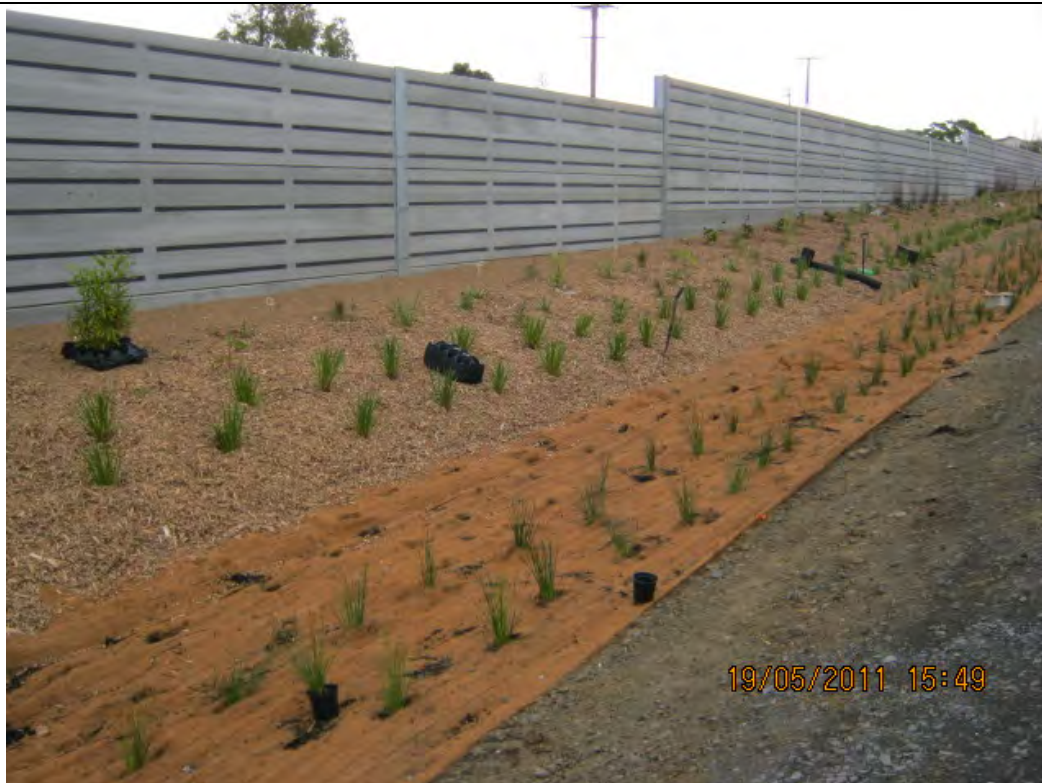
Figure 30: New Noise-wall and Swale planting in progress

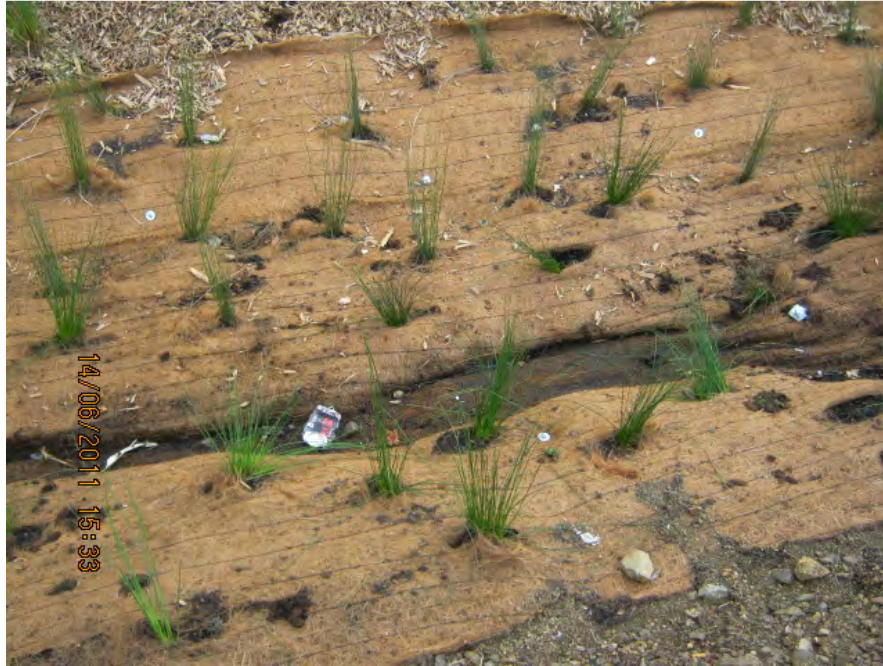
- Some minor erosion has occurred at the site, caused by a heavy rainfall storm shortly after application of the blown topsoil/compost. In some places migration of the top soil has left minor channelised depressions and some downstream blockages (Figure 32).

Figure 32: Channel depressions forming

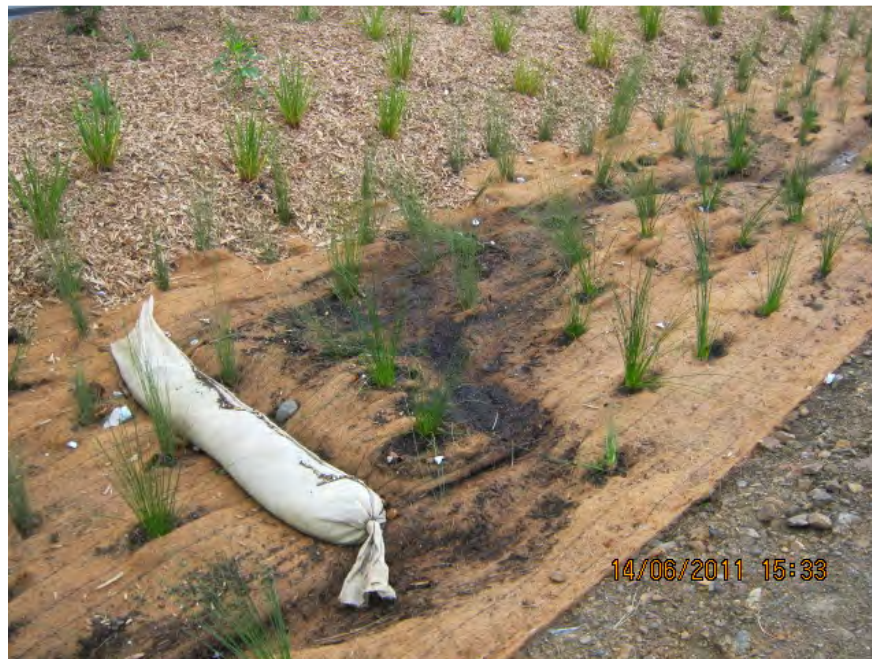
- Temporary filter-bag check-dams were installed to remedy the erosion but these have been limited in their effectiveness (Figure 33). At some locations flows have bypassed around some the check-dams, missing out on effective attenuation. This problem was not unforeseen but it was anticipated that the plants would have had more time to bed-in and stabilise the mat and topsoil before high intensity rain events occurred.
- Rip-rap protection from the lateral inlet structures from the noise-wall project did not operate as effectively at dissipating energy as expected (Figure 34). This compounded the minor erosion experienced at the planting site.

Figure 33: check-dam short-circuiting

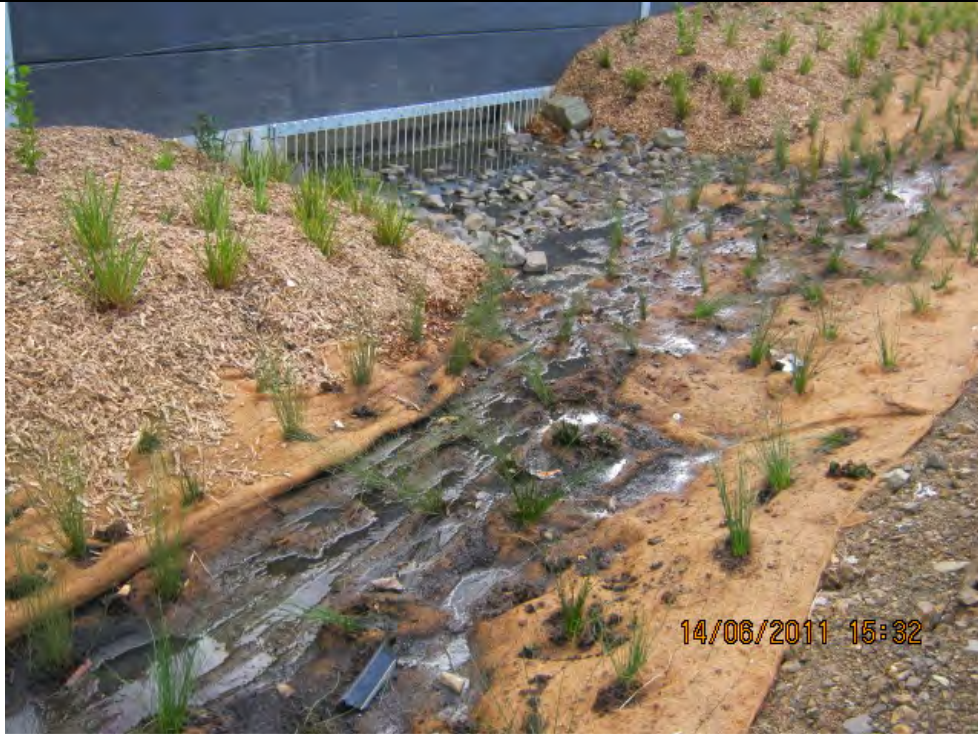
Figure 34: Lateral inlet causing minor ponding and short-circuiting
