rail safety update

Special edition October 2013

Special edition: Dry pipe failures – steam locomotives

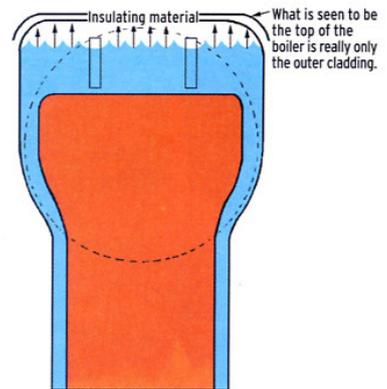
Fig.1
Belpaire
Firebox

■ **Cause 1** Boiler water carried too high in the glass. Belpaire boilers will carry an almost full glass with ease because ebullition (the process of boiling) takes place over a greater area and steam flow is not concentrated. Round-topped boilers are safer at half a glass because ebullition is under a narrower 'roof' and the steam flow is very concentrated. In both cases, high water is nearer the regulator valve (Figs 1 and 2).
