# AHB Alliance Coatings Life Cycle Management Plan

# Coatings Life Cycle Management Plan

The Auckland Harbour Bridge (AHB) Coatings Life Cycle Management Plan outlines the philosophy, policy and approach for the maintenance of the AHB steelwork protective coatings. The approach described in this plan has then been applied to develop a long-term forecast of coatings maintenance required over the next 40 years. The annual plans for coatings maintenance will be developed based on the approach recommended in this plan along with annual condition inspections.

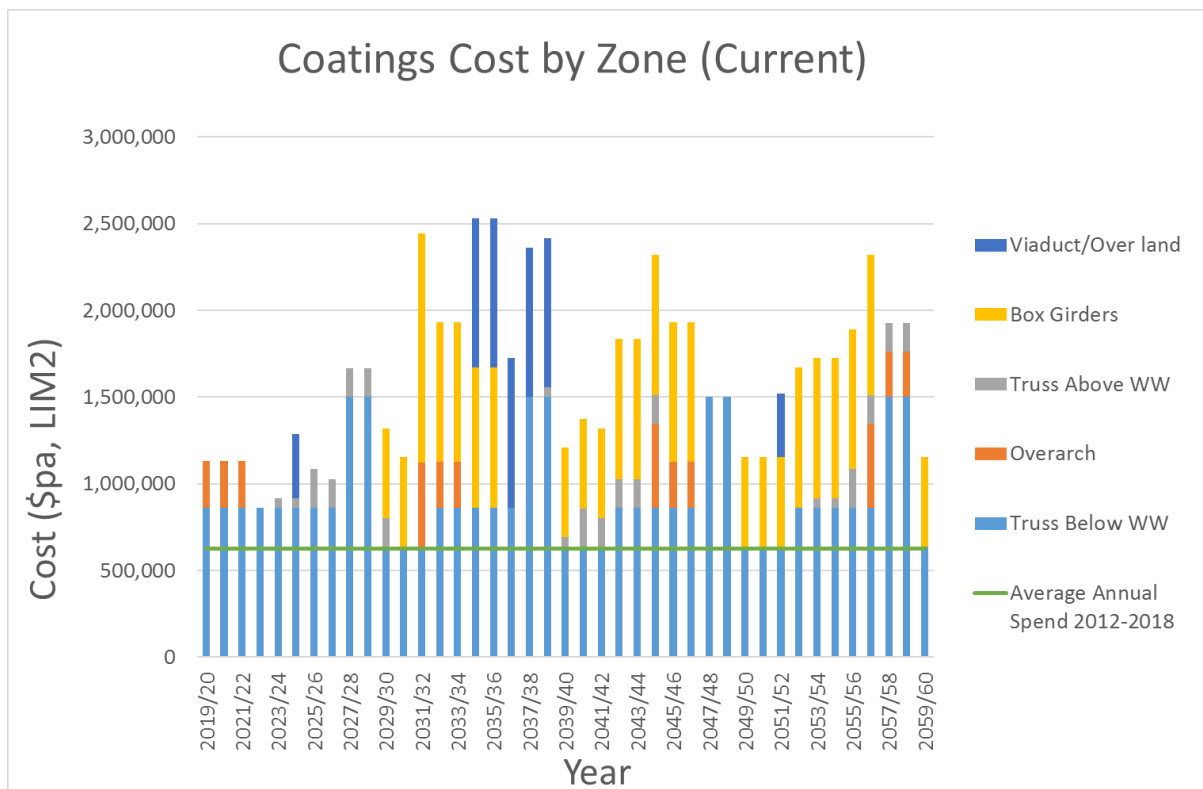
Figure 1: Long term Coatings Maintenance Forecast

The preferred maintenance approach for the approach viaduct and above land areas is to undertake minimum repairs of structural critical defects, followed by full replacement of the coatings when large scale breakdown of the coatings occurs. This is option is favoured due to the cost of containment needed for collecting all discharges over land. The aesthetic implications of this adopting this maintenance approach need to be considered, as these areas are highly visible to the public, and the poor visual condition may not be acceptable prior to undertaking the full replacement of the coating.

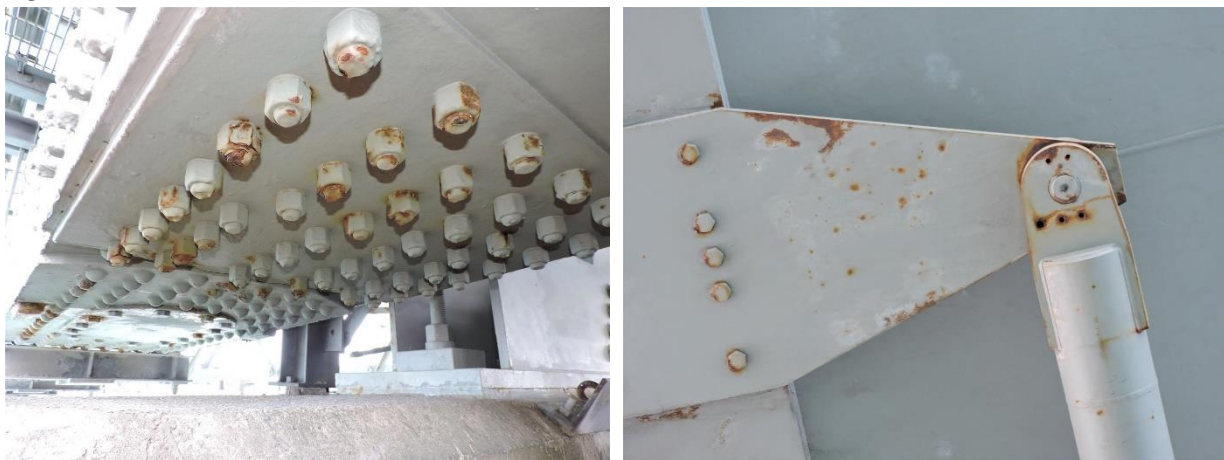
**Figure 4-2: Example of substrate corrosion.**

Corrosion of the steel substrate under the coating, often due to salt contamination prior to painting or low film build of the coating. Examples of this type of breakdown are commonly seen throughout the bridge, but especially on the more complex AHB Truss Bridge below deck, see Figure 4-2.
