Project Number: 2-A0012.00

State Highway 1 and State Highway 29 Intersection Upgrade Assessment of Effects on the Environment -Ecology

23 August 2021

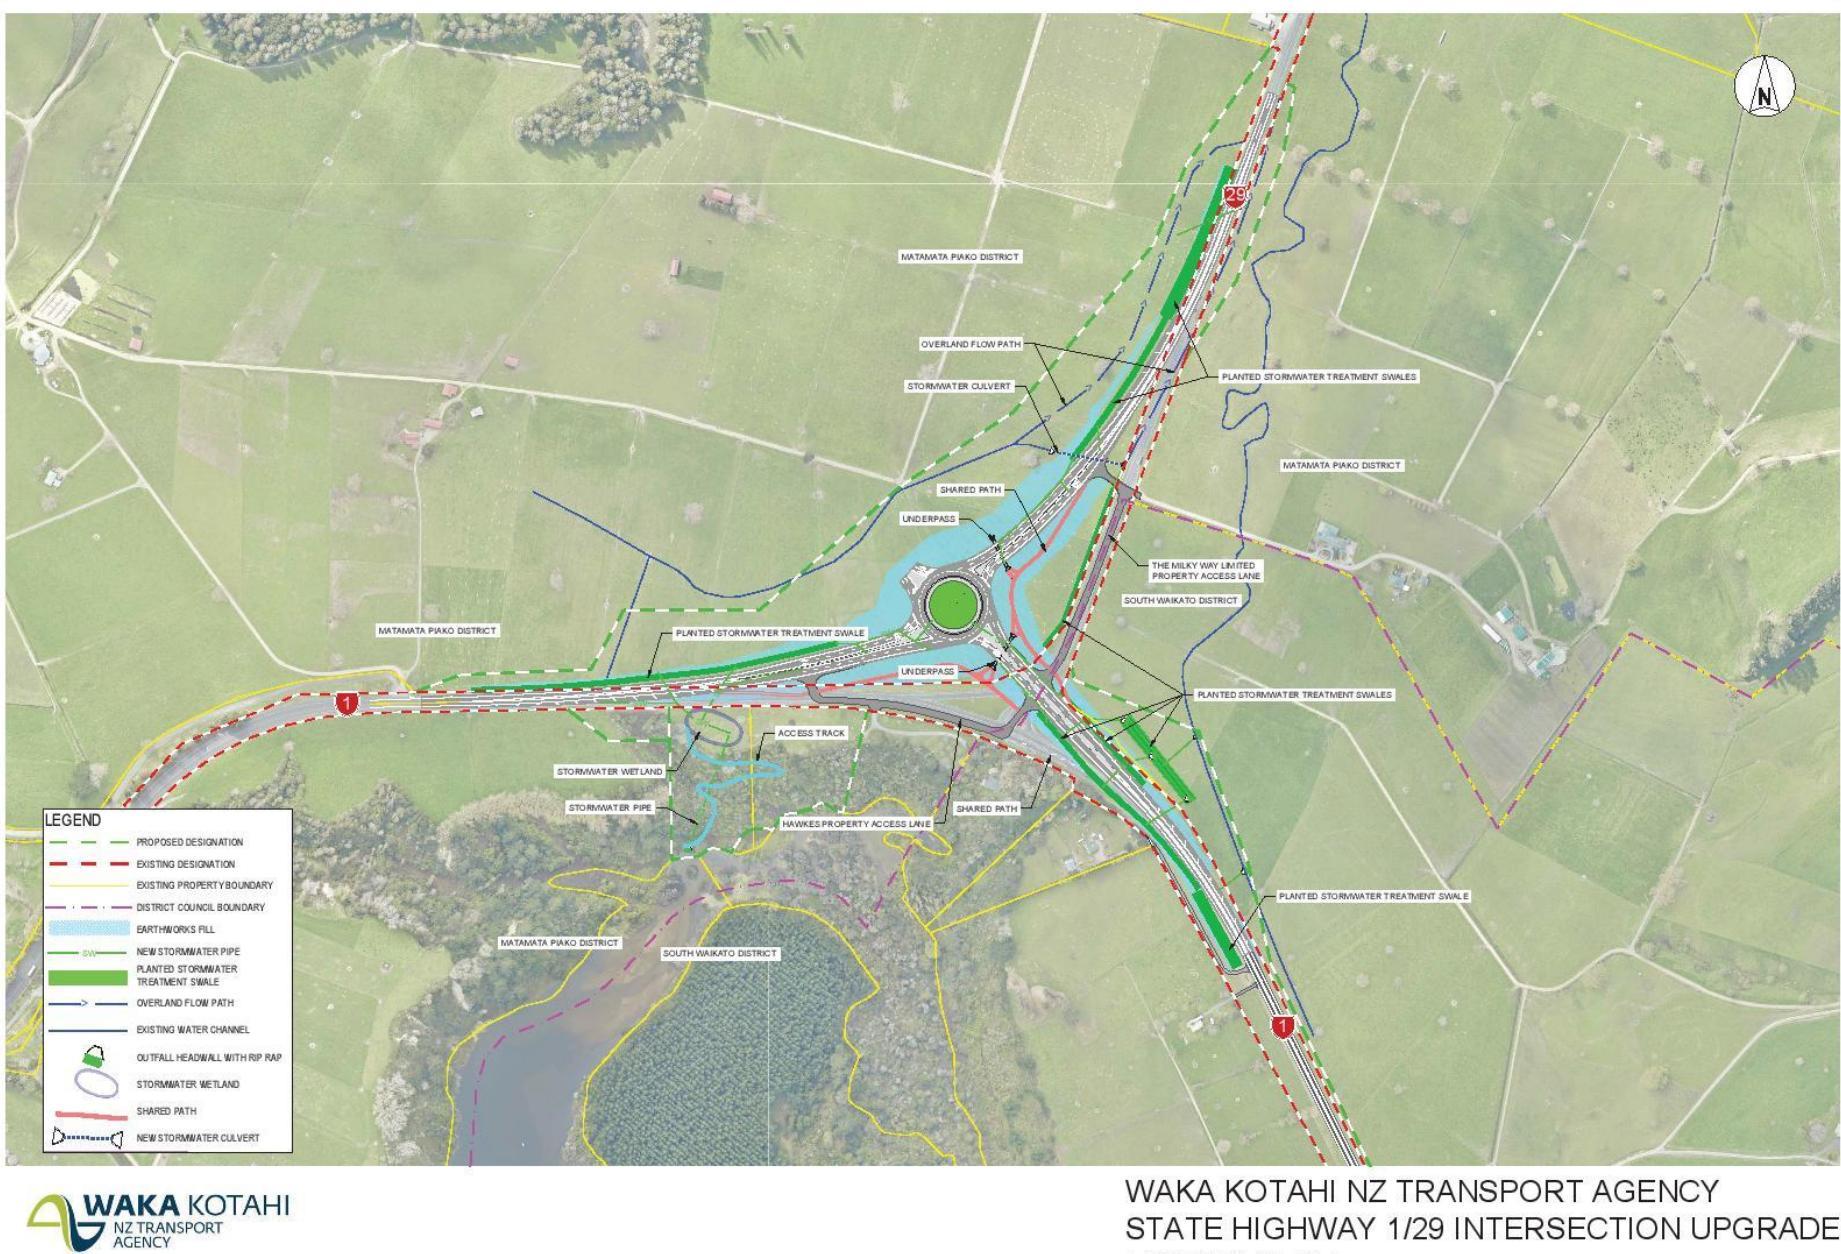
WAKA KOTAHI NZ TRANSPORT AGENCY STATE HIGHWAY 1/29 INTERSECTION UPGRADE LAYOUT PLAN

Figure 1-1: The Project design map showing proposed locations of stormwater culverts, wetland ponds and discharge points.

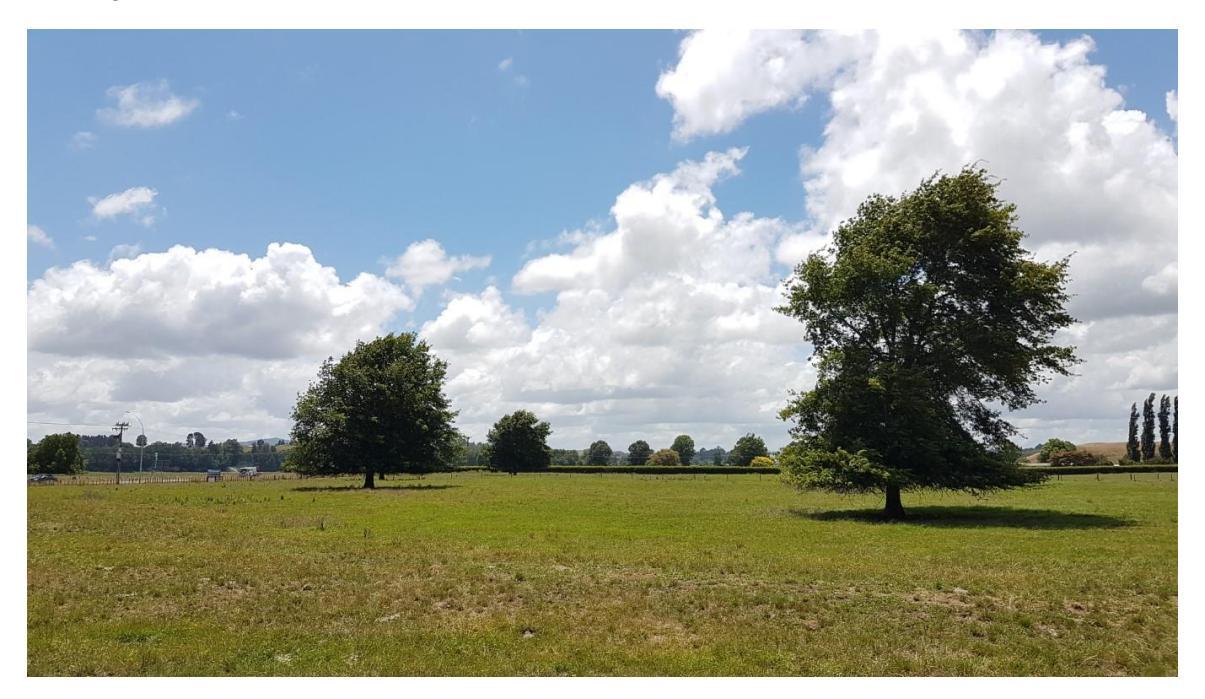
Photo 1: Looking north-west on property SA646/95 showing vegetation on the eastern side of the existing intersection.

On the eastern side of SH29, vegetation is dominated by grazed exotic pasture, with areas of rank grass and weeds along the roadside fence. There are also several scattered exotic Pin Oak trees (*Quercus palustris*) and three of these trees will be removed within the Project footprint (Photo 1; and Figure 3-5).

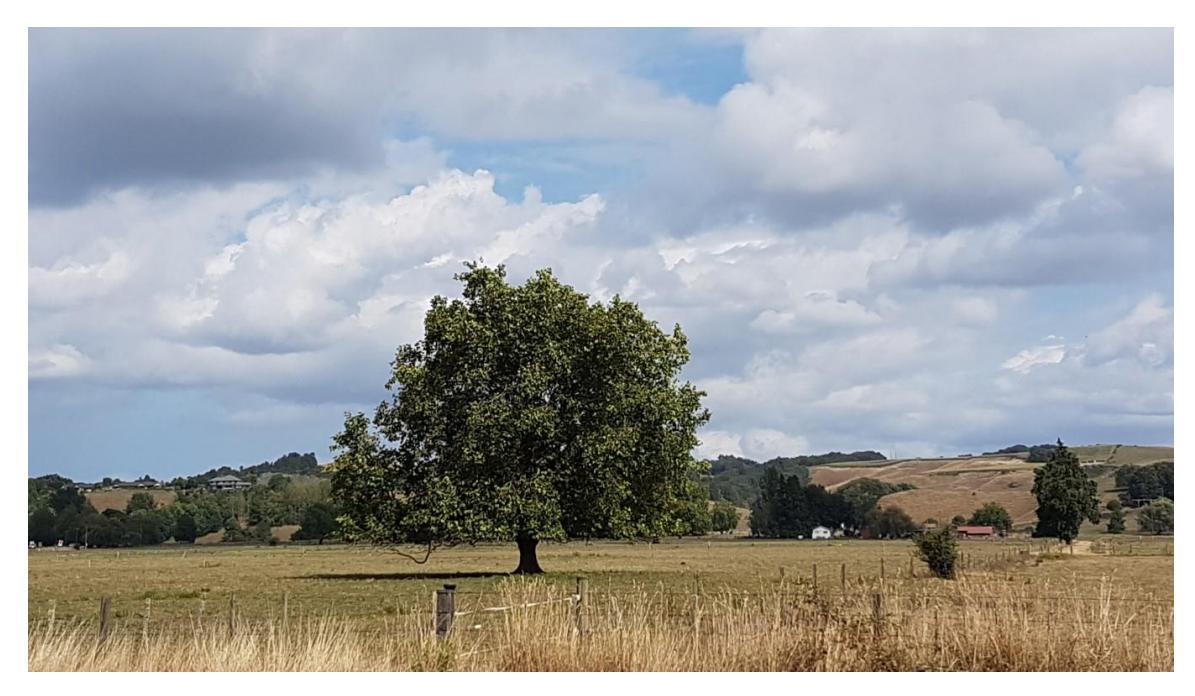
Photo 2: Looking west on property SA646/95 showing vegetation on the western side of the existing intersection.

On the western side of SH29, similar to the eastern side, vegetation is dominated by grazed exotic pasture with areas of rank grass and weeds along the roadside fence. There are several scattered exotic plane trees (*Platanus* sp.) located within the designation boundaries. Three plane trees are proposed to be removed as part of the Project works in this area (Photo 2; and Figure 3-5).

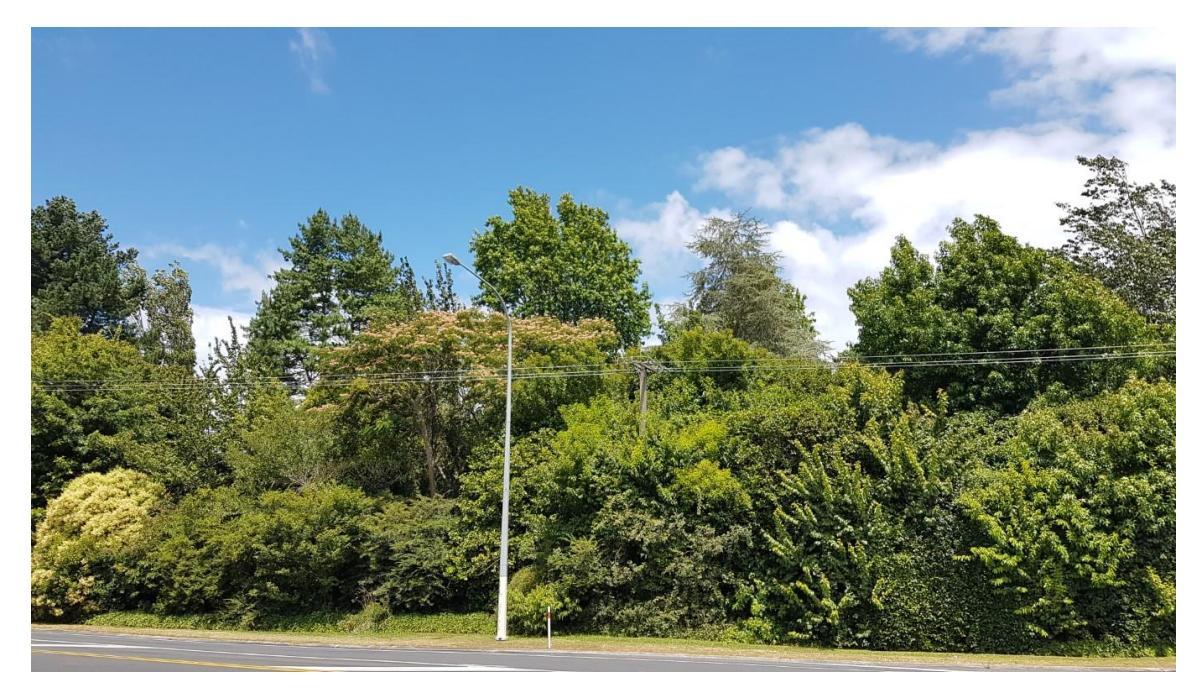
Photo 3: Looking south from property SA646/95 showing the existing native and exotic vegetation on the southern side of the existing intersection.

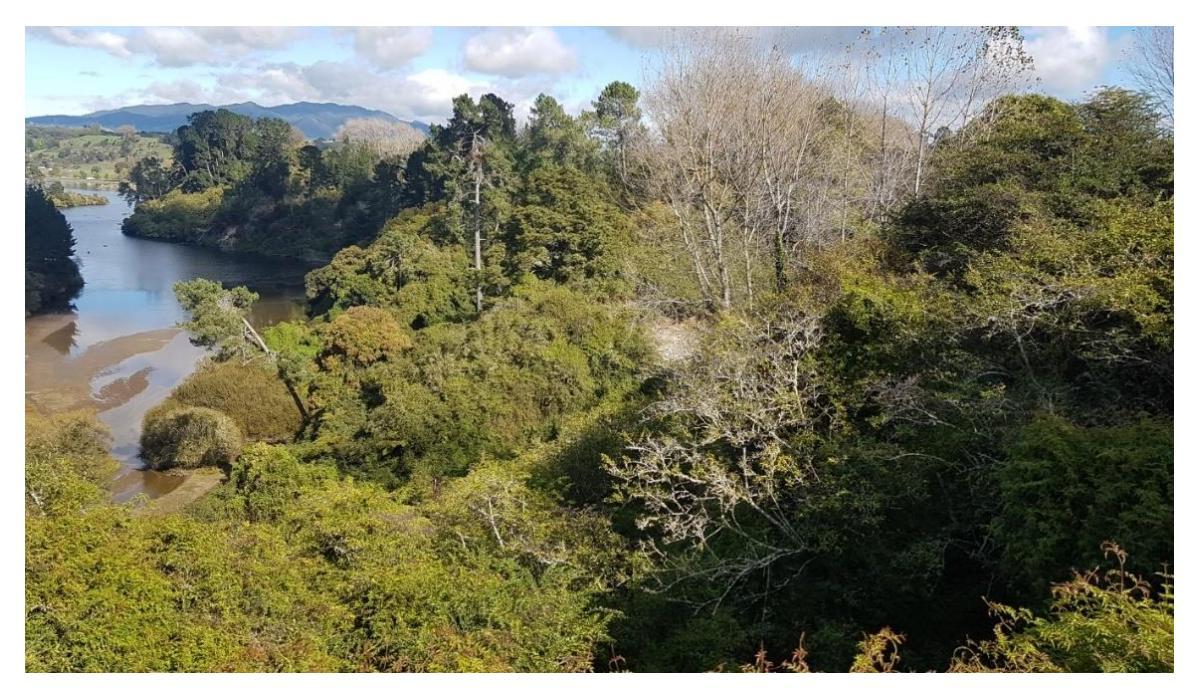
Photo 4: Western gully showing a variety of vegetation present within property SA32A/615, view looking south down to the Unnamed River from the top of the gully where the access track is proposed to start.

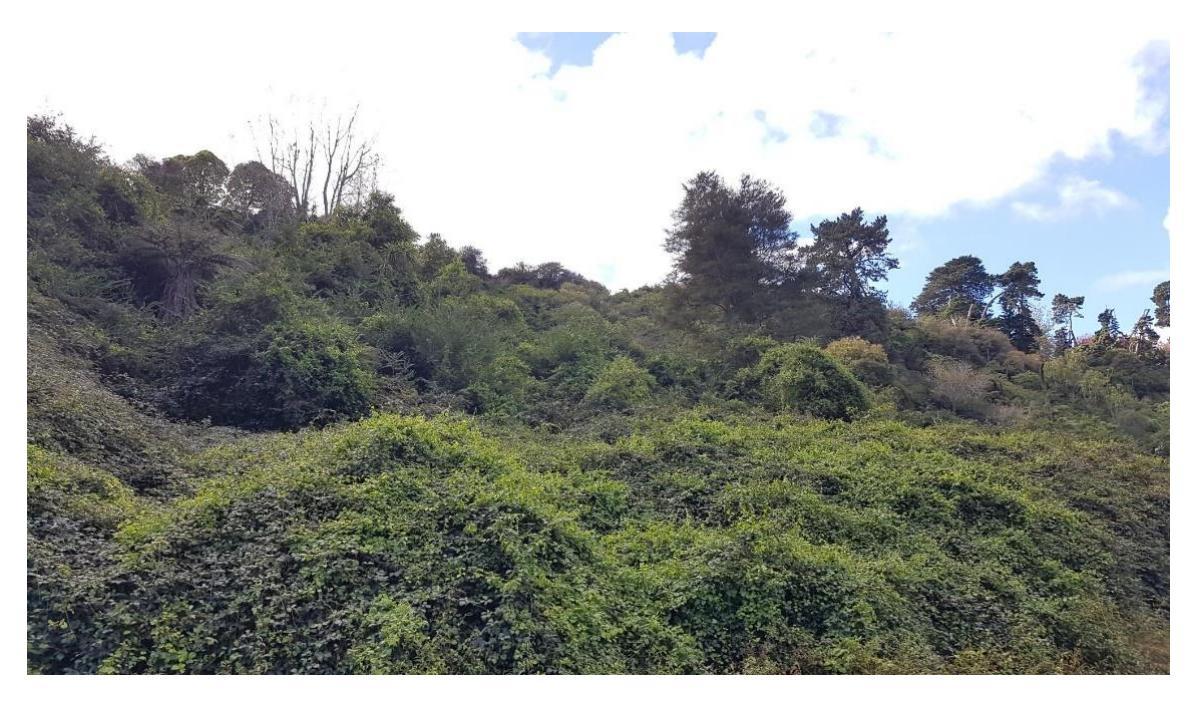
Photo 5: Western gully showing a variety of mainly exotic vegetation present within property SA32A/615, looking north-east from the Unnamed River where the access track is proposed to start.

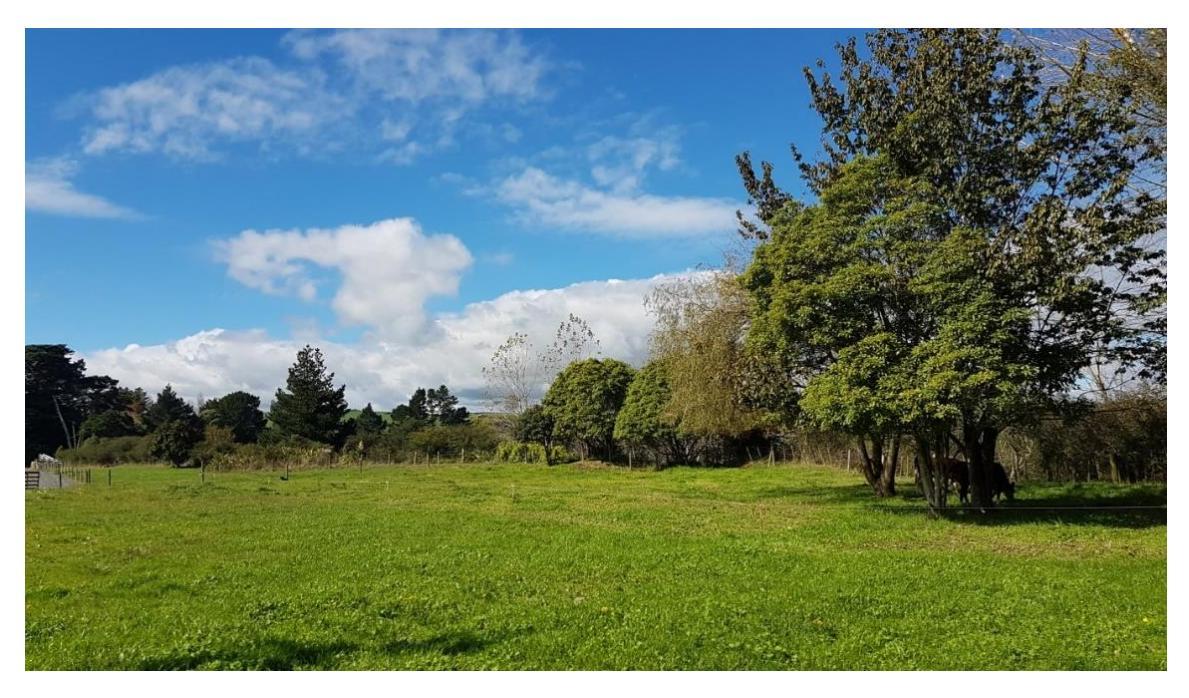
Photo 6: Western gully showing a variety of vegetation present within property SA32A/615, looking south-east at the location of the proposed wetland pond.

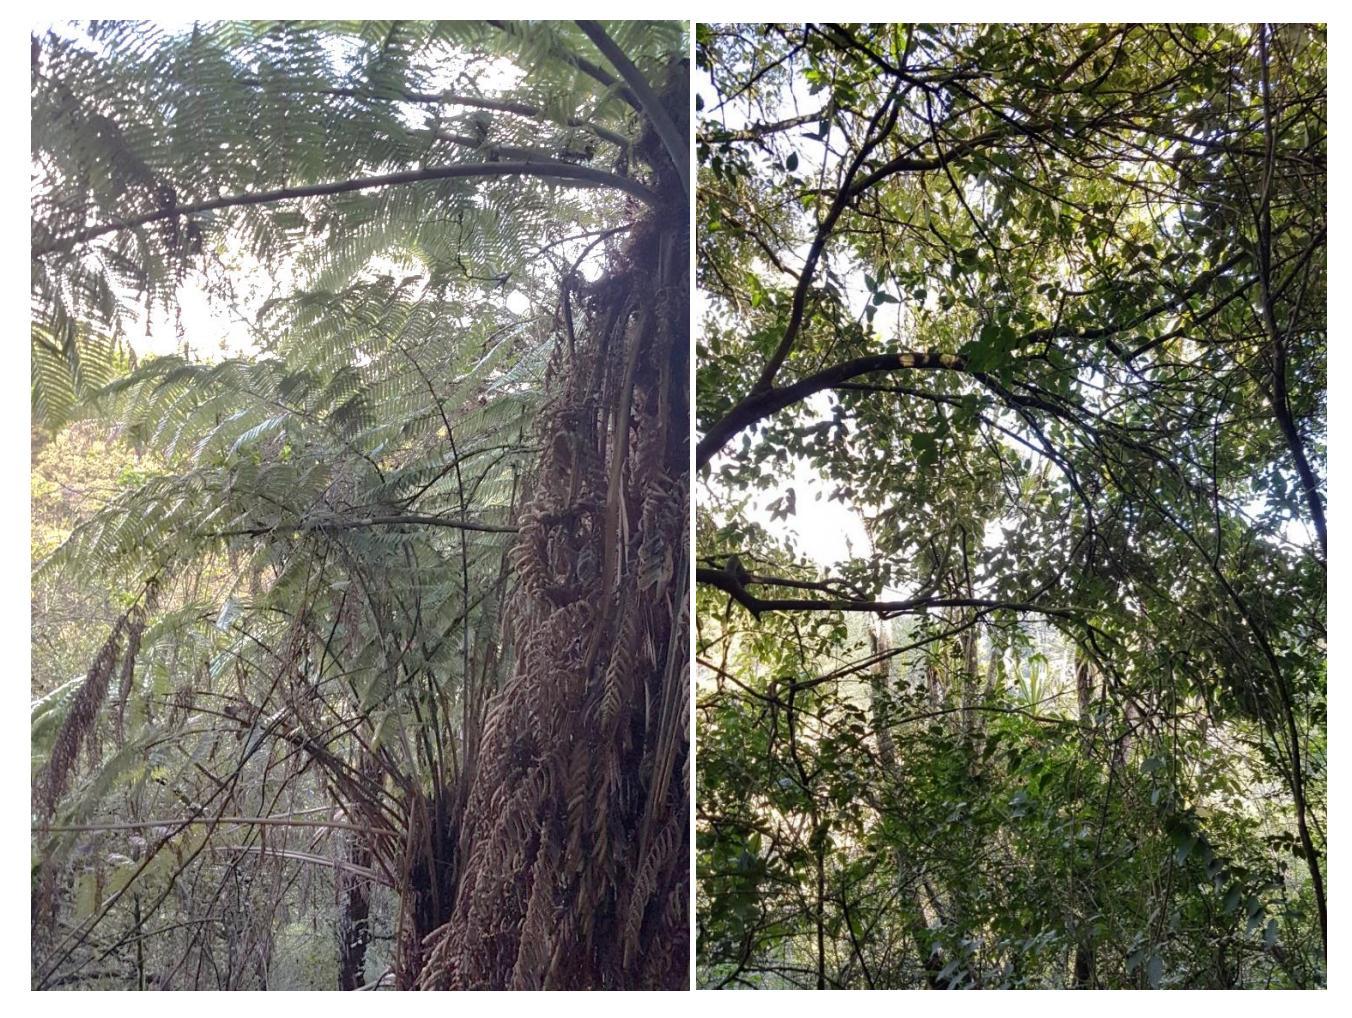
Photo 7: Western gully showing a variety of vegetation present within property SA32A/615, scattered tree ferns present in the middle reaches of the gully provide a small area of higher quality habitat.

Photo 8: Western gully showing a variety of vegetation present within property SA32A/615, privet dominates the gully vegetation, several of which are dead or falling over.

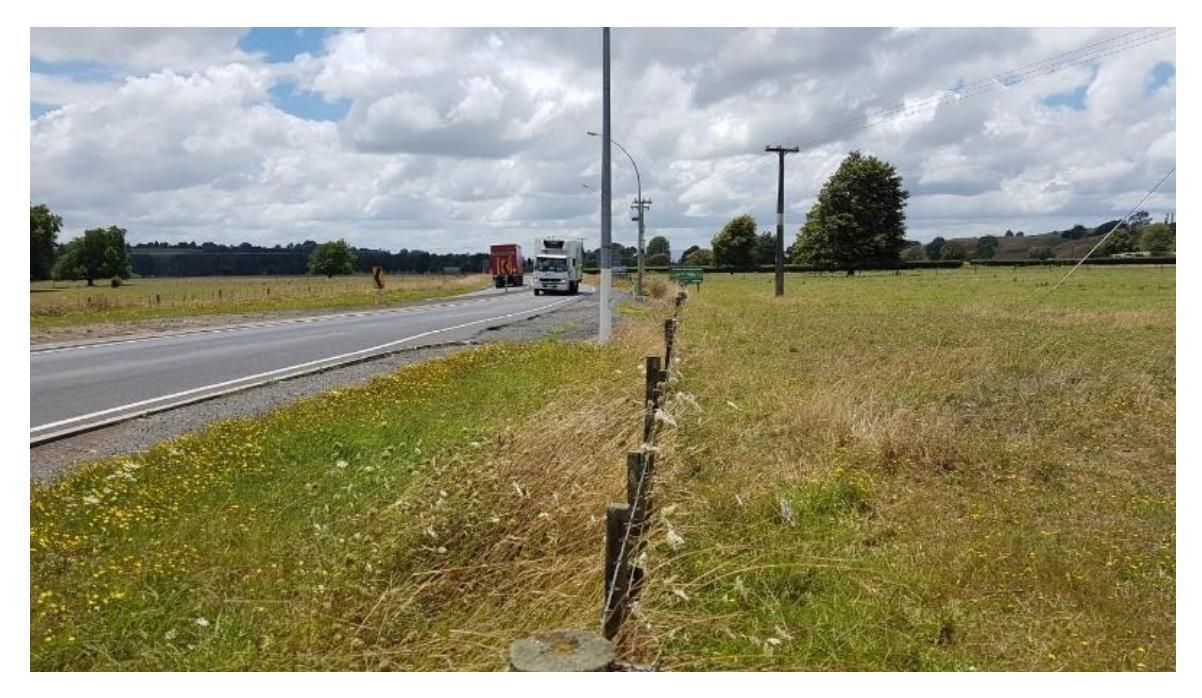
Photo 11: Eastern side of SH29. No lizards were observed during manual searches of higher quality habitat which consisted of rank grass along the existing roadside, looking north-west on property SA646/95.

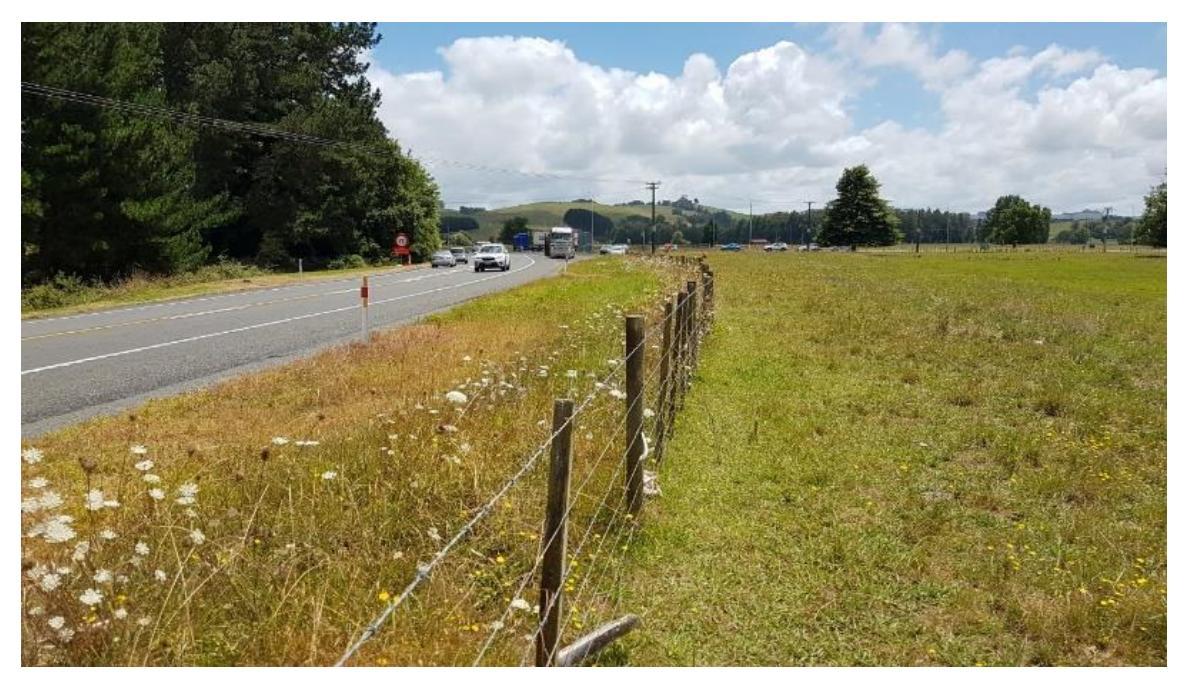
Photo 12: Eastern side of SH29. No lizards were observed during manual searches of higher quality habitat which consisted of rank grass along the existing roadside, looking northeast on property SA646/95 along SH29.

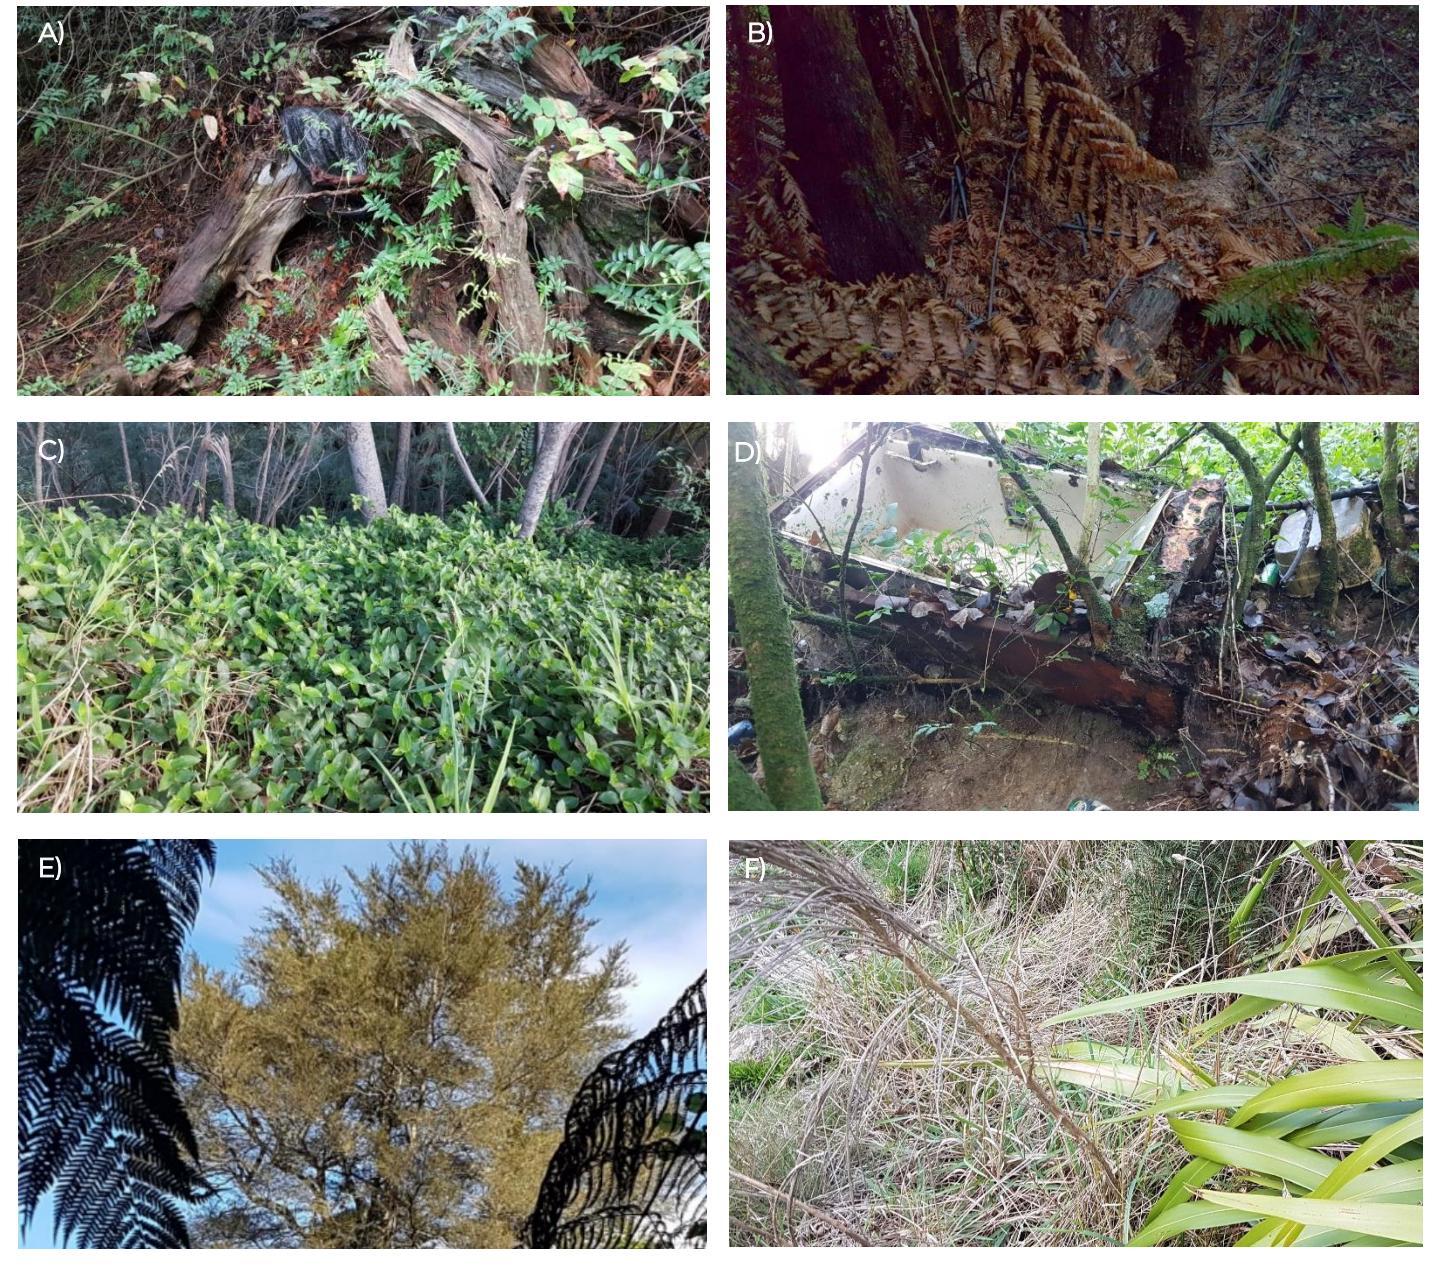
Photo 13: Western gully showing a variety of habitats present. No lizards were observed during manual searches of higher quality habitat (A-F) within property SA32A/615.

Manual searches focused on searching the highest value habitat in areas more likely to be directly impacted by the proposed works i.e. the rank grass on the eastern side of SH29; and areas with high ground cover such as rotting wood, rocks, wandering jew, thick leaf litter and grass within the western gully. Whitaker's (1994) 'searching by day' methodology was used which included pushing through rank grass, lifting cut grass, fenceposts, rocks, bricks, rotting logs, cut wood, and various types of rubbish such as microwaves, corrugated iron, ovens, and barbeques.

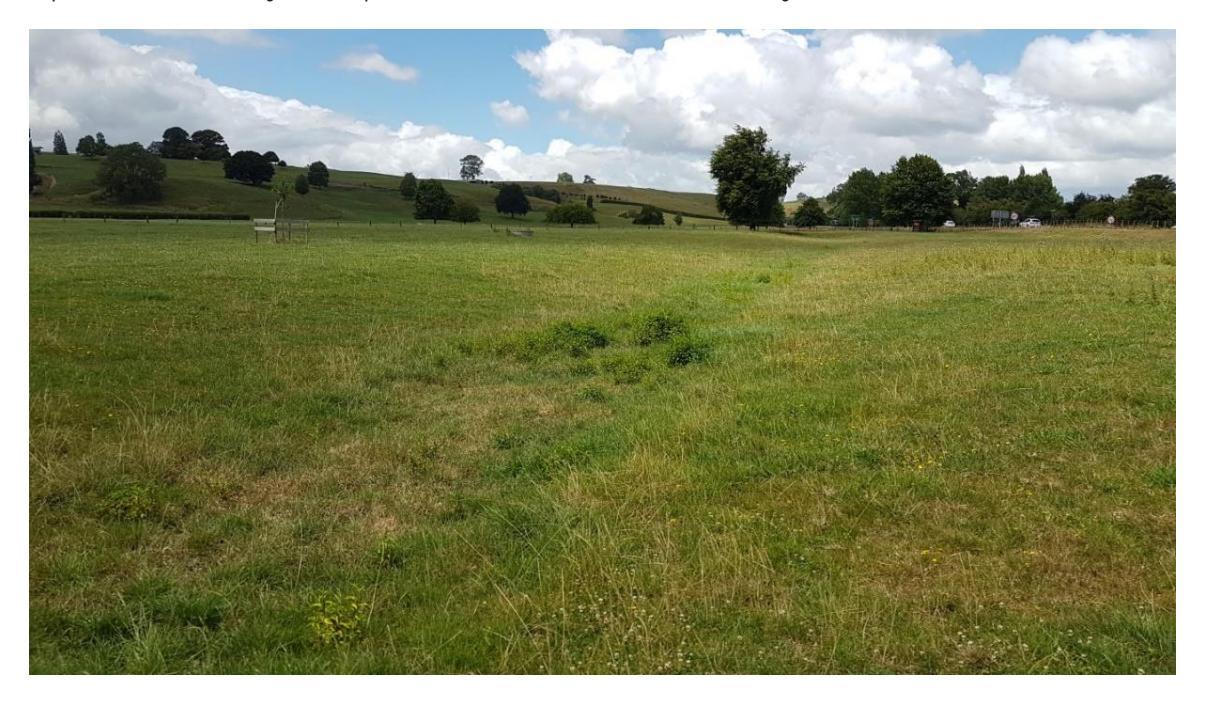
Photo 14: Eastern watercourse: ephemeral watercourse on the eastern side of SH29, looking north on property SA646/95.

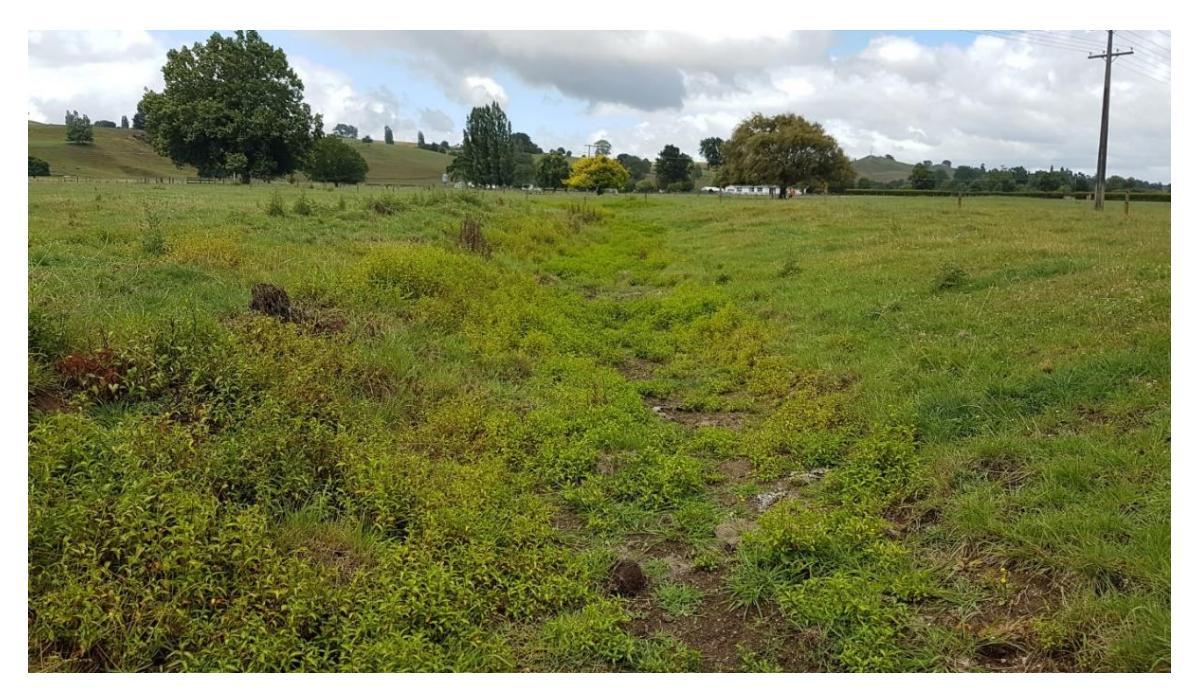
Photo 15: Eastern watercourse: ephemeral stream on the eastern side of SH29, looking southeast from roadside drain on property SA1701/33.

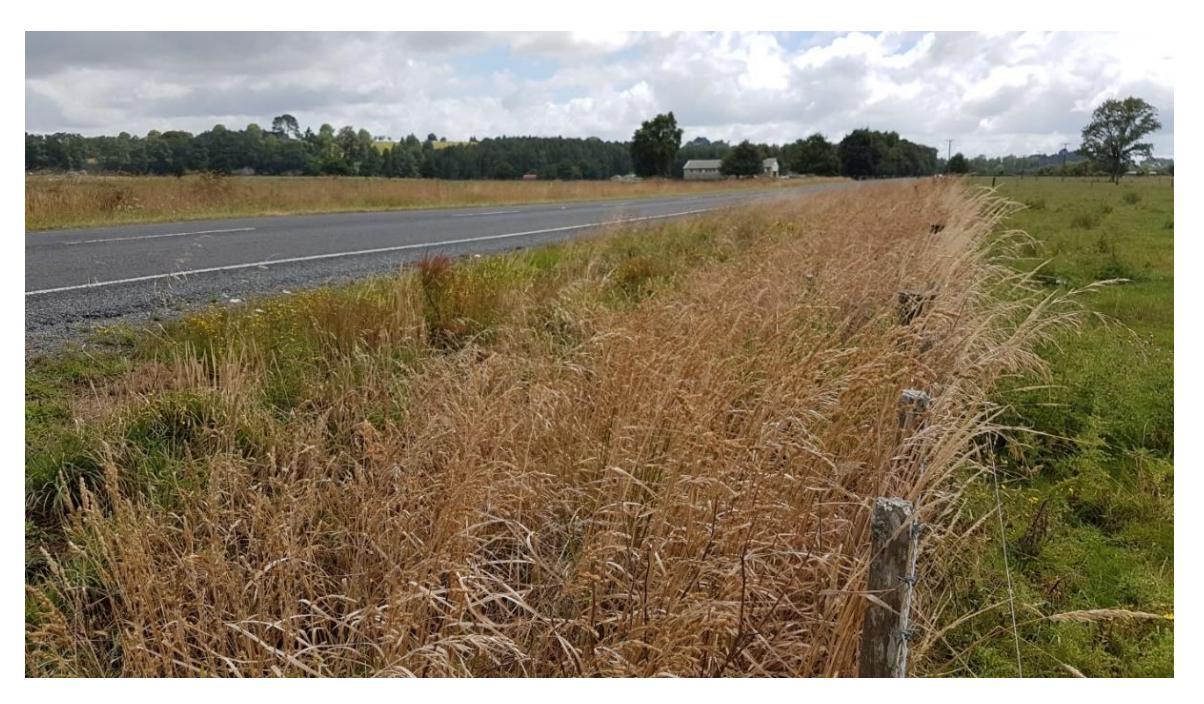
Photo 16: Roadside drain: the eastern side of SH29, looking north-east along the roadside drain on property SA1701/33.

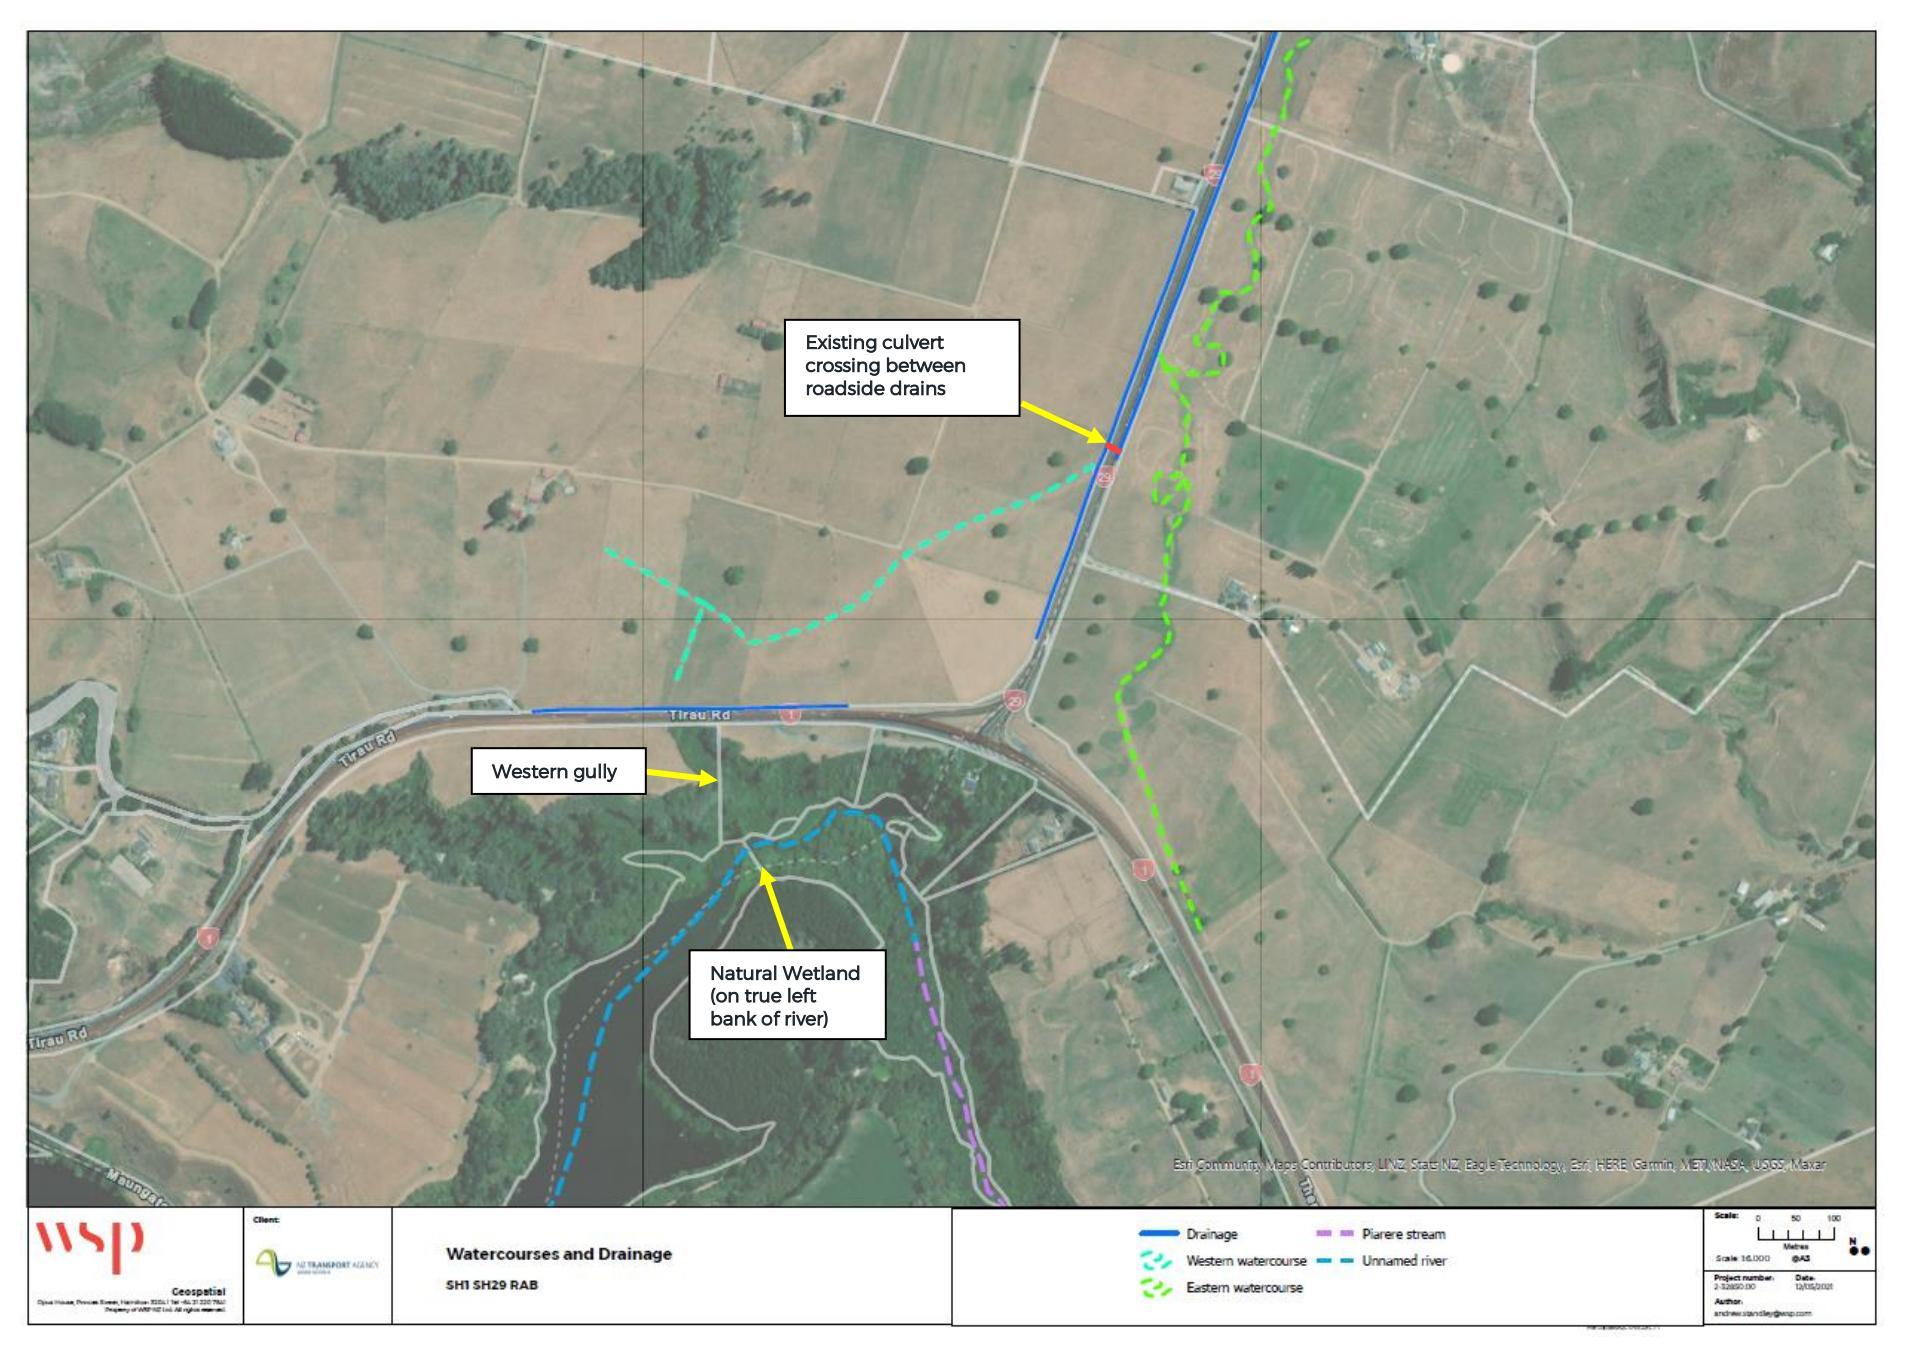
Figure 3-1: Design map showing approximate locations of watercourses, roadside drains and natural wetland within the site.

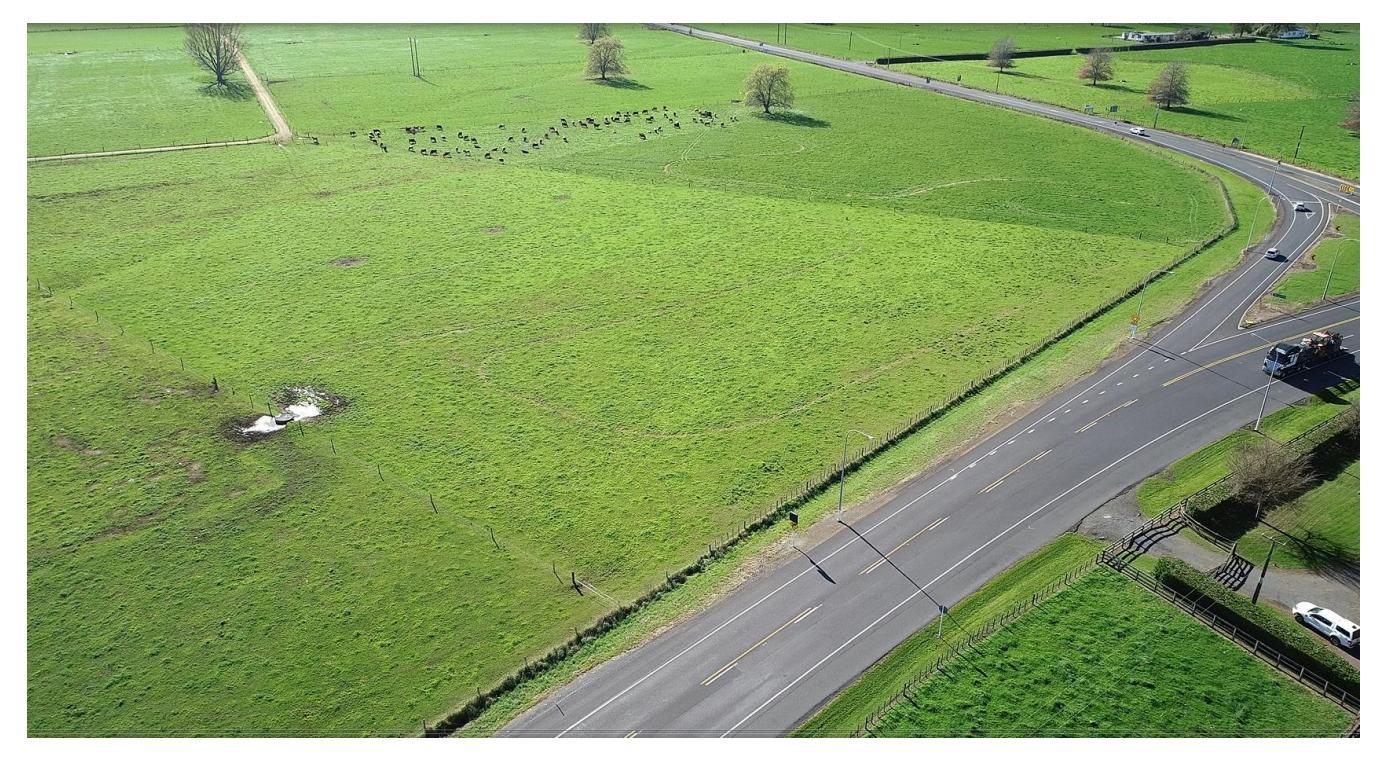
Photo 17: Drone imagery of the overland flow path in June 2021 on the western side of SH29. Looking north east from SH1.

As the overland flow path is only expected to flow for short periods after heavy rain in winter months, it is expected that the watercourse will only periodically support macroinvertebrate taxa that are tolerant of degraded conditions and high disturbance. Due to the ephemeral modified nature, it is unlikely that this watercourse will support native fish.

Overall, based on the ephemeral nature of the watercourse, lack of any riparian cover, poor quality habitat for aquatic biota, and the watercourse being unfenced from stock, the watercourse is considered to have low value.

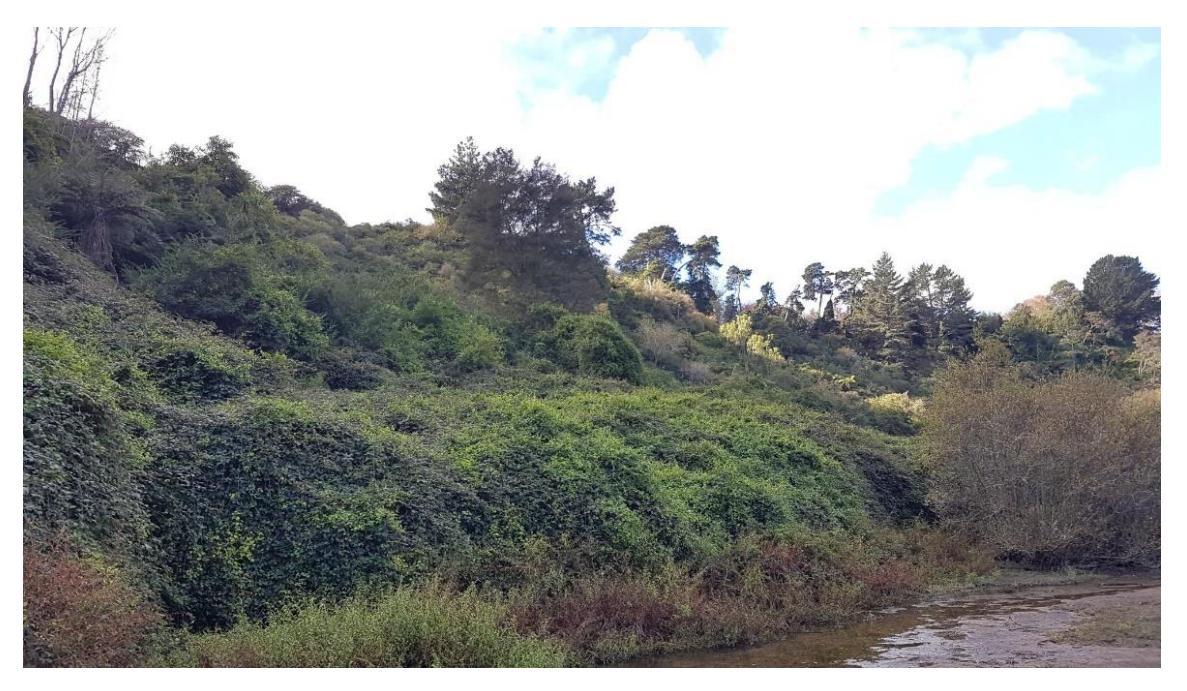
Photo 18: Unnamed River in the vicinity of the proposed discharge point, looking north-east showing the true right bank where the proposed access track will be located.

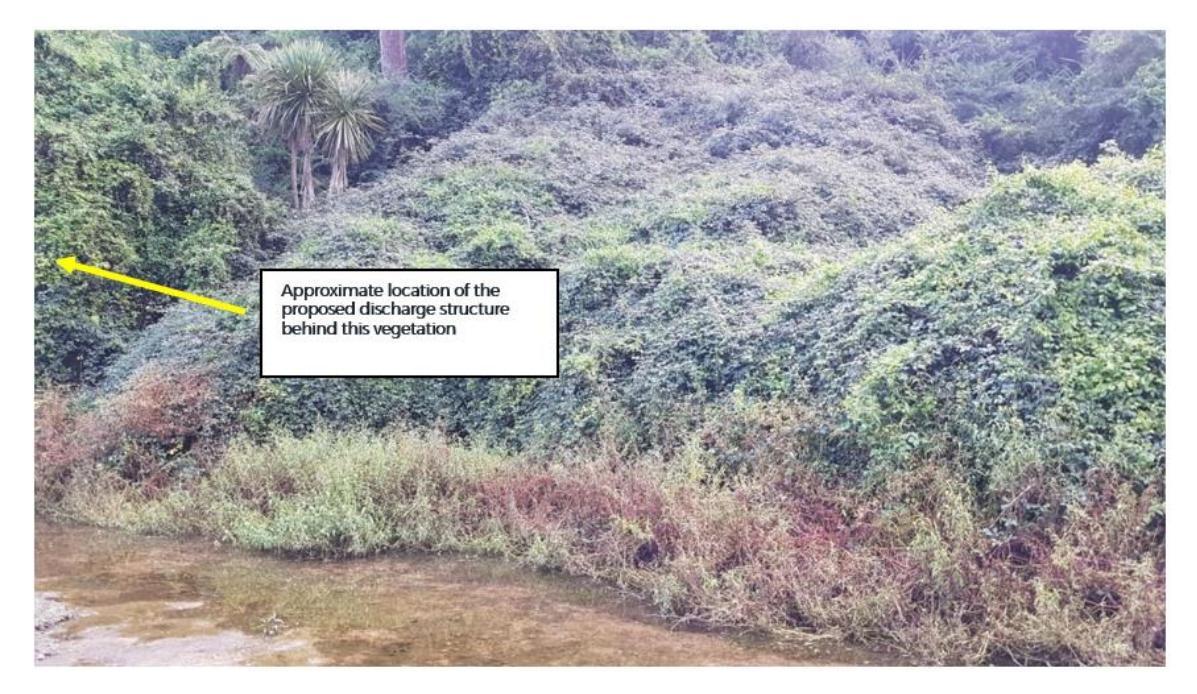
Photo 19: Unnamed River in the vicinity of the proposed discharge point, looking west where the proposed discharge point is located.

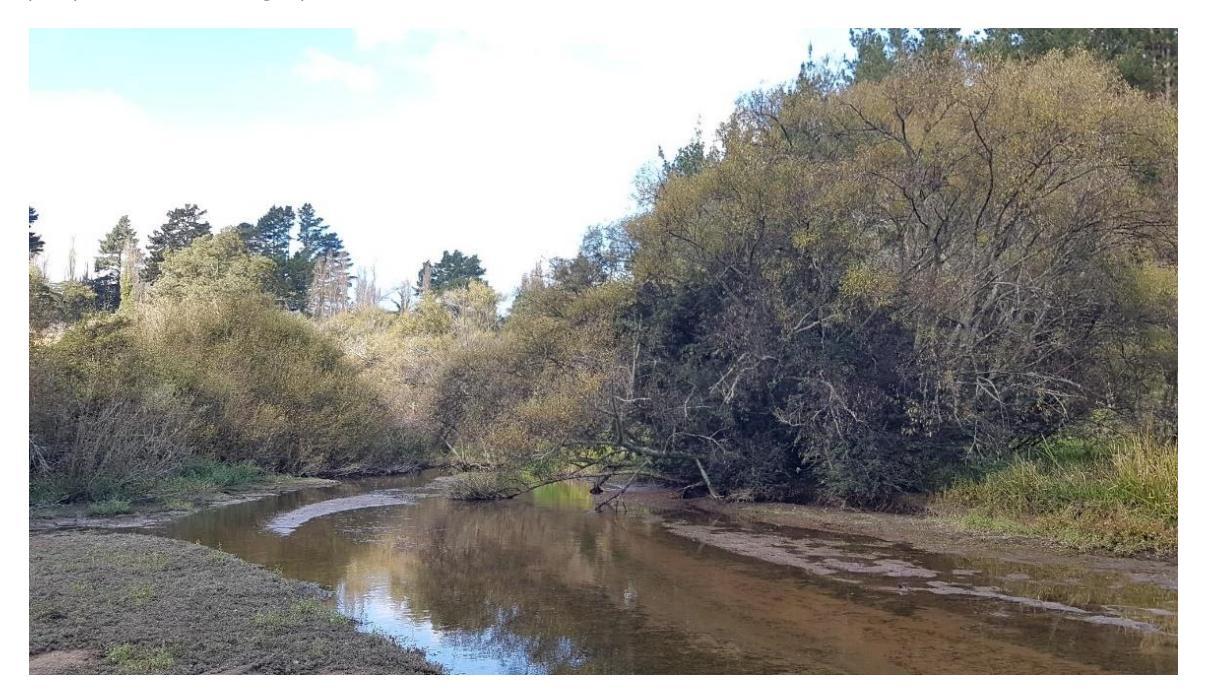
Photo 20: Unnamed River in the vicinity of the proposed discharge point, looking north-east showing both the true left and true right banks. The wetland area is on the right of this picture.
