Project Number: 2-A0012.00

State Highway 1 and State Highway 29 Intersection Upgrade Assessment of Effects on the Environment -Ecology

23 August 2021

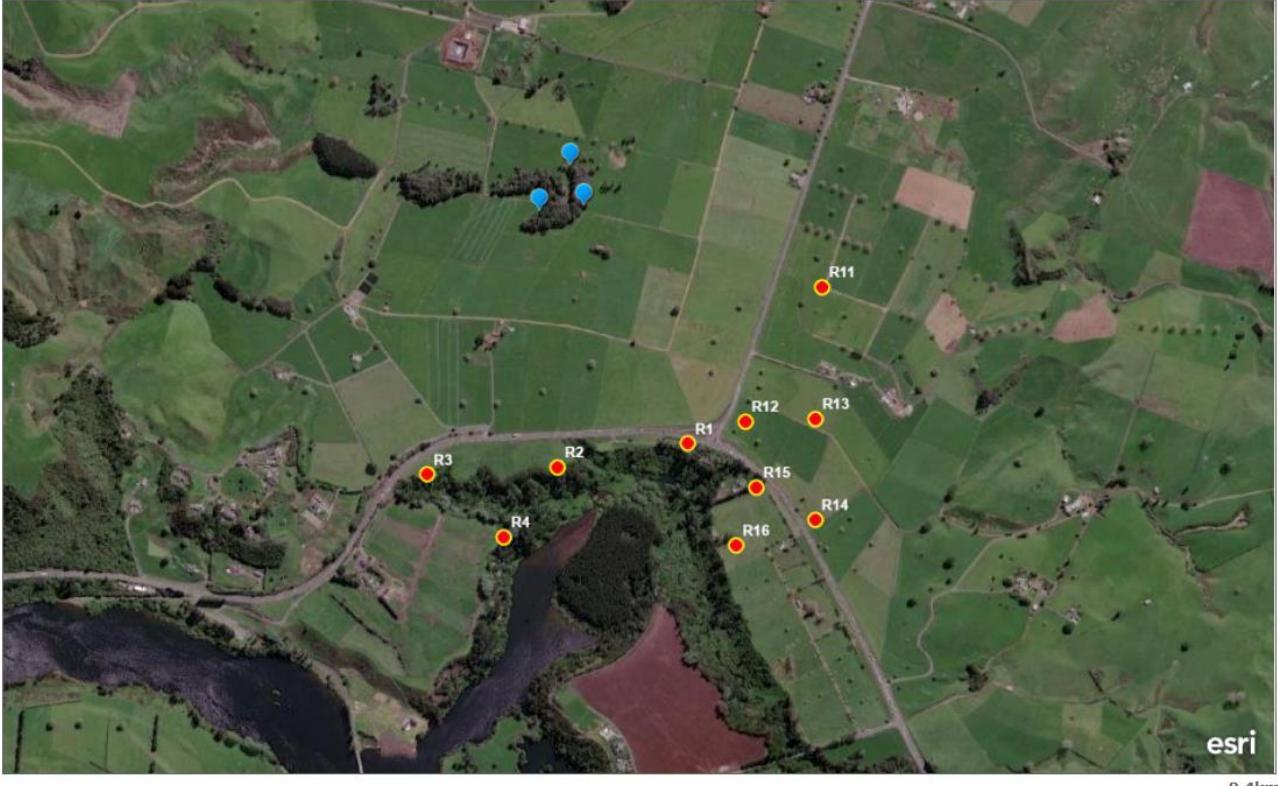
Figure 3-2: Acoustic monitoring locations surveyed between February and March 2021. The blue points show historical records of bat activity taken from the DOC Bat BioWeb Database.

A total of ten ABMs were deployed along properties to the north-east and south of the existing intersection on 26 February 2021. ABMs were deployed continuously for 21 nights where weather conditions remained favourable for bat activity. Once collected, the data were then processed using BatSearch software (DOC). Figure 3-2 provides a map of bat monitoring locations.

Site # (refer to Fig 3-2 for location)	Total passes (21 valid nights)	Mean activity levels ± SD
RI	101	4.8 ± 4.3
R2	5710	271.9 ± 88.1
R3	518 (failure after 15 nights)	34.5 ± 23.5
R4	92 (failure after 1 night)	92.0 ± 0.0
RII	66	3.14 ± 2.9
R12	43	2.04 ± 1.8
R13	98	4.7 ± 2.6
R14	49	2.3 ± 1.9
R15	Failure	-
R16	28	1.3 ± 1.5

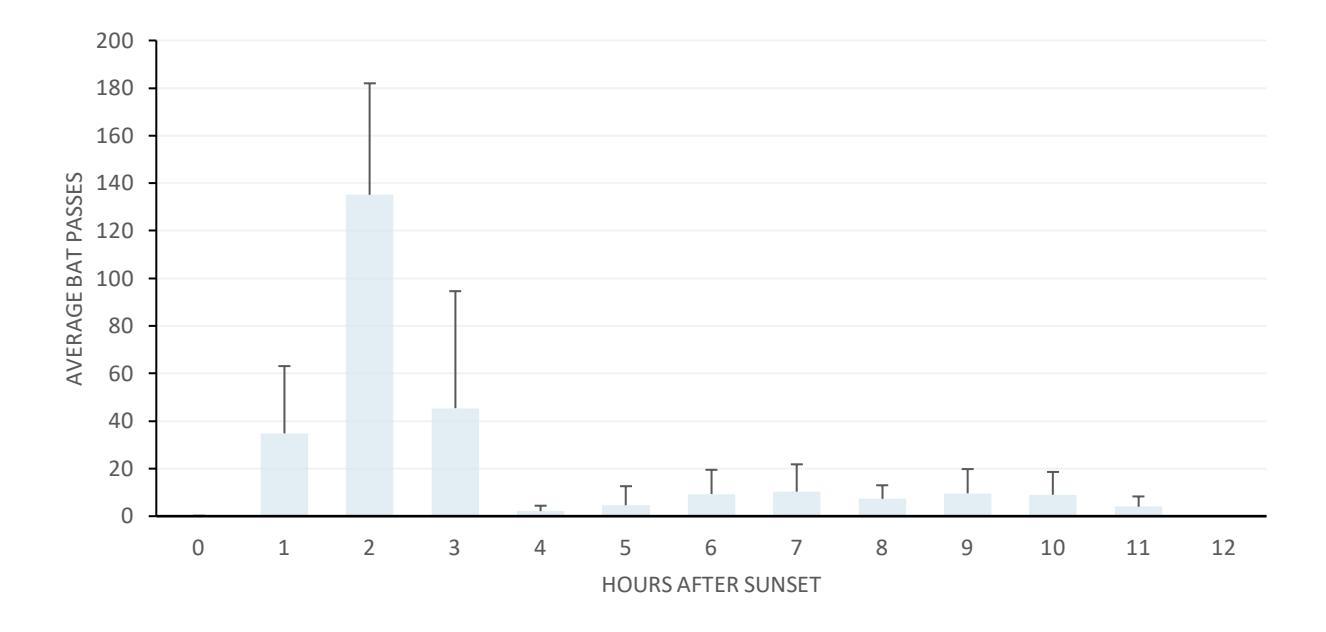
Figure 3-3: Average bat activity (+ std dev) recorded at site R2 at each hour after sunset.

The timing of activity recorded at Site R2 (closest site to proposed gully stormwater footprint) shows that bats were recorded at higher levels within the first one to two hours after sunset (Figure 3-3.) All other sites showed reasonably consistent low activity at each hour after sunset (Figure 3-4).

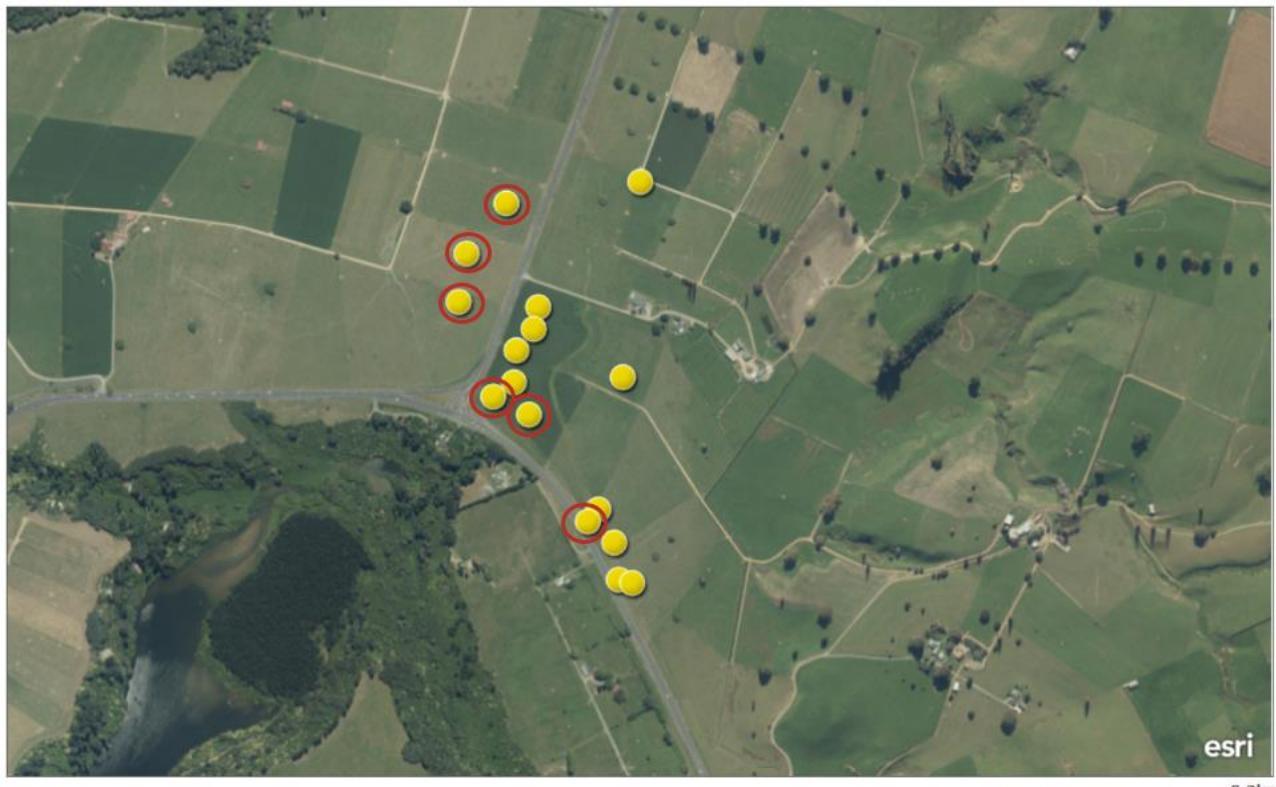
Figure 3-5: Trees assessed as potential bat roosts within the roundabout footprint and adjacent. Those trees circled in red are proposed for removal.

Three plane (*Platanus sp.*) trees that are located on the property on the western side of SH29 (SA69C/317) were viewed from across the road (Figure 3-5). Based on the report and the author's knowledge of exotic trees of that size, it is possible that they have at least some features for bats to

roost. Therefore, they are considered to have moderate suitability for a bat roost which excludes potential maternity or communal roosts. All three trees will be removed for construction of the roundabout.

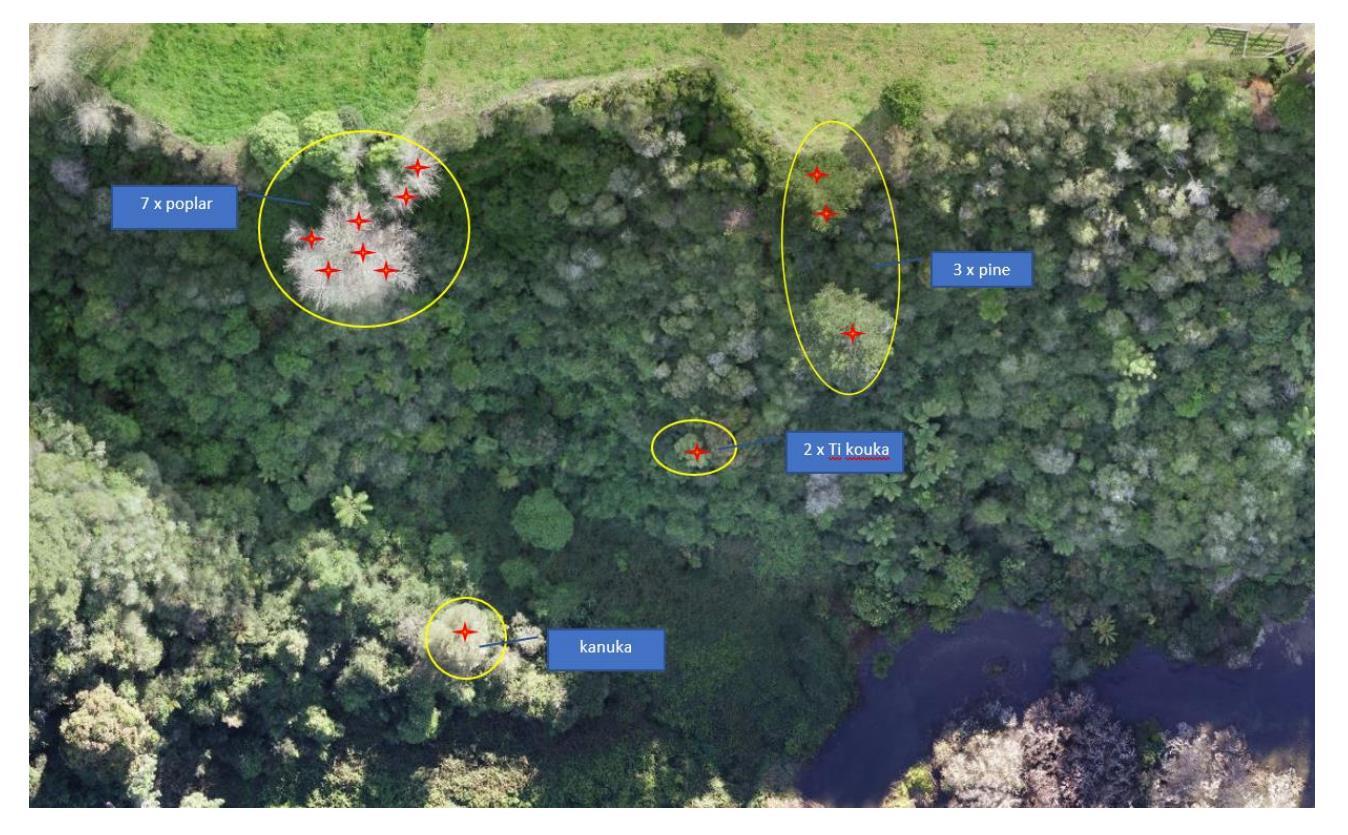
Figure 3.6: Drone image of western gully showing trees already identified as having moderatehigh suitability for roosting bats (the trees circled on this map will be avoided). There are also a number of scattered tree ferns, cabbage trees, and privet that were identified as having some suitability as roosts, but a detailed assessment will be undertaken once the location of the access track has been refined.

As the potential roost trees are reasonably scattered throughout the proposed gully stormwater footprint, it may be possible to avoid all higher quality roost trees with minor alterations to the access track and only remove the lower-quality bat roost trees such as privet and tree ferns.

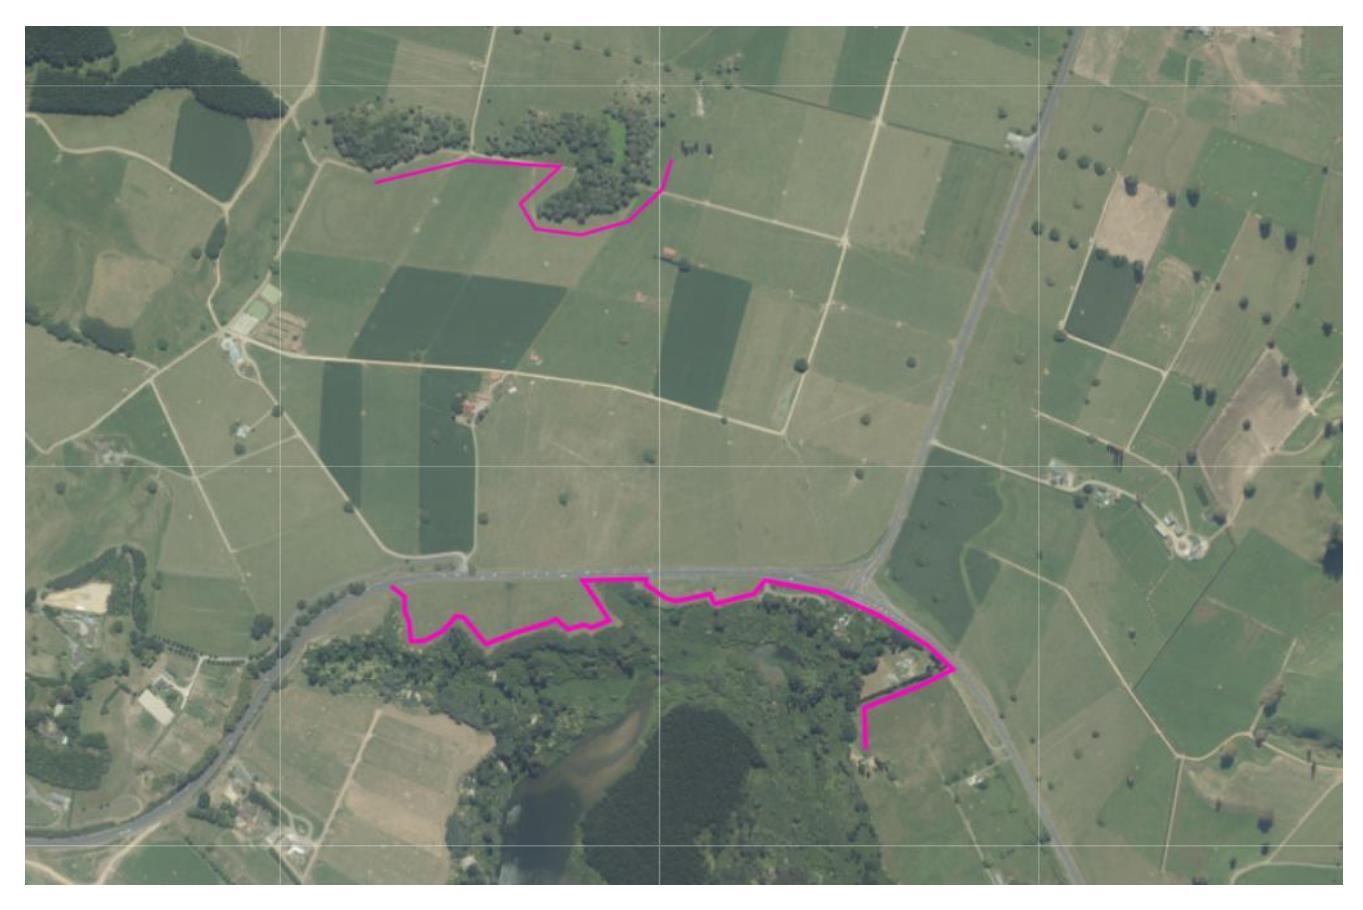
Figure 1. Key bat habitats where light levels will not exceed 0.3 Lux.

- Luminaires shall produce no direct upwards light;
- Luminaires shall have a maximum colour temperature of 2700K (white); and
- Light levels on the boundary of key bat habitats (as presented in Figure 1) will not exceed 0.3 Lux.
